**ABANDONED MINE
SITE INVESTIGATION
OF THE
IDORA MINE SITE
ALONG
BEAVER CREEK
IDAHO**

U.S. Army Corps of Engineers, Sacramento District and
U.S. Army Corps of Engineers, Omaha District

Bitterroot Restoration, Inc.
445 Quast Lane
Corvallis, MT 59828

July 28, 2003

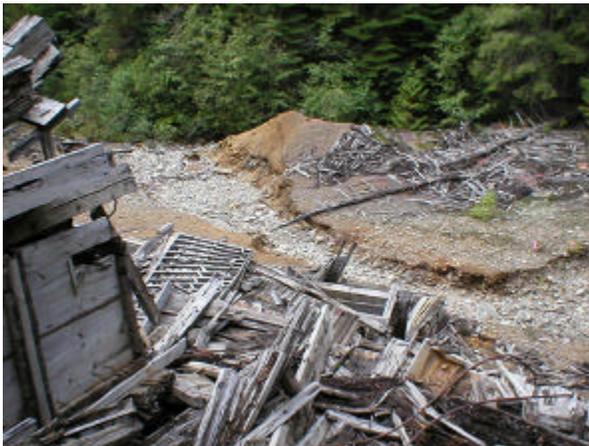
Photo of the Idora Mine looking down on Beaver Creek

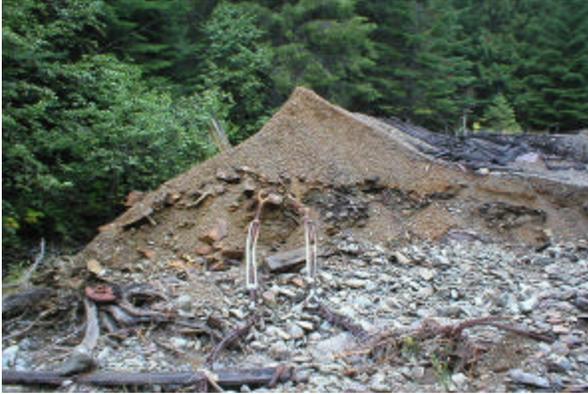
Tailings piles on Subreach 2

The stream gradient (8 percent) is moderately steep. The tailings piles are virtually devoid of vegetation. However, the remaining 80 percent of the subreach floodplain is well vegetated, both in terms of plant coverage and plant diversity. One habitat type, defined by the dominance of Western Redcedar in the overstory and Lady Fern in the understory, is found in Subreach 2. This short segment is approximately 400 feet long and ranges from 3,501 feet to 3,469 feet in elevation.

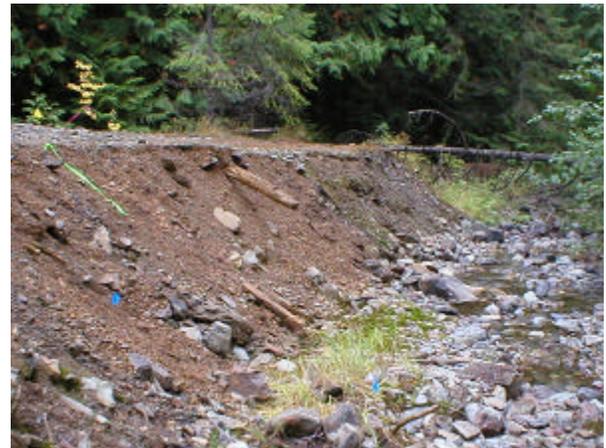
Subreach 3 is characterized by numerous braids cut down into terraced tailings. The stream incline is moderately steep, eight percent. Similar to Subreach 2, the area surrounding the stream is a barren tailings and waste rock terrace. Most of the floodplain, however, is well vegetated by numerous plants that fall into a single habitat type: Western Redcedar/ Lady Fern. This approximately 800 feet long segment ranges in elevation from 3,469 feet to 3,406 feet.

Creek braid cut into a terraced tailings pile on Subreach 3

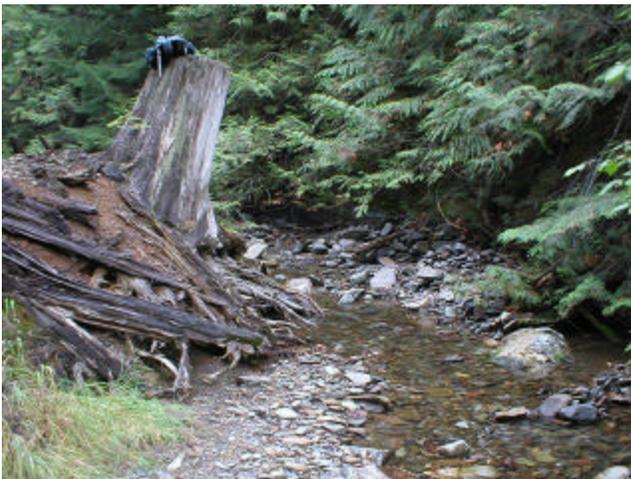
Forested hummocks pile and cedar forest on Subreach 4

Subreach 4 ranges from 3,406 to 3,375 feet in elevation. This 430 feet long subreach is confined on the right side by relatively high embankments and an old road. The left side is open, containing a wide cobbled floodplain. Forested hummocks (tailings piles) and cobble piles are interspersed throughout the floodplain as a result of aggradation. Subreach 4 is characterized as a boulder/log cascade sequence with a moderate (seven percent) incline. It is also classified as a Western Redcedar/ Lady Fern habitat type.

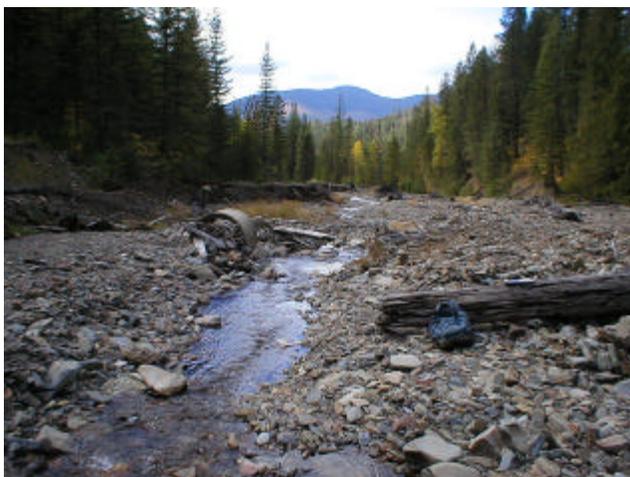
Wide cobble floodplain on Subreach 7

in elevation. The bottom of the subreach, at 3,068 feet in elevation, is at the confluence of Beaver and Carbon Creeks. Its lower end is populated with tailings and cobble piles. This approximately 1,500 feet long reach has a moderate incline (five percent) with numerous high flow scour channels. The wide, rocky floodplain associated with this subreach is sparsely vegetated. There are, however, a few bermed areas with grasses, forbs, and conifers. An estimated 30 percent of Subreach 7 is dominated by the Western Redcedar/Lady Fern habitat type. An additional 70 percent is categorized as an unclassified habitat type that is dominated by cobbles. This subreach lacks fine soil material.

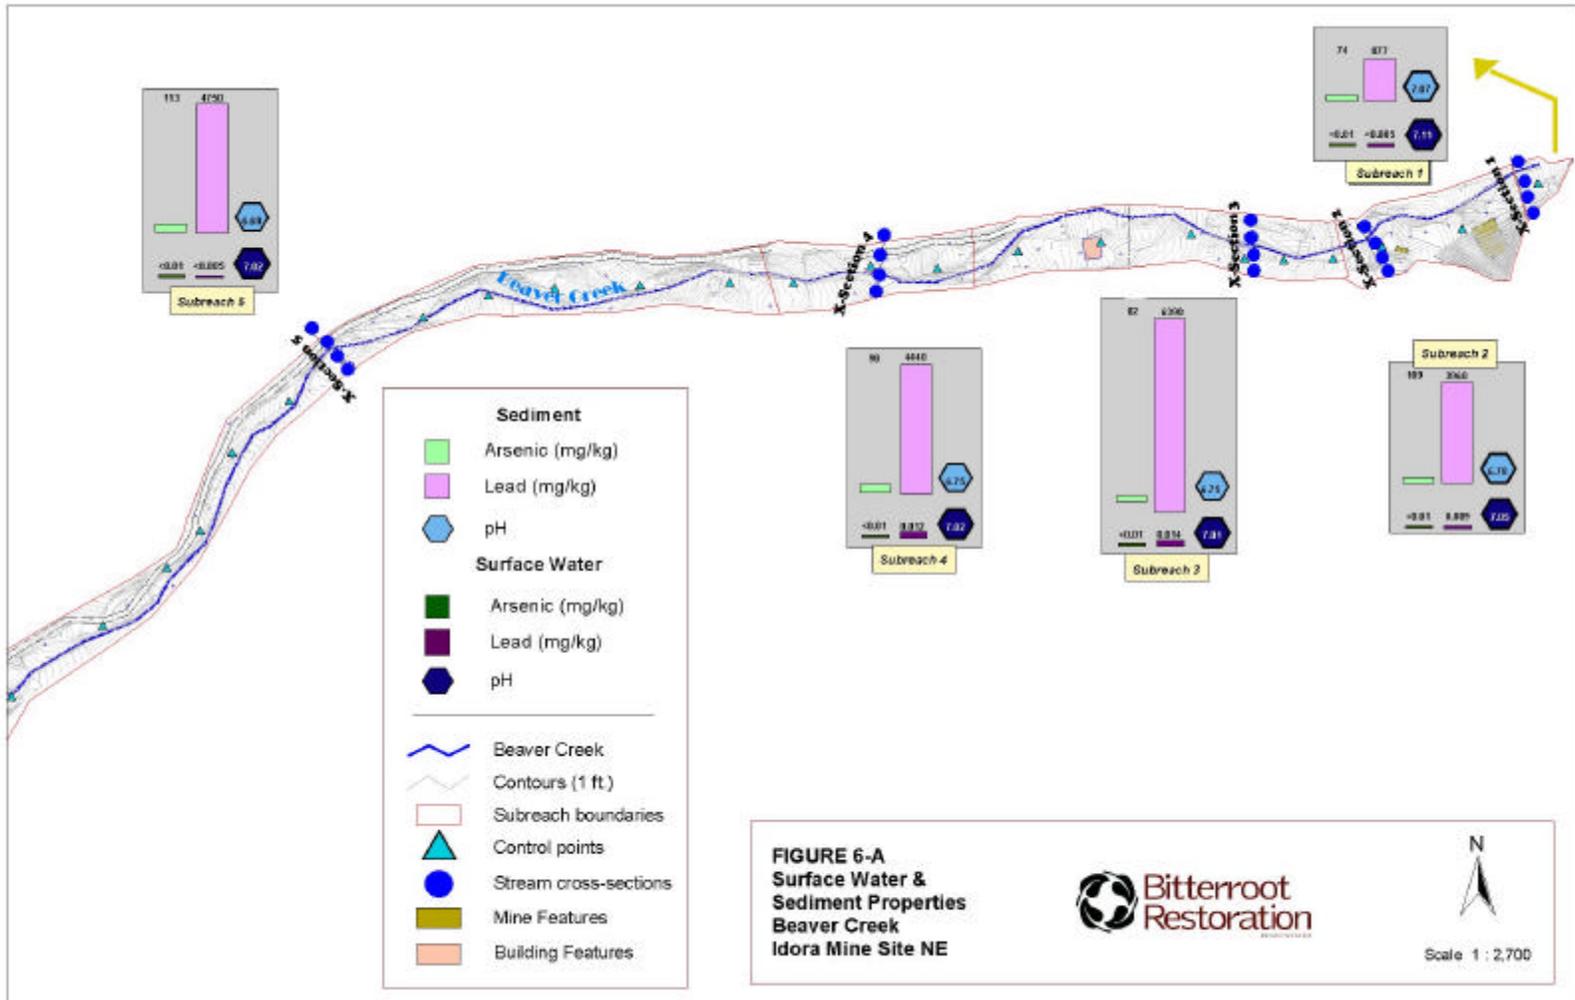
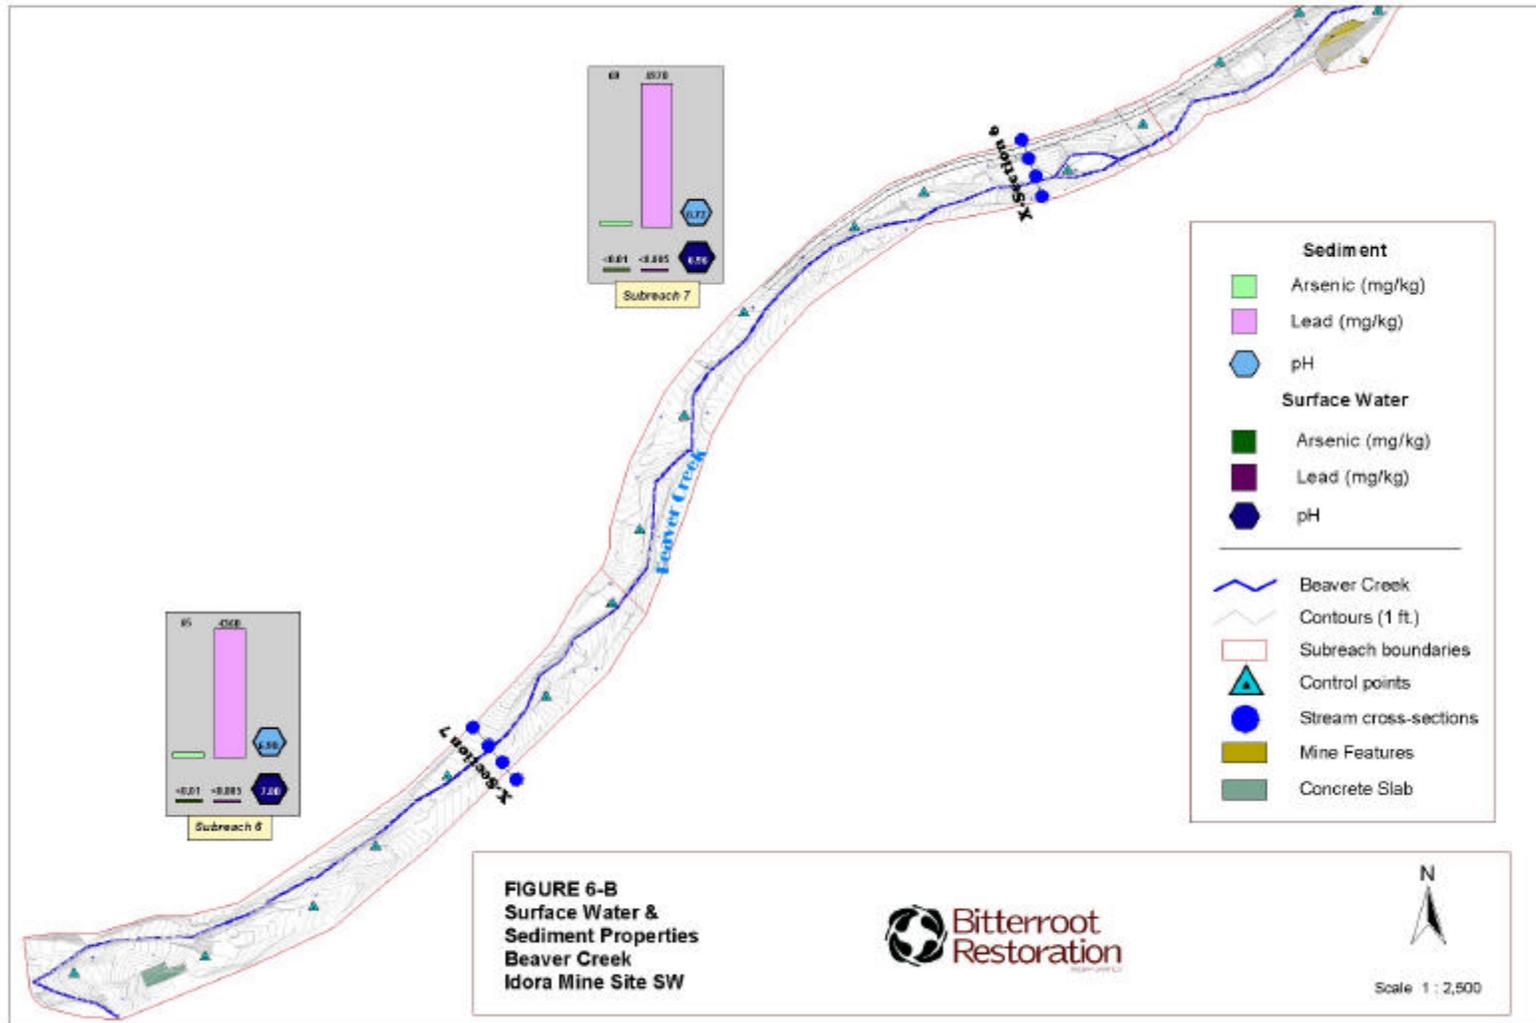
Figure 6-A.

Seven sediment samples were collected and analyzed for total metals, pH and conductivity. These results (see Table 7.10 and Figures 6-A and 6-B) indicate that, like surface soil/mine waste samples, a significant percentage of streambed samples contained high concentrations of lead. Although other metal concentrations are elevated, they do not exceed the recommended thresholds for recreational users.
