## **Appendix F**

# **Hazardous, Toxic and Radioactive Waste**

The United States Army Corps of Engineers (USACE) Albuquerque district has completed a hazardous, toxic, and radioactive waste (HTRW) Phase 1 Site Assessment per ASTM Standard D6008-96 (2014) to evaluate the environmental baseline conditions at Spring Creek, Co, as part of the Spring Creek restoration project. The project Site is located along Spring Creek in central-east Colorado Springs, CO. (Figure 1). Subject Site is currently owned by the sponsor.

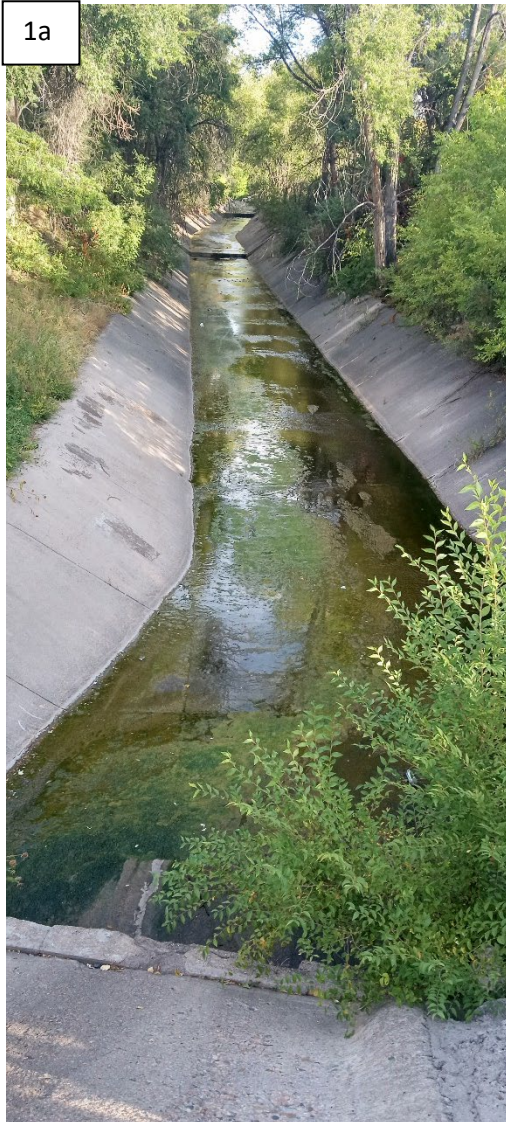
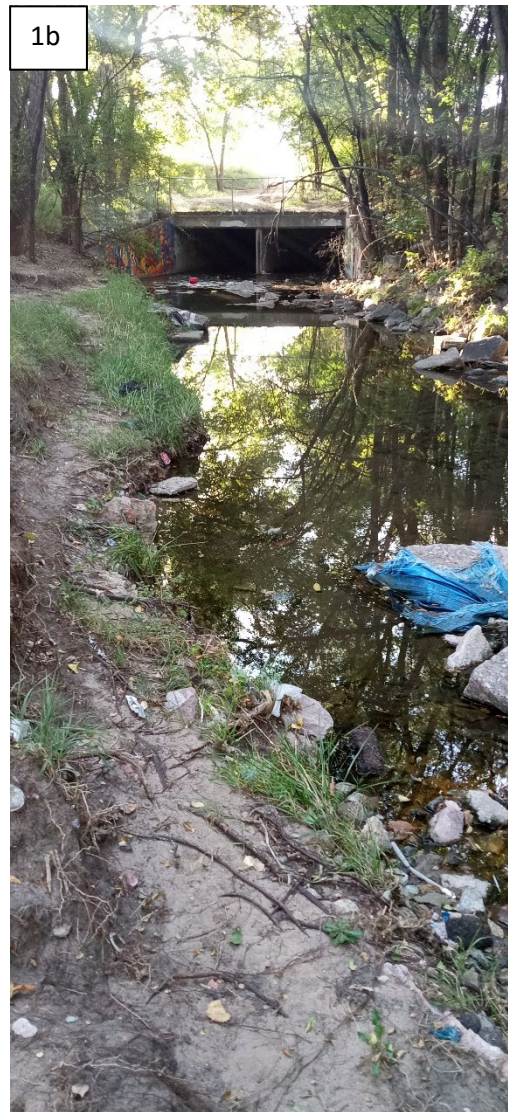
Reach 1:

Figure 1a and b. View looking along the channelized Spring Creek and the underpass at to the south of E Platte Ave showing solid waste.

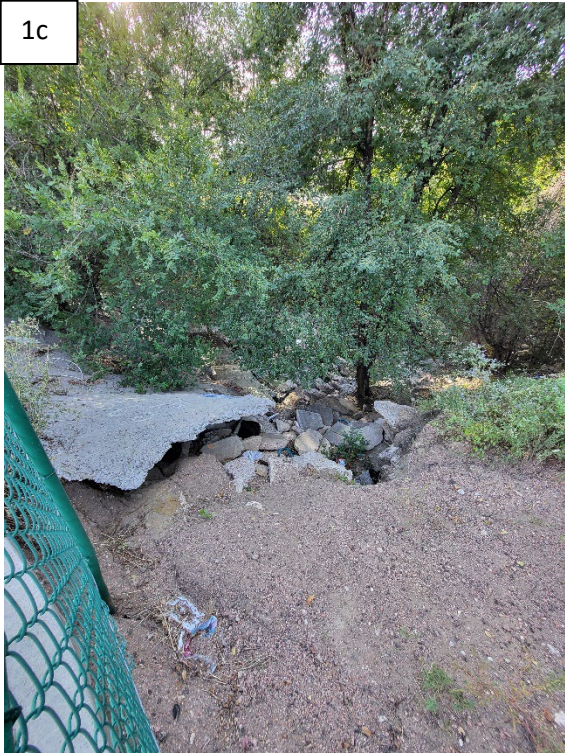
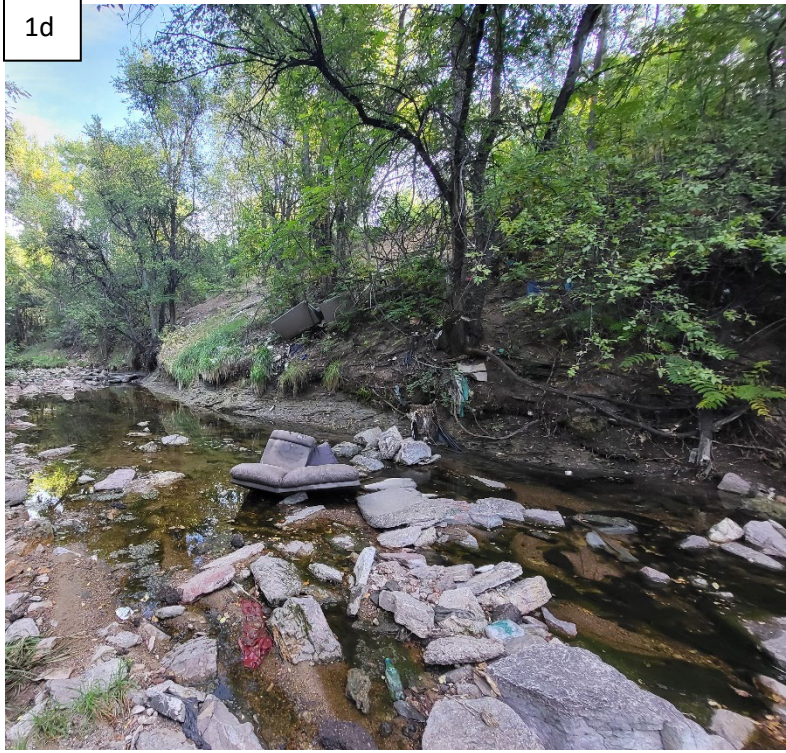
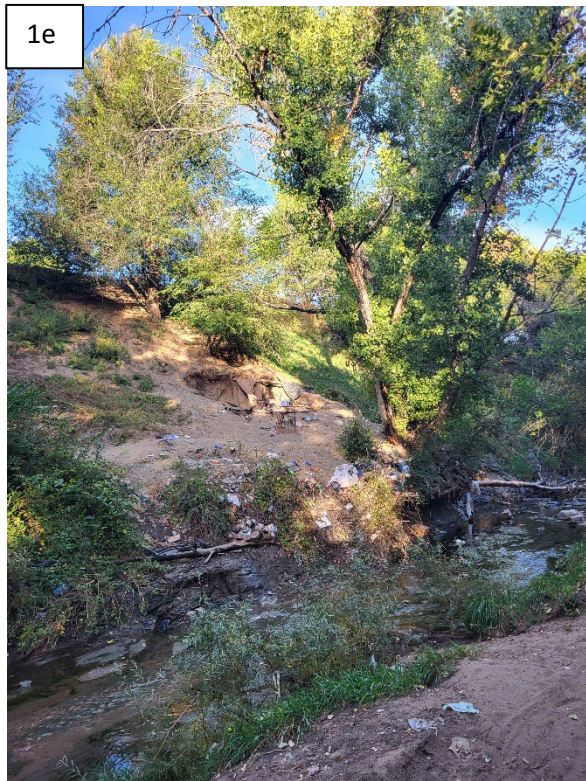
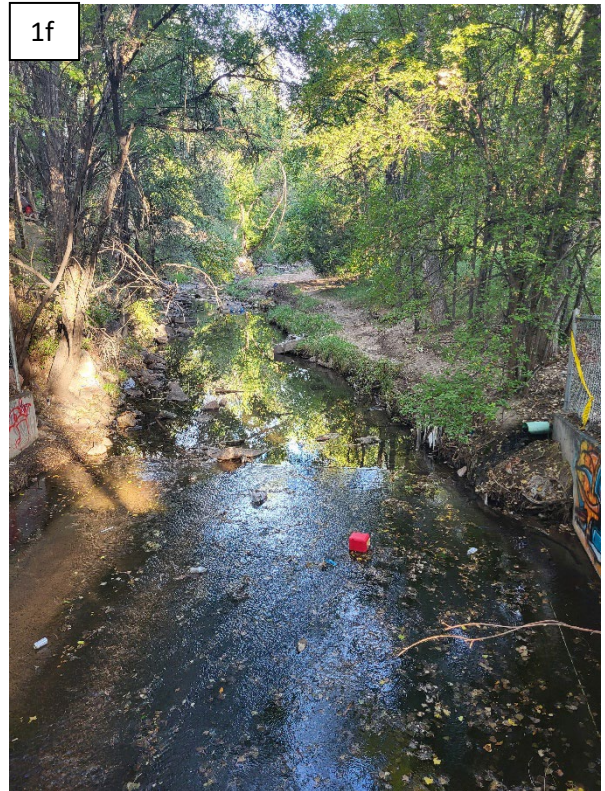
The concrete could be left over from construction of storm drains, culverts or be brought in during flooding events. Large concrete slabs have eroded from the bank, fallen into the stream and act to trap trash. Stream water is clear, with low turbidity.

Figure 1c, d, e and 1f. Accumulations of solid waste and section of concrete slab that have entered Spring Creek

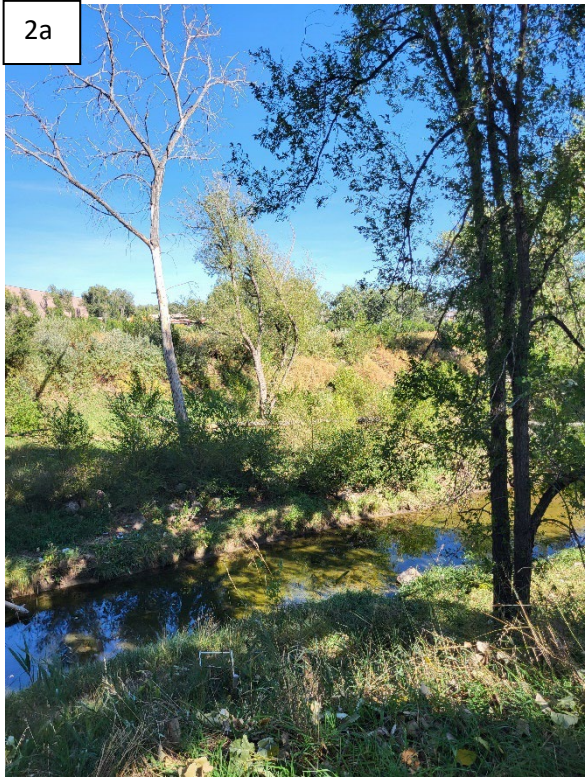
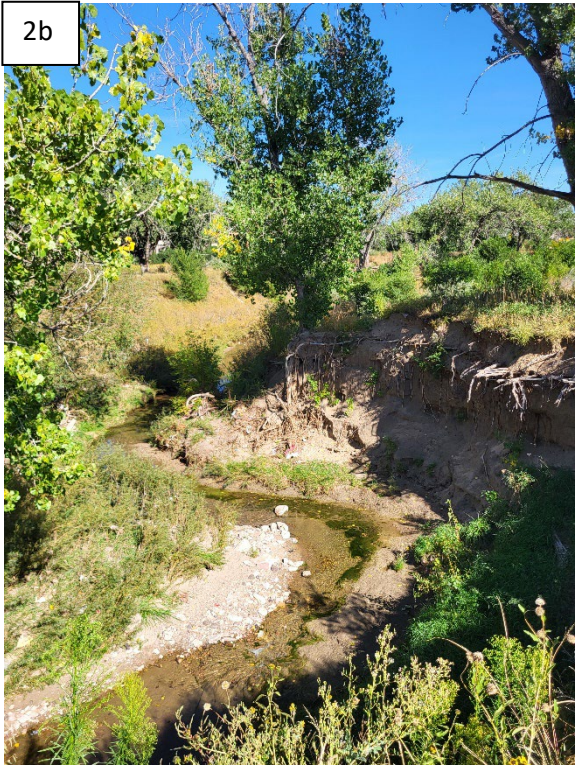
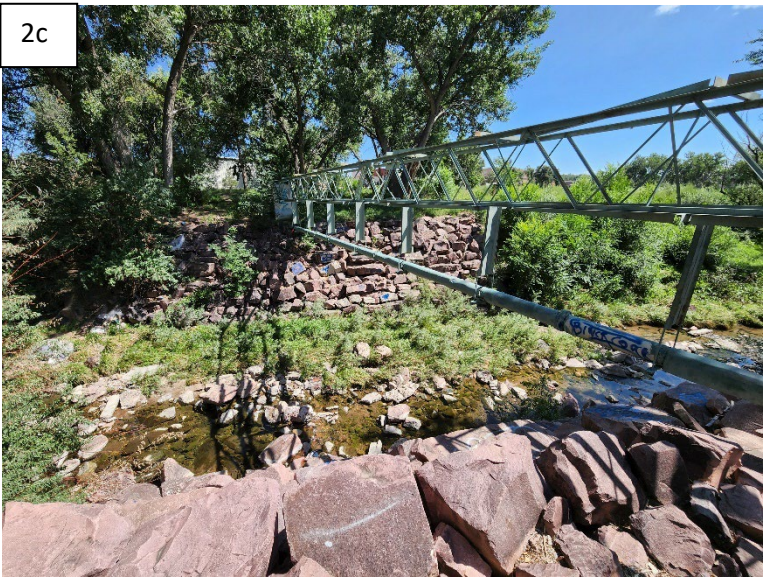
Reach 2

The Site has steep tree line banks leading down to stream, in places there is little surface vegetation. Sections of the stream bank have been eroded back to vertical, up to 10 feet high with exposed sediment. These two features will likely lead to high levels of erosion during large precipitation events. Erosion may expose buried substances. Graffiti exists on entrances to tunnels/culverts. In reach 2, the former wetland site, a sewer pipe crosses the stream, and appears to be well maintained. There are multiple homeless encampments at the Site, with associated debris.

Figure 2a, b and c. The natural banked channel, river incision and erosion of bank, and aerial sewer line

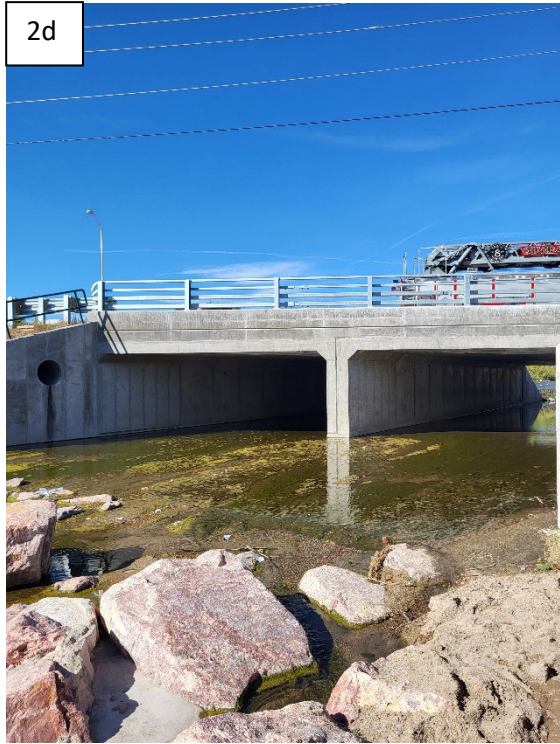
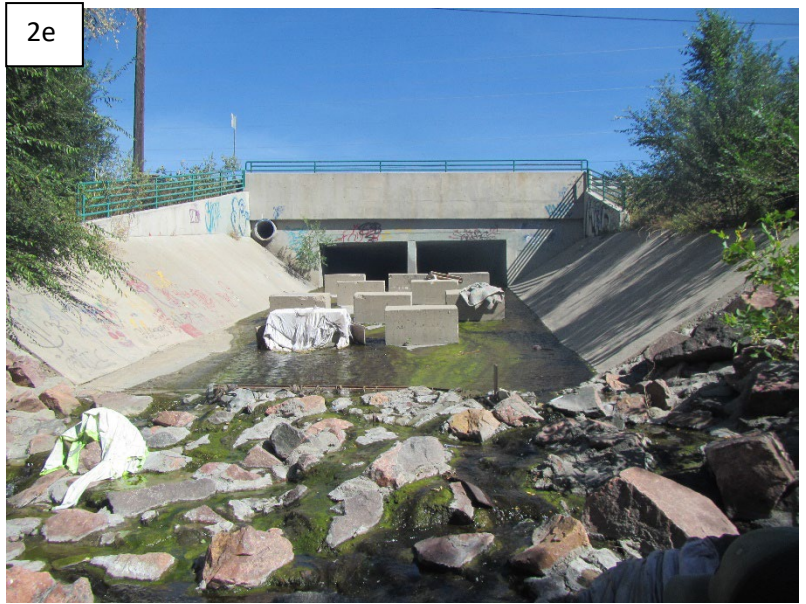
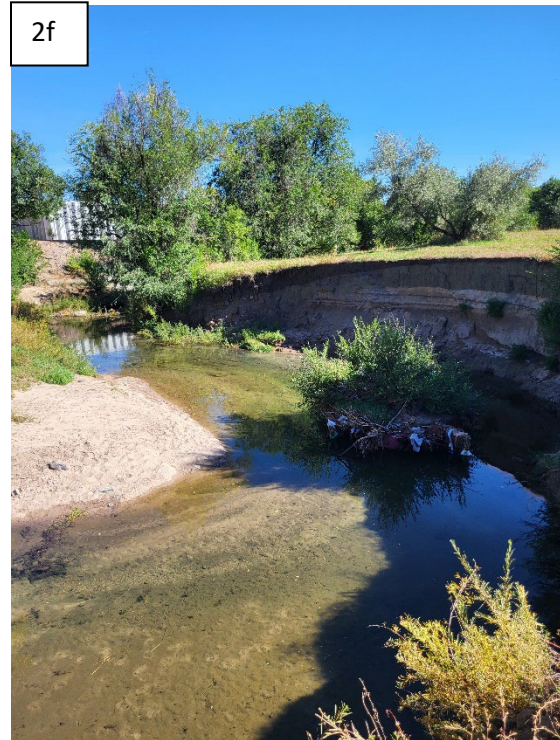
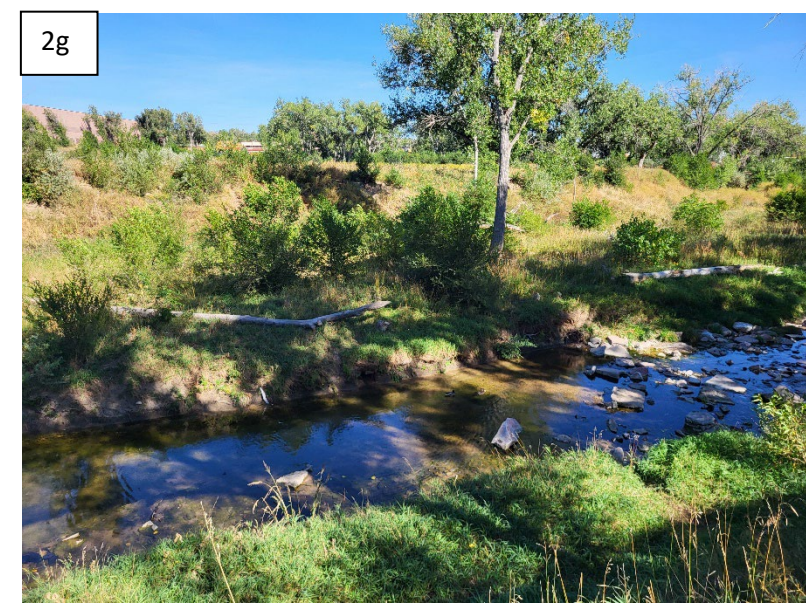
Figure 2d, e, f and g. Culverts at Airport Rd and Academy Rd, river incision and bank erosion and solid waste in river.

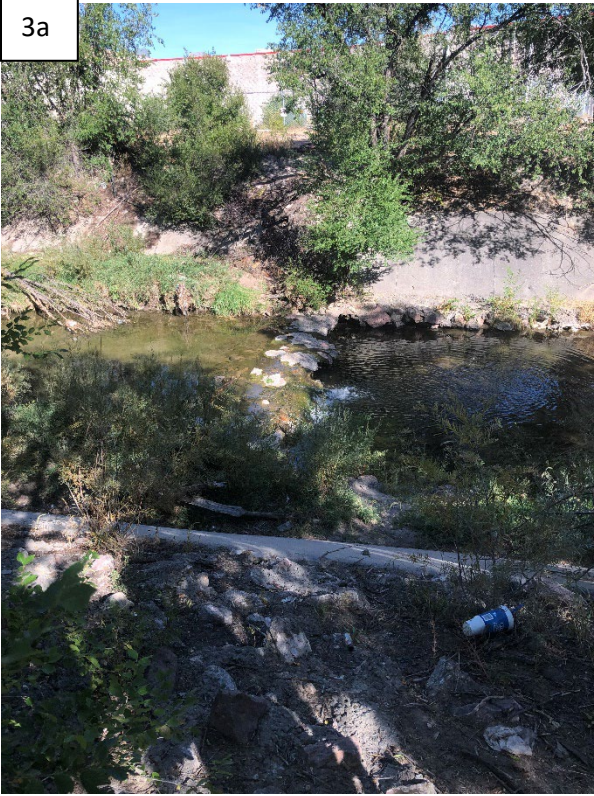
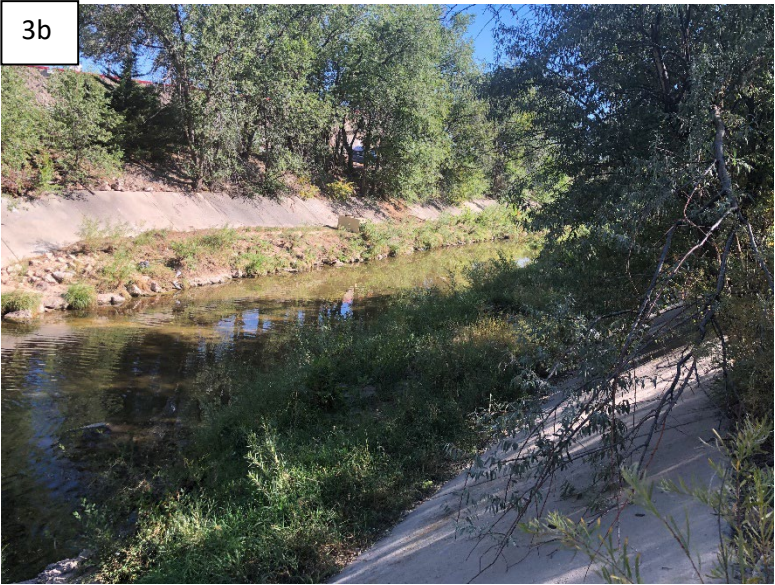
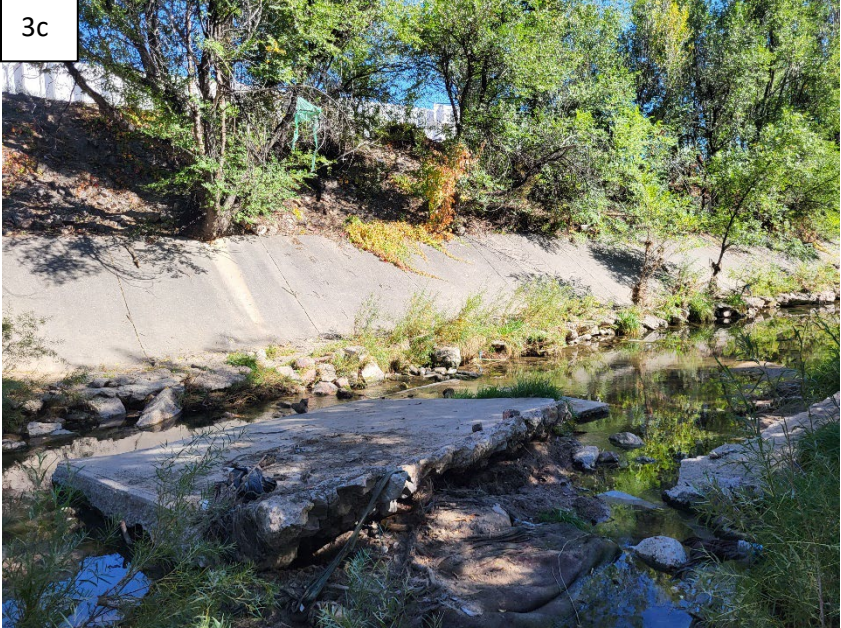
Reach 3

Figure 3a, b and c. Wier, concrete lined channelized section with concrete slab in river

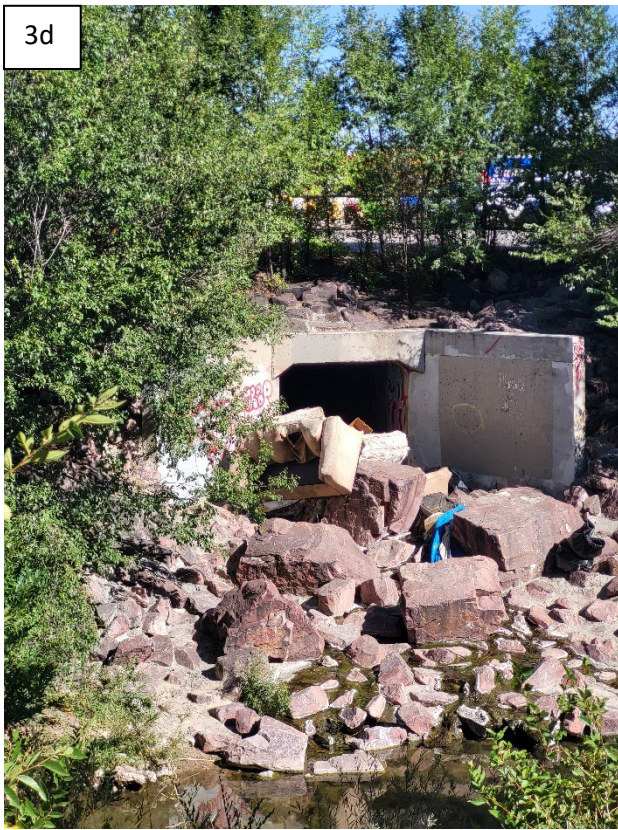
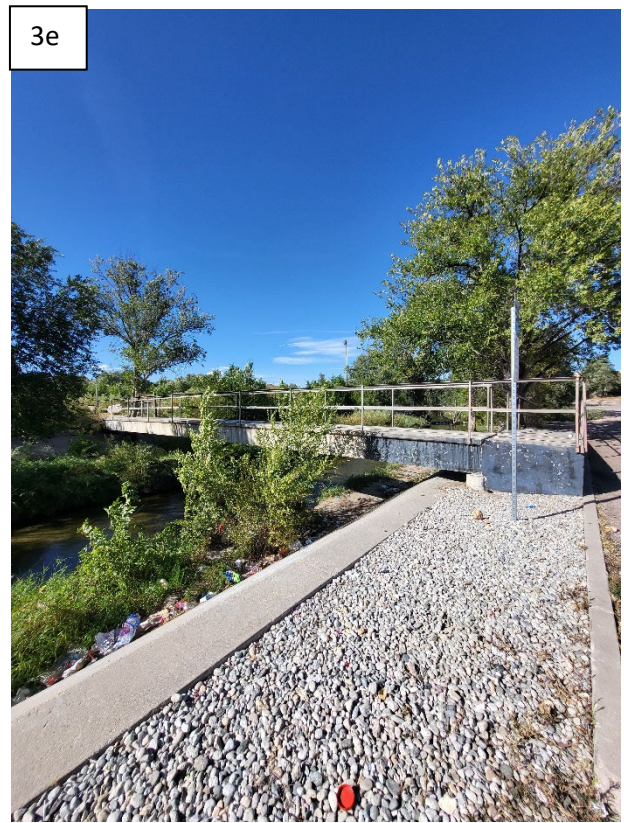
Figure 3d and f. Culvert and foot bridge crossing Creek both with solid waste accumulation.
