# **PROSPECTUS**

# Stonewall Springs Wetland Mitigation Bank Pueblo County, Colorado

Bristlecone Ecology 2023 W. Scott Place Denver, CO 80211 Dan Maynard, Owner/Ecologist info@bristleconeecology.com

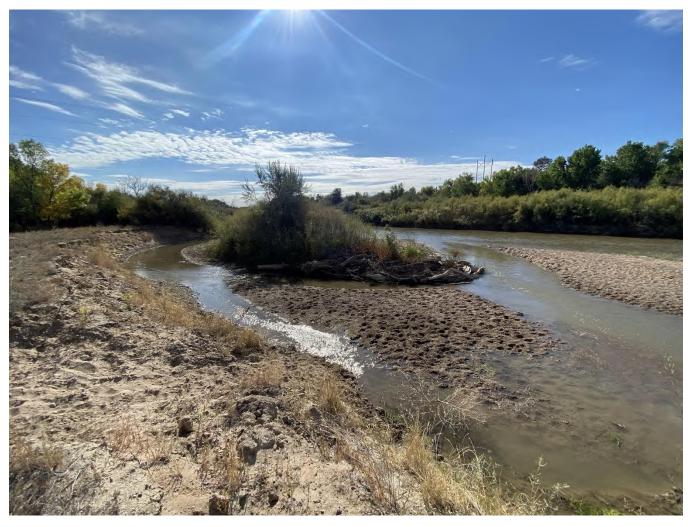
PHOTO 1 – Overview of typical riverine habitat, taken near the southeast corner of the site, facing east toward Nyberg Road. The Arkansas River is a broad, sometimes braided channel throughout the site, with fairly steep-sided banks. The observer is ~6-8' above the riverbed in the photo. Wetlands outside of the river channel are nonexistent on the north bank, and thick with willows, tamarisk, and Russian olives on the south bank.

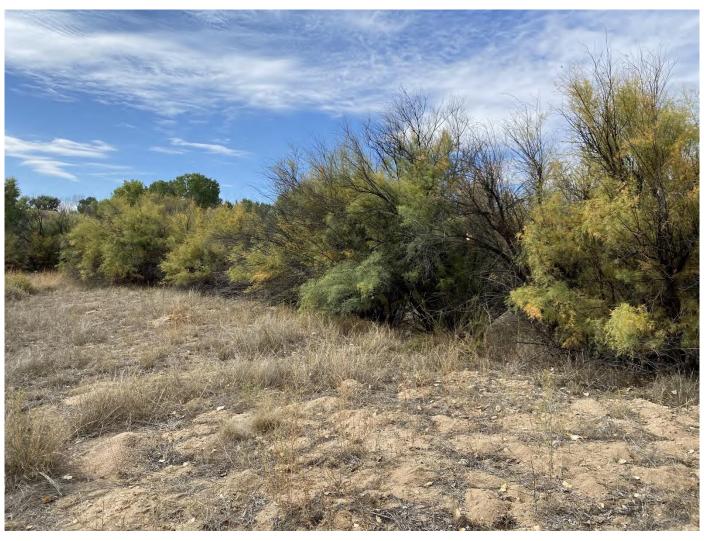
PHOTO 2 – Another overview of habitat along the Arkansas River, looking southeast toward the river from the site. Thick stands of tamarisks guard access to the river in many locations, with dry, weedy fields just a few feet beyond the riparian corridor lining the riverbanks.

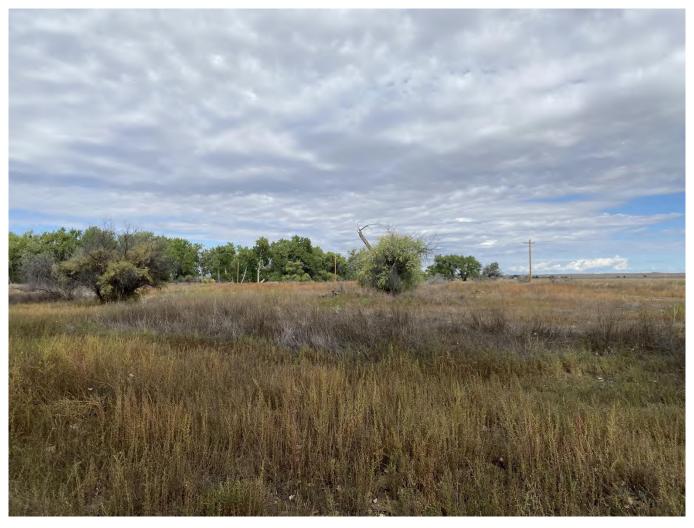
Рното 3 – View of the eastern part of the site facing northwest, with Nyberg Road just visible at right center parallel to the transmission line poles. Overall, much of the site is characterized by weedy fields such as this, with scattered plains cottonwoods forming extensive galleries along and extending out from the Arkansas. These are former agricultural fields and will be quarried down to the water table in future years.

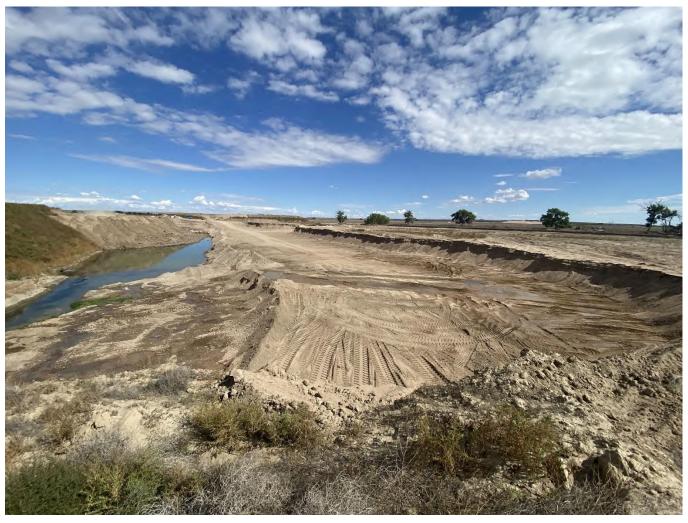
PHOTO 4 – A portion of the site undergoing active quarrying, viewed from the southern half of the Phase 1 Mitigation Area, facing north. The water table has been exposed at this location and the excavated area ponds naturally. This area is being actively pumped, otherwise water would fill in to a much greater depth. Running water can be seen at right center flowing across the center of the photo to fill the ponded area.

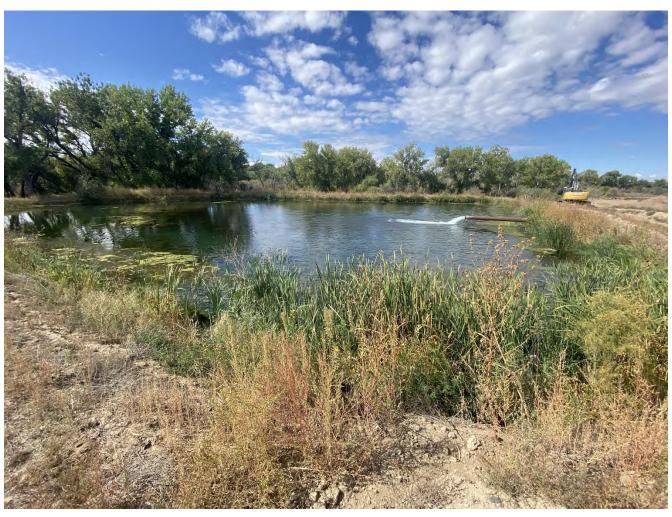
PHOTO 5 – View facing west of groundwater being pumped/piped from the quarry pit in the previous photo into a pond at a higher elevation so it can drain via gravity back to the Arkansas River. Volunteer cattails and hardstem bulrushes can be seen in the foreground around the border of the pond, one of the handful of "preamble wetlands" or excluded wetlands that have formed incidental to the mining operation.

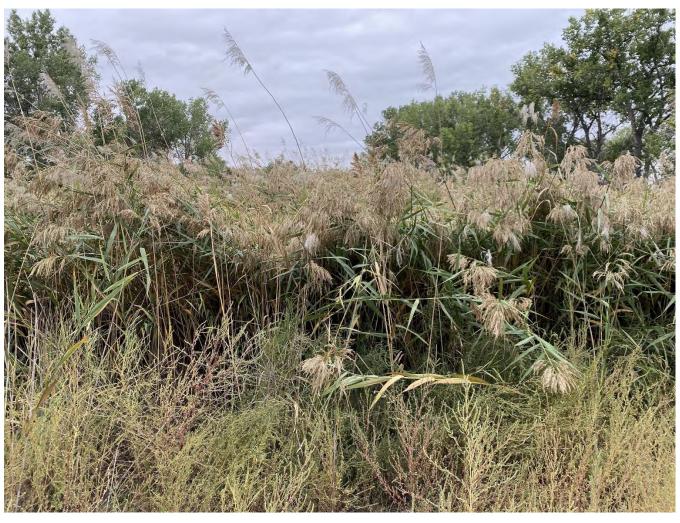
Photo 6 – A stand of common reeds (Phragmites australis) along the Arkansas River near where the ditch through the site empties to the river. Though nonnative and generally considered a low quality wetland plant, naturally occurring common reeds such as these are indicative of the site's potential to support wetlands under the right conditions.

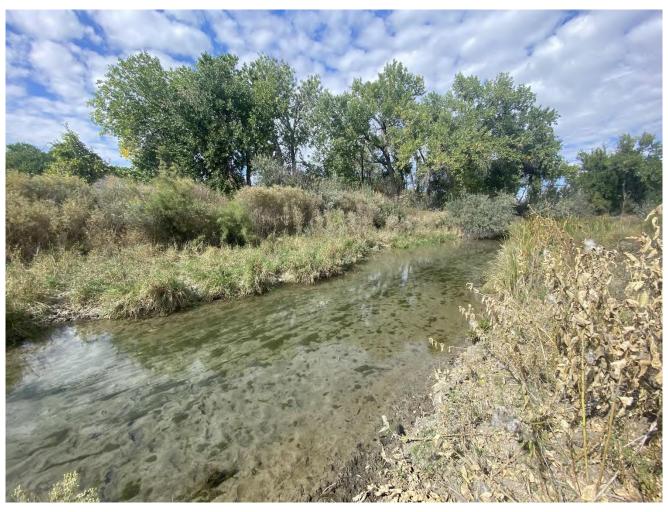
Photo 7 – View of the ditch running through the southwest part of the site, facing southwest. The Arkansas River lies beyond the cottonwood gallery in the background. The area on the far bank is a sort of forested island separated from the rest of the site by the ditch. This area is labeled as a PFOA (Palustrine forested) wetland in the NWI data, but the wetland assessment confirmed very few areas that passed any of the three wetland indicators on this island further than 30 feet from the Arkansas River or the ditch in this photo.

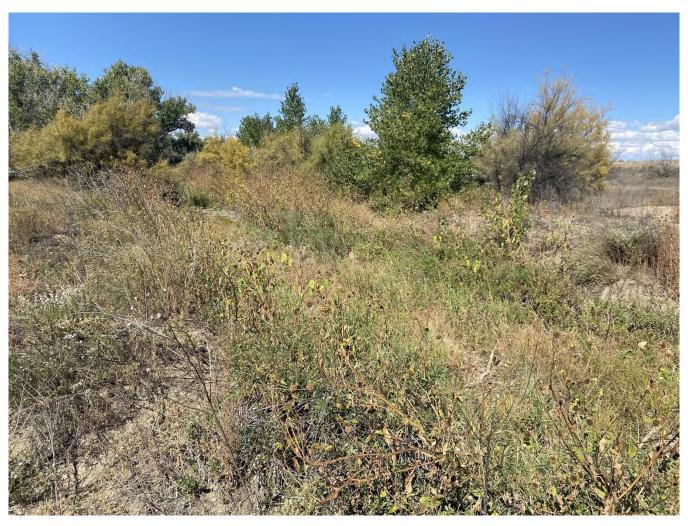
Photo 8 – View of the upper reach of the same ditch from the prior photo, facing northwest. The ditch, which can faintly be seen running from upper left to lower right in the photo, was completely dry at the time of the site visit along this reach. Along the banks of the ditch was mostly weedy upland vegetation such as sunflowers, kochia, lambsquarters, and Russian thistle.

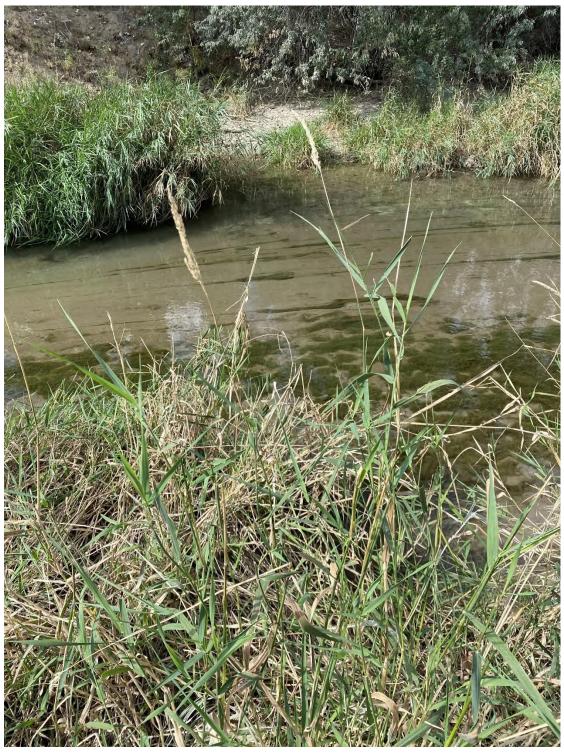
Photo 9 – Typical vegetation along the wetter portions of the ditch includes reed canary grass (Phalaris arundinacea), pictured here, along with sandbar willow, Russian olives, tamarisk, hardstem bulrushes, cattails, and a variety of other grasses.

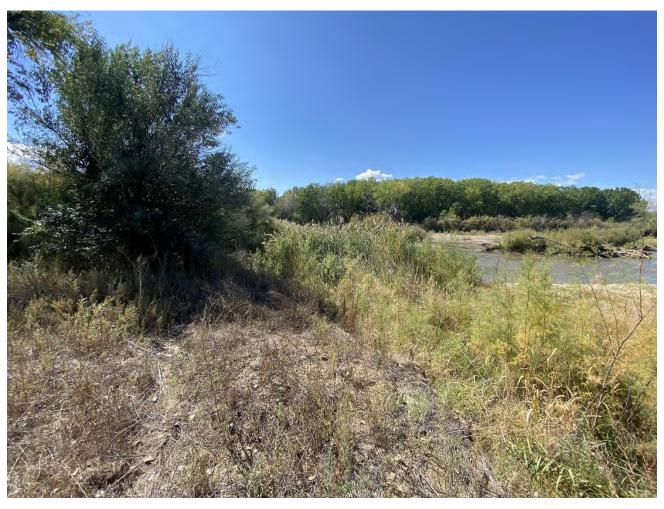
Photo 10 – Another view of vegetation along the Arkansas River, shown at the southwest corner of the site, facing southeast. Common reed, reed canary grass, sandbar willow, Russian olive, tamarisk, cottonwood, and cattails can all be seen along the riverbed and adjacent floodplain. Vegetation quickly transitions to upland plants away from this area, just a few feet to the north. This photo highlights how critical elevation on is to accessing the available hydrology at the site – and how critical adequate hydrology will be to developing wetlands in a semi-arid ecosystem.

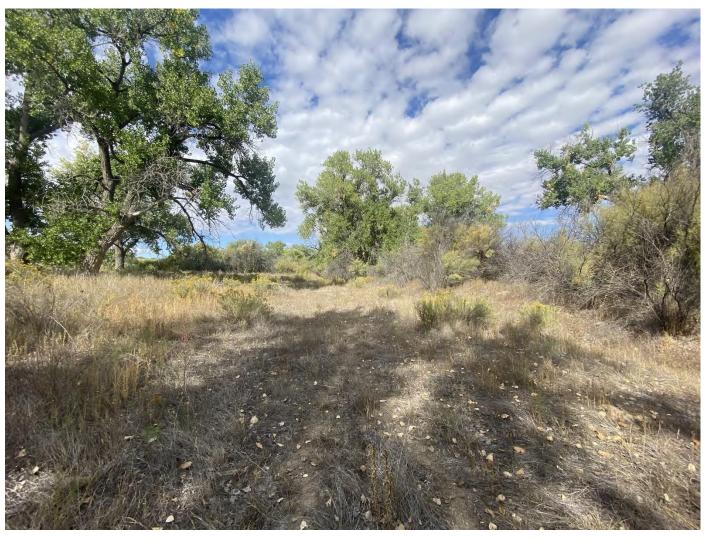
Photo 11 – A final view of the cottonwood gallery and riparian corridor along the Arkansas River, facing west from the south-middle of the site. Rabbitbrush, weeds, and upland grasses grow alongside cottonwoods, tamarisks, and willows in the rich and varied habitat along the river.
