M L Wetlands, Inc. proposes to establish the Maria Lake Mitigation Bank (Bank) in Huerfano County, Colorado with the intent of providing compensatory mitigation for permitted impacts to Waters of the United States. This will be accomplished through establishment, re-establishment, rehabilitation, enhancement, and preservation of wetlands and riparian habitats on the Bank Property. The mitigation Credits generated by the Bank will be used by permittees within the Arkansas River watershed. Currently, there are no other mitigation banks in the region and transportation projects and future regional growth create a need for additional compensatory mitigation options.

# Maria Lake Ranch: Wetland Delineation Report for Proposed Wetland Mitigation Bank

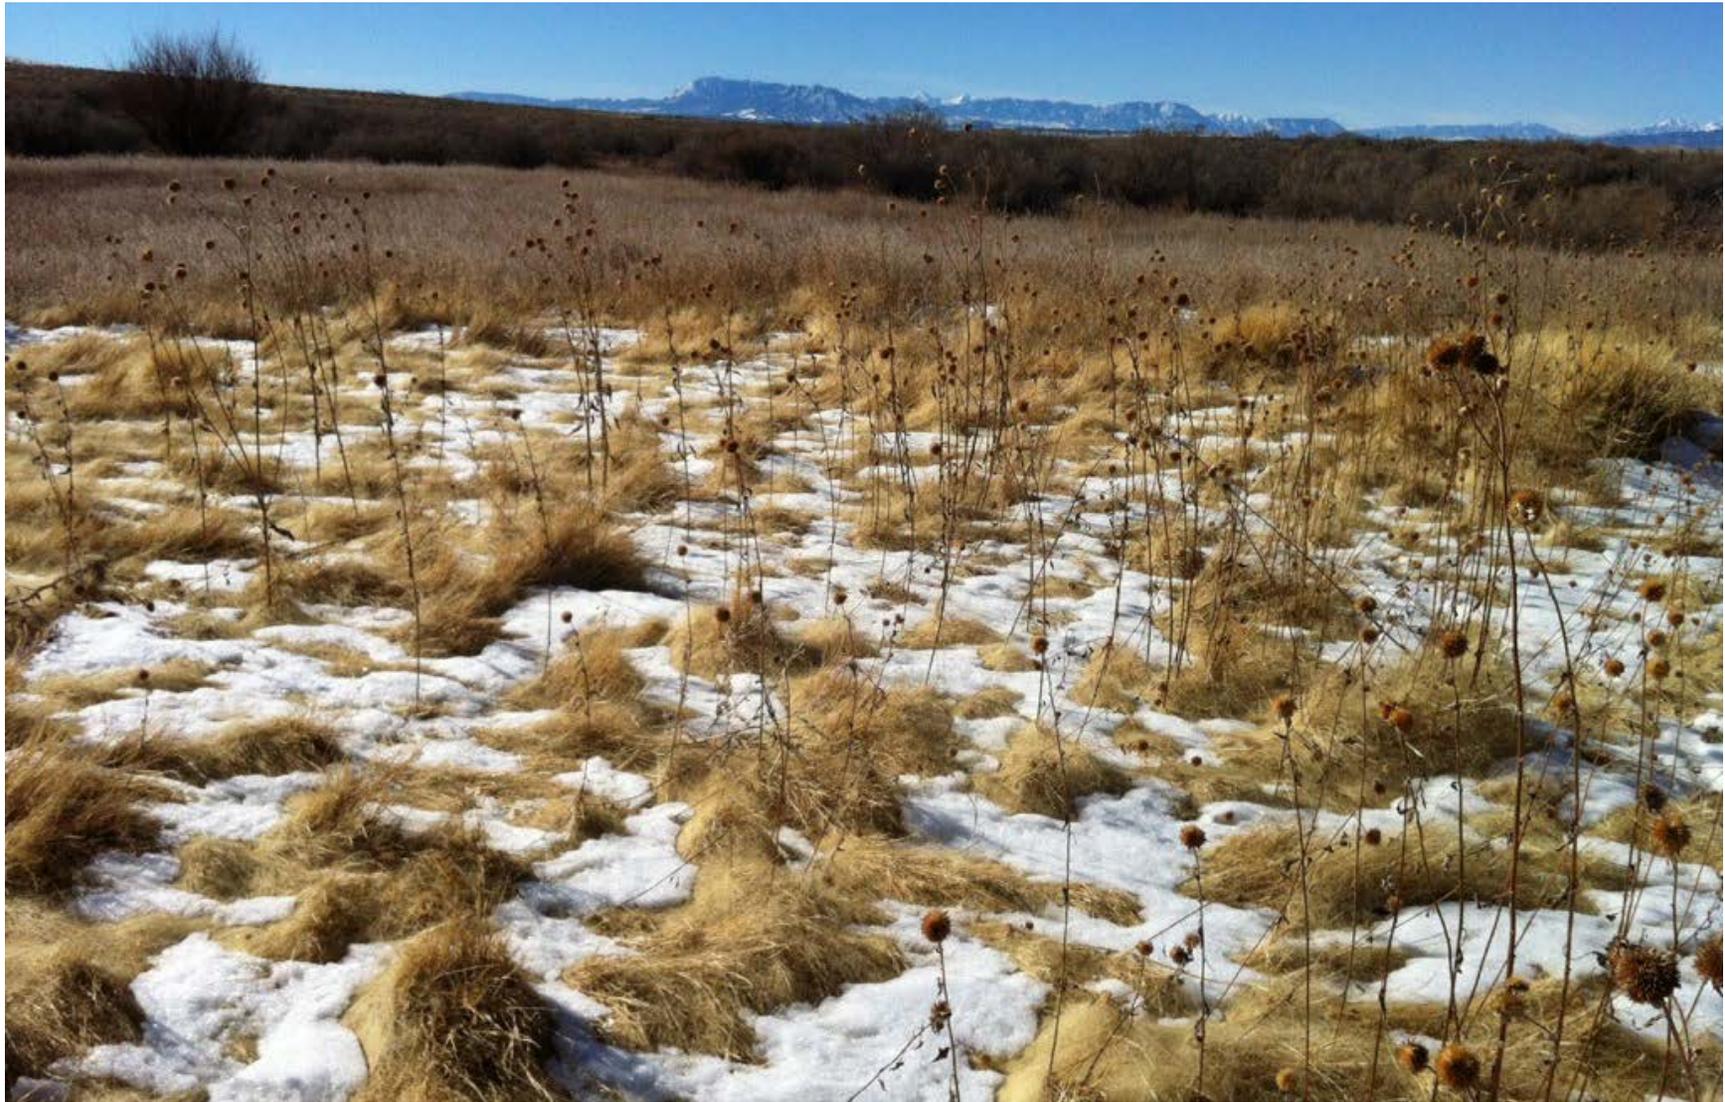
Alkali muhly (*Muhlenbergia asperifolia*) dominated wetland area in northeast corner of Bank Property

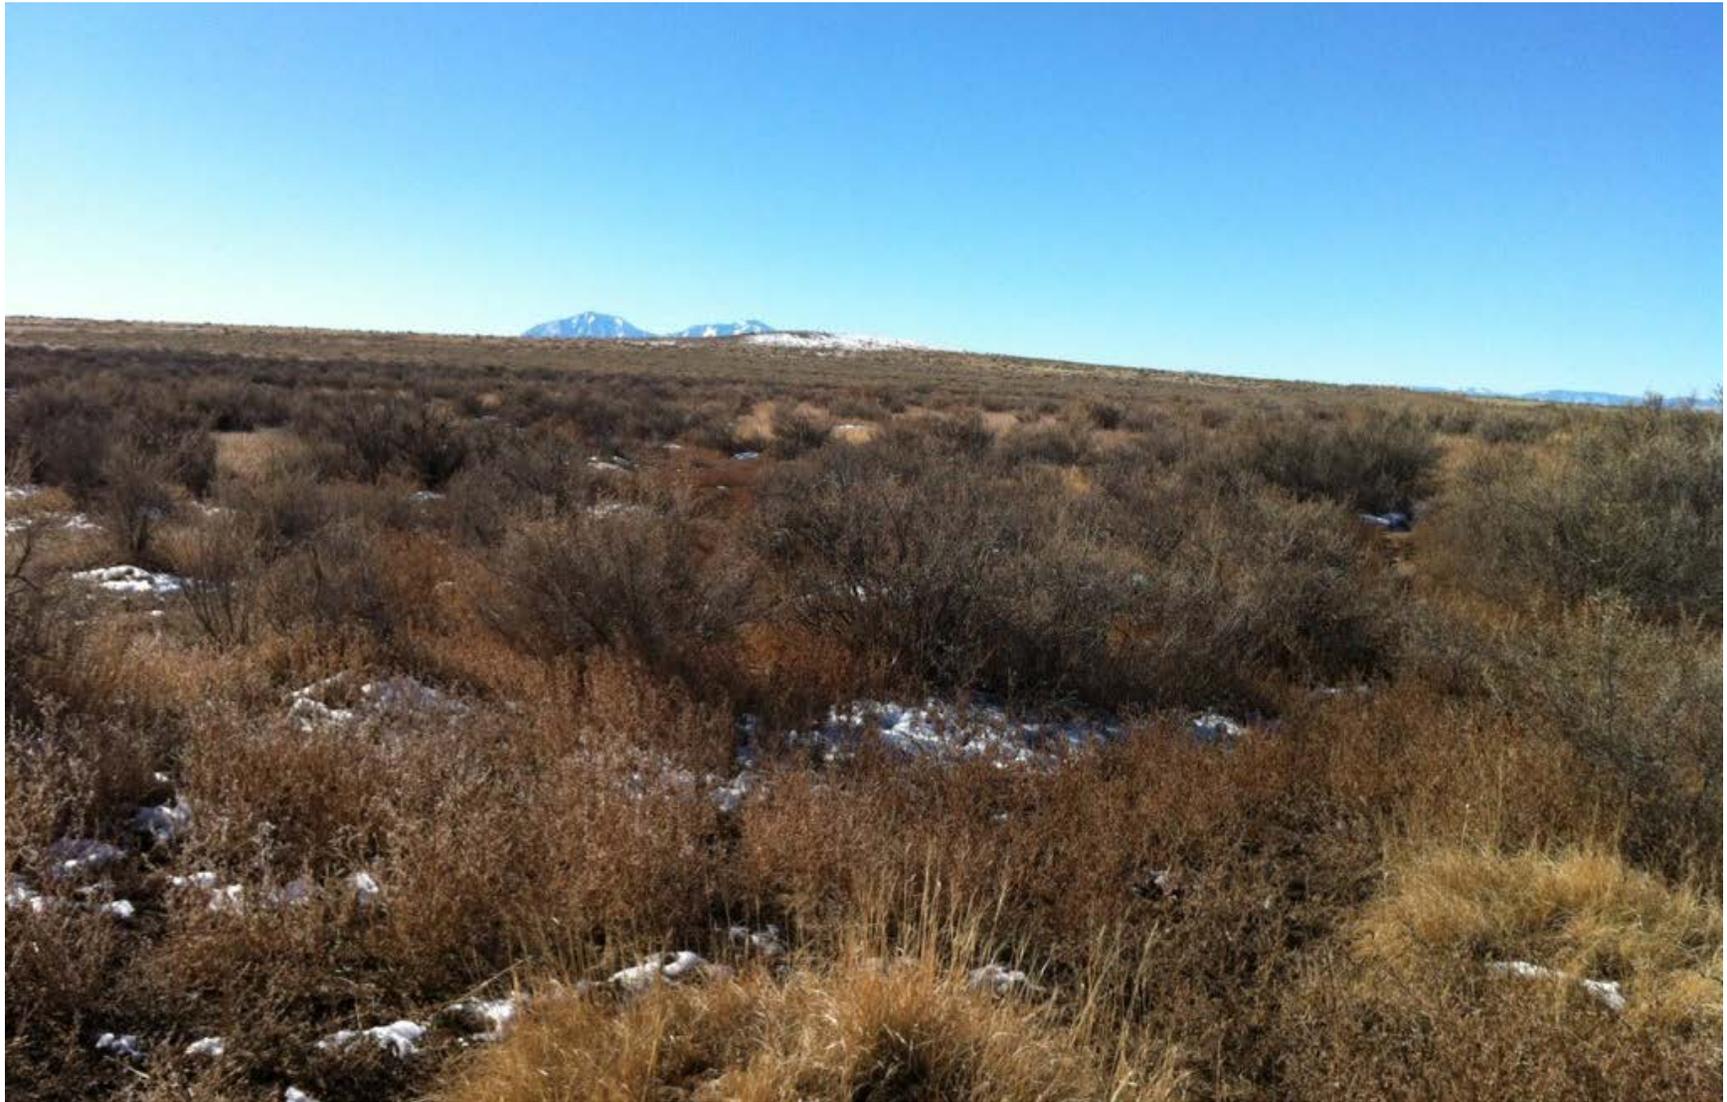
Northern boundary of Bank Property.

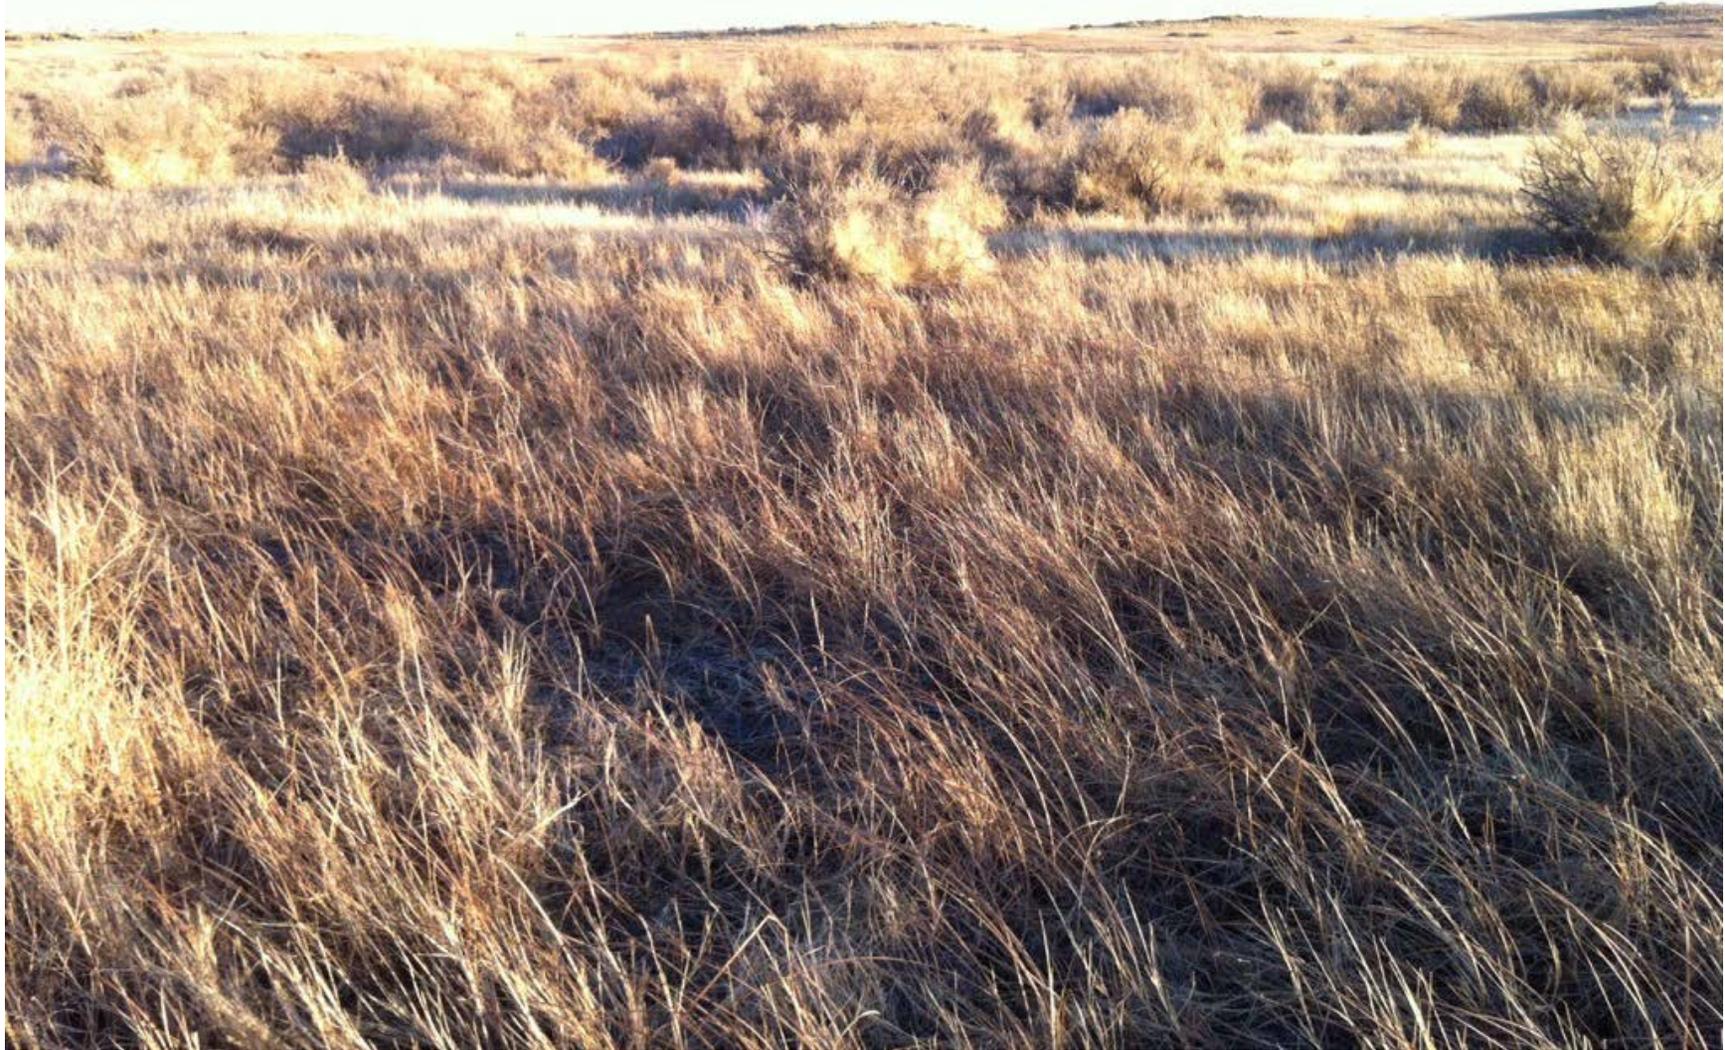
Wetland in central-eastern region of Bank Property; tule (*Schoenoplectus acutus*), alkali muhly (*Muhlenbergia asperifolia*), and foxtail barley (*Hordeum jubatum*) dominate

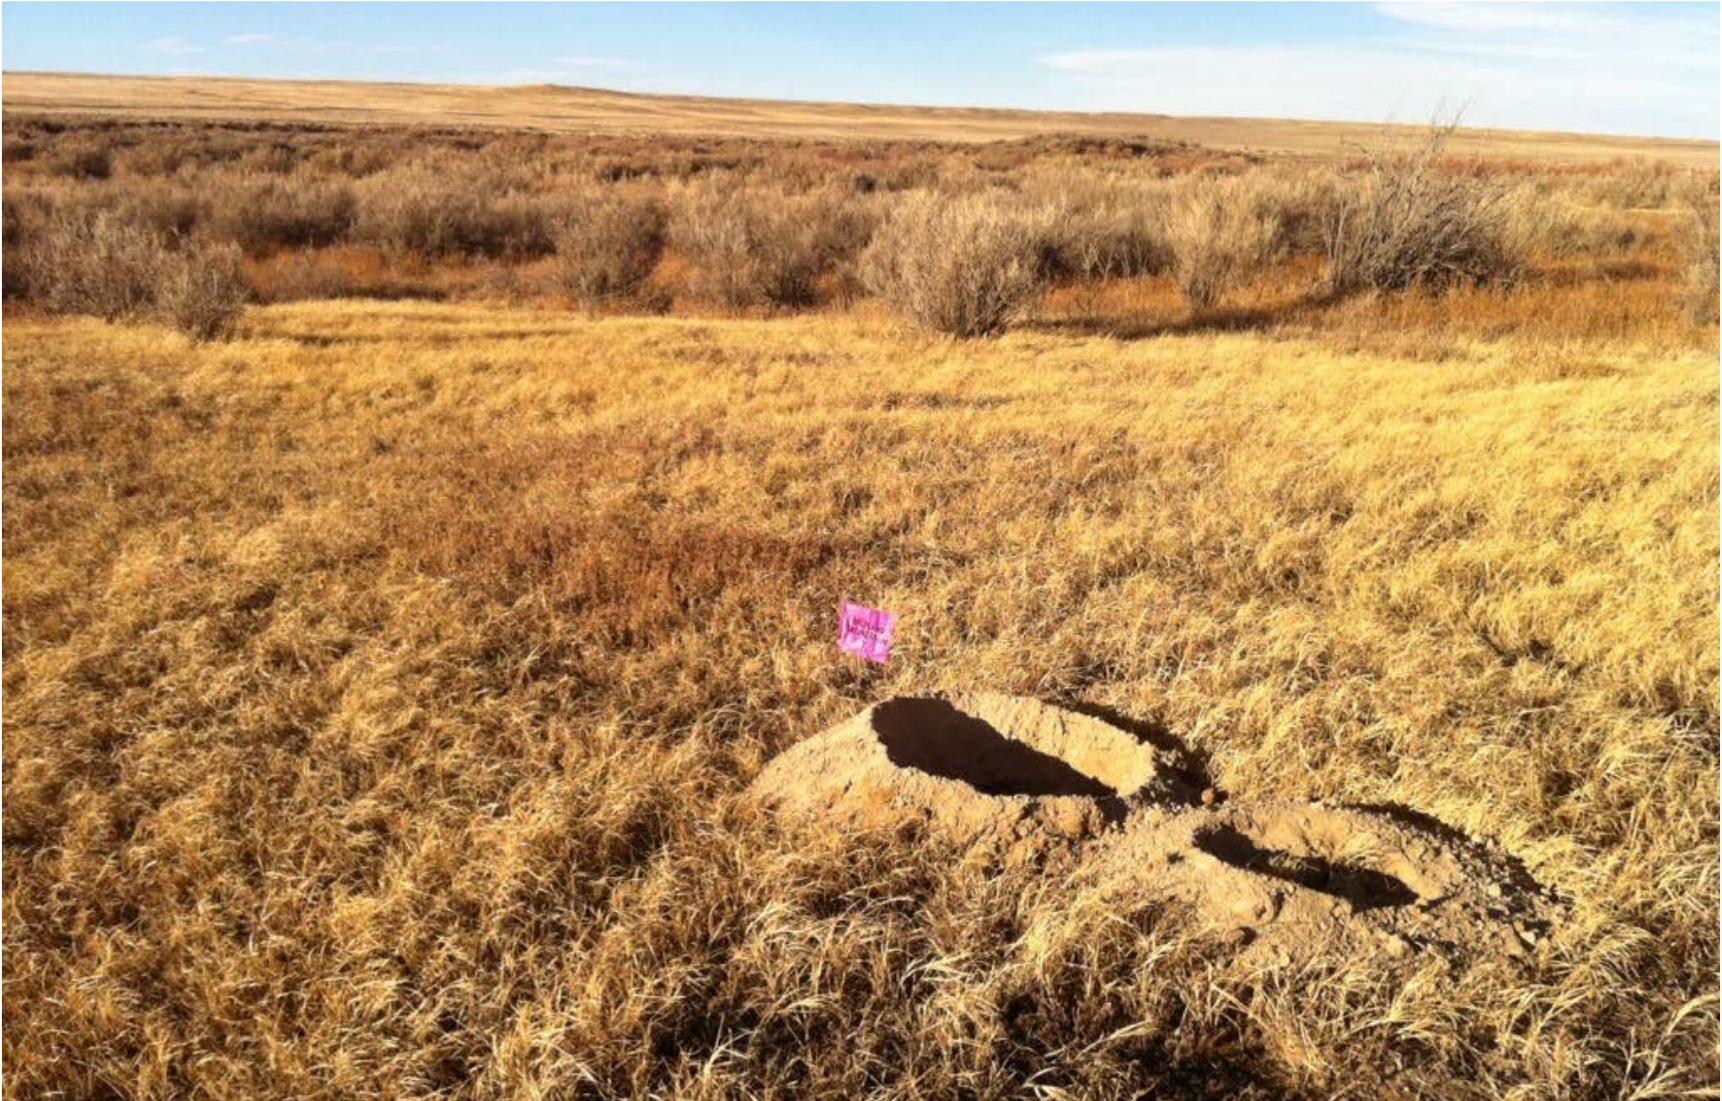
Upland area in northeastern region of Bank Property where slender wheat (*Elymus trachycaulus*) dominates

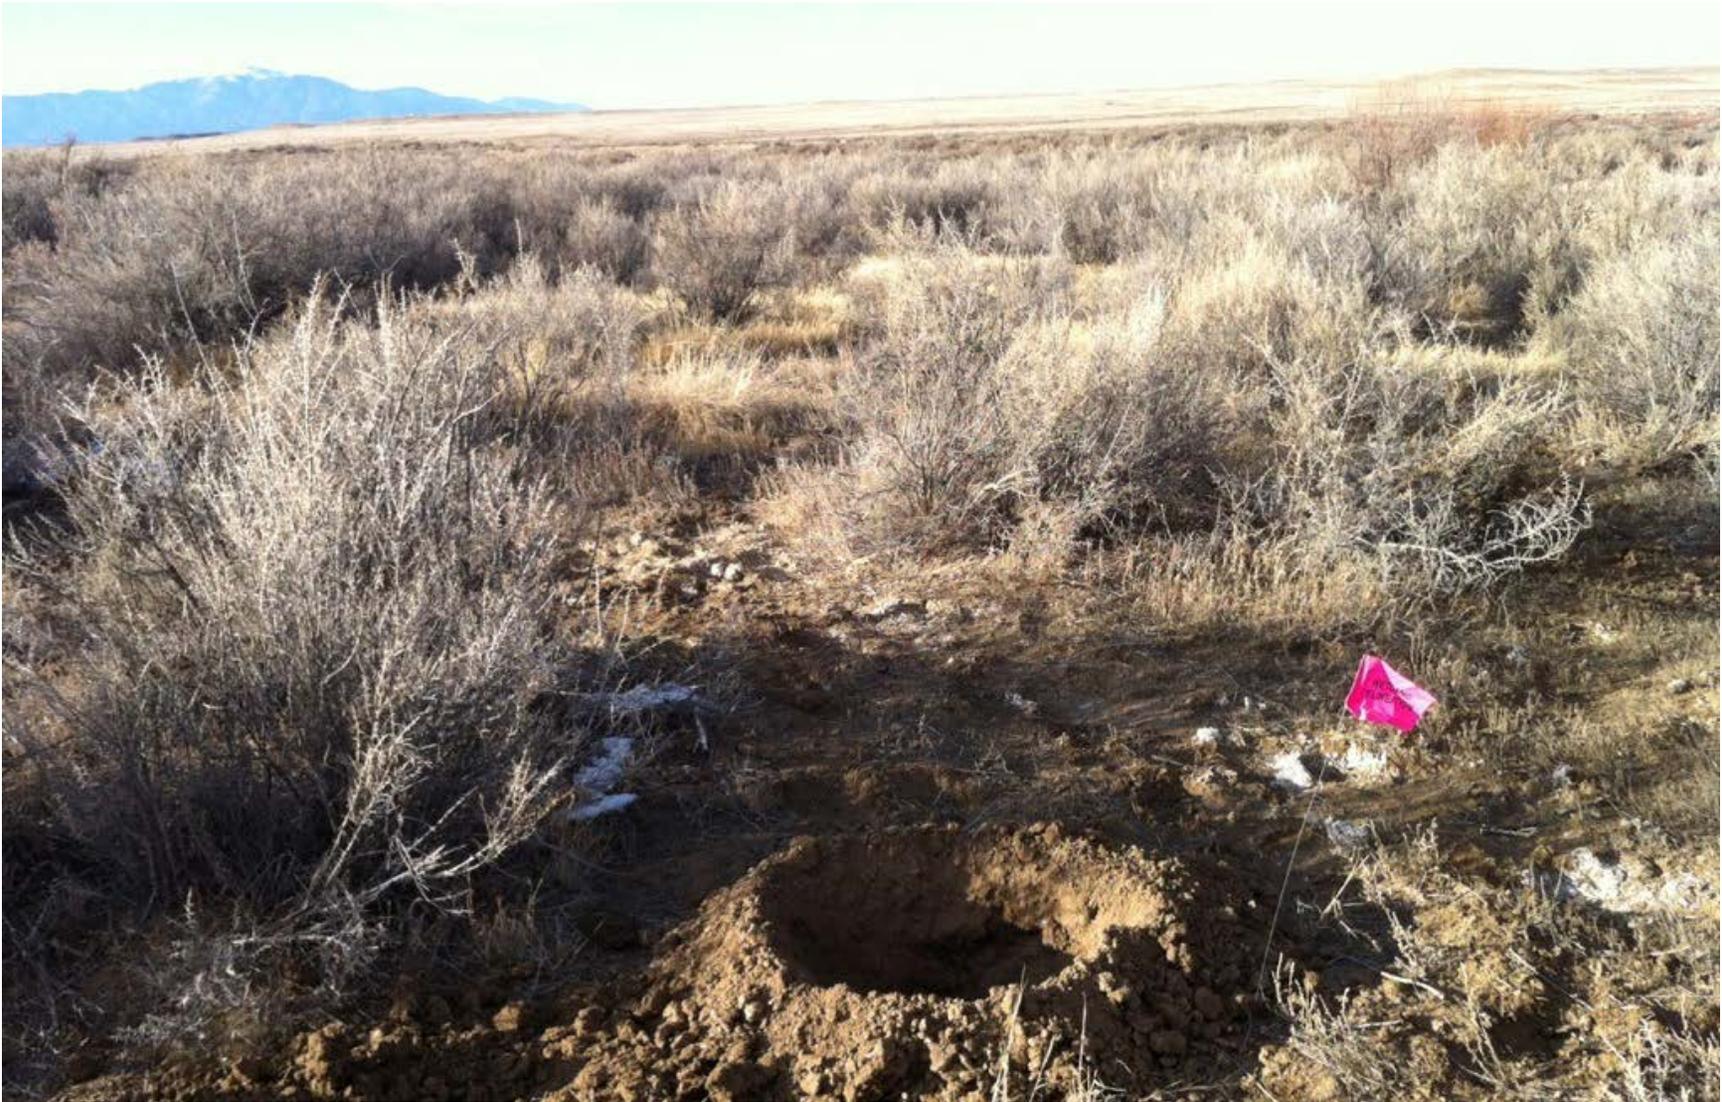
Greasewood flat in northeastern region of Bank Property with weak hydric soil indicators

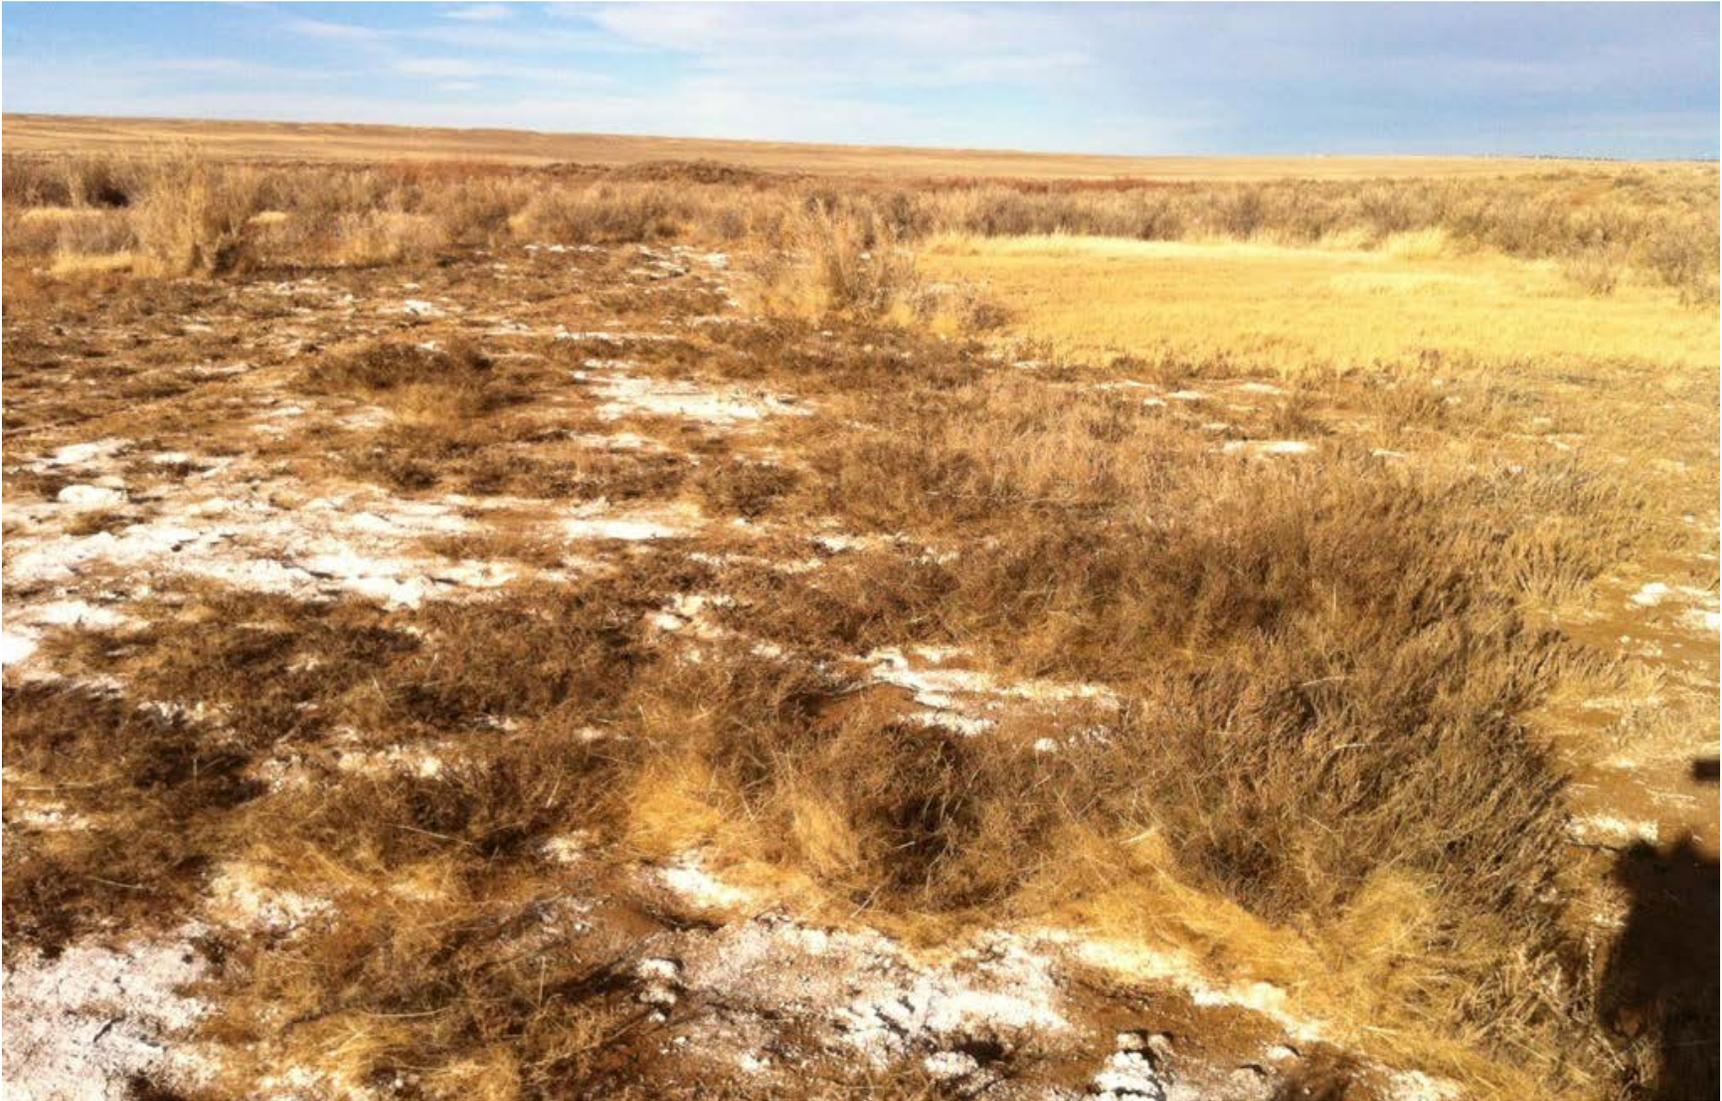
Sparse pursh seepweed (*Suaeda calceoliformis*) wetland in northeastern region of Bank Property.

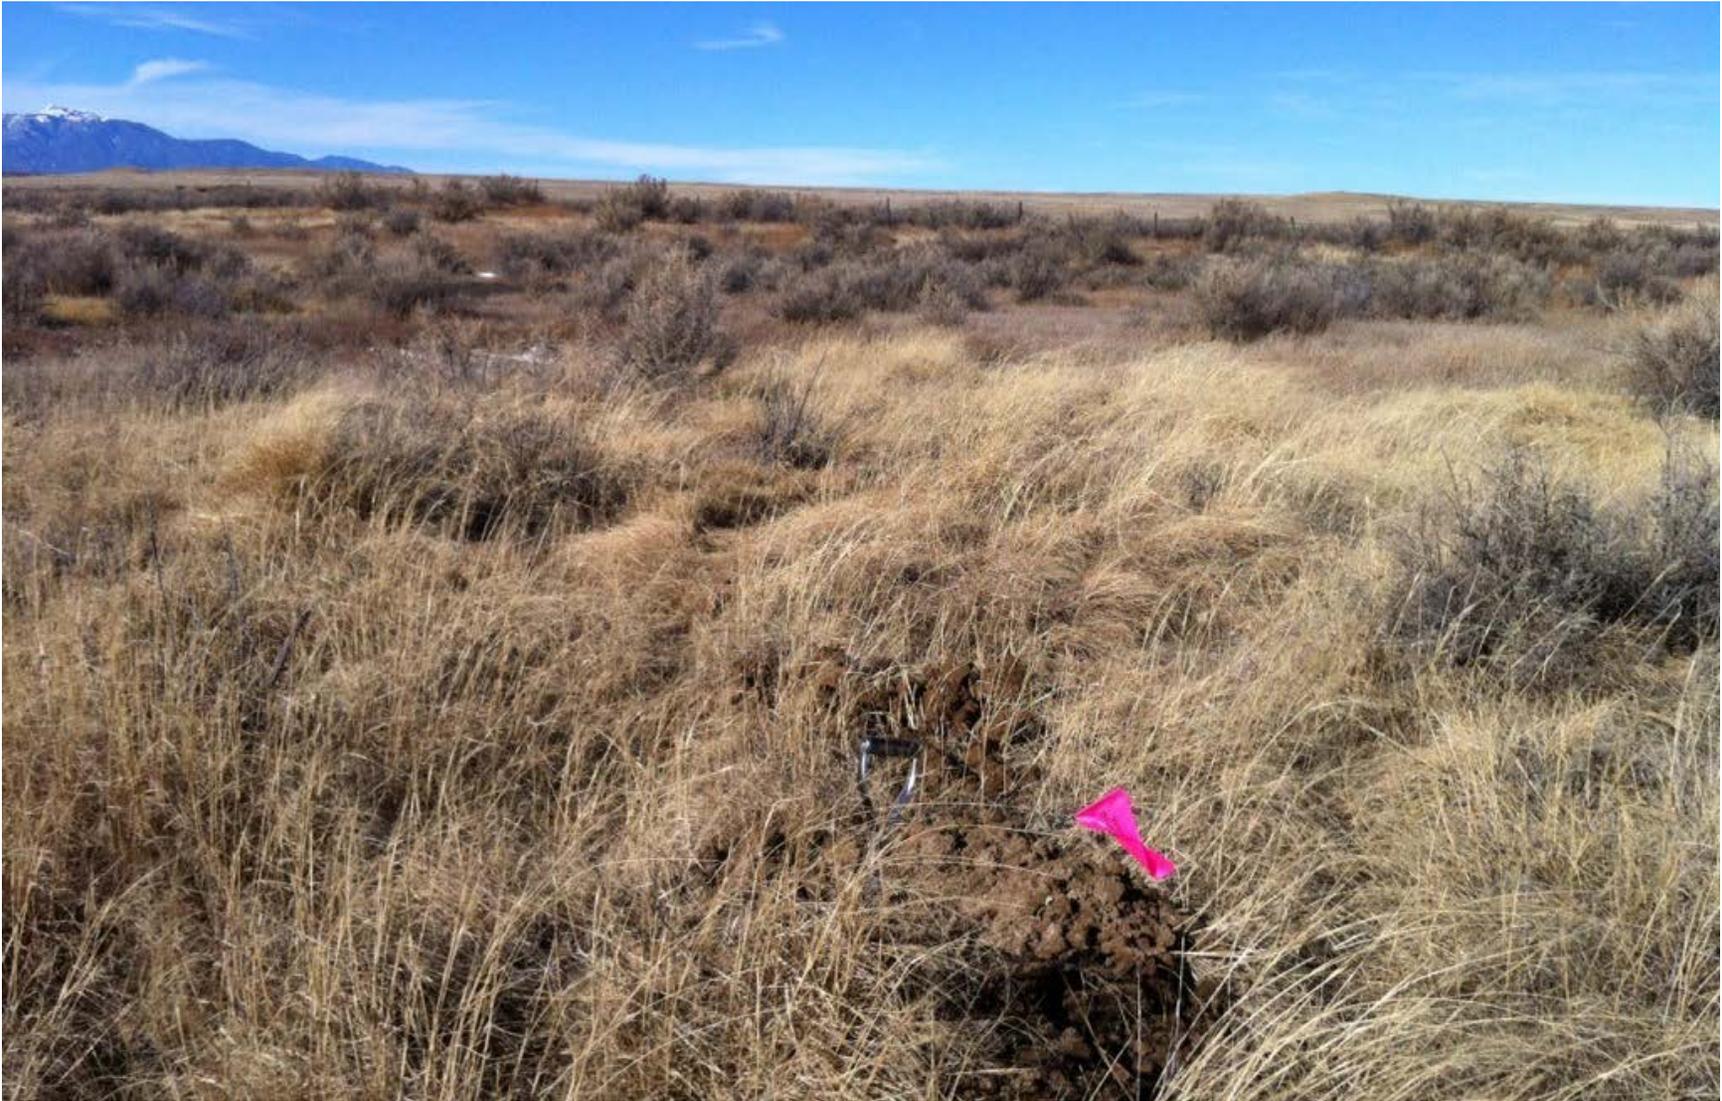
Alkali sacaton (*Sporobolus airoides*) mixed with greasewood (*Sarcobatus vermiculatus*) in the northern region of the Bank Property

There was a patch of alkali sacaton mesic grassland (SP 21) on a low, slightly sloped area located between a pursh seepweed flat and a higher greasewood area. Alkali sacaton (66%) was the dominant species and there was also 10% cover of greasewood. Alkali sacaton is present throughout the Bank, but most often occurs mixed with greasewood. This species is less salt-tolerant than alkali muhly and saltgrass (NatureServe, 2015) and was observed to occur on more well-drained soils than those two species. This species is also noted to be sensitive to grazing pressure and may have decreased in the Bank area.

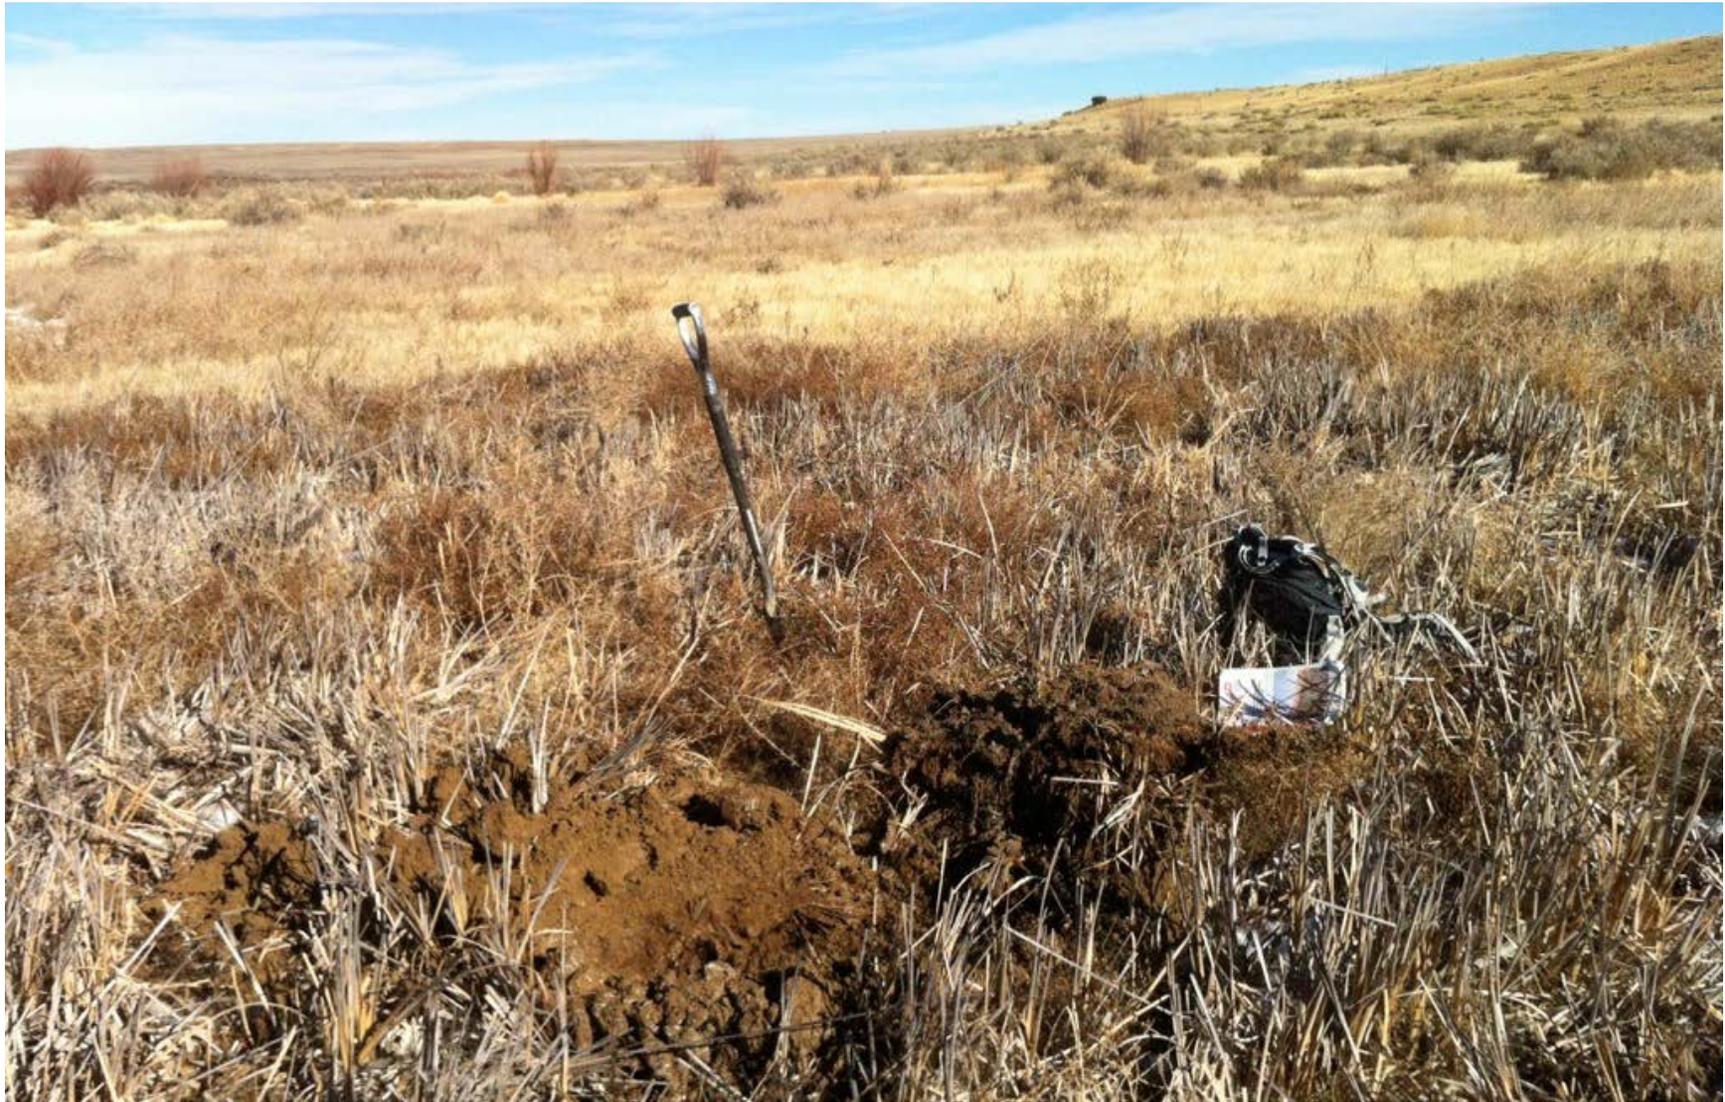
Edge of central emergent marsh at Bank Property; hydrology is on surface and soils are not saturated

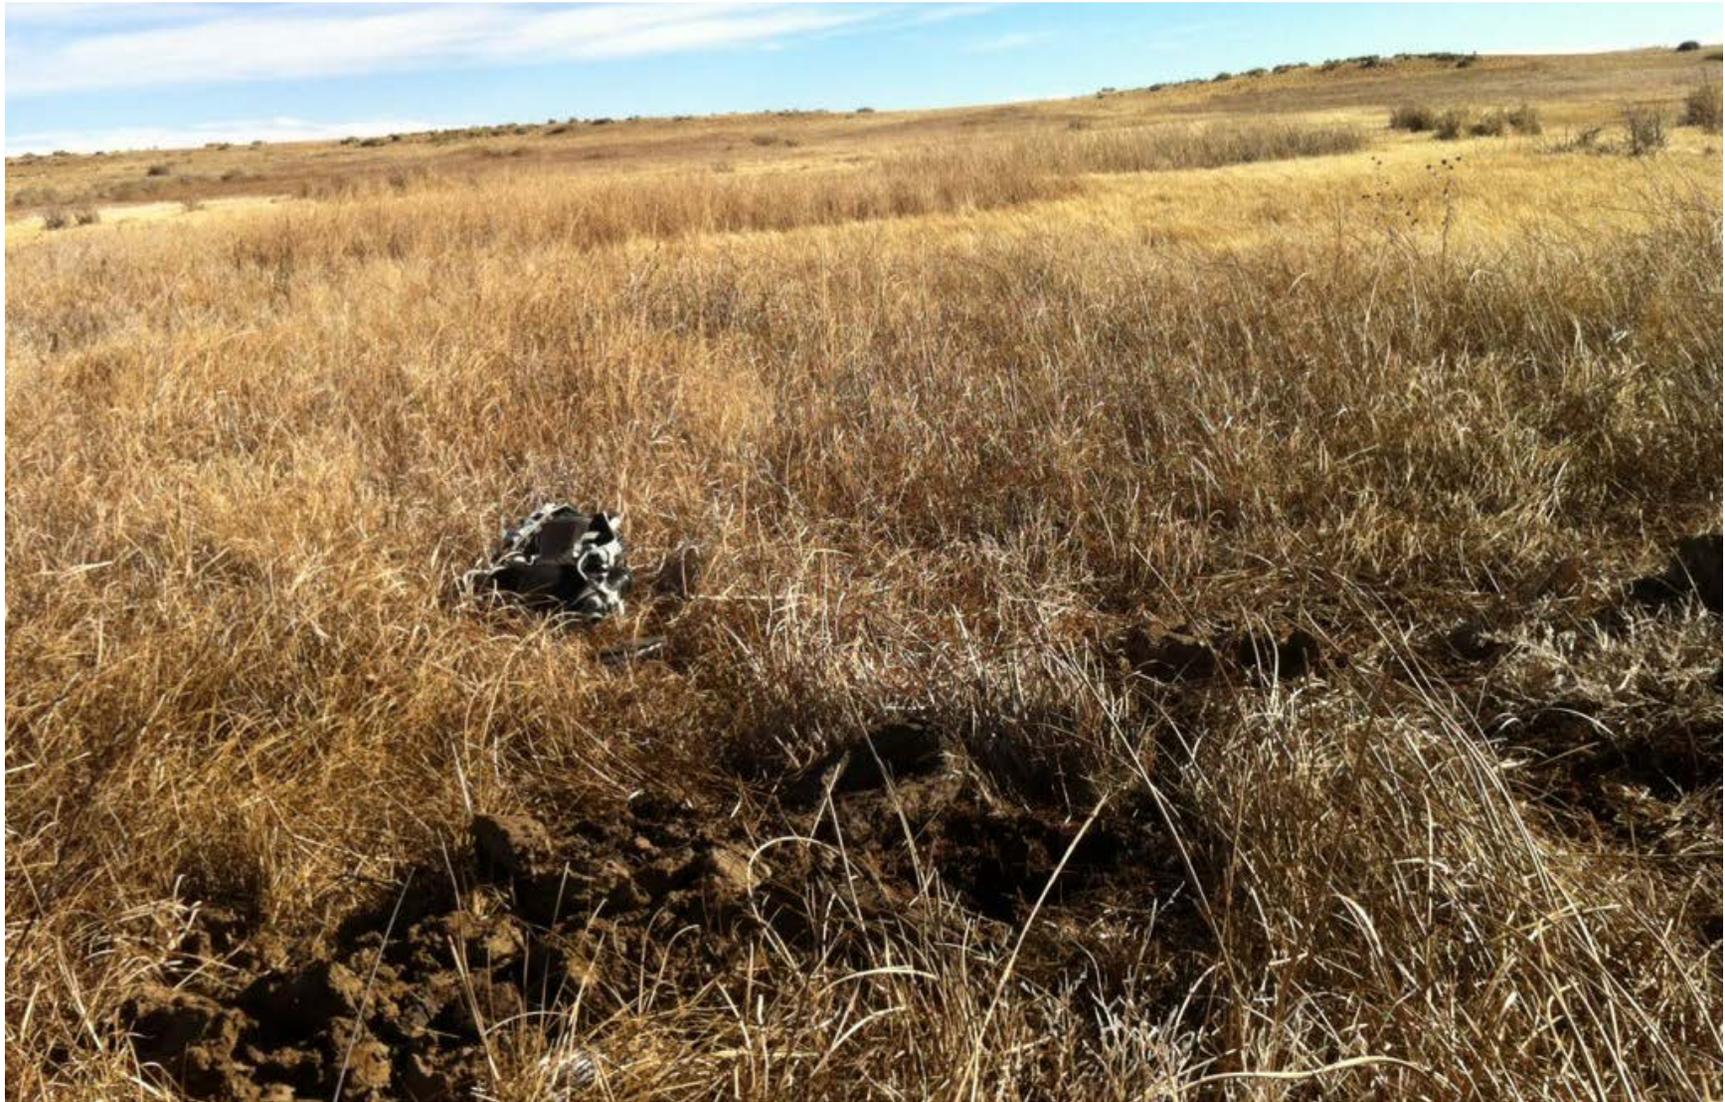
Interior of central emergent marsh at Bank Property; water table at 36 inches and soils saturated throughout

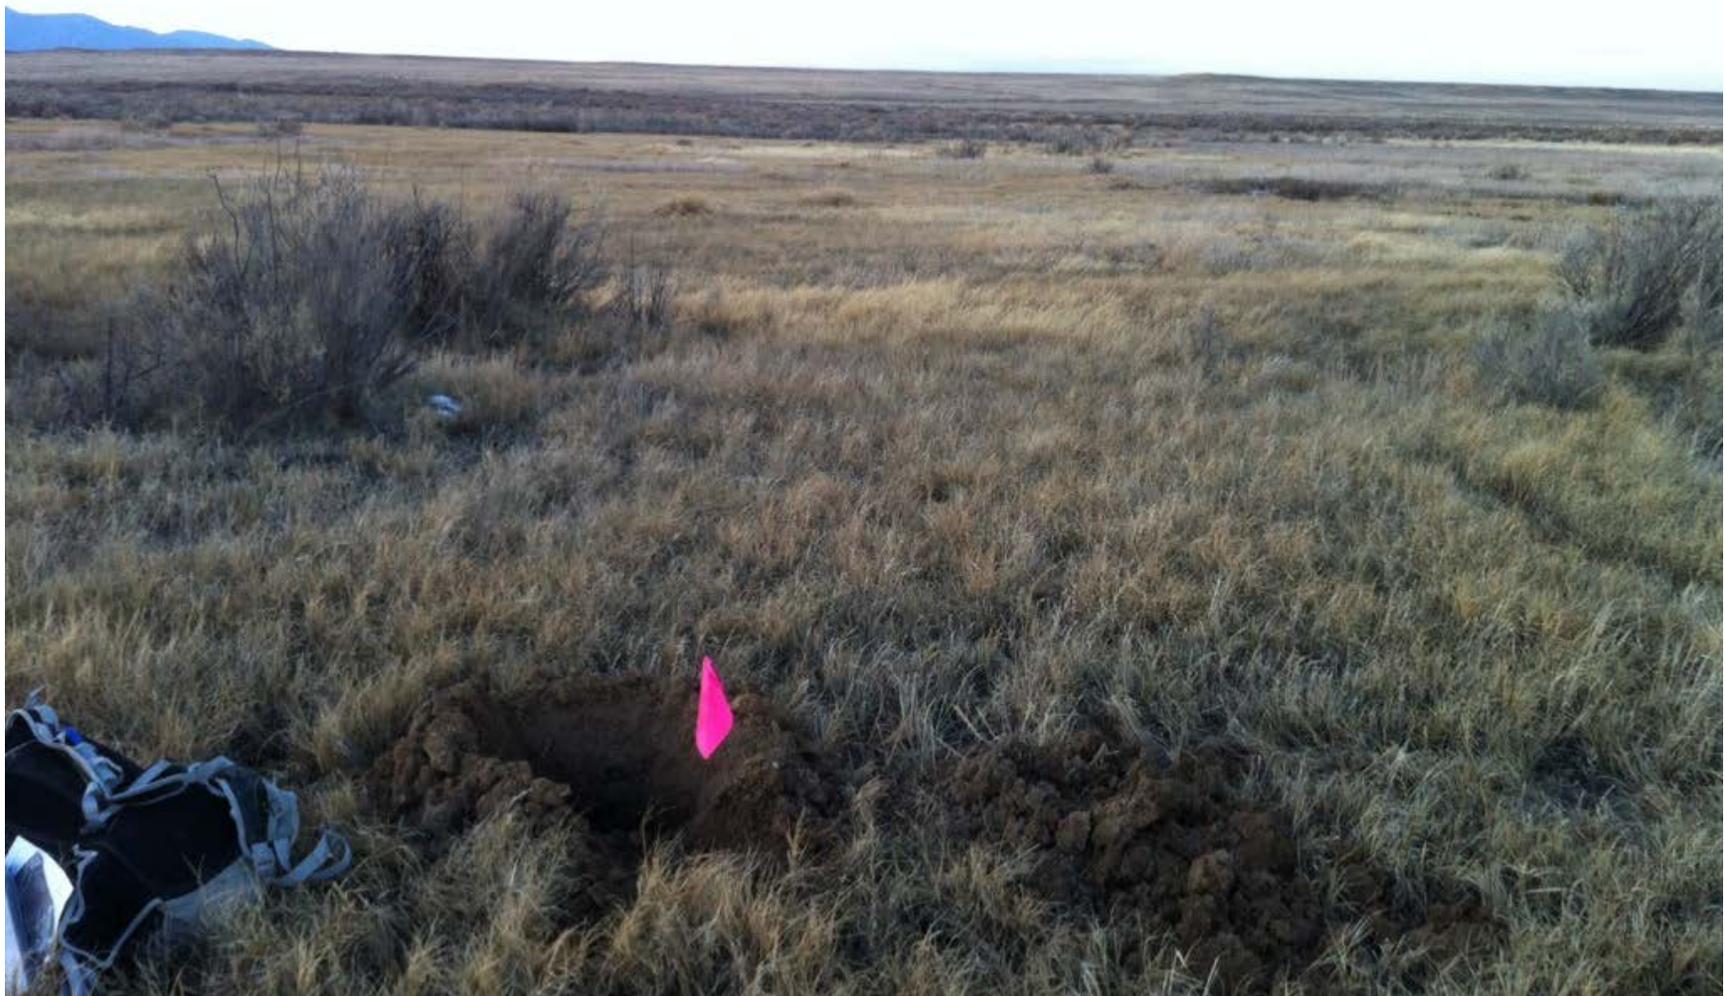
West-central region of Bank Property supporting inland salt grass (*Distichlis spicata*) meadow

Saltgrass meadow (SP 18) is common on the southern perimeter of the bank and extends south from the main flat terrace up a gradual slope. This vegetation community is characterized by dominance of saltgrass (50-80%) mixed with other hydrophytic species including Nutall’s alkali grass (1-20%), and alkali muhly (5-30%). There are occasional patches of greasewood. Along the upland margins of this habitat, there is up to 10% cover of western wheat, slender wheatgrass, and kochia. Although saltgrass is categorized as a FACW, it can tolerate fairly dry conditions.

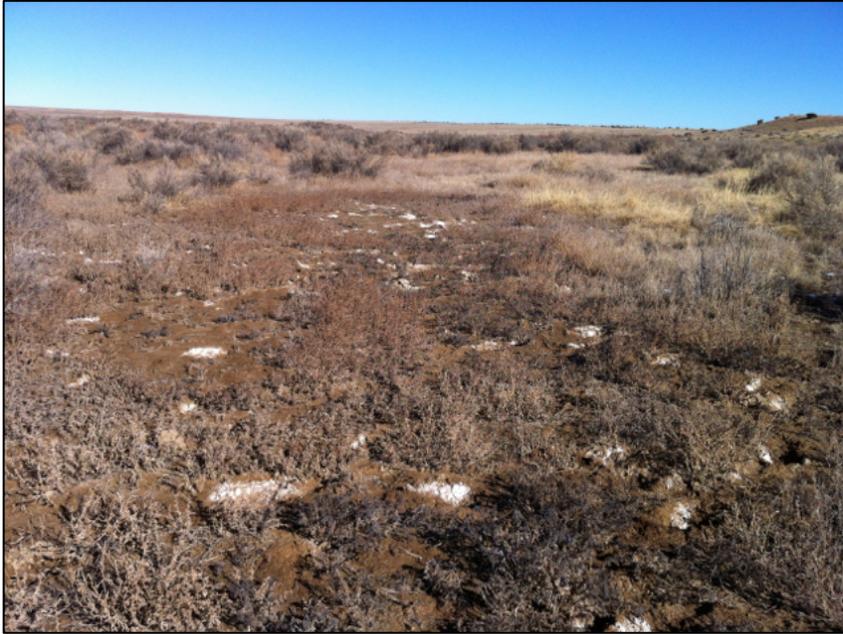
1. Sampling Point 12 (SP-12). Facing north along a low swale vegetated with representative pursue seepweed flat wetland vegetation. Disturbed greasewood shrubland (upland) is visible to the left and alkali sacaton mesic grassland (wetland) near SP21 is visible to the right.

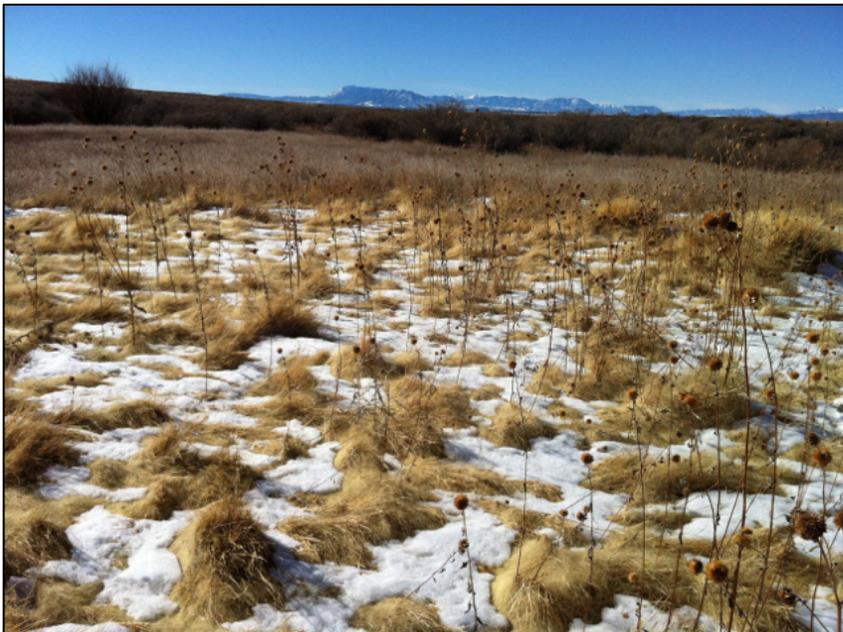
2. SP-13 – facing southwest. A wetland sampling point was completed in the alkali muhly wet meadow. A low area dominated by kochia is visible in the background.

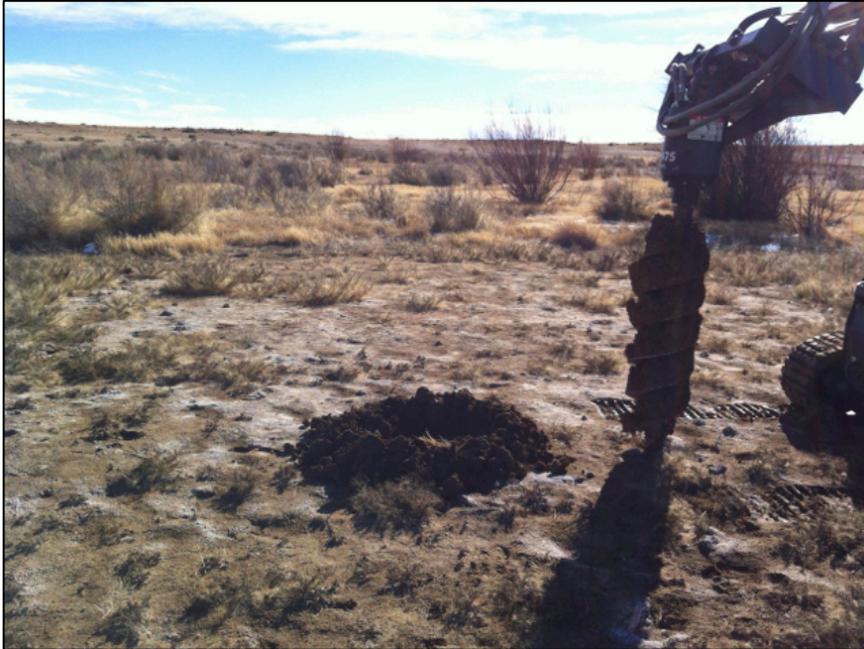
3. Facing southeast from SP-14. A pursh seepweed flat wetland sampling point was completed here.

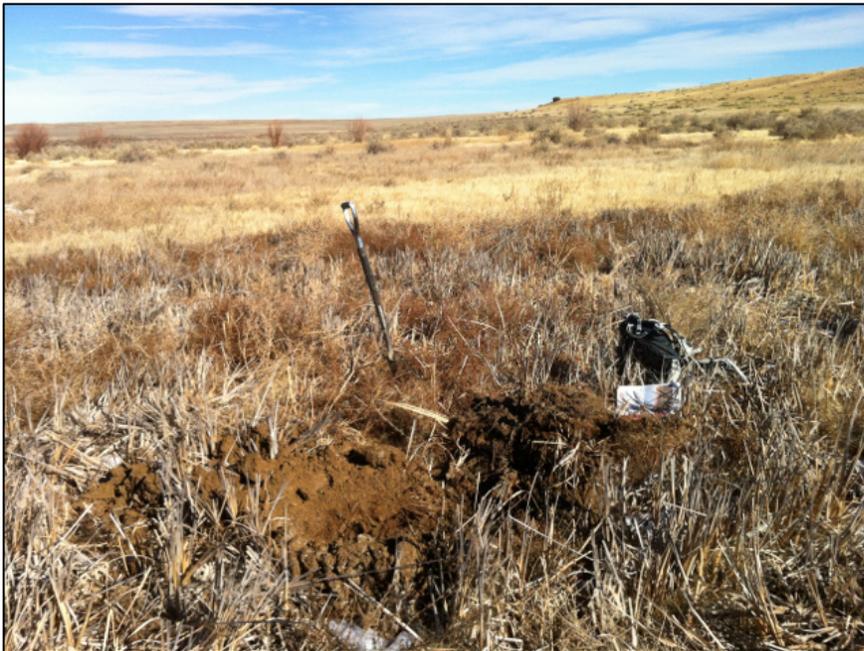
4. Facing north from SP-15, an alkaline marsh wetland. Note the scattered tamarisk trees in the distance. At this location, hydrology was surficial and soils were not saturated.

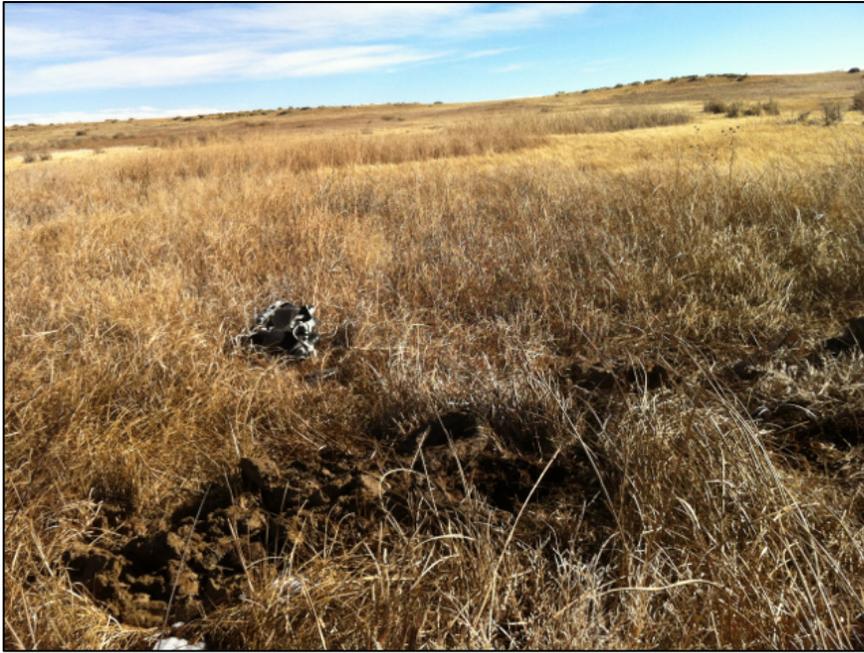
5. Facing northeast from SP-16, an alkaline marsh wetland. This location seems to be on top of a spring because soils were saturated throughout, the water table was present at 36", and soils were more depleted than at SP-15.

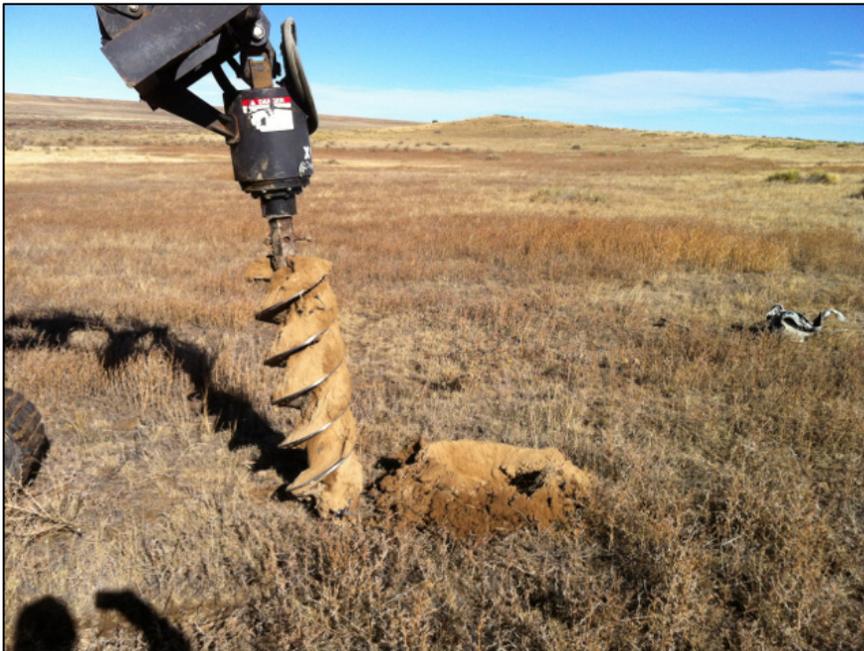
6. SP-17 facing north. Representative kochia/perennial grassland upland vegetation.

- **“Schamber-Midway complex, 3 to 25 percent slopes” (Schamber-Midway):** This map unit is on hills, terrace, edges, and side slopes. The observed soil at SP17, an upland, most closely resembles the Midway series (Figure B, Appendix B). Midway soil is described as shallow, well drained, slightly saline, and moderately alkaline. The typical profile is an 18-inch thick layer of clay on top of platy shale. Runoff is rapid to very rapid. This soil is not classified as hydric.
