M L Wetlands, Inc. proposes to establish the Maria Lake Mitigation Bank (Bank) in Huerfano County, Colorado with the intent of providing compensatory mitigation for permitted impacts to Waters of the United States. This will be accomplished through establishment, re-establishment, rehabilitation, enhancement, and preservation of wetlands and riparian habitats on the Bank Property. The mitigation Credits generated by the Bank will be used by permittees within the Arkansas River watershed. Currently, there are no other mitigation banks in the region and transportation projects and future regional growth create a need for additional compensatory mitigation options.

# Maria Lake Ranch: Wetland Delineation Report for Proposed Wetland Mitigation Bank

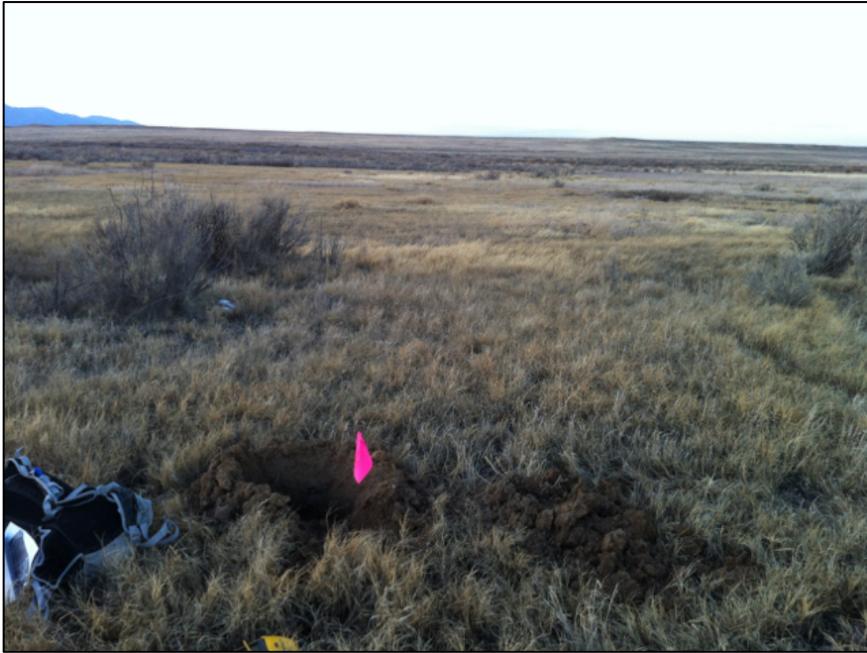
7. SP-18 facing northwest. Representative saltgrass meadow wetland vegetation.

Saltgrass meadow (SP 18) is common on the southern perimeter of the bank and extends south from the main flat terrace up a gradual slope. This vegetation community is characterized by dominance of saltgrass (50-80%) mixed with other hydrophytic species including Nutall’s alkali grass (1-20%), and alkali muhly (5-30%). There are occasional patches of greasewood. Along the upland margins of this habitat, there is up to 10% cover of western wheat, slender wheatgrass, and kochia. Although saltgrass is categorized as a FACW, it can tolerate fairly dry conditions.

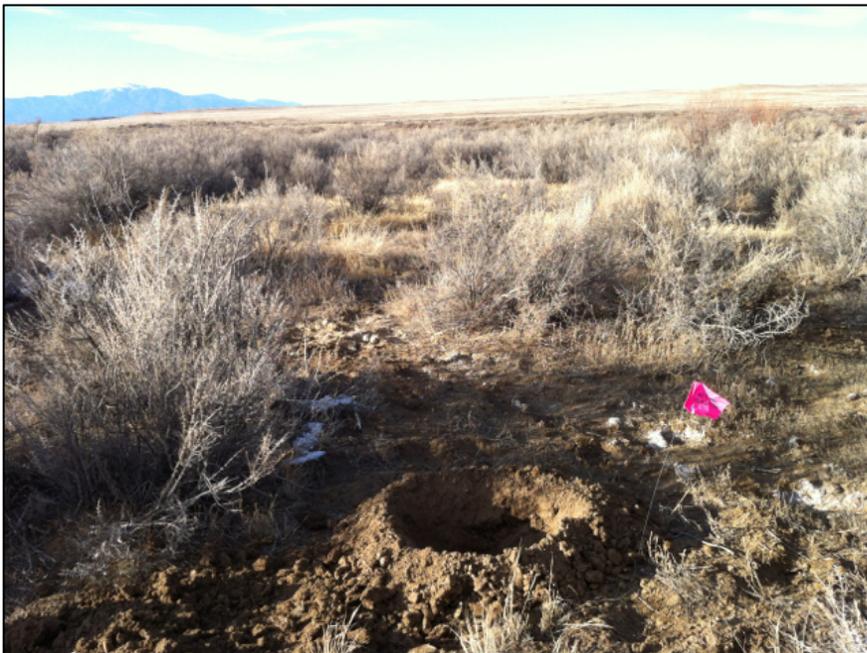
8. SP-19 facing northwest. Representative greasewood mesic shrubland wetland.

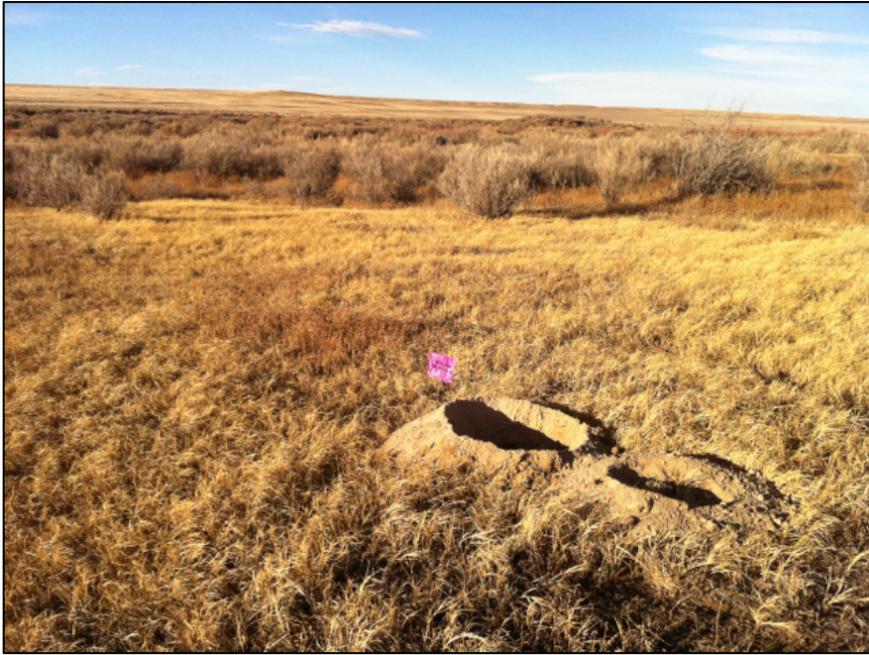
9. SP-20 facing north. Upland area dominated by a small, dense patch of slender wheatgrass. Surrounding areas have high cover of kochia.

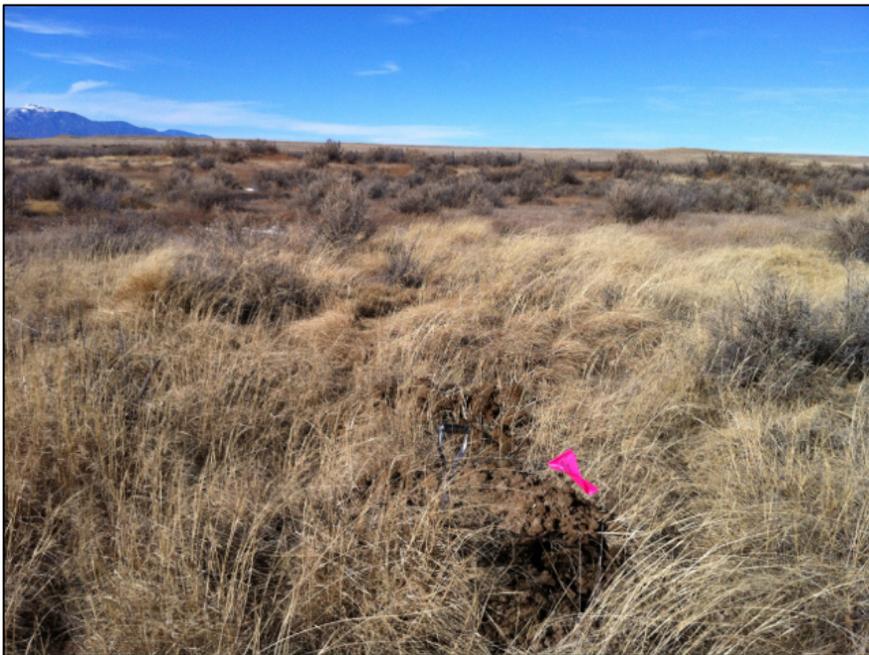
10. SP-21 facing northwest. Representative alkali sacaton mesic grassland wetland.

There was a patch of alkali sacaton mesic grassland (SP 21) on a low, slightly sloped area located between a pursh seepweed flat and a higher greasewood area. Alkali sacaton (66%) was the dominant species and there was also 10% cover of greasewood. Alkali sacaton is present throughout the Bank, but most often occurs mixed with greasewood. This species is less salt-tolerant than alkali muhly and saltgrass (NatureServe, 2015) and was observed to occur on more well-drained soils than those two species. This species is also noted to be sensitive to grazing pressure and may have decreased in the Bank area.
