**Middle Rio Grande Flood Protection
Bernalillo to Belen, New Mexico
Mountain View, Isleta, and Belen Units**

DRAFT Phase 1 Environmental Site Assessment

**Replacement of East and West Spoil Banks with Engineered Levees
Mountain View, Isleta and Belen Sections
Middle Rio Grande Floodplain
Bernalillo and Valencia Counties, New Mexico**

**US Army Corps of Engineers, Albuquerque District
Environmental Engineering Section
4101 Jefferson Plaza NE
Albuquerque, NM 87109**

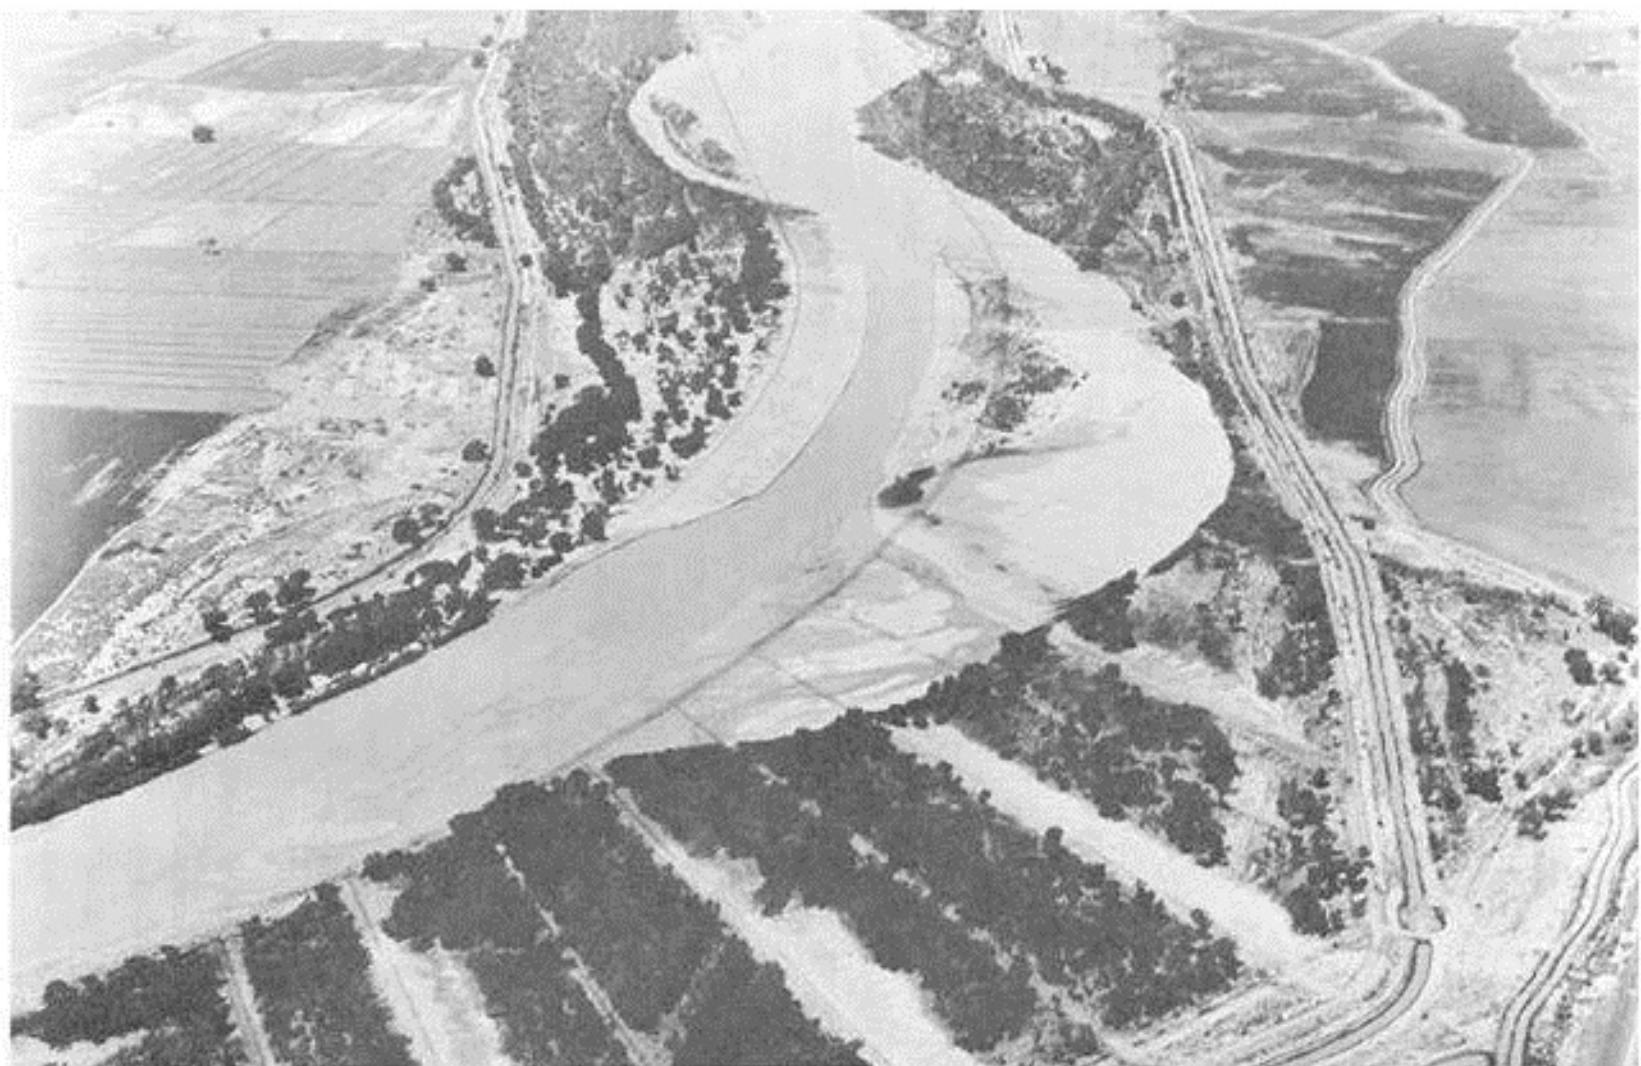
Aerial view of a completed jetty system, including a dredged pilot channel on the Middle Rio Grande (COE, 1963).

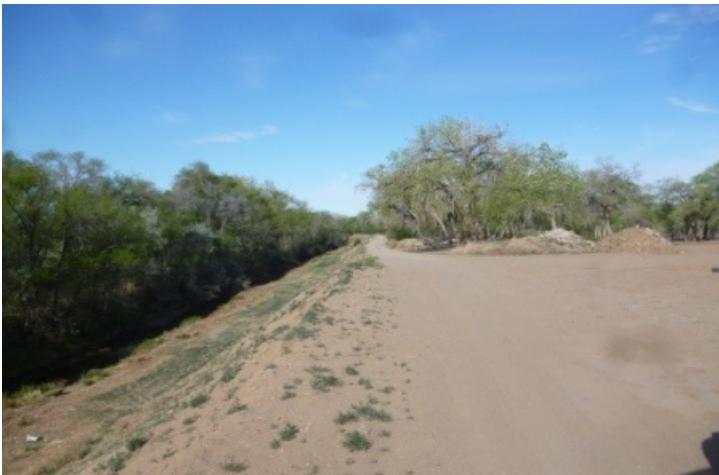
Mountain View Facing South Mile 0 East Side of RG

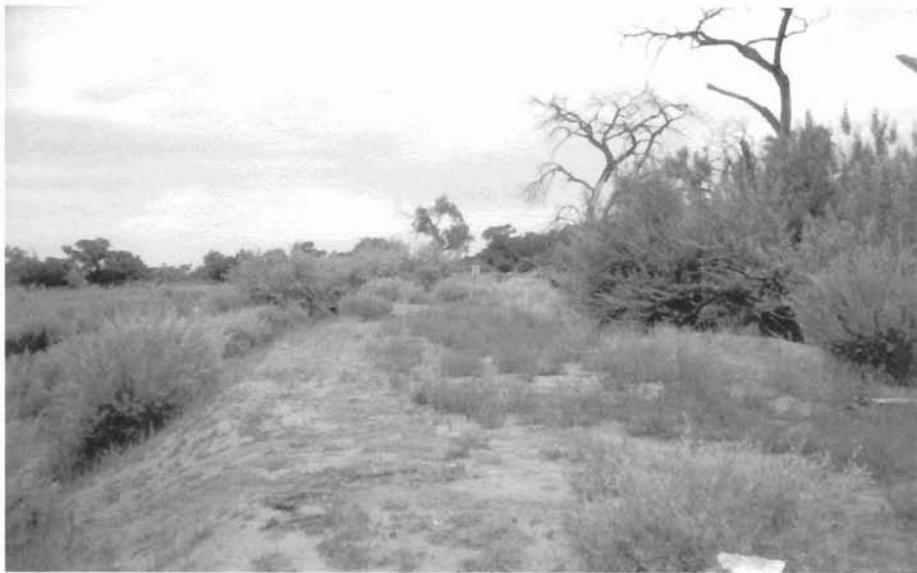
A freely passable, competent dirt road, with some vegetative overgrowth is present at the top of the levee. The heaviest vegetative overgrowth on this road occurs along the southernmost extent of the levee, near the northern Isleta Reservation Boundary (Photograph 3). An impassable, incompetent dirt road that is heavily overgrown with vegetation runs along the

Photograph 3 - Vegetative Overgrowth Along Southern Extent of Levee

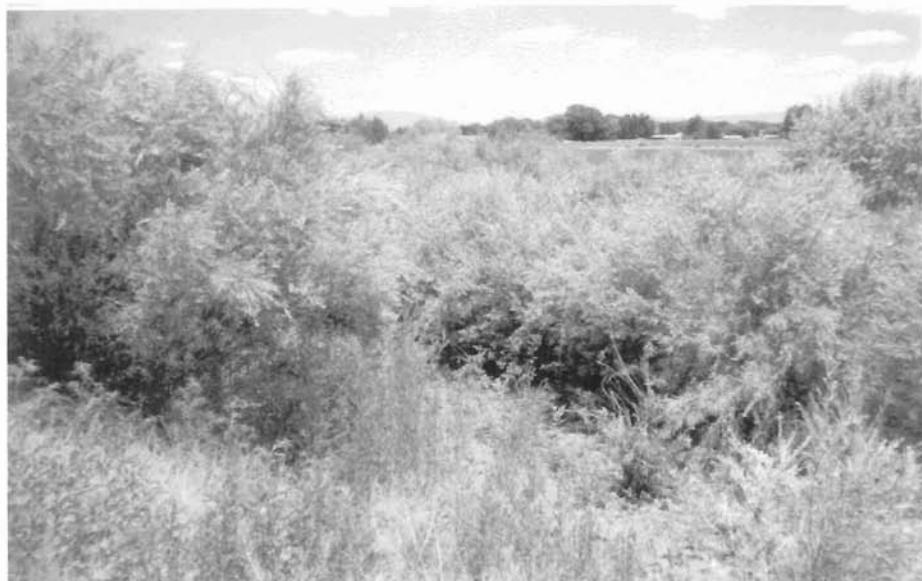
eastern toe of the levee (Photograph 4). This road is impassible along most of its extent due to a thick mantling of loose sand and dense overgrowth that has thrived due to a lack of maintenance and usage. EMI estimated that the eastern and western toes of the levee are approximately 30 and 50 percent overgrown with vegetation, respectively. Again, the density of vegetation increases toward the county line. These areas of excessive overgrowth could not be visually surveyed due to the vegetation.

Photograph 4 -View of Lower Road Along Eastern Toe of Levee

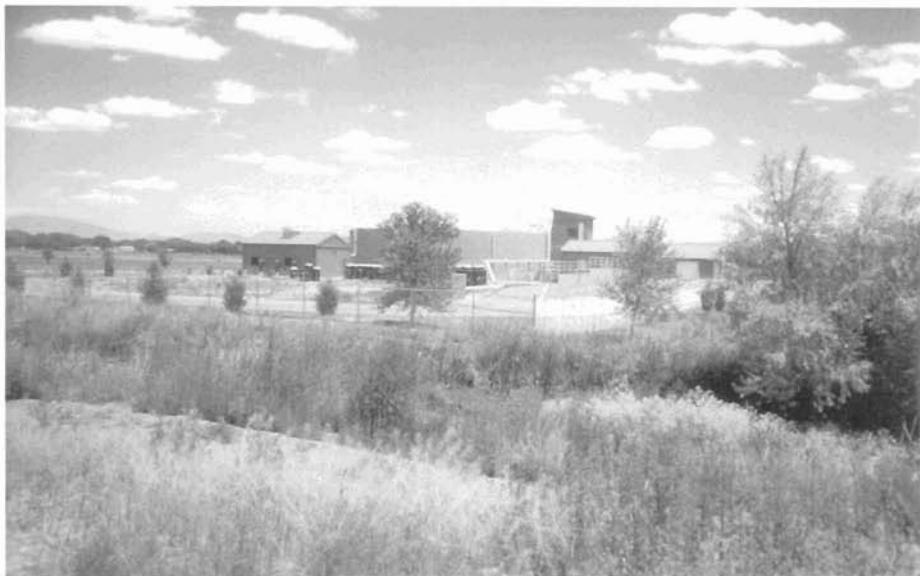
Finally, six sites of potential concern were identified within the ASTM-recommended search distances in the priority risk report (See Section 5.0 and Attachment C). These nearby sites include: McKinley Fiber, Mountain View Subdivision, The City of Albuquerque Waste Water Treatment Plant, Why Wastewater, Inc., Van Waters & Rogers, and REK Chemical Manufacturing Corporation/CAM Industries, Inc.. As all of the above-mentioned sites are located cross-gradient from the area of investigation (the levee) a more detailed analysis of local hydrology is needed to assess the effect these potential contamination sources may have on the aquifer beneath the levee. Of the six sites, only Why Wastewater, Inc. is visible from the levee (Photograph 5).

Photograph 5 - View of Why Wastewater, Inc. from Levee

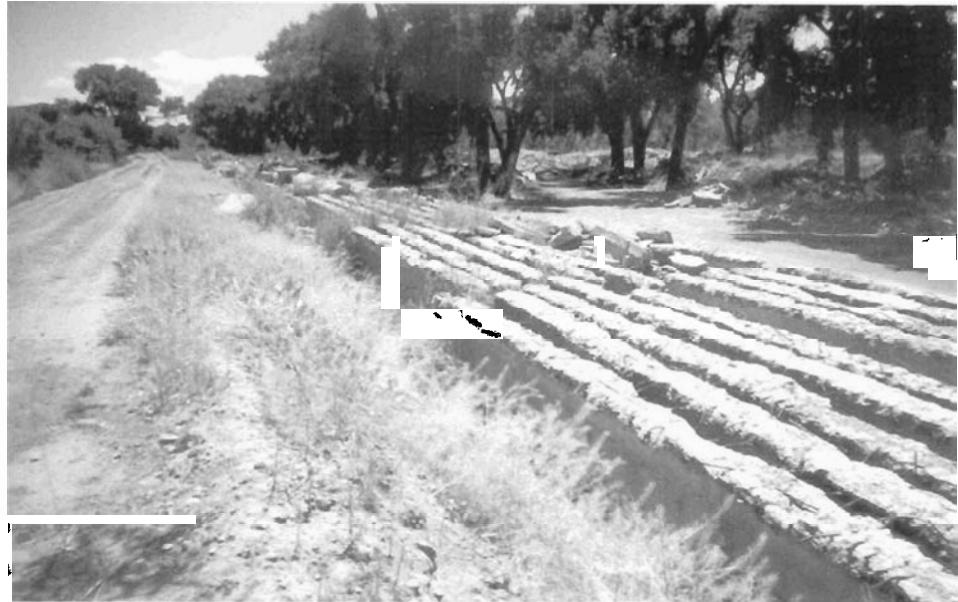
No illicit solid waste dumpsites were observed anywhere along the levee; however, occasional loose windblown trash (e.g., aluminum cans, paper, plastic bottles) was observed all along their extent. A very large amount of concrete (hundreds of cubic yards) was observed at the northern entrance gate of the eastern levee directly adjacent to the levee to the east (Photographs 9 and 10). The debris appears to be related to the demolition of a parking area and/or bridge. Several other concrete piles were observed along the two levees (see Attachment C for their specific locations). Finally, one unusual large concrete object (with mirrors) was found along the eastern levee immediately south of the railroad bridge (Photograph 11). All of the concrete observed appears to be clean and free of visible contamination.

Photograph 9 - Concrete Rubble Next to West Side of Levee- Old Bridge at SR6

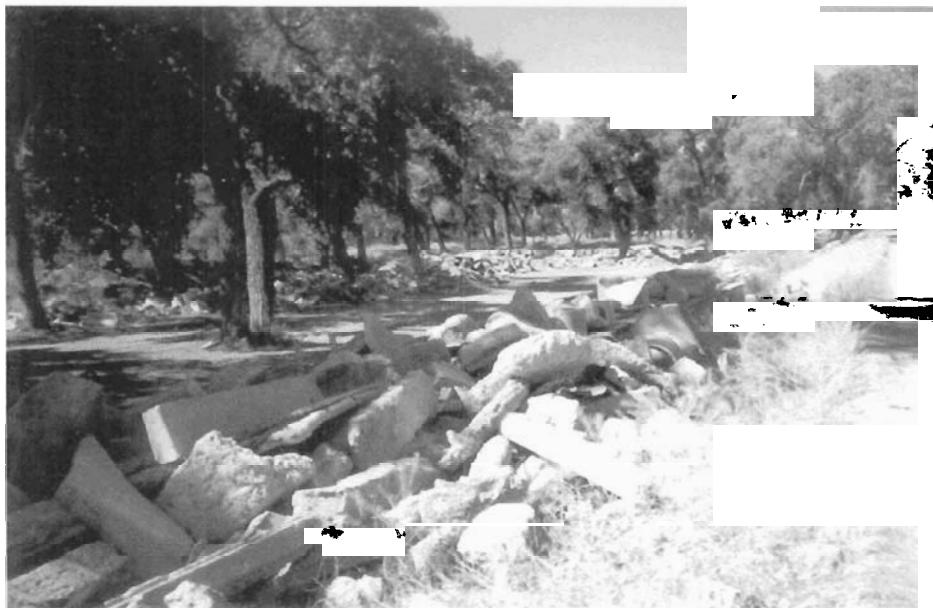
Photograph 10 - View of Concrete Rubble Near Bridge at SR 6

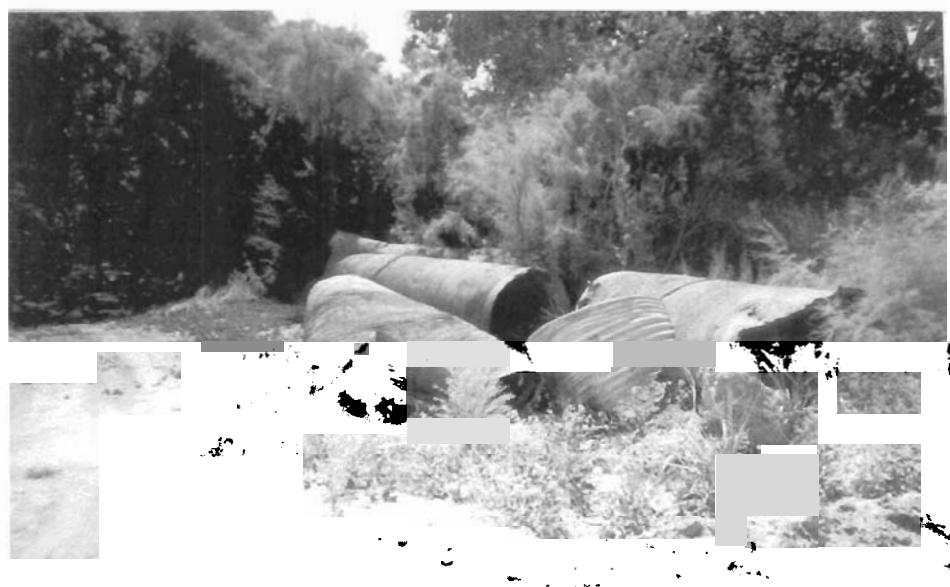
A few relatively clean stainless steel drainage culverts feeding into the riverside drains and under bosque access roads were observed. Several piles of culvert materials were observed adjacent to the eastern and western levees (Photographs 12 through 13). These drainage culverts present no apparent environmental hazard. No culverts draining off-site locations that may impact the levees were found.

Photograph 12 - View of Metal Culverts Next to West Side of Levee

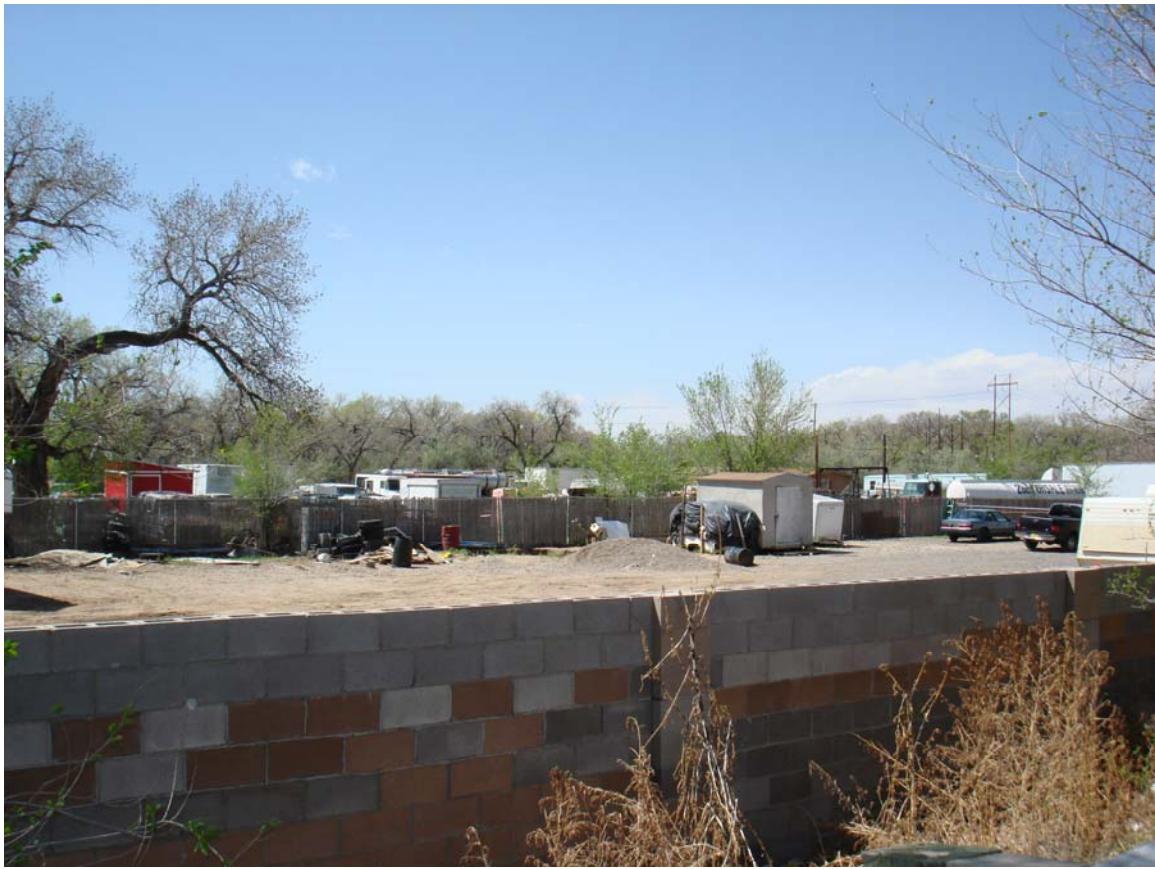
Northern Mountain View Section, Maintenance/Salvage operation.

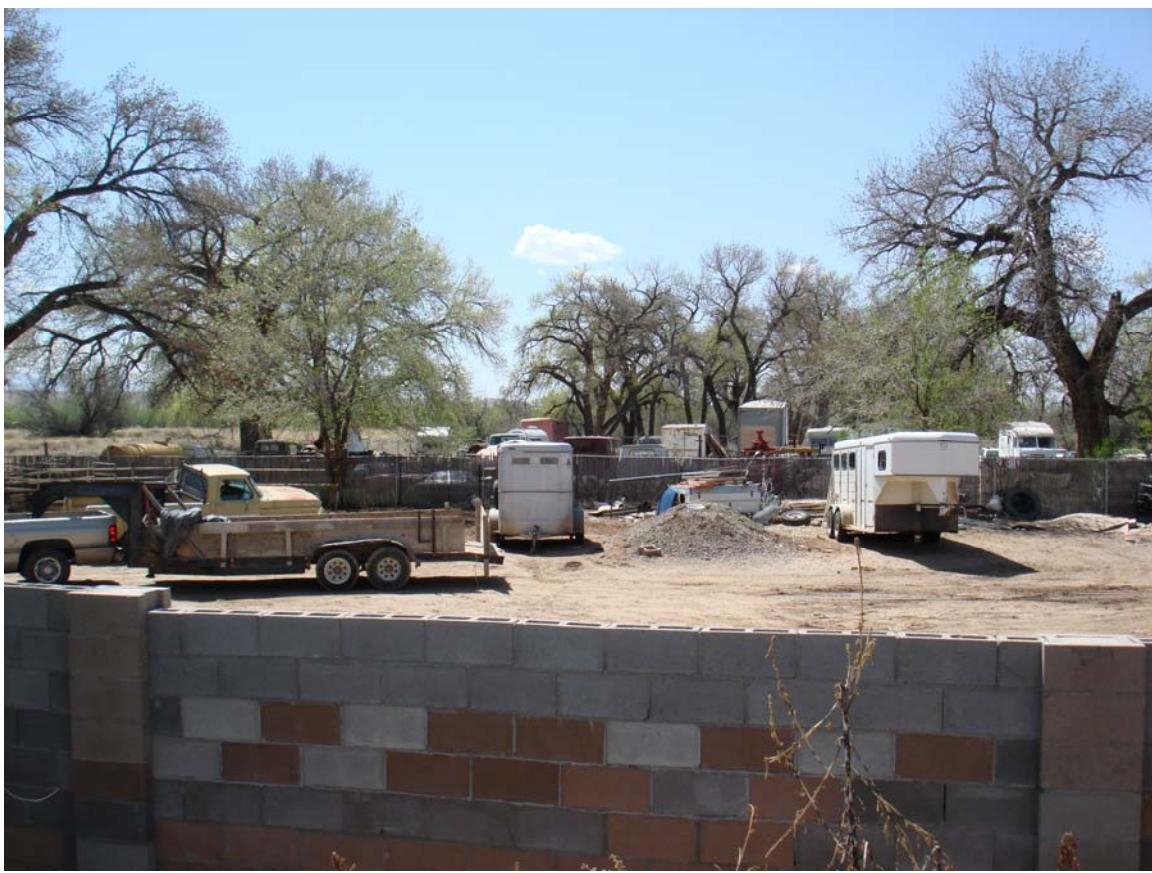
Northern Mountain View Section, Maintenance/Salvage operation.

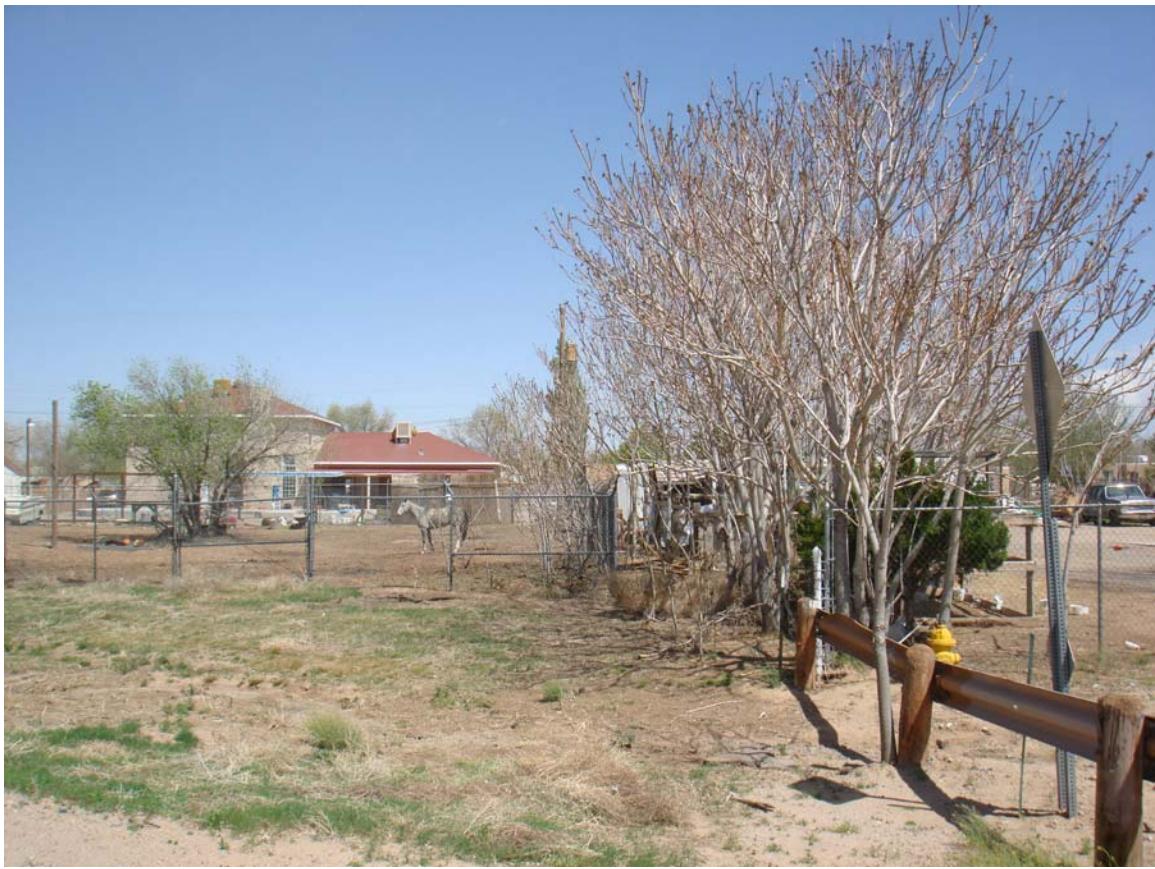
Southern Mountain View Section, residential property.

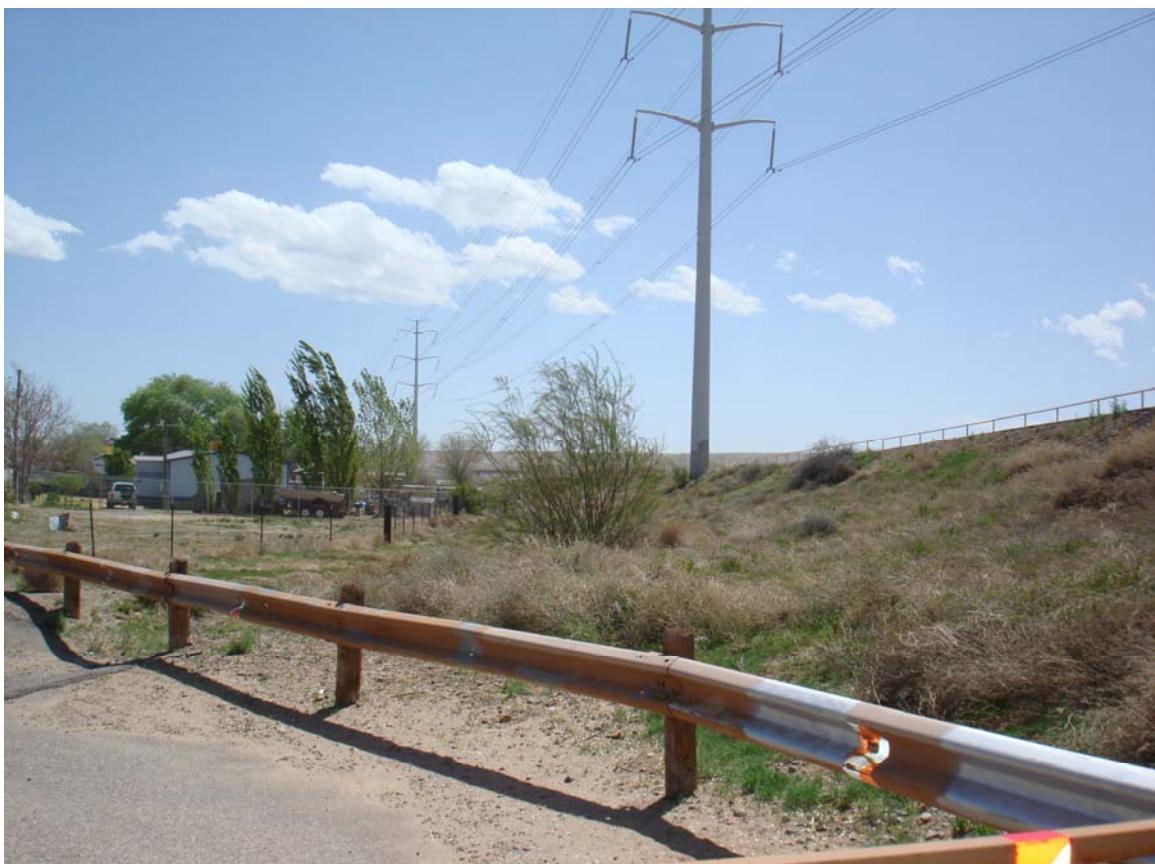
Southern Mountain View Section, residential property.

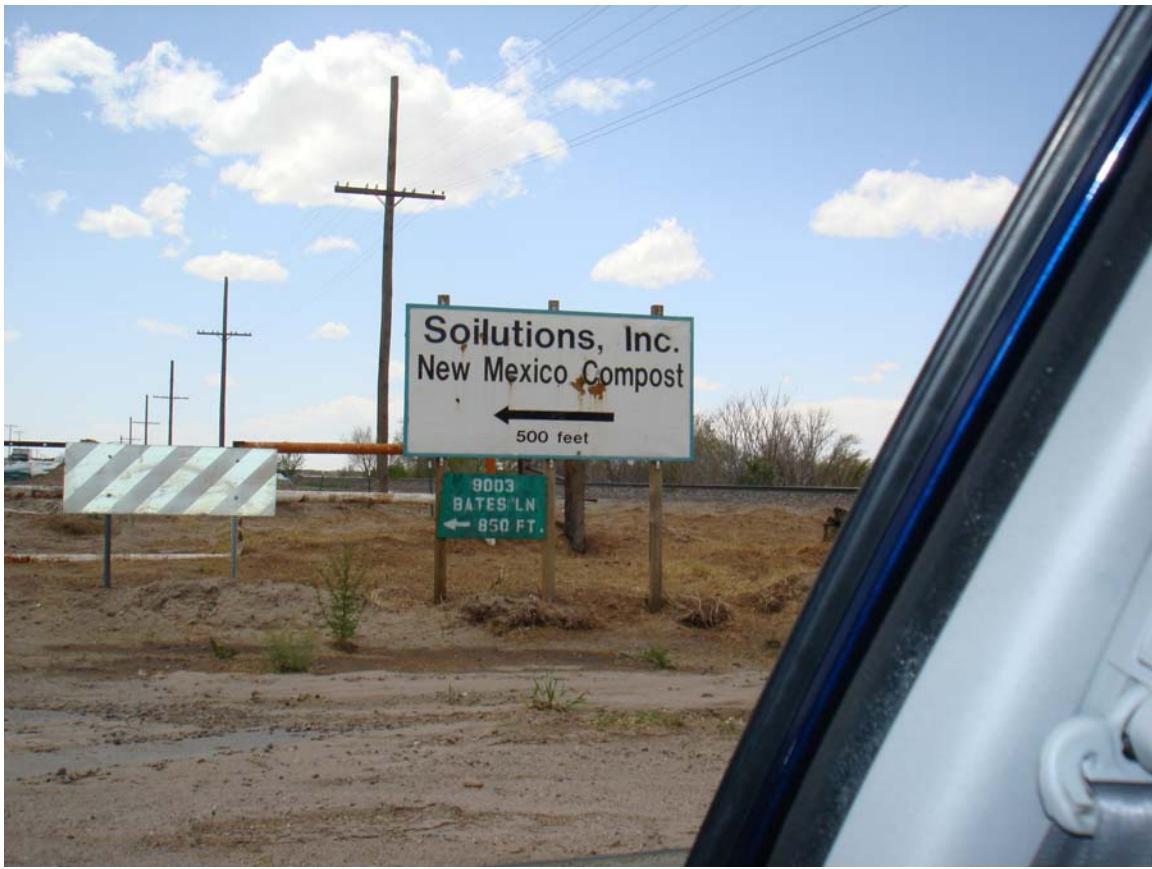
Southern Mountain View Section, Agricultural Operations.

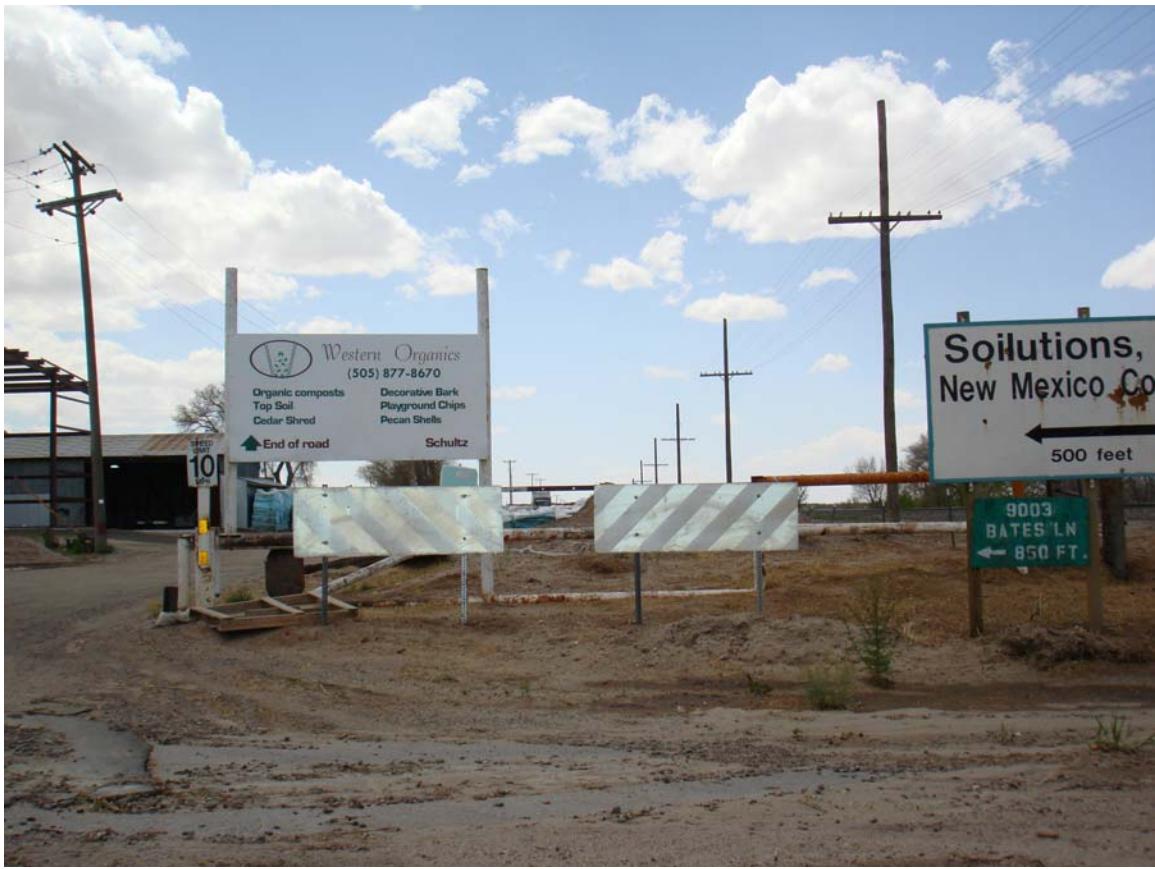
Southern Mountain View Section, Agricultural Operations.
