Amphibian Survey Report

**Rimini Wetland Restoration and Amphibian
Habitat Enhancement
Tenmile Creek Near Rimini, Montana**

**Draft Report
September 2006**

ANALYTICAL DATA REPORT

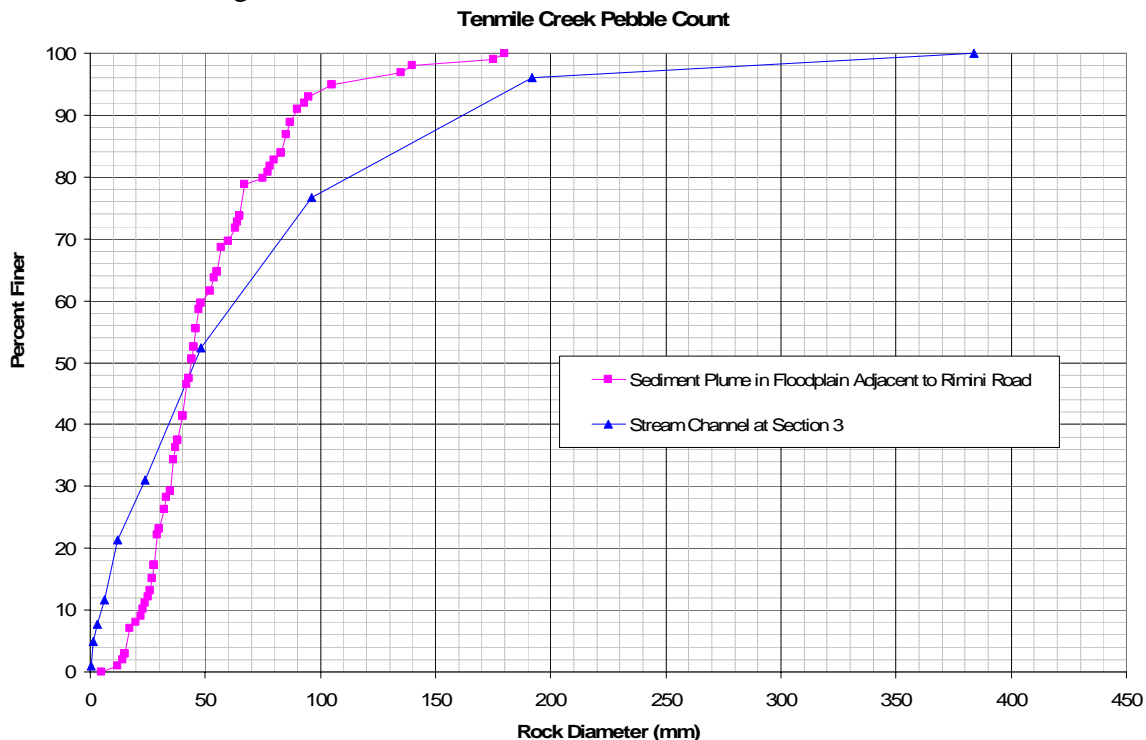
Figure 2 Material Gradation

Numerous exposed sediment deposition plumes consisting of cobbles and gravels are present throughout the overbank area. During the site visit, a pebble count was conducted of one of the exposed sediment plumes. Collection of channel sediment data was not possible due to the high flow rate. Forest Service representatives collected pebble count data at section 3. Both areas have a material D_{50} of about 50 mm. Gradations are for both areas are similar with the exception that the sediment plume does not contain the larger material greater than about D_{80} . This is expected since the larger material would not be transported in the floodplain. Data from the two collection areas are shown in figure 2.

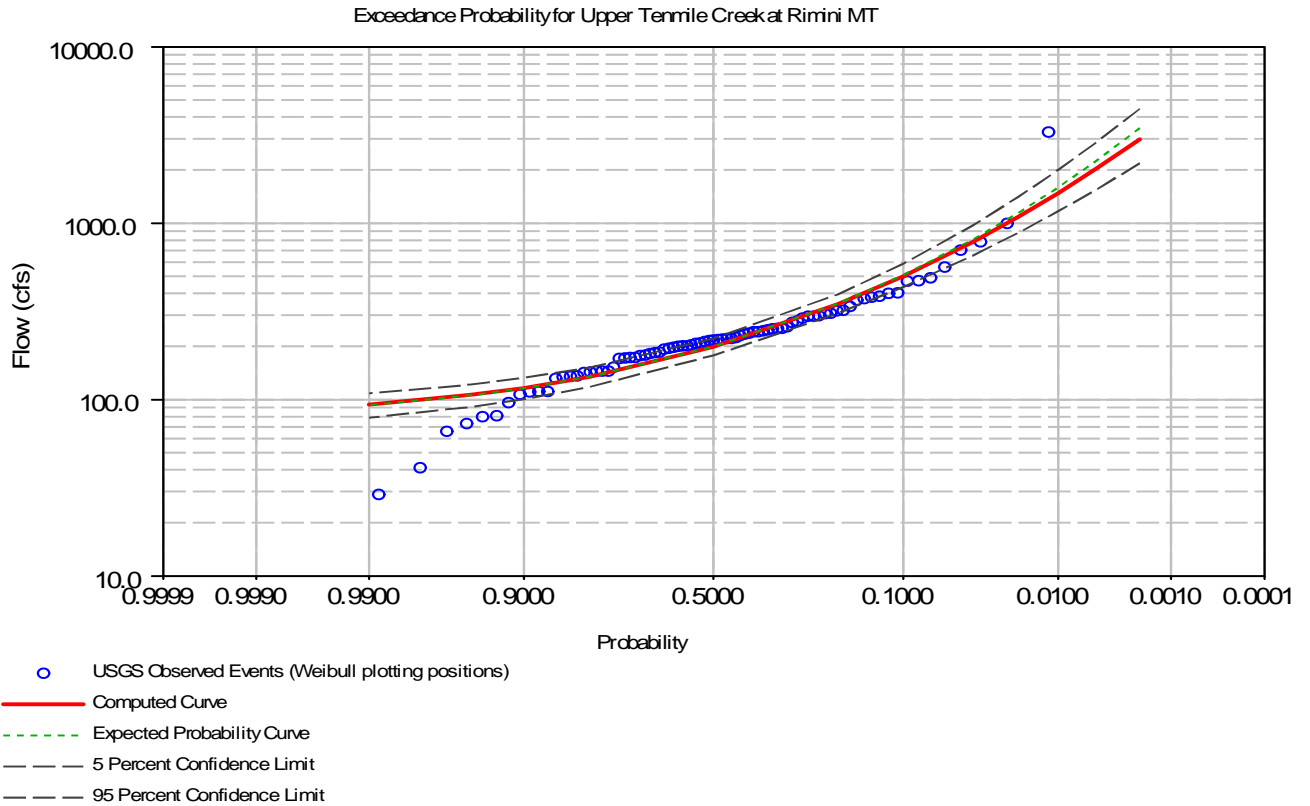
Bulletin 17B Frequency Analysis
 07 Aug 2006 02:41 PM

Results from annual peak frequency analysis, computer program HEC-SSP, version 1, June 2006.

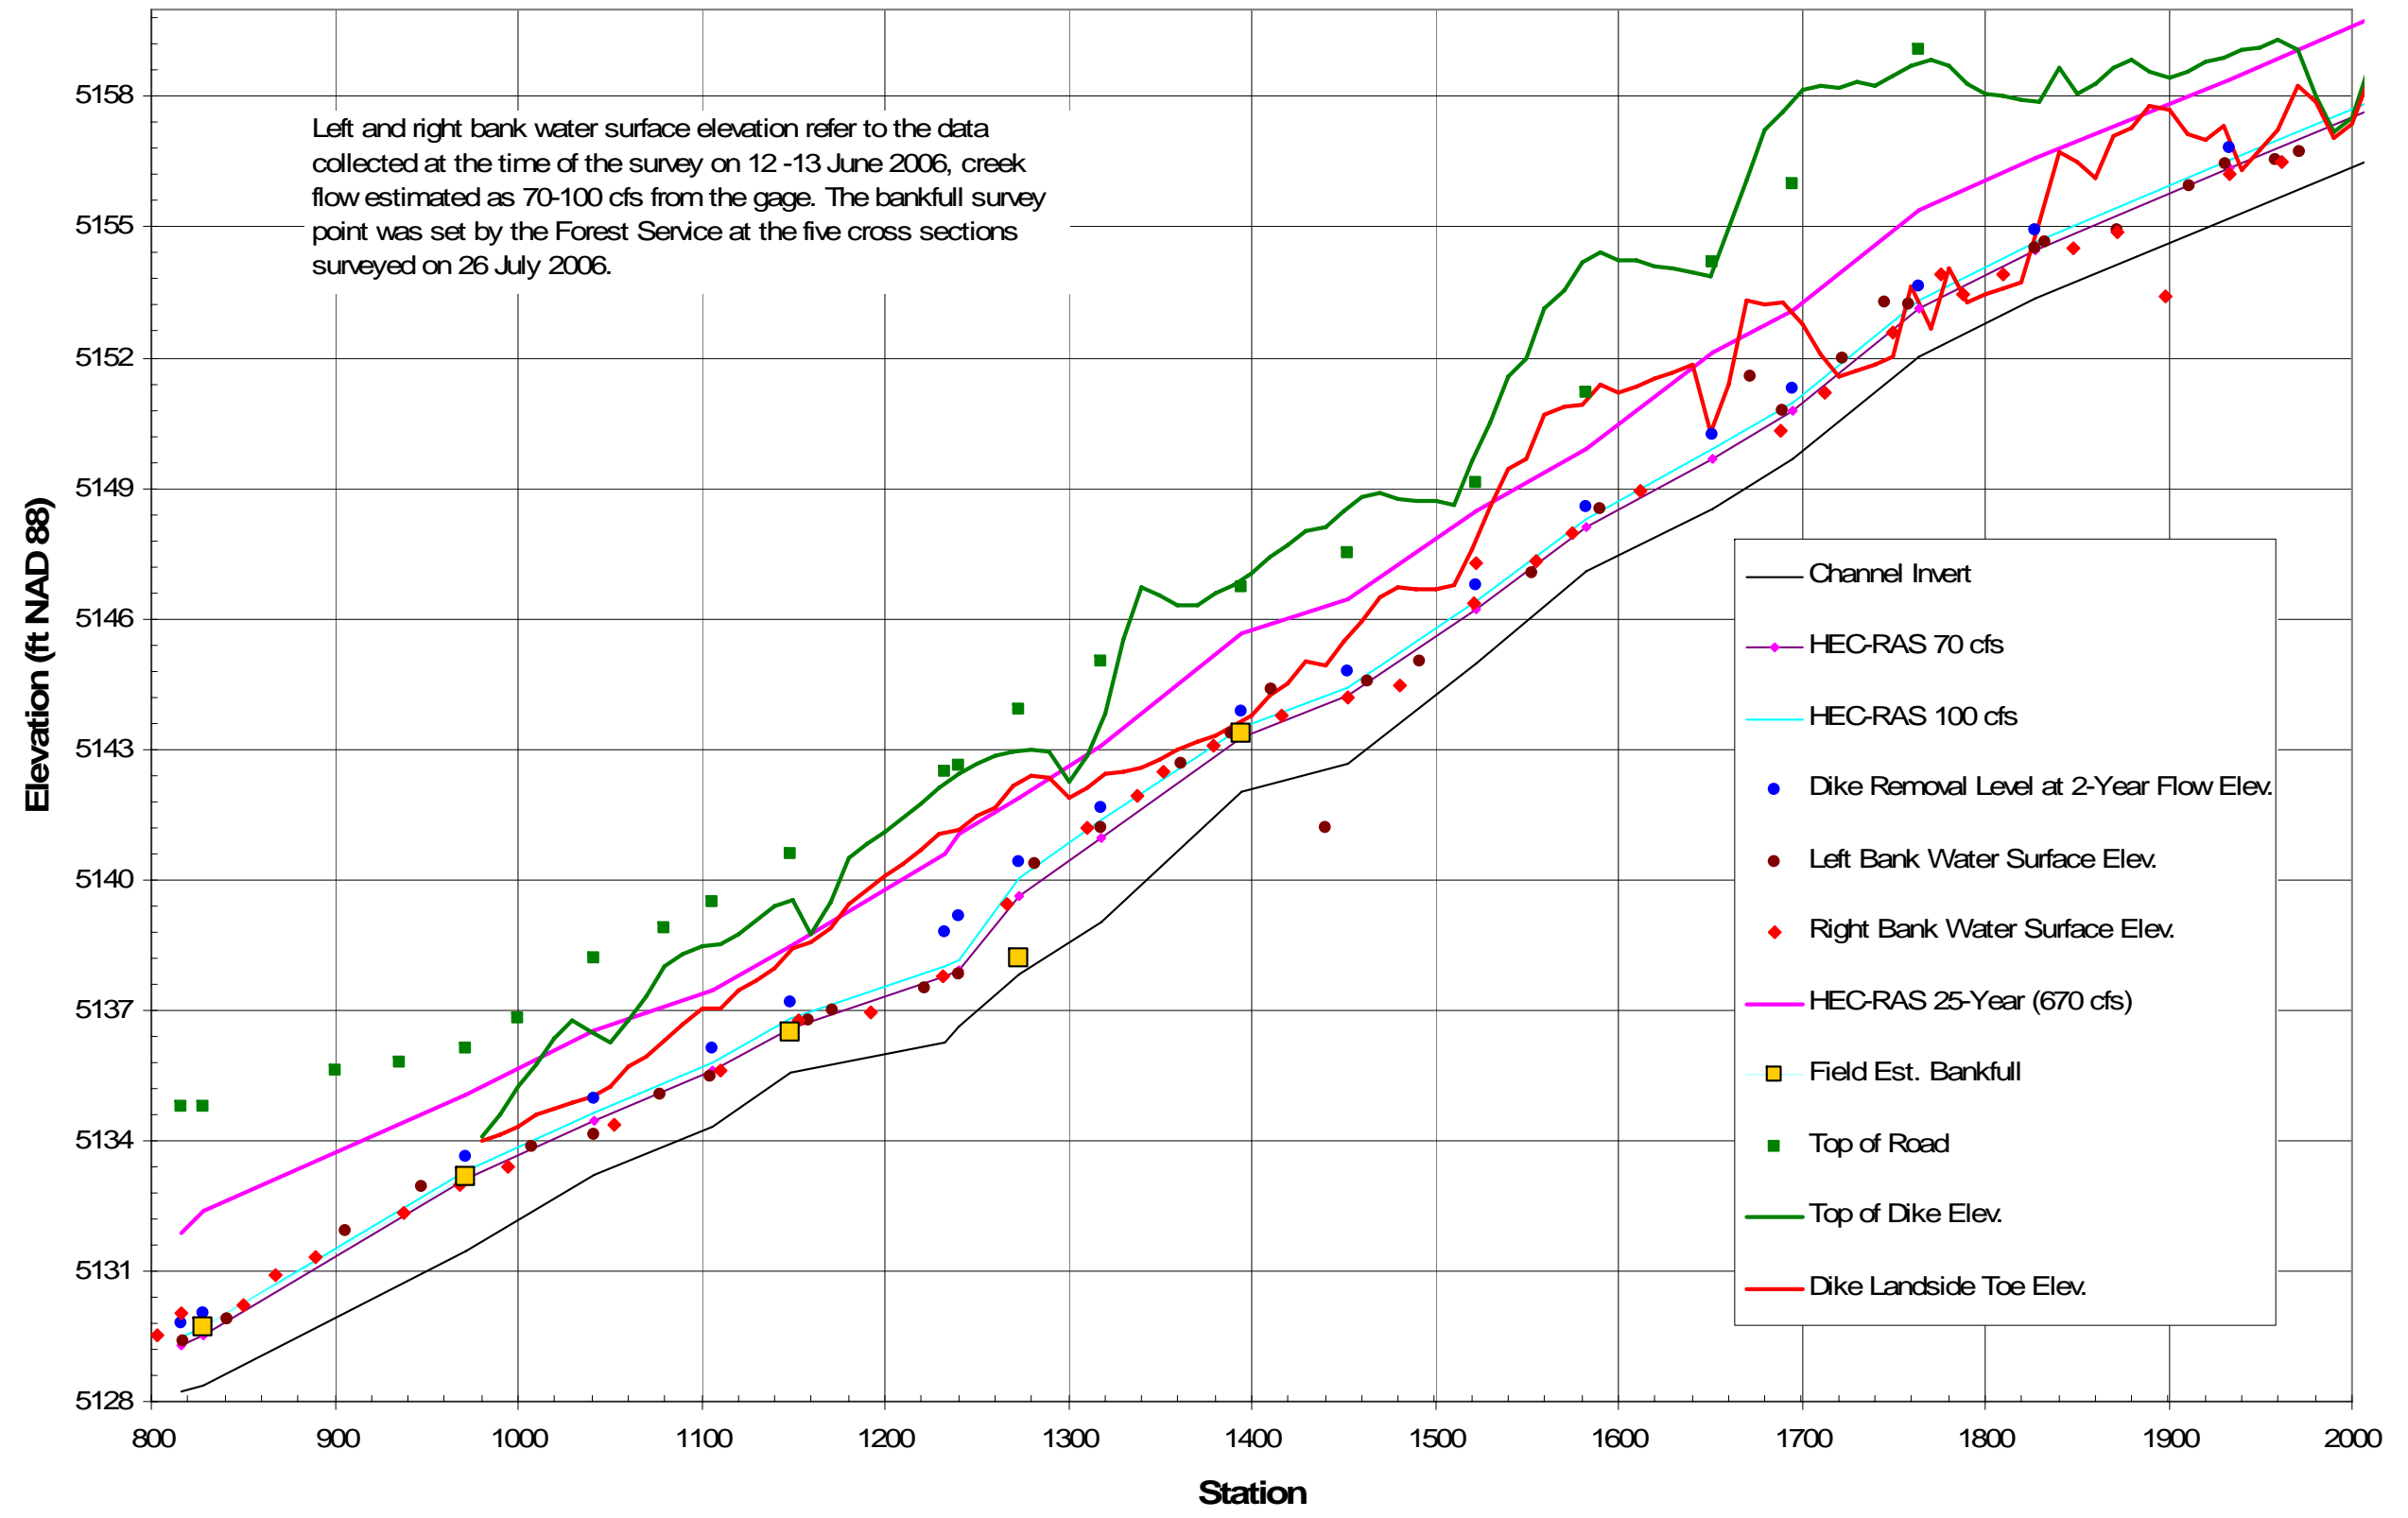
Tenmile Creek HEC-RAS Profile

The calibrated roughness value for the site was 0.036. This roughness value is consistent with the bed material size and shallow flow depth. The calibrated HEC-RAS profile is shown in Att. F. Tabulated results are included in Att. G. In order to match the observed water surface elevations, additional loss was required through the steep slope rapid section that includes numerous boulders. Cross section data was not available for this area and was generated within the RAS model from adjacent areas. Without any additional information, the boulder reach was simulated by adding geometry to represent boulders within the stream channel section until the observed elevations were matched.

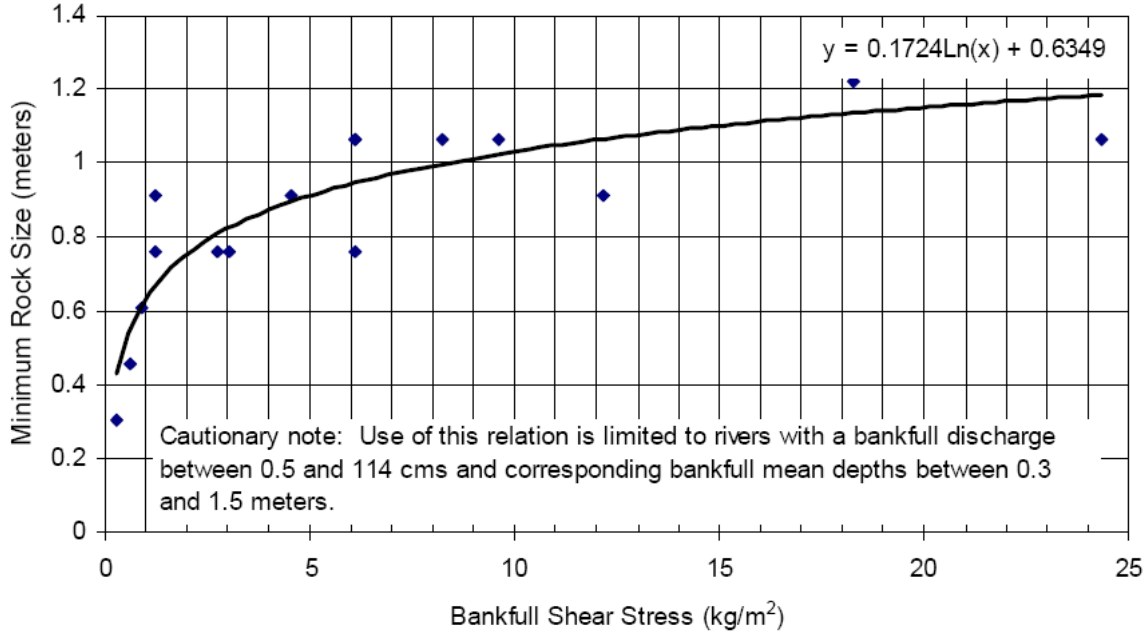
Figure 10. Minimum rock size as a function of bankfull shear stress

Reference: Rosgen, D.L., *The Cross-Vane, W-Weir and J-Hook Structures, Their Description, Design and Application for Stream Stabilization and River Restoration*, Proceedings of the 2001 Wetlands Engineering & River Restoration Conference, Reno, NV, Aug 2001.

Table 1 provides limits for idealized conditions or the stability of sediments in the bed. Therefore, these values represent a minimum stability threshold. For application at the site, rock exposure, turbulence, and other variable will reduce stability. Table 1 values are not representative of a single exposed rock above the bed surface.

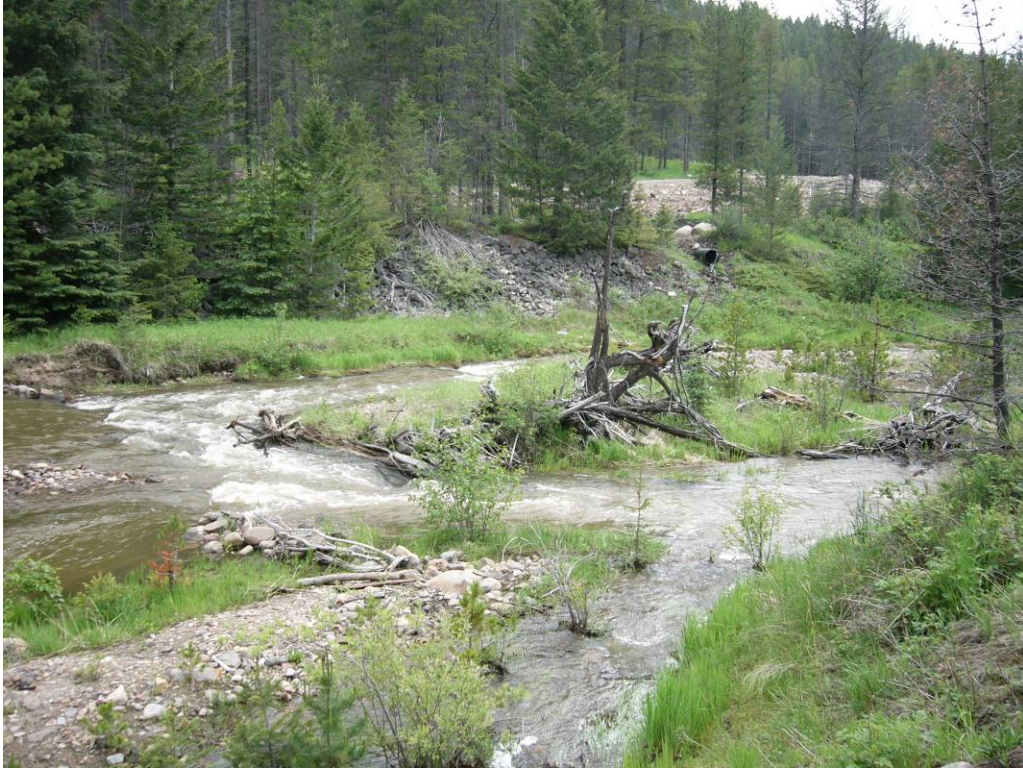
From right bank looking downstream at mid channel bar/snag and wsel drop. Snag is located on large boulder rapid across channel.

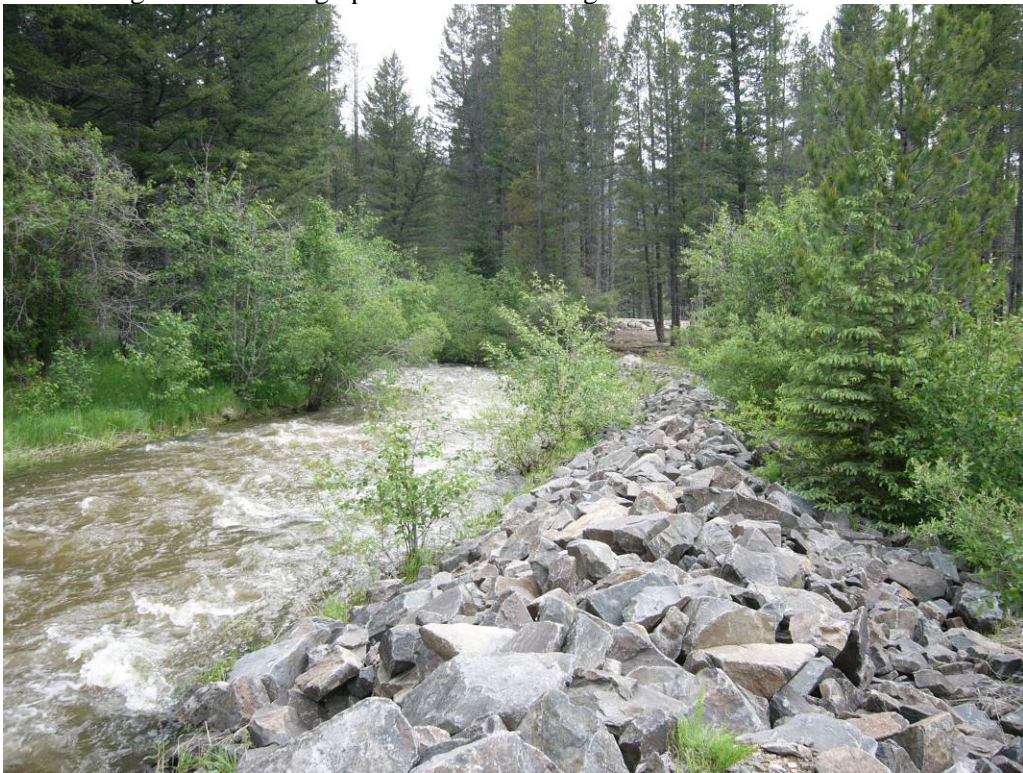
From right bank looking downstream at rock berm, just below trailer.

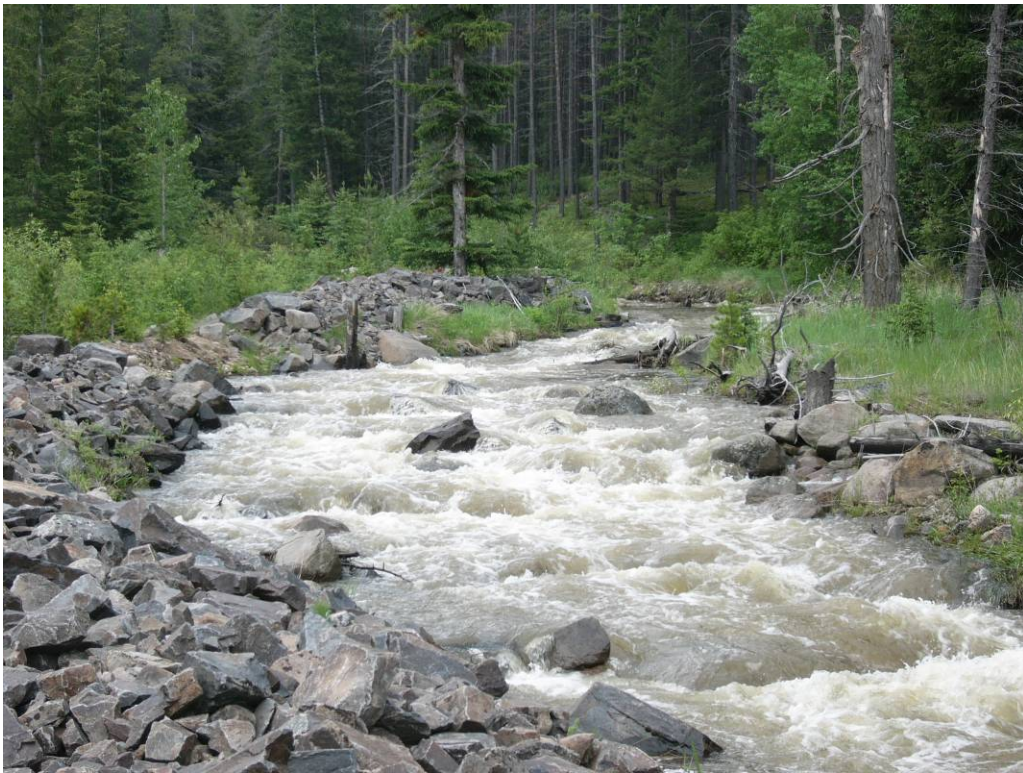
From right bank, just upstream of trailer looking at rapid section and rock berm on right bank.

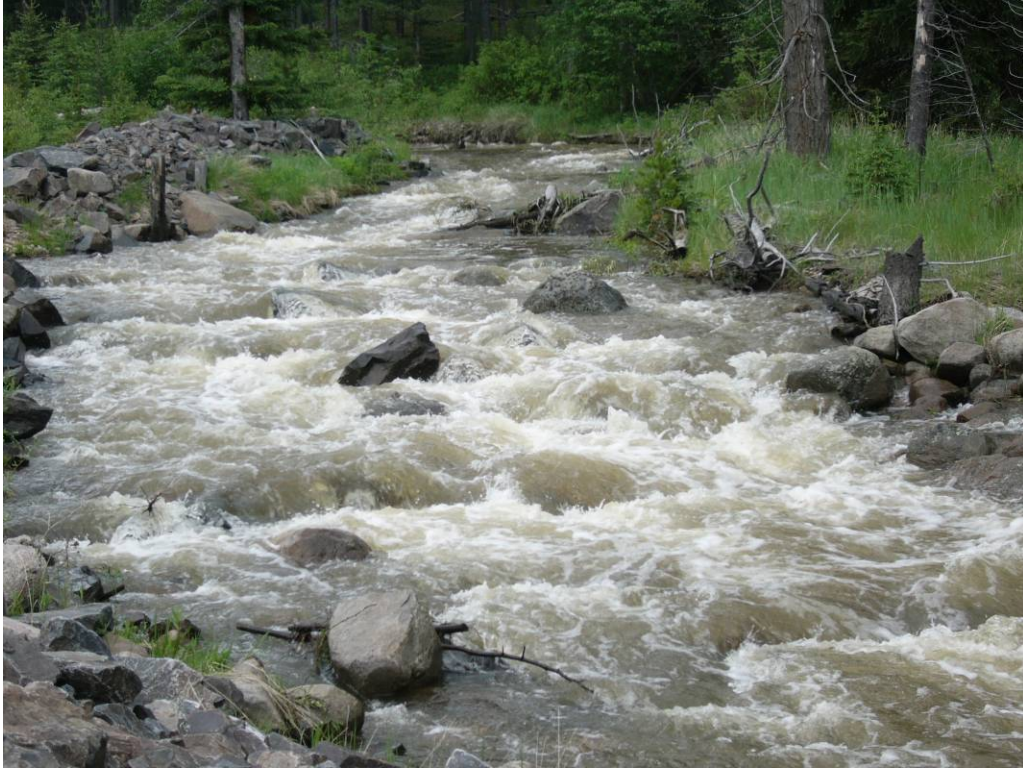
From right bank looking upstream at rapids with close up, and bend above drop reach. Notice large size rock and turbulence.

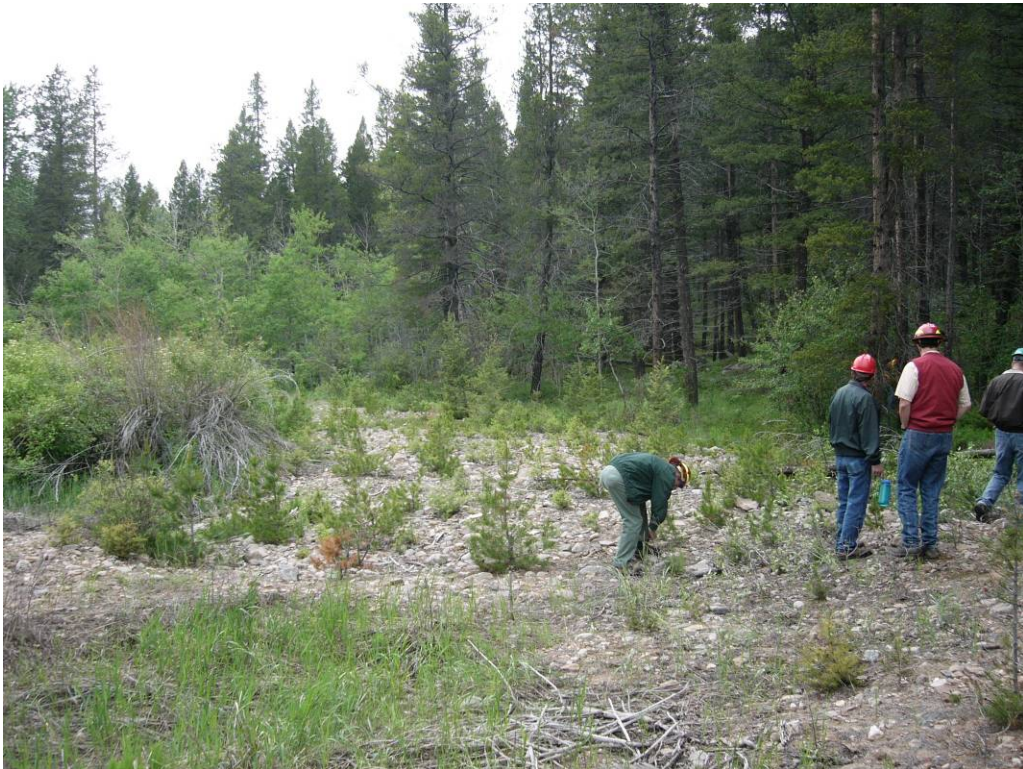
On east side of Rimini Road (away from stream) looking at sediment plume deposition from flood.

Numerous sediment deposition areas consisting of cobbles and gravels are present throughout the overbank area. Discussion indicated that a major flood occurred in 1981. Plans were furnished by the County that illustrate flood repair work following the 1981 flood. Based on the plans and photos of the site, it appears that the channel was temporarily flowing down the road and in the right overbank (east of Rimini Road) location. Repair work was conducted to remove sediment blockage and reconstruct the channel. Verbal accounts indicated that Rimini residents were airlifted from the town.

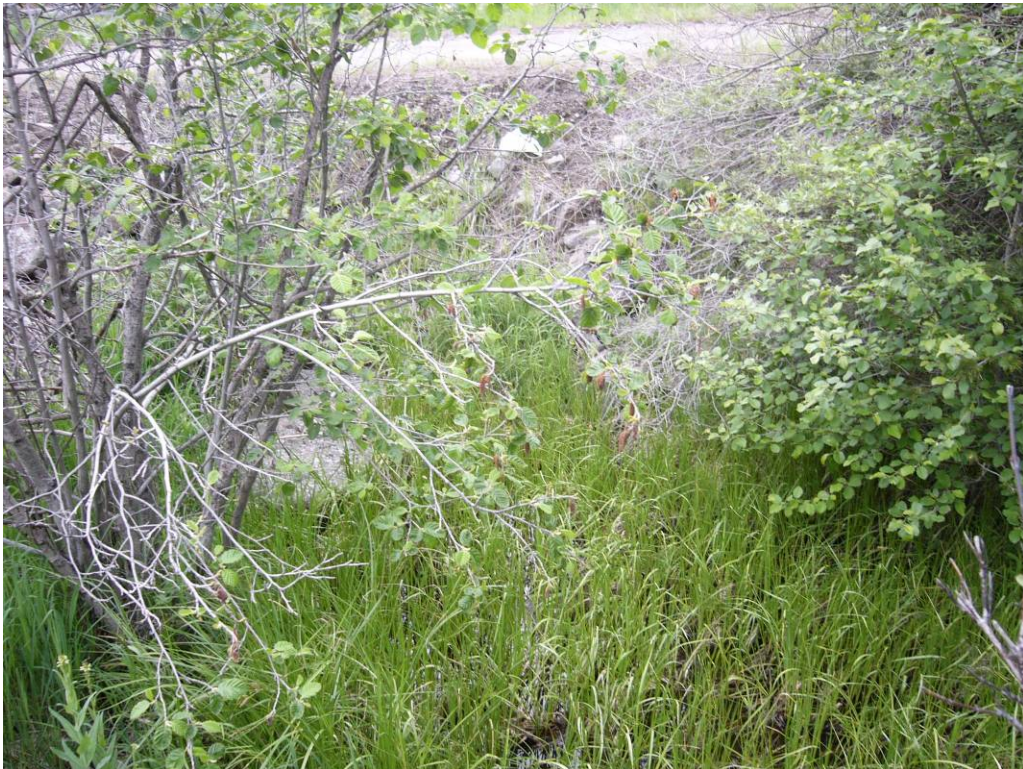
From channel looking at culvert entrance. Appeared to be an 12 to 18" culvert mostly blocked by vegetation and sediment. Culvert at base of slope near photo center. Top of road visible at photo top.

Within the right overbank downstream of the site on the east side of Rimini Road, the topography includes what appears to be an old channel segment. The old channel terminates at Chessman Road with a 12 to 18" diameter culvert. The culvert is mostly blocked with debris and sediment, an outlet on the downstream side could not be located. A noticeably inflow was observed. The pasture on the downstream side has an undrained low spot.

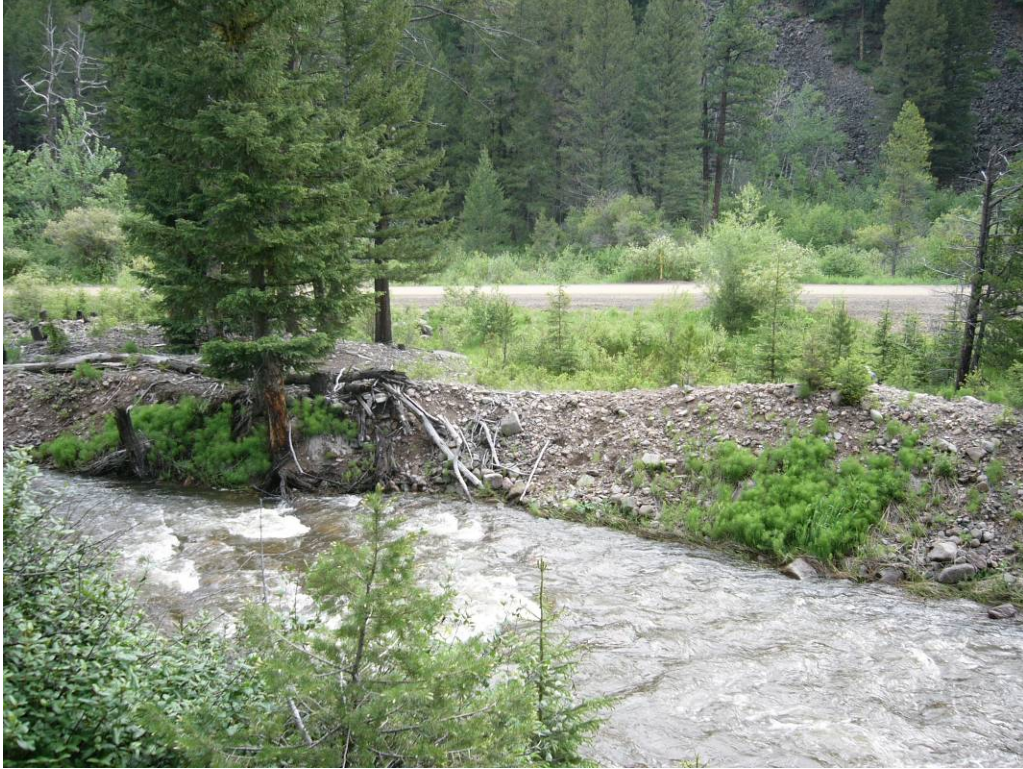
From top of left bank near XS#6, looking downstream with focus upstream of previous photo, looking at opposite bank and low saddle in rock berm. Evergreen tree area is natural high spot, near possible culvert location beneath Rimini Road for wetlands on east side.

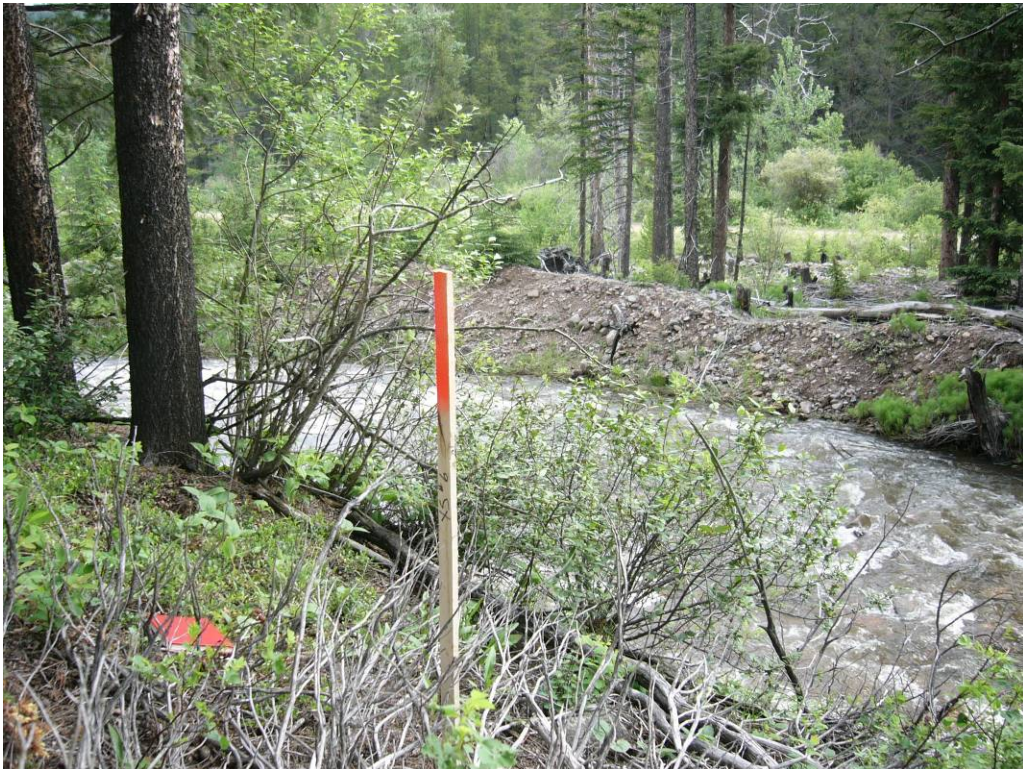
Looking at lathe marker for XS#6, typical marker for all six cross section endpoints.

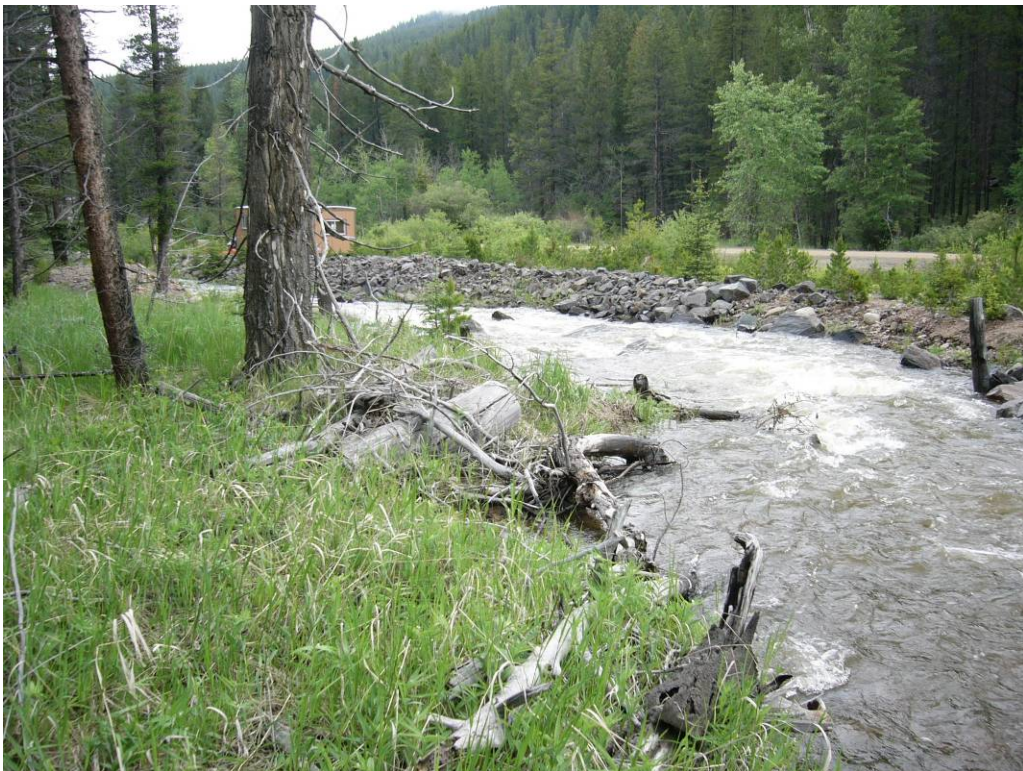
Looking upstream on left bank, lathe for XS# 5, large boulder to big Aspen on left bank is straight reach, potential widening reach, swing back to join channel at top of rapids.

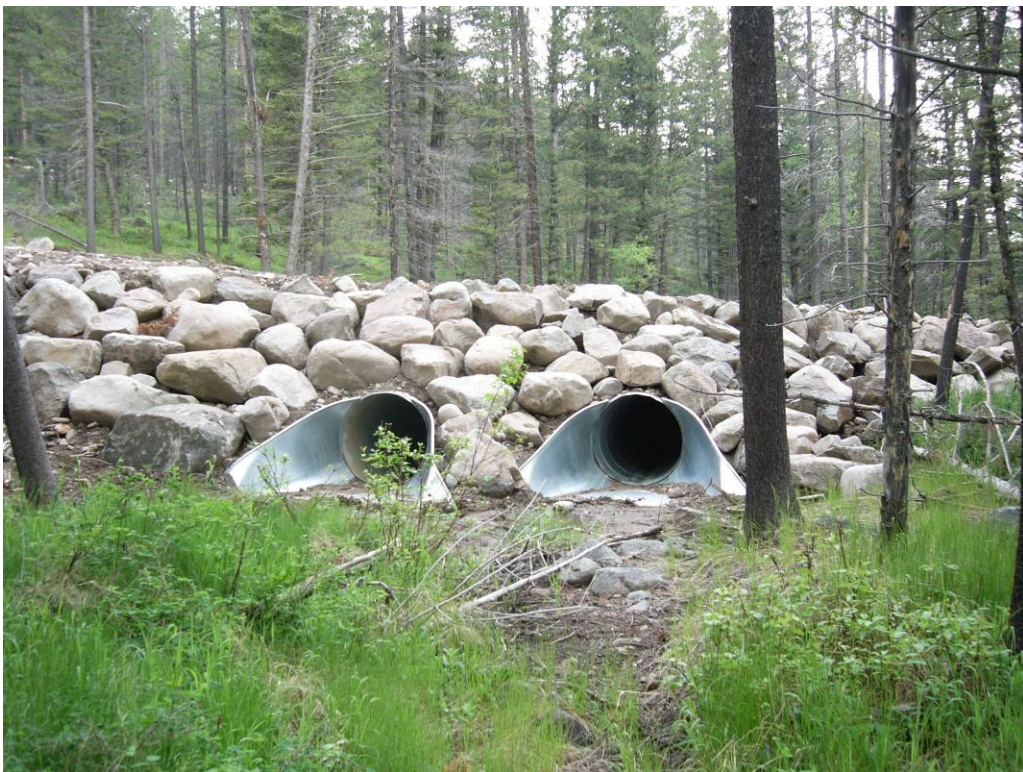
Two 42" diameter CMP beneath new road crossing that provides outlet for left bank overland flow.

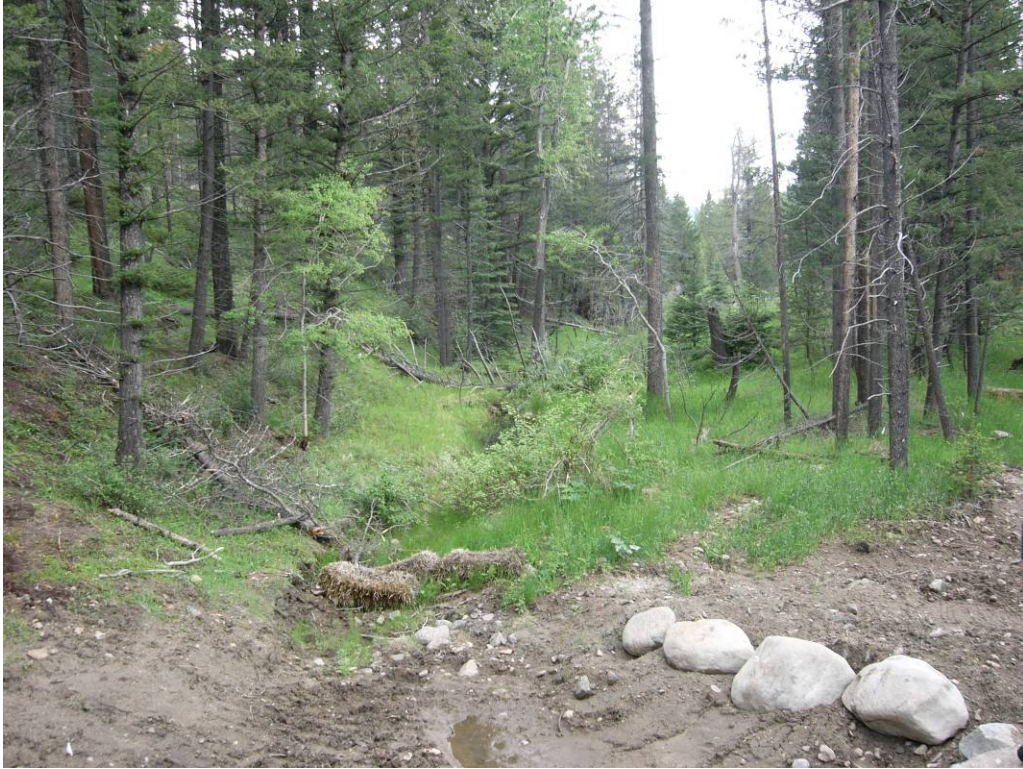
From road looking downstream at outlet for 2 42" culverts.

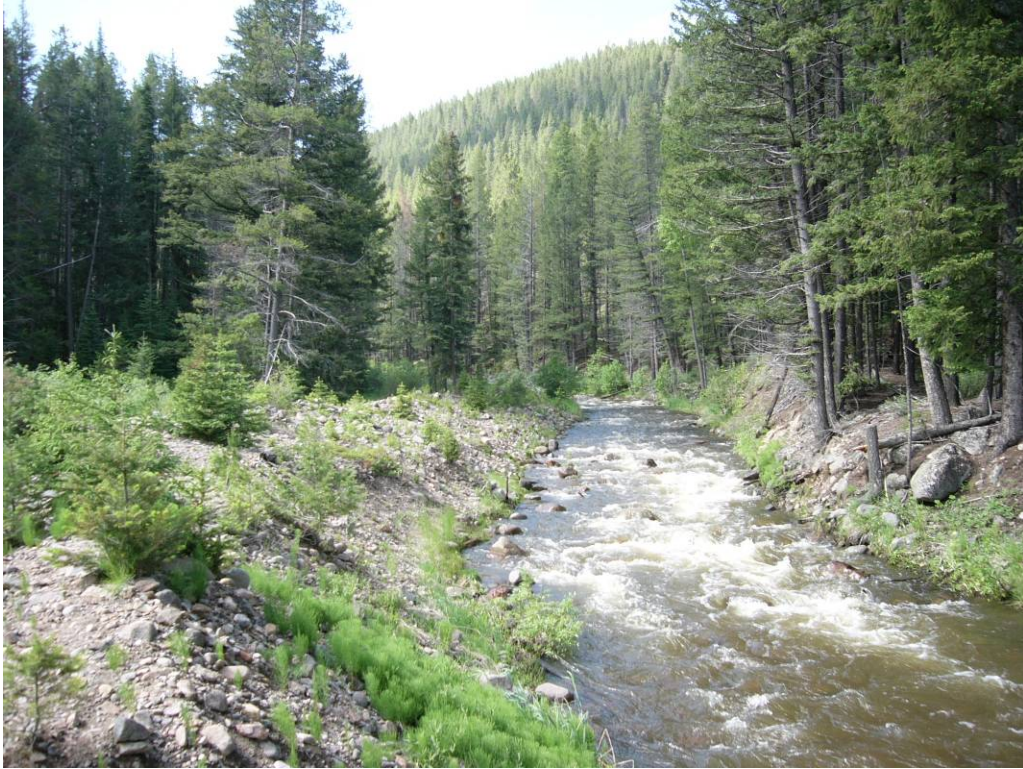
From right bank near opposite of XS#6 looking upstream at rock berm, looks to be built of river sediment with gravel and cobbles.

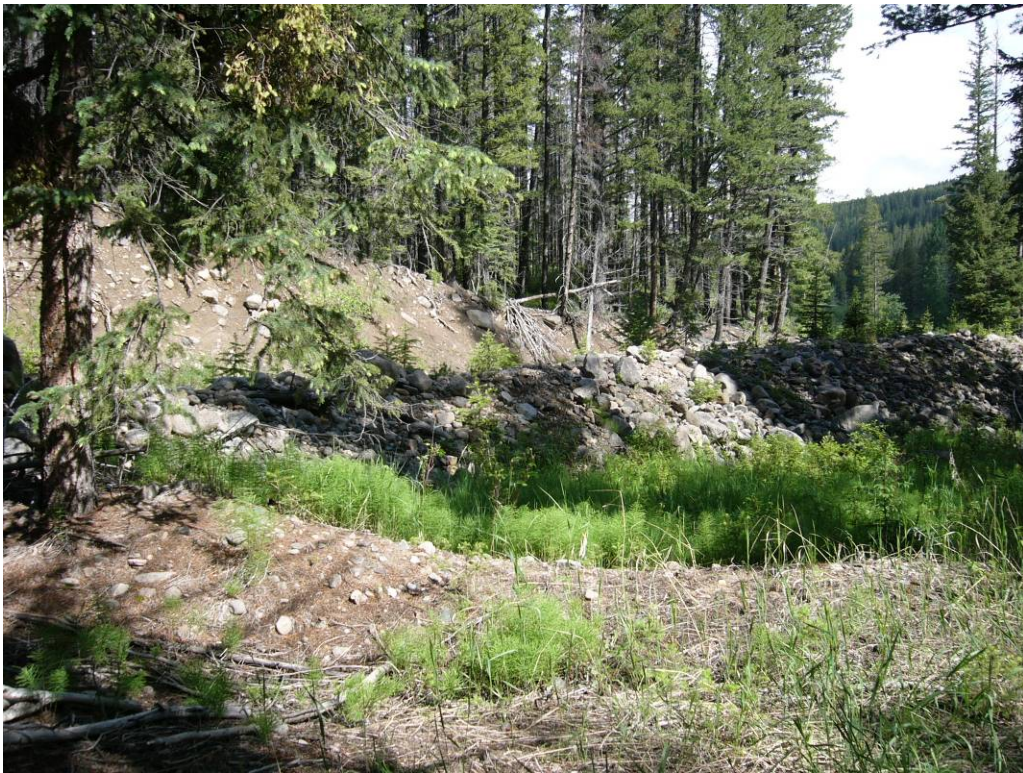
On right bank near upstream end of possible diversion to wetland, toe of left bank hill slope starts just upstream, dike height decreases to about 4 ft in this area (8 ft d/s).

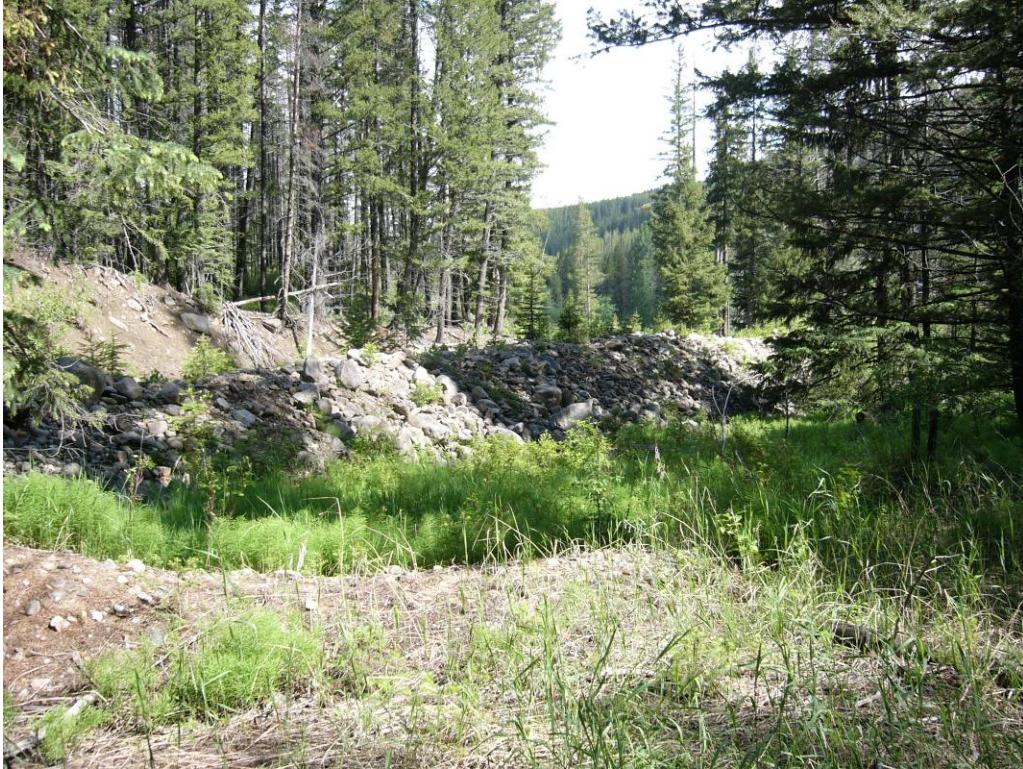
On right bank, same location as previous looking further downstream at main dike with 8 ft height compared to lower dike of 4 ft in upstream area.
