## Site Inspection Report

### Former Carlsbad Army Airfield

Eddy County, New Mexico

FUDS Project No. K06NM034203  
Contract No. W912DY-04-D-0005  
Task Order 0009

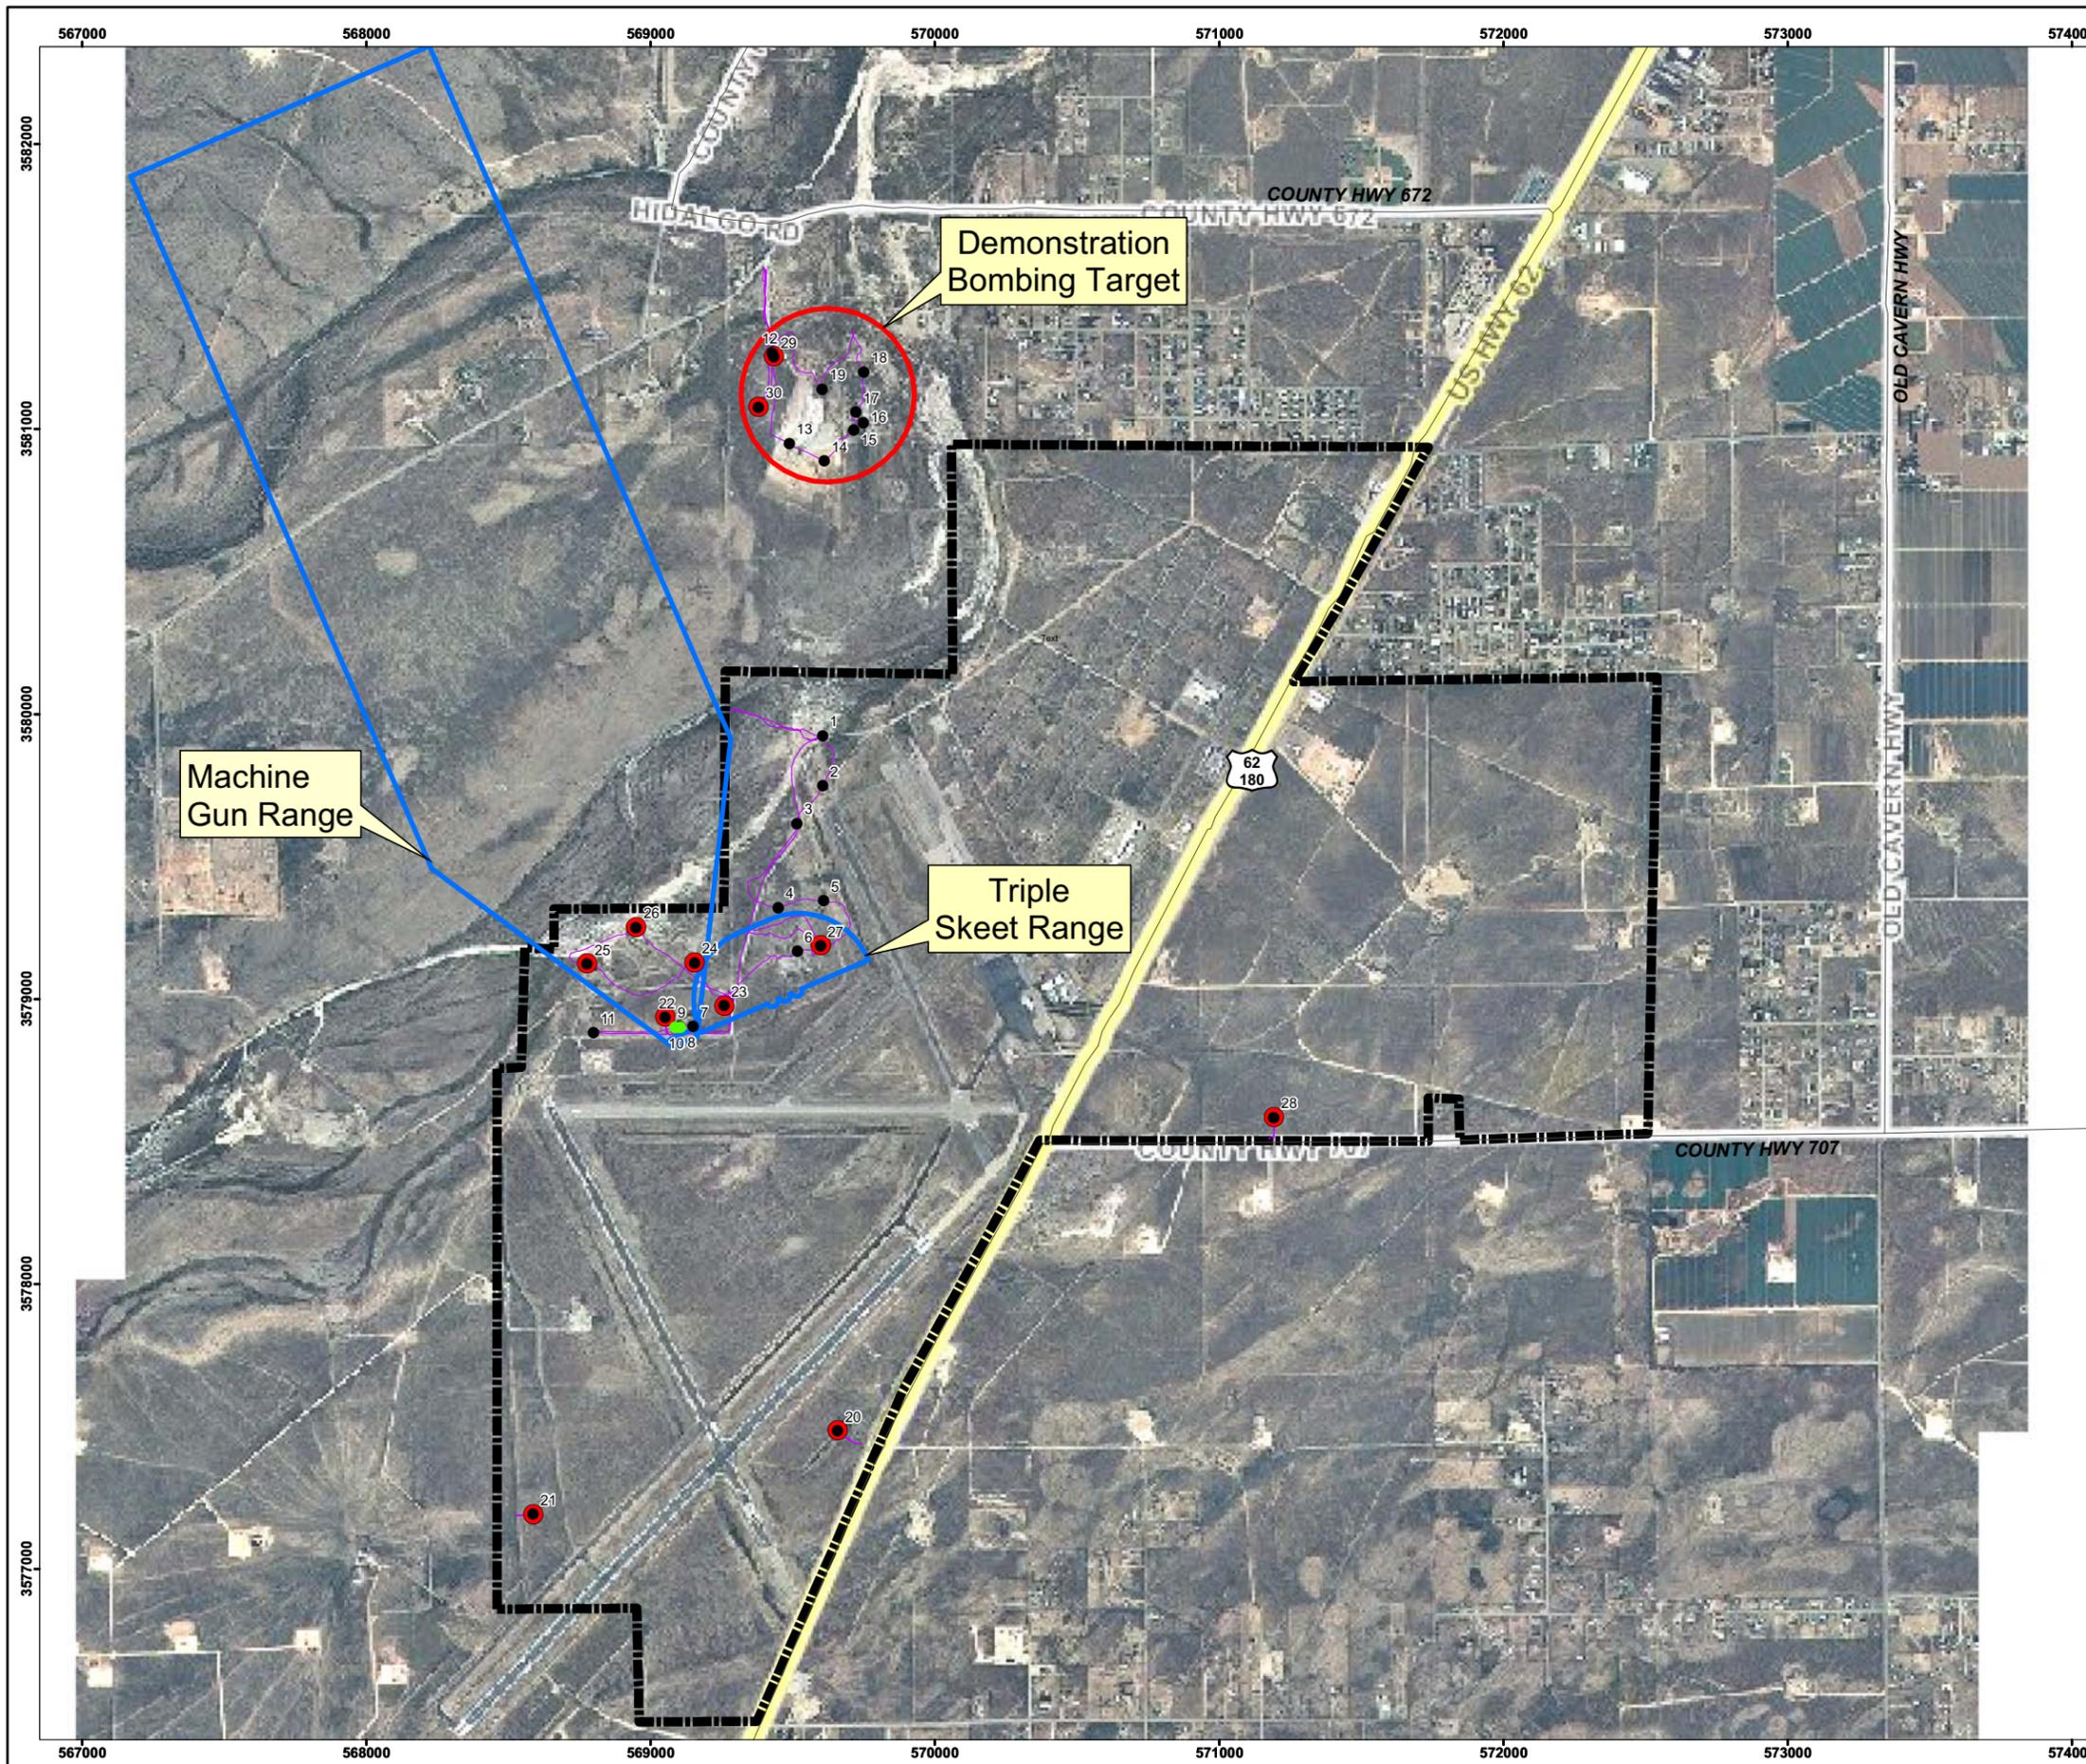
**General Site Overview**  
**Formerly Used Defense Site**  
**Carlsbad Army Airfield**  
**FUDS Project # K06NM034203**

ES.2.3 The field team did not find MEC during the QR at the former Carlsbad AAF, although munitions debris from small arms was observed during the QR. Table ES.1 and Figure ES.1 summarize the results of the SI.

ES.3.1 No MEC were found during the SI, although the field team did observe large amounts of small arms munitions debris in the vicinity of the former Range Complex No. 1 firing line. Small arms do not pose a threat if encountered by receptors; therefore, there is no potential for MEC or a complete MEC exposure pathway at Range Complex No. 1.

Based on the observation of practice bomb debris by the ASR site visit team, the Demonstration Bombing Target MRS is recommended to proceed to RI/FS status for MEC. However, the data supports no further MC sampling during the RI/FS, and a removal action is not warranted at this time. Range Complex No. 1 is recommended to proceed to NDAI status, as no risk was associated with either the munitions debris or MC identified in this MRS during the SI.

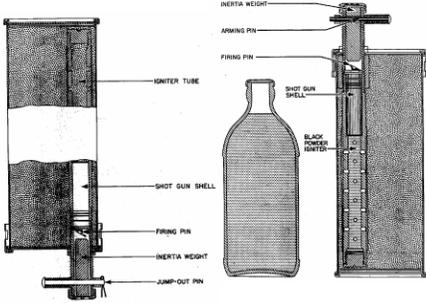
<p><b>M1A1</b>                      <b>M5</b>                      <b>M3</b></p>

<p>Signals, Spotting Charge, M1A1, M5, and M3</p>

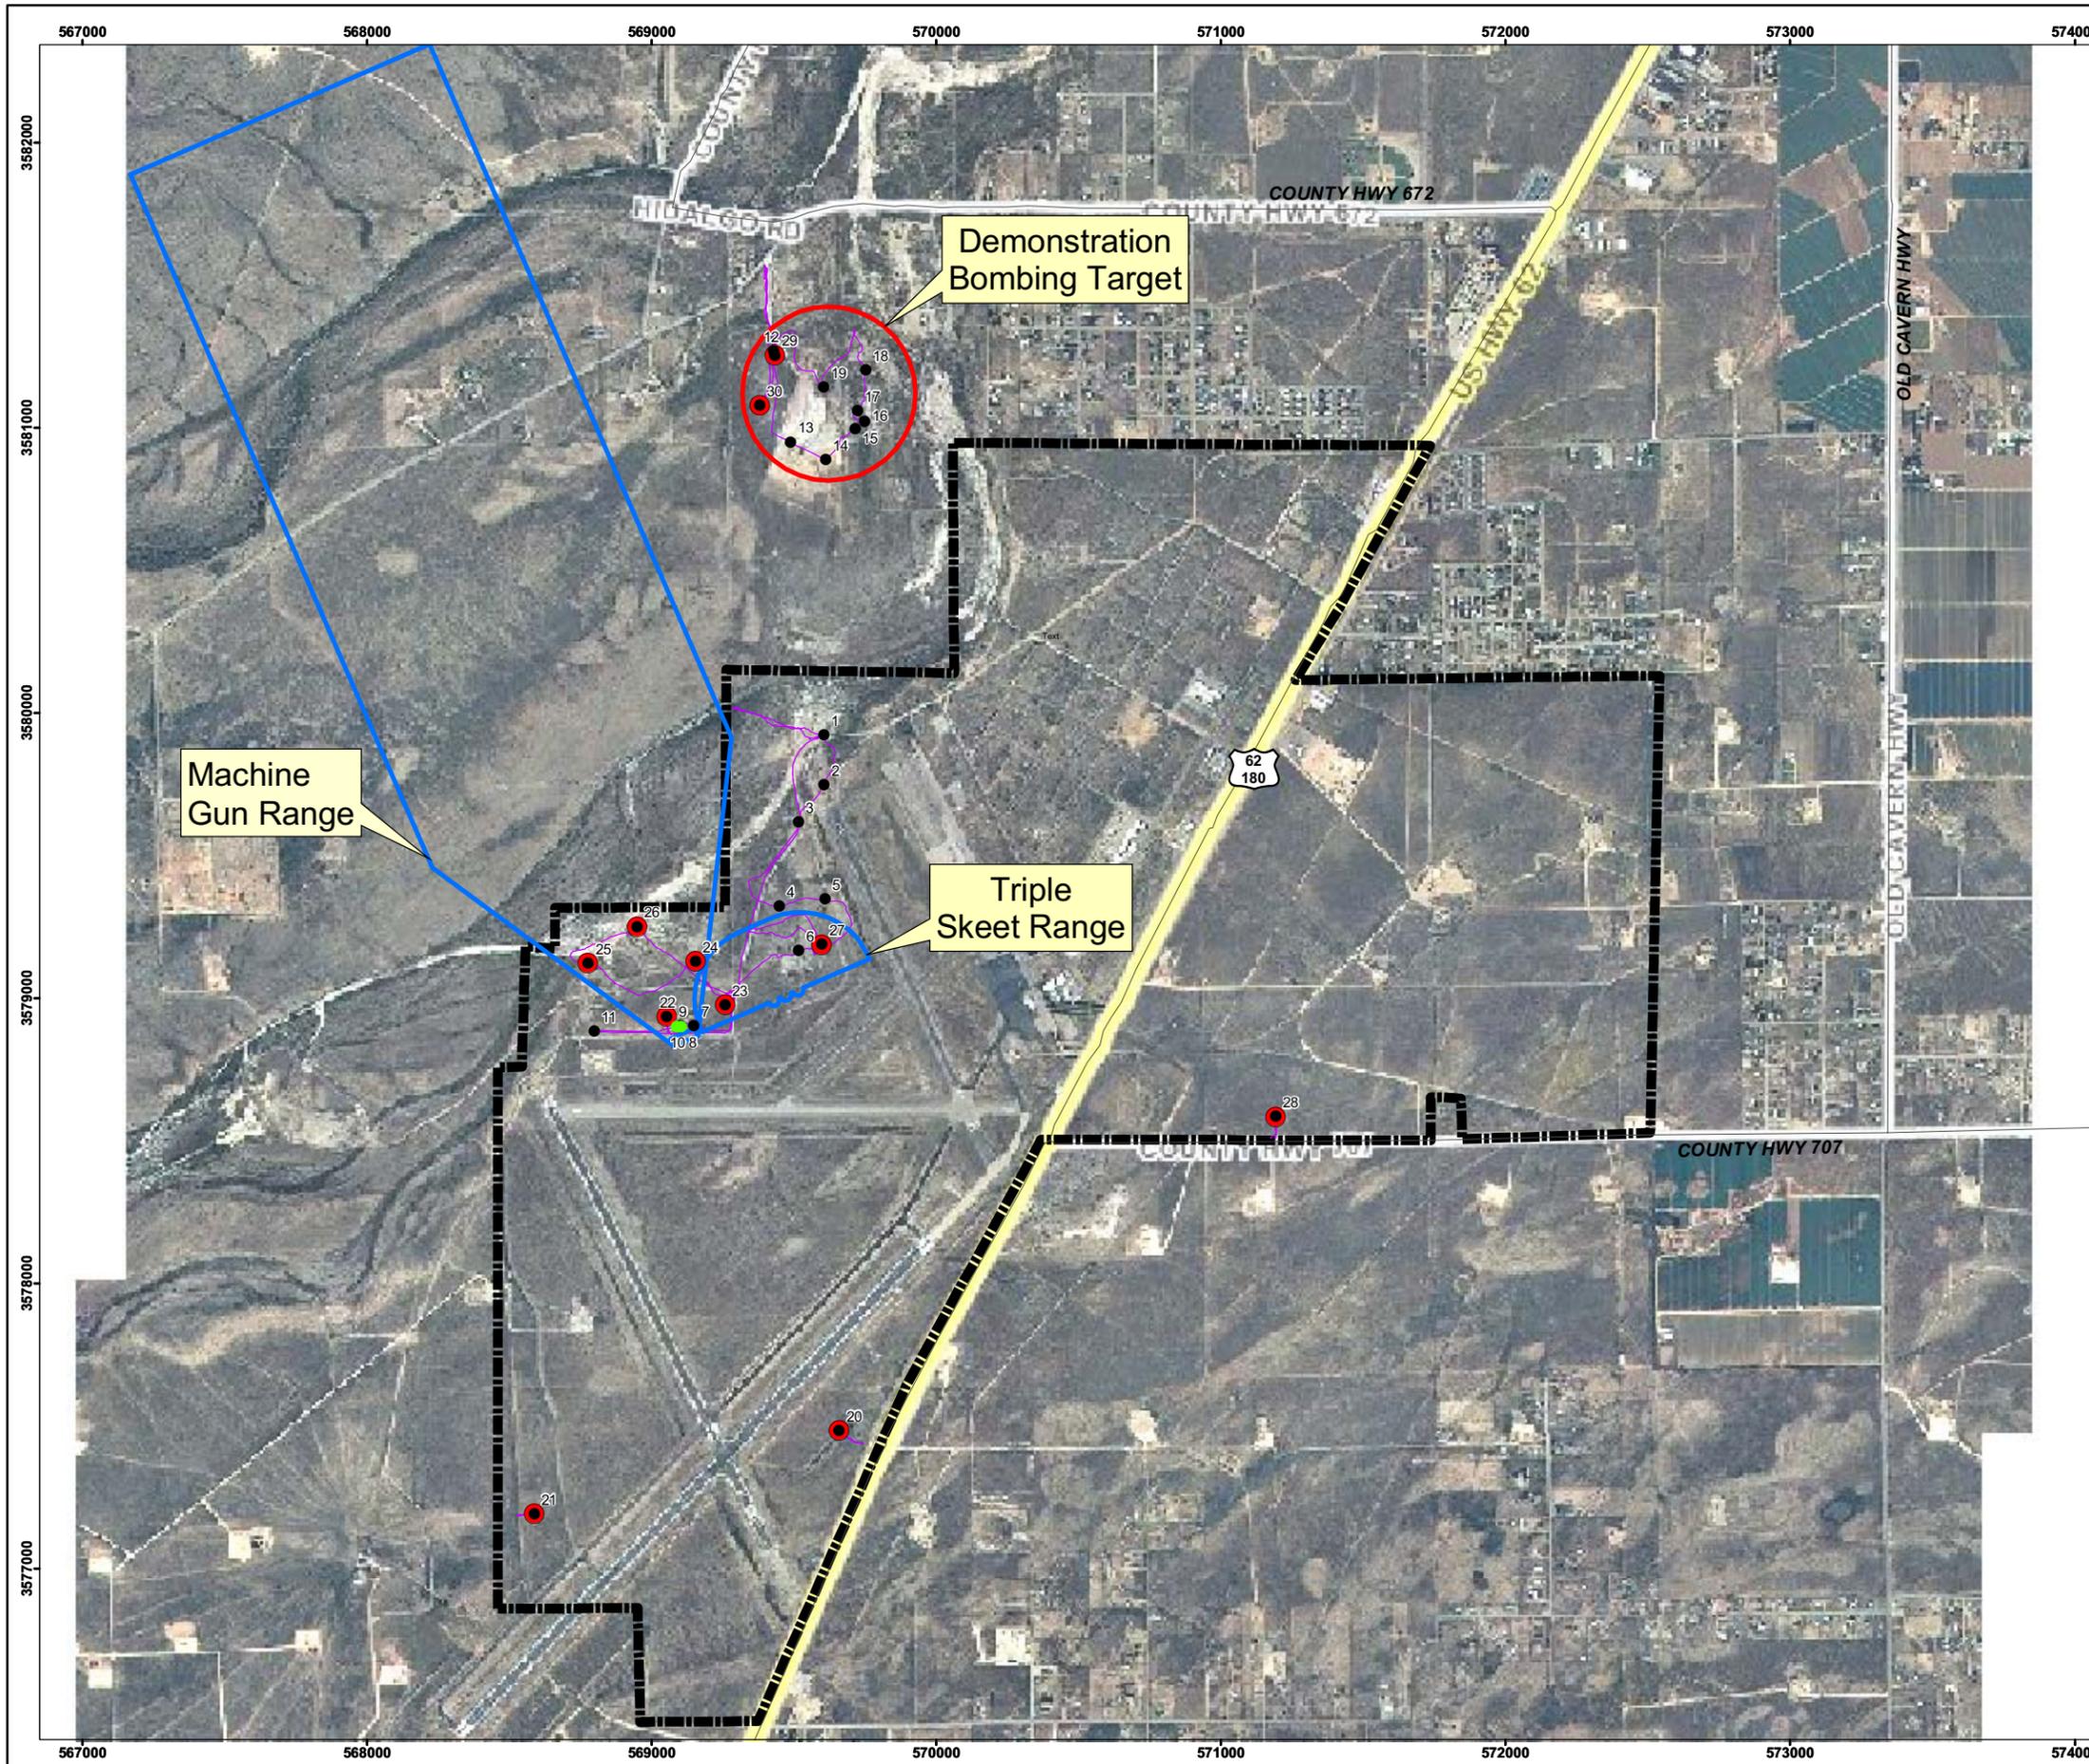
Figure 4.1  
**Qualitative Reconnaissance and  
 Field Observation Locations  
 Formerly Used Defense Site  
 Carlsbad Army Airfield  
 FUDS Project # K06NM034203**  
 Eddy County, New Mexico

4.1.1.4 The team recorded field observations when collecting samples; if they observed munitions debris, munitions-related features, or terrain changes; or if they encountered any barriers. Figure 4.1 shows the QR routes and the locations where field observations were recorded during the SI. As discussed in the SS-WP, the field team was given the flexibility to revise the route based on visual observations and site features (Parsons, 2007a). Where possible, samples were collected directly adjacent to munitions

To assess the presence of MEC contamination within the former Demonstration Bombing Target, the SI field team conducted approximately 1.4 miles of QR within the MRS (Figure 4.1). No munitions debris were observed within the MRS, although the SI team did not investigate Dark Canyon, where the ASR team found the bomb debris. Most of the area covered by the QR was being used as part of a gravel and crushed stone operation. Very little undisturbed ground was present anywhere other than the western side of the MRS. The team did not find any remaining evidence of the bomb target itself, and no MEC were identified.

The SI field team conducted approximately 2.25 miles of QR within the former Range Complex No. 1 (Figure 4.1). Conditions were similar to those encountered by the ASR team, with casings and bullets from various types of small arms scattered throughout the area. The team found no evidence of any of the former ranges such as berms or firing positions and identified no MEC.

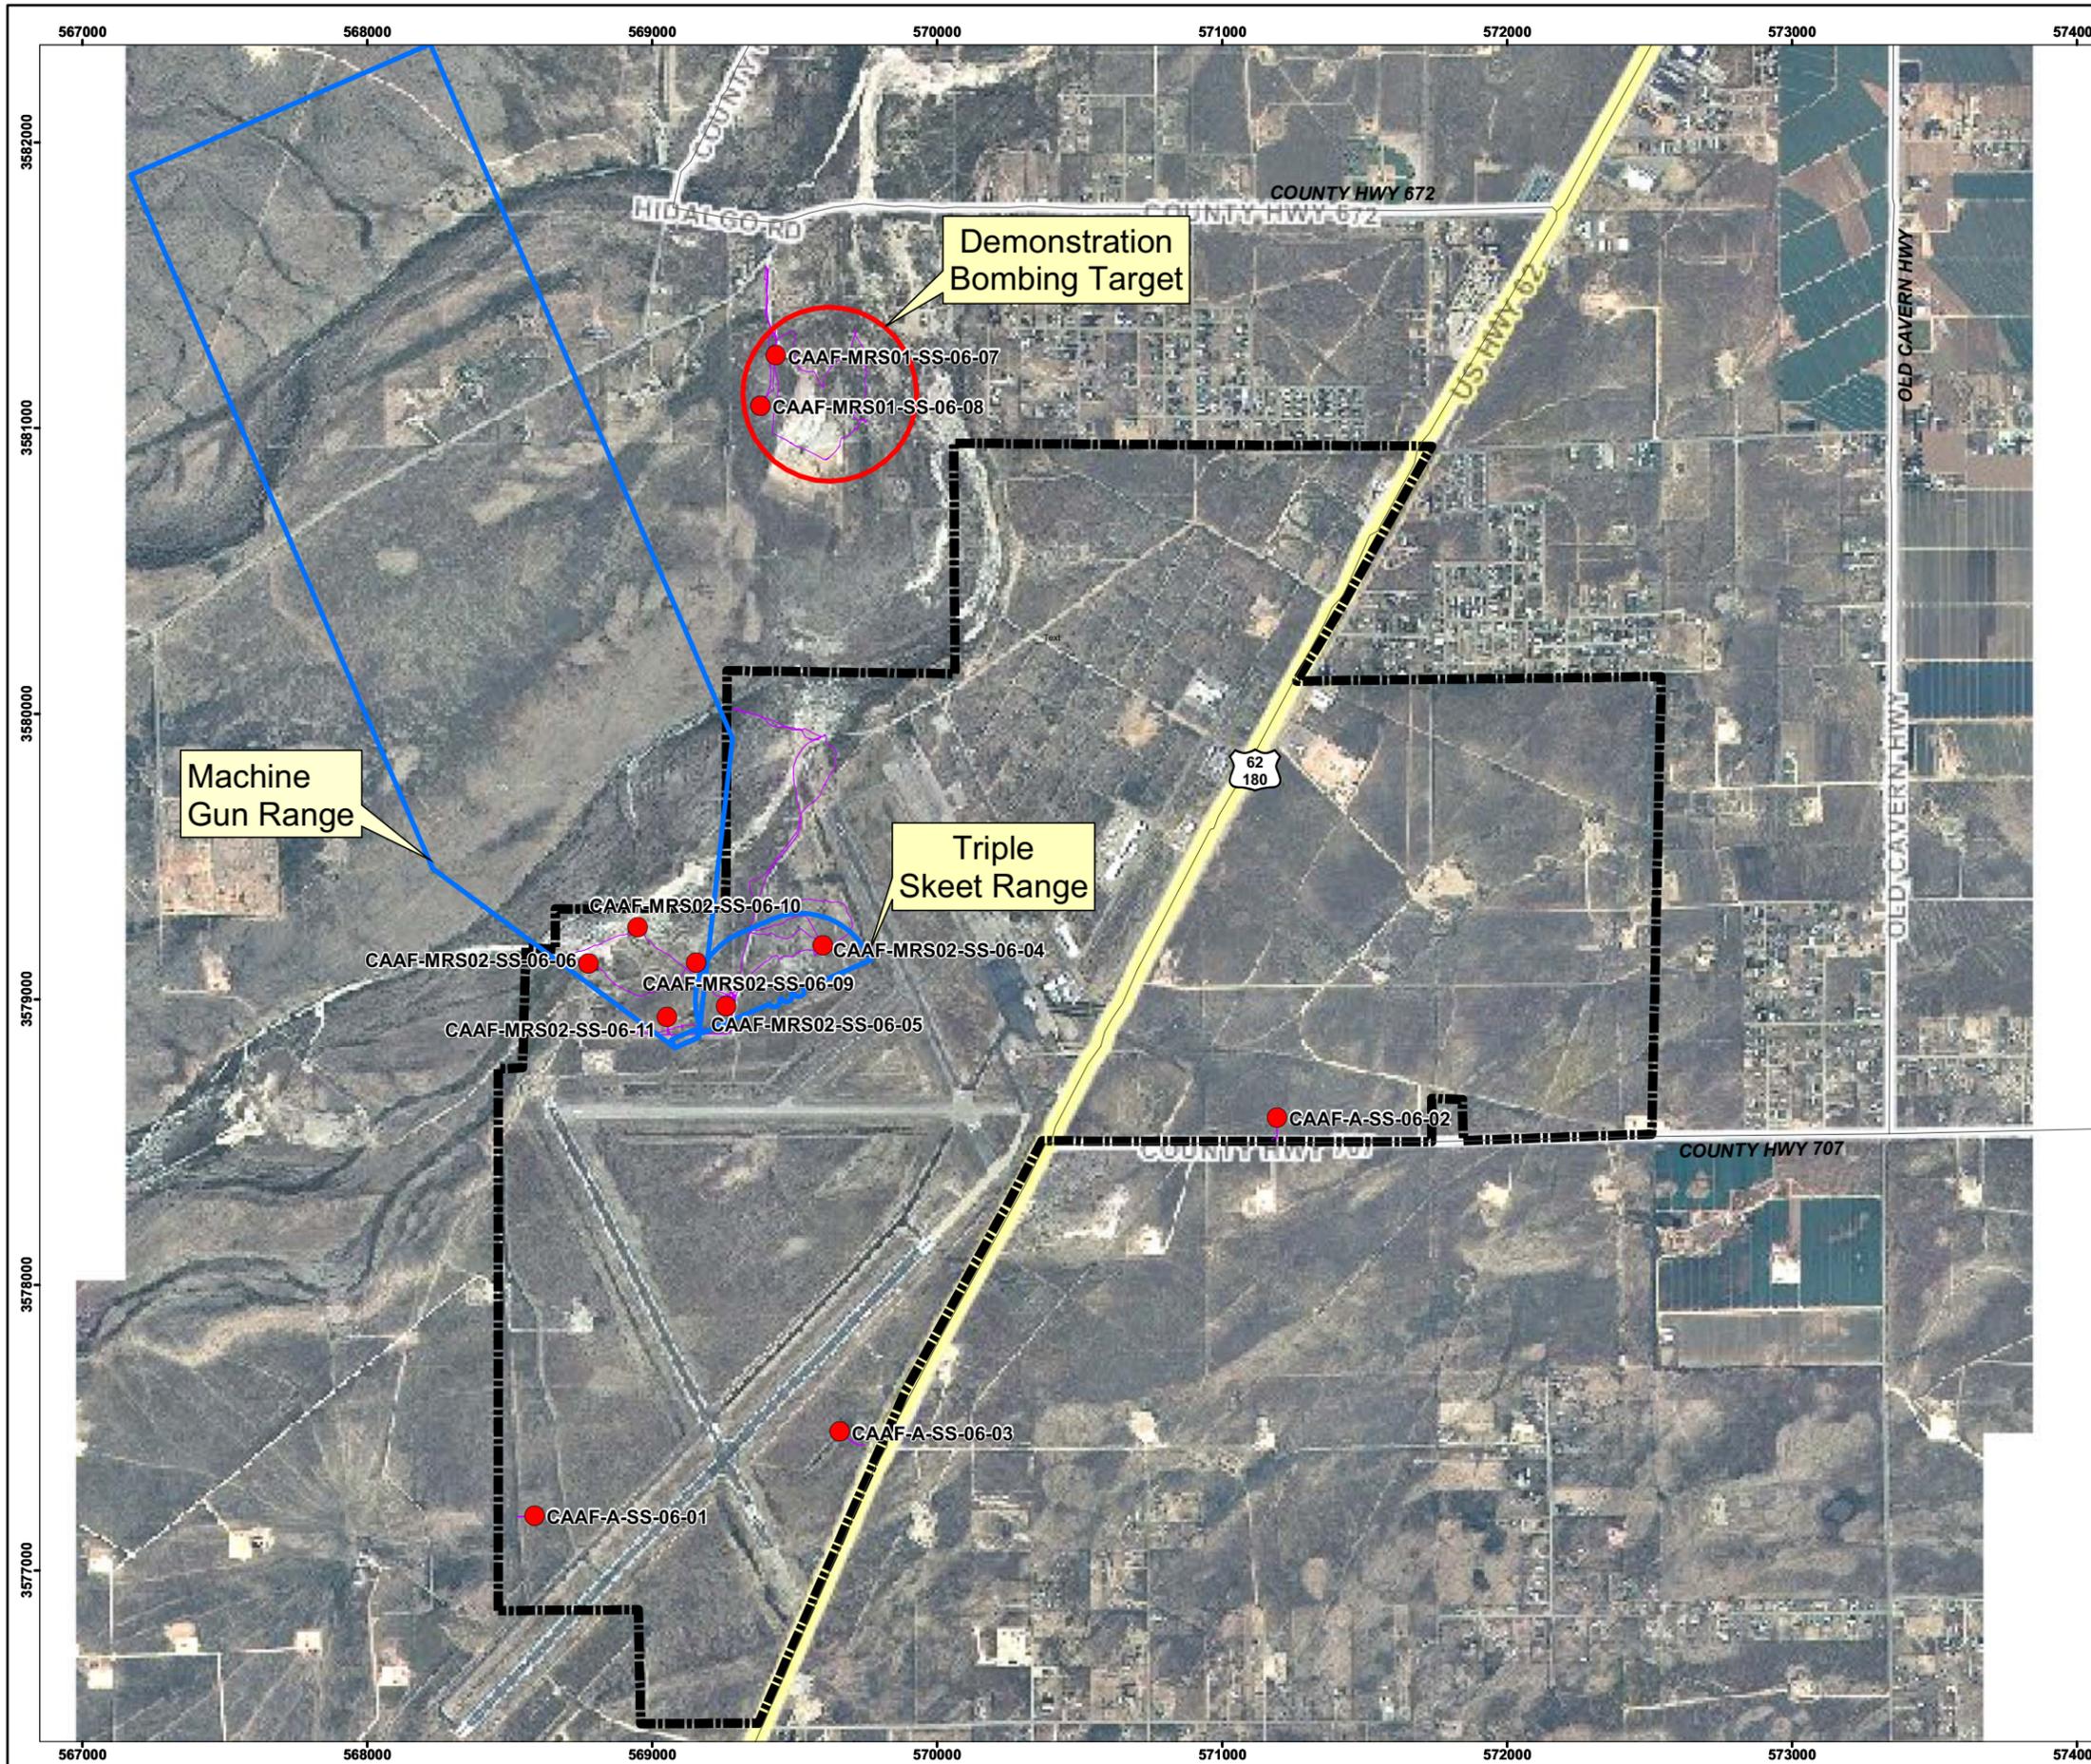
Figure 5.2  
**Qualitative Reconnaissance and  
 Sample Locations**  
**Formerly Used Defense Site**  
**Carlsbad Army Airfield**  
**FUDS Project # K06NM034203**  
 Eddy County, New Mexico

5.2.5.2 Soil samples were collected from 11 locations within the former Carlsbad AAF (Figure 5.2). Three of these samples were collected at locations outside any identified MRS for to determine ambient conditions at the FUDS. Six samples were
