DRY LAND APPROVED JURISDICTIONAL DETERMINATION FORM¹
U.S. Army Corps of Engineers

B. DISTRICT OFFICE, FILE NAME, AND NUMBER: Albuquerque District, EVRAZ JD, SPA-2018-00288

B. REQUIRED ADDITIONAL COMMENTS TO SUPPORT JD. EXPLAIN RATIONALE FOR DETERMINATION THAT THE REVIEW AREA ONLY INCLUDES DRY LAND:

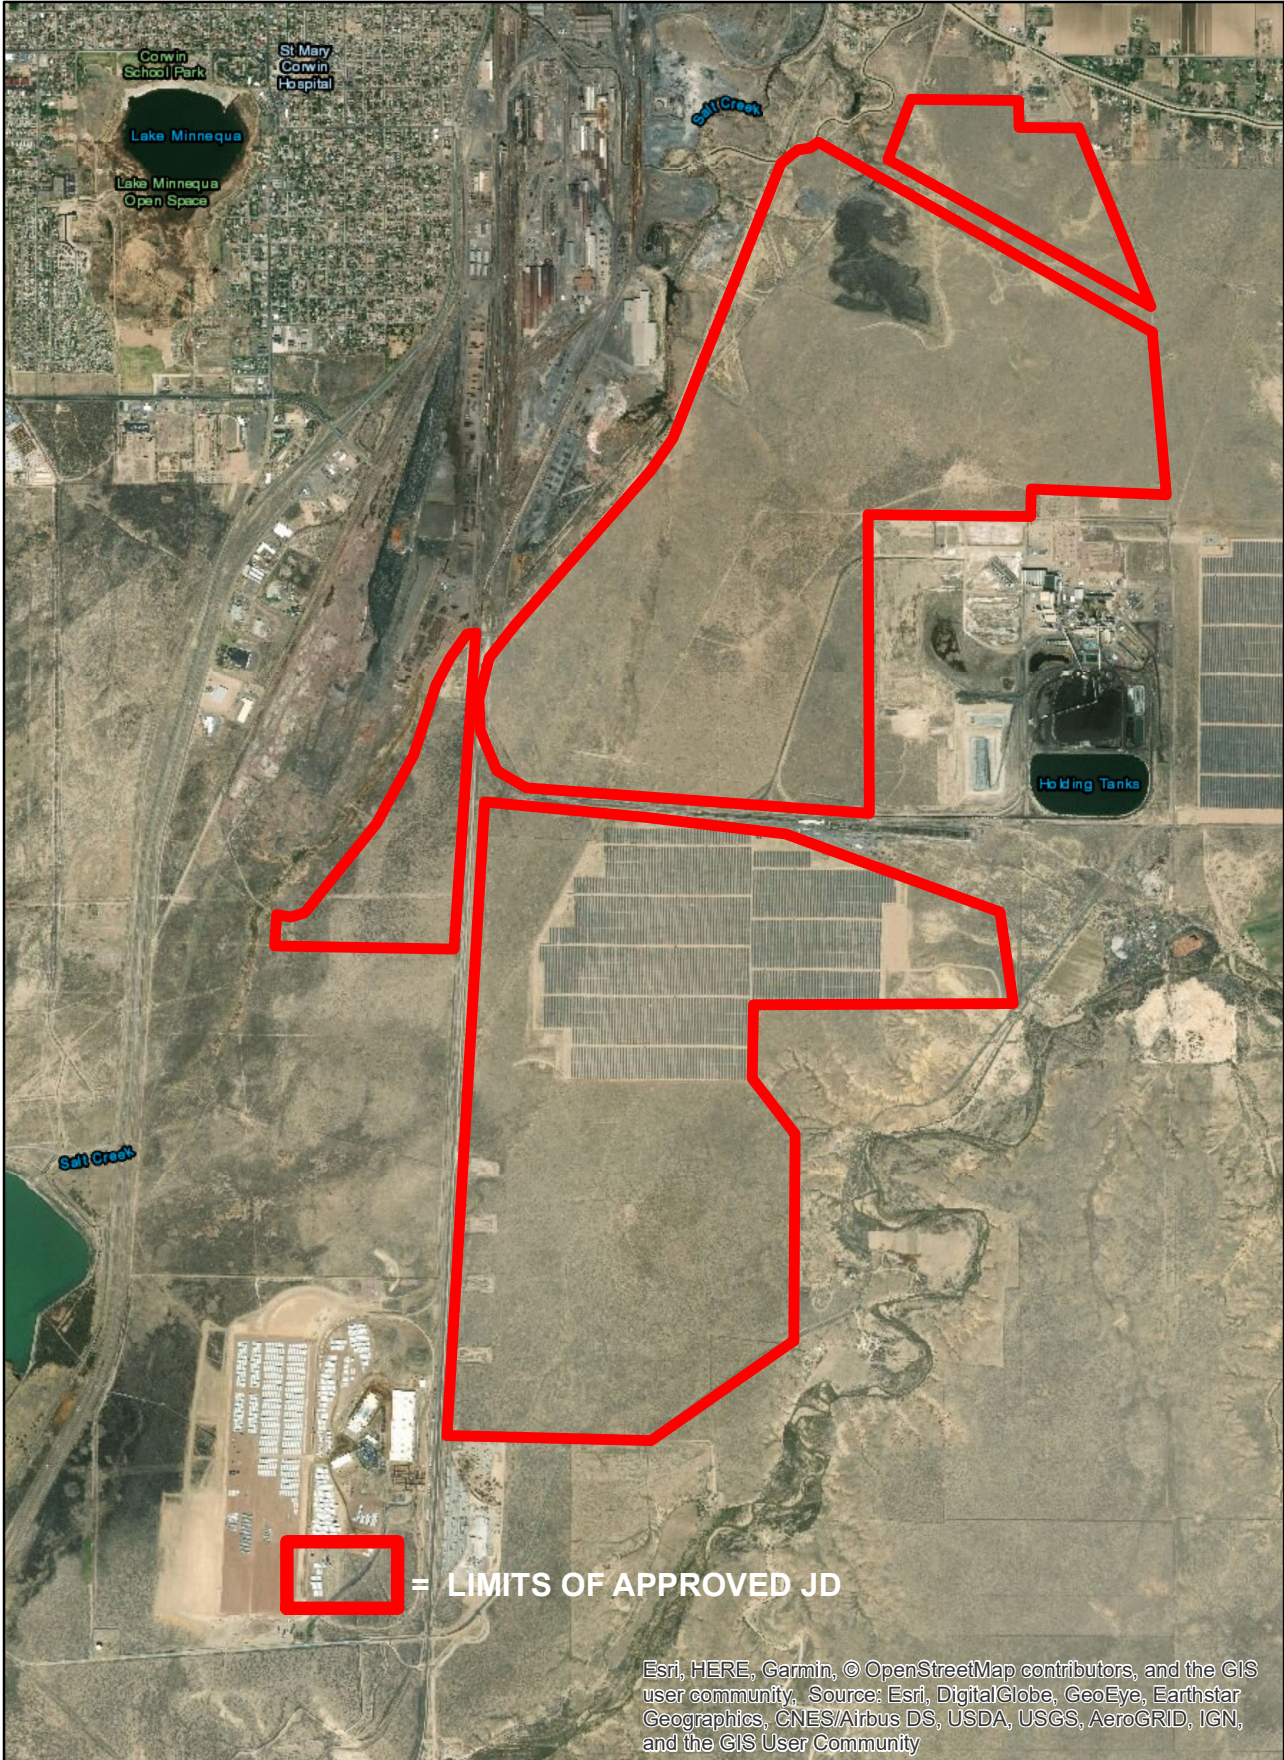
Approved JD Boundary SPA-2018-288

At "Site 4" we observed a dry defined channel approximately 15 feet in width that appeared to have several small drainages contributing into it (Enclosure 6). We observed several physical characteristics within the channel indicating presence of an OHWM; including sediment sorting, scour, shelving, and matted down vegetation. The stream appeared to be ephemeral or intermittent in nature and we could not consider it an RPW, so a significant nexus determination would need to be done to determine if it was in fact jurisdictional. We conveyed this information to the applicant and consultant and they decided to exclude this area from consideration in the AJD because the topography is not suitable for development of their solar project activities anyway. We then modified their AJD request boundary to exclude this area (Enclosure 2) and it is no considered part of this AJD.

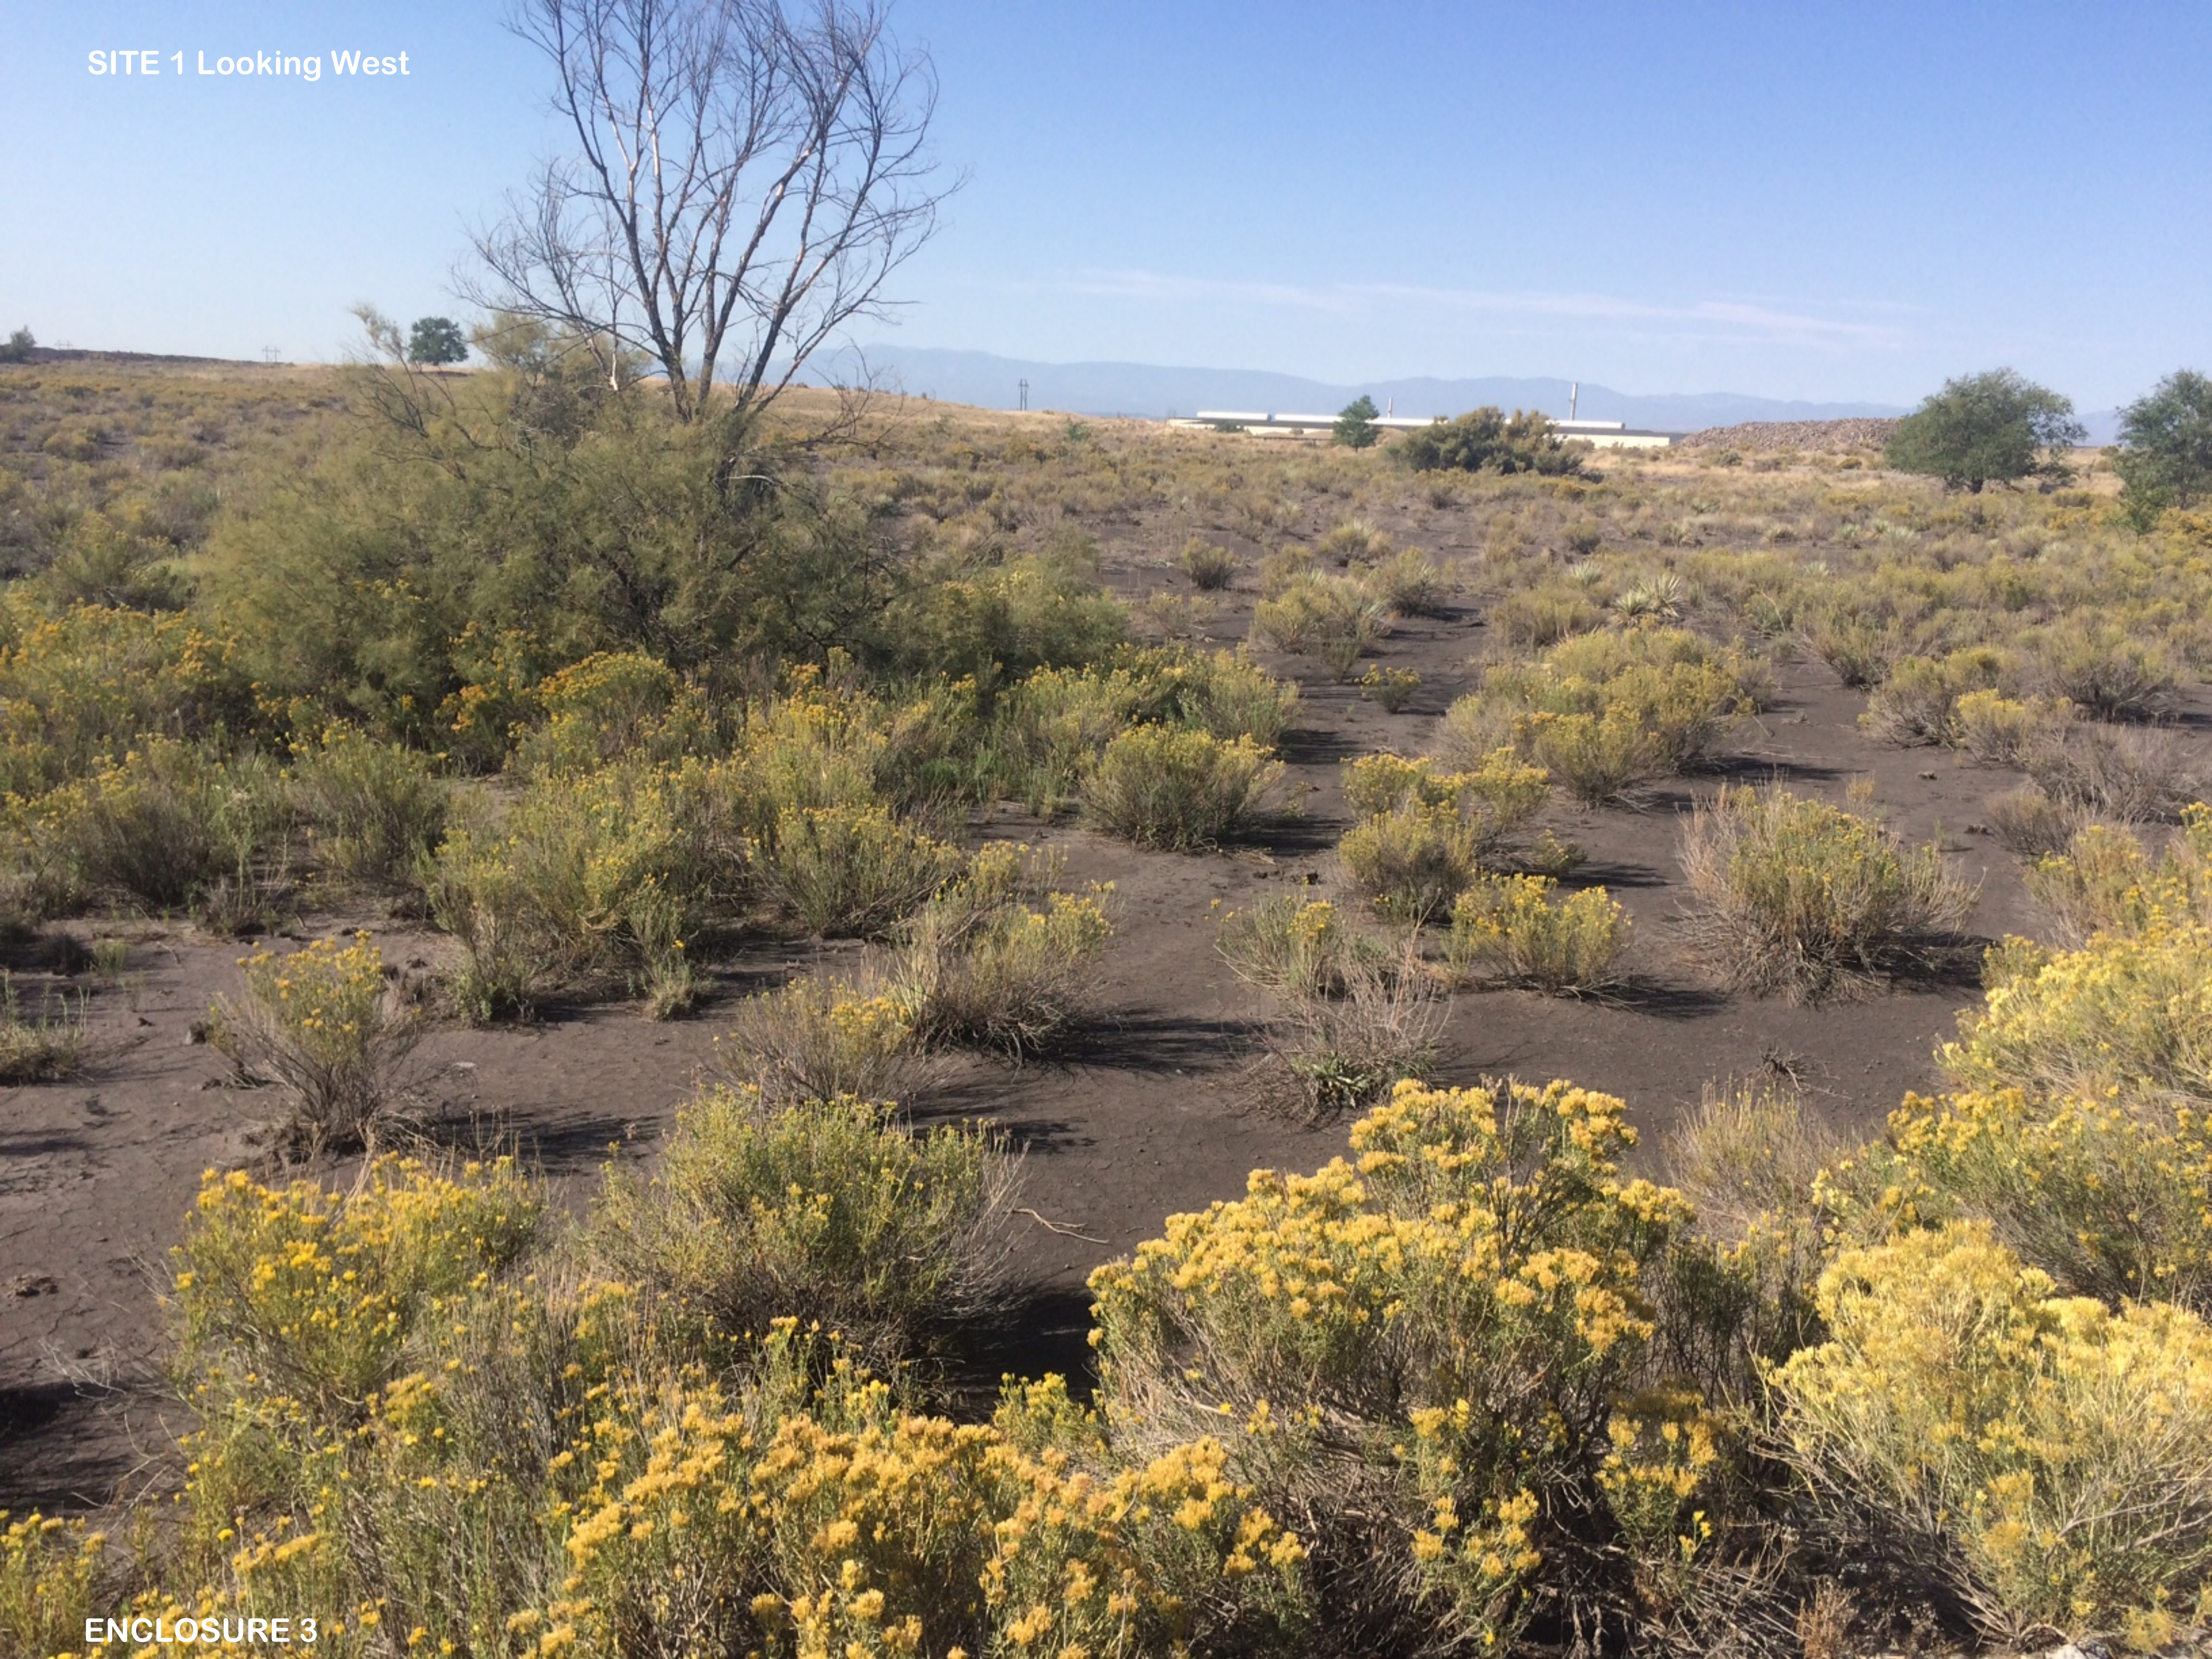
ENCLOSURE 3

Upon arrival at "Site 1" it became clear this area was not a wetland, being dominated by Rabbitbrush (*Chrysothamnus spp.*) and showing no signs of hydrology (Enclosure 3). The EVRAZ representative then informed us that coal and other spoils were historically stored in this area, staining the ground surface a dark coloration, which looked similar to water signatures in the aerial photos. Site 1 was then ruled out as a WOUS.

SITE 1 Looking West

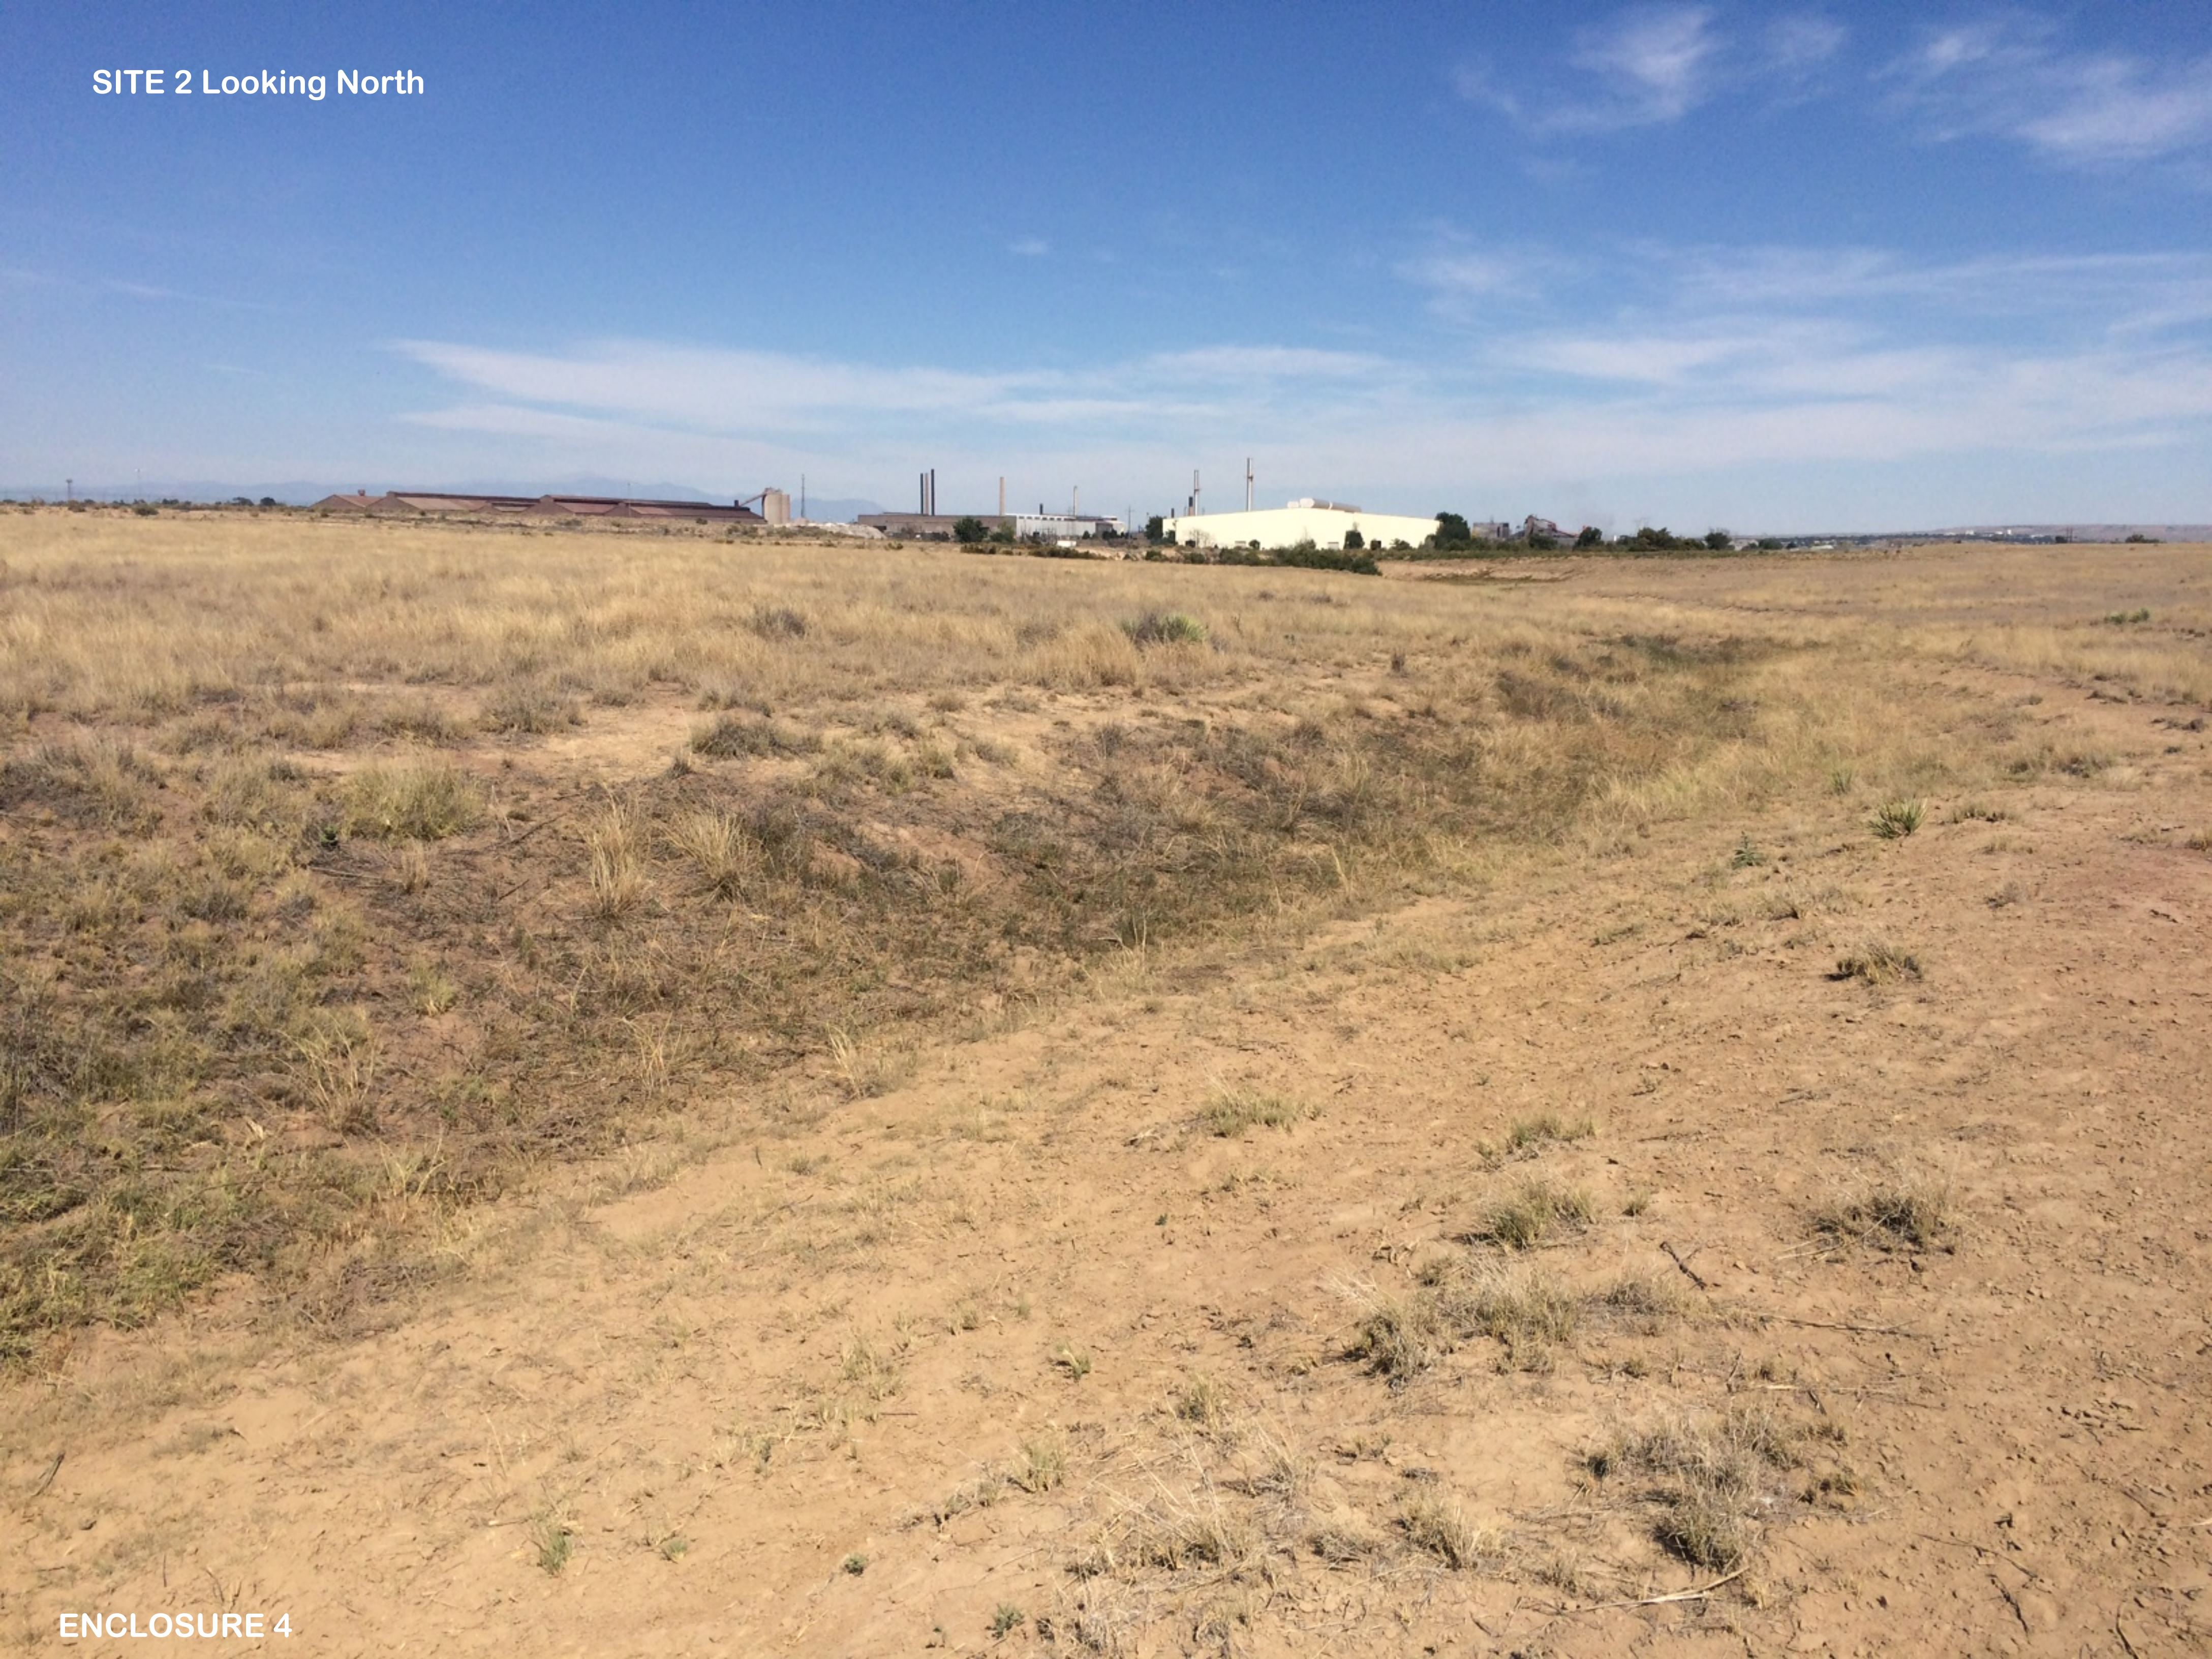
ENCLOSURE 4

At "Site 2" we observed a shallow, linear drainage feature running north-south (Enclosure 4). Upon closer inspection we discovered there was no OHWM or established bed and banks and upland vegetation growing in the center of the channel. The feature appeared to be a historic drainage ditch constructed entirely in uplands. The channel petered out into uplands prior to reaching sand creek. Based on these observations the site was ruled out as a WOUS.

SITE 2 Looking North

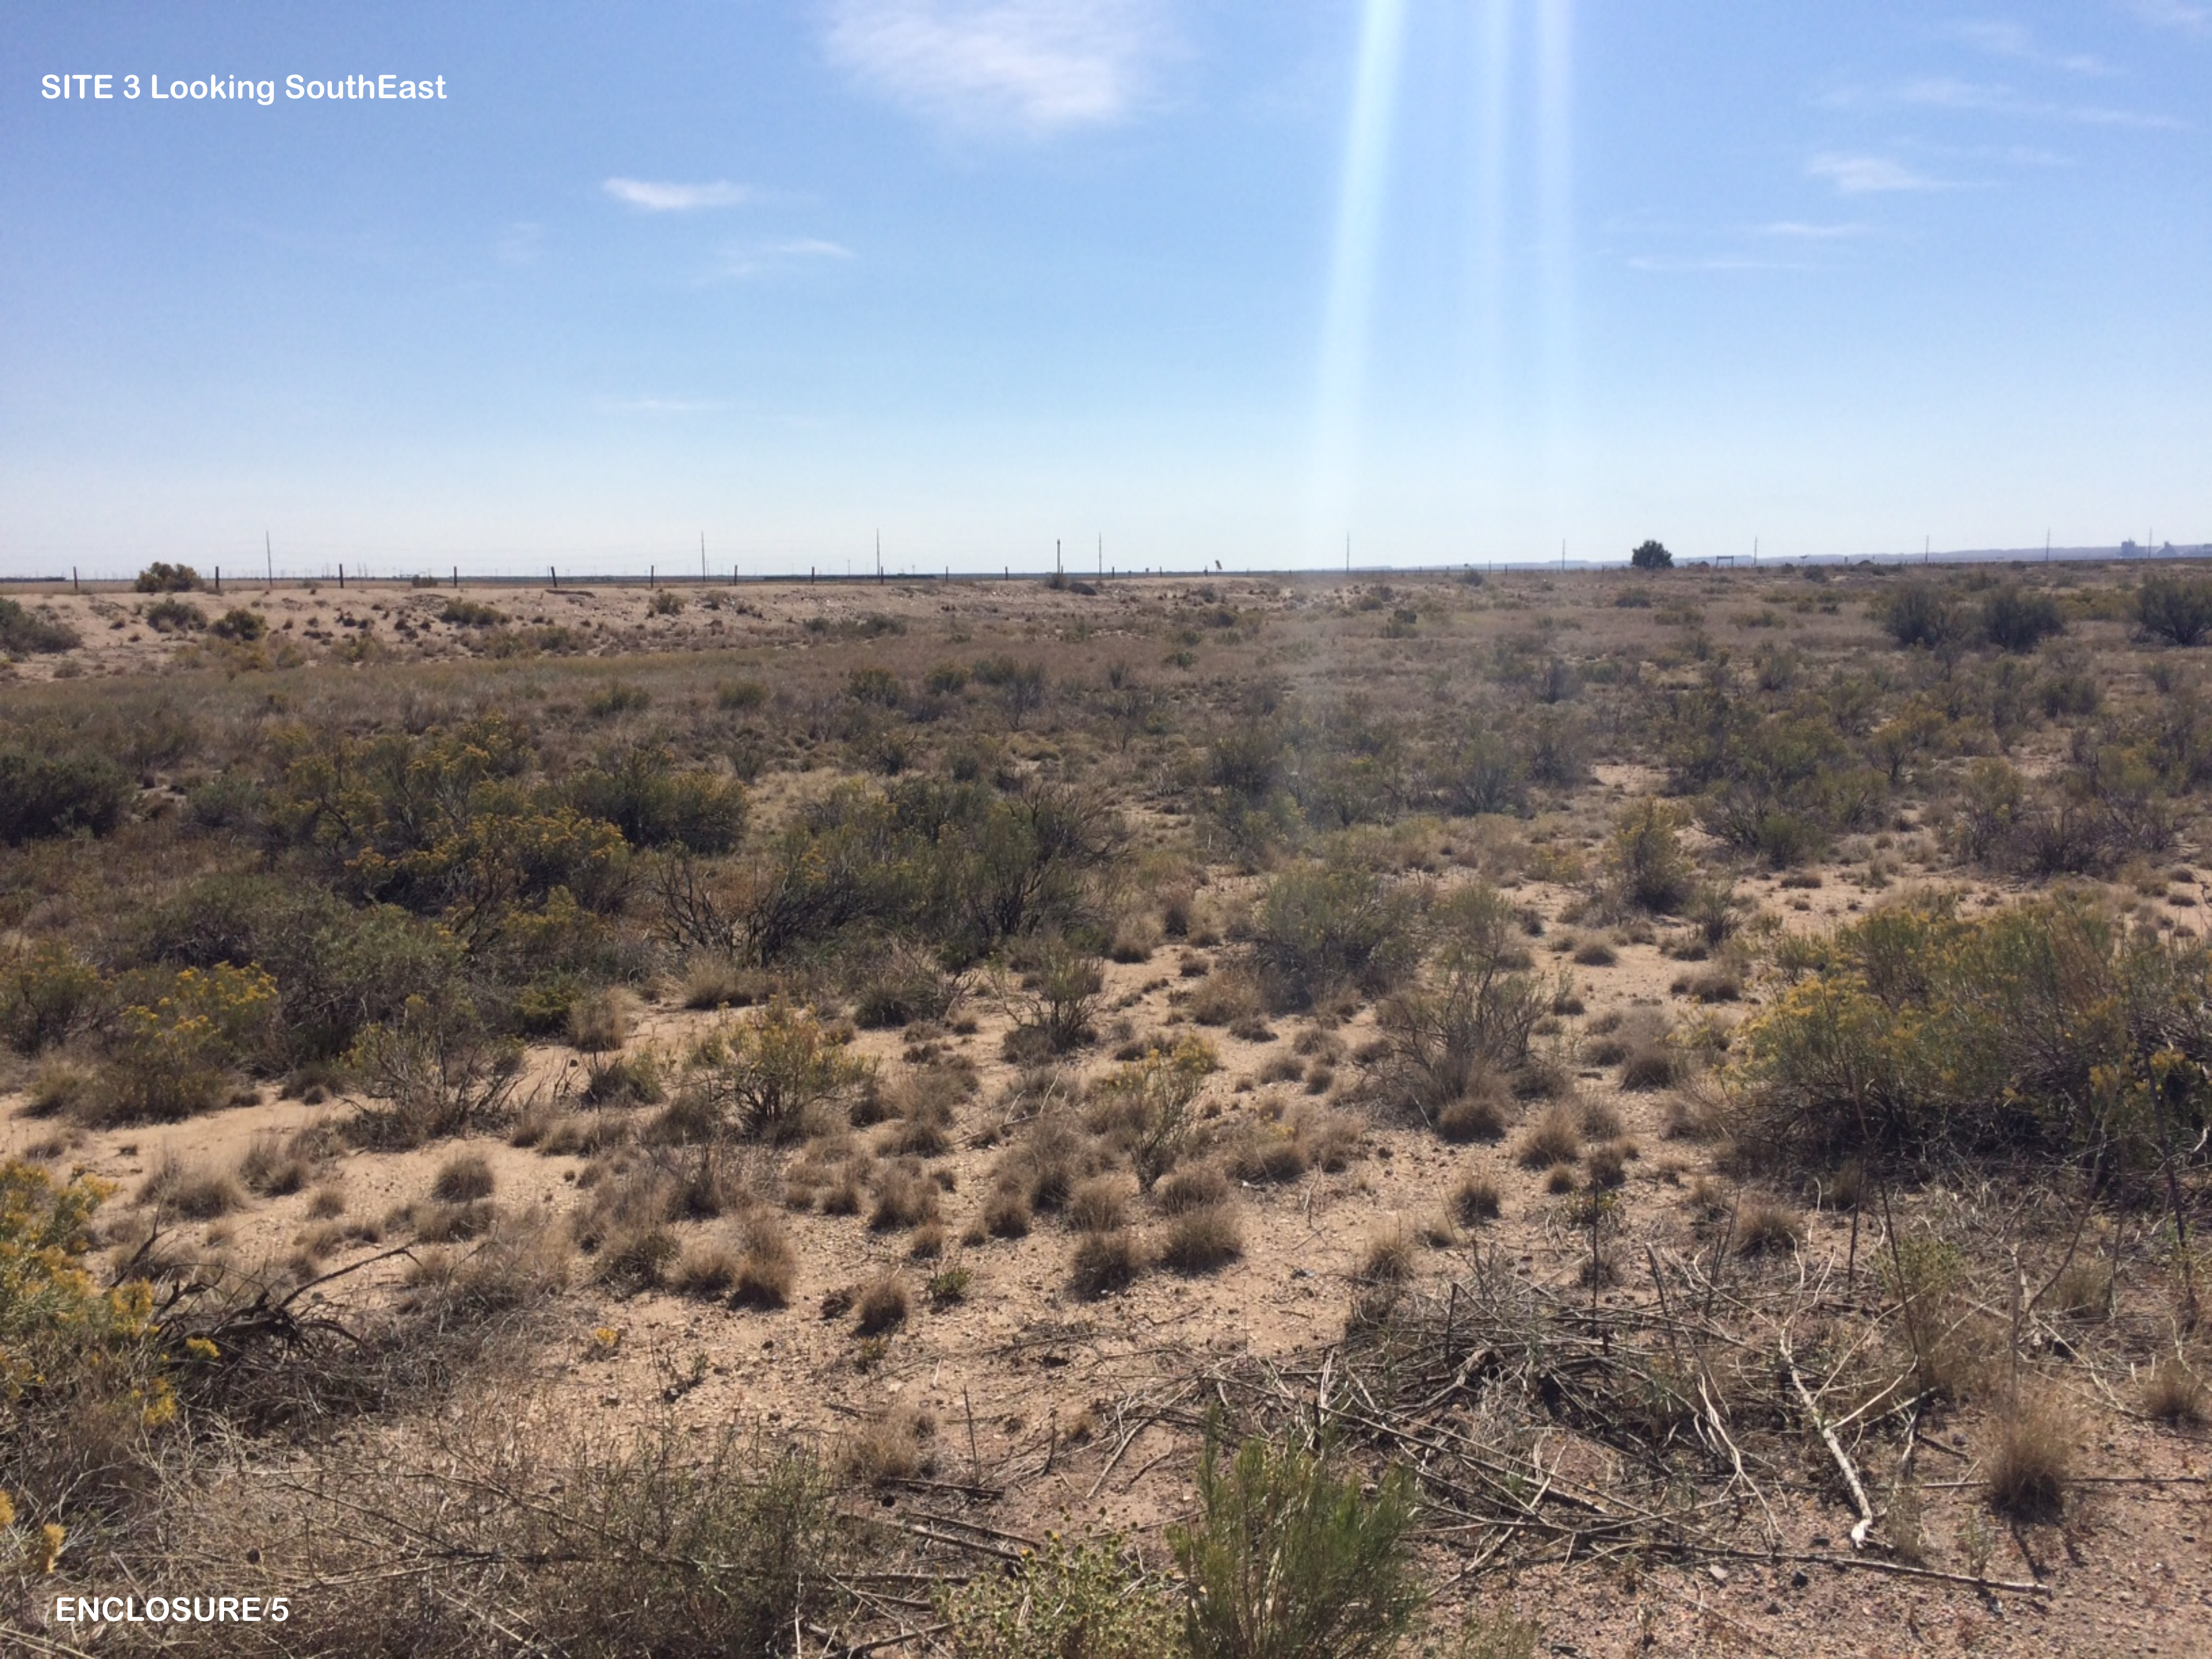
At "Site 3" we observed dominant upland species including Rabbitbrush (*Chrysothamnus spp.*) and Saltcedar (*Tamarix spp.*) and no other indicators of wetlands (Enclosure 5). Based on these observations the site was ruled out as a WOUS.

SITE 3 Looking SouthEast

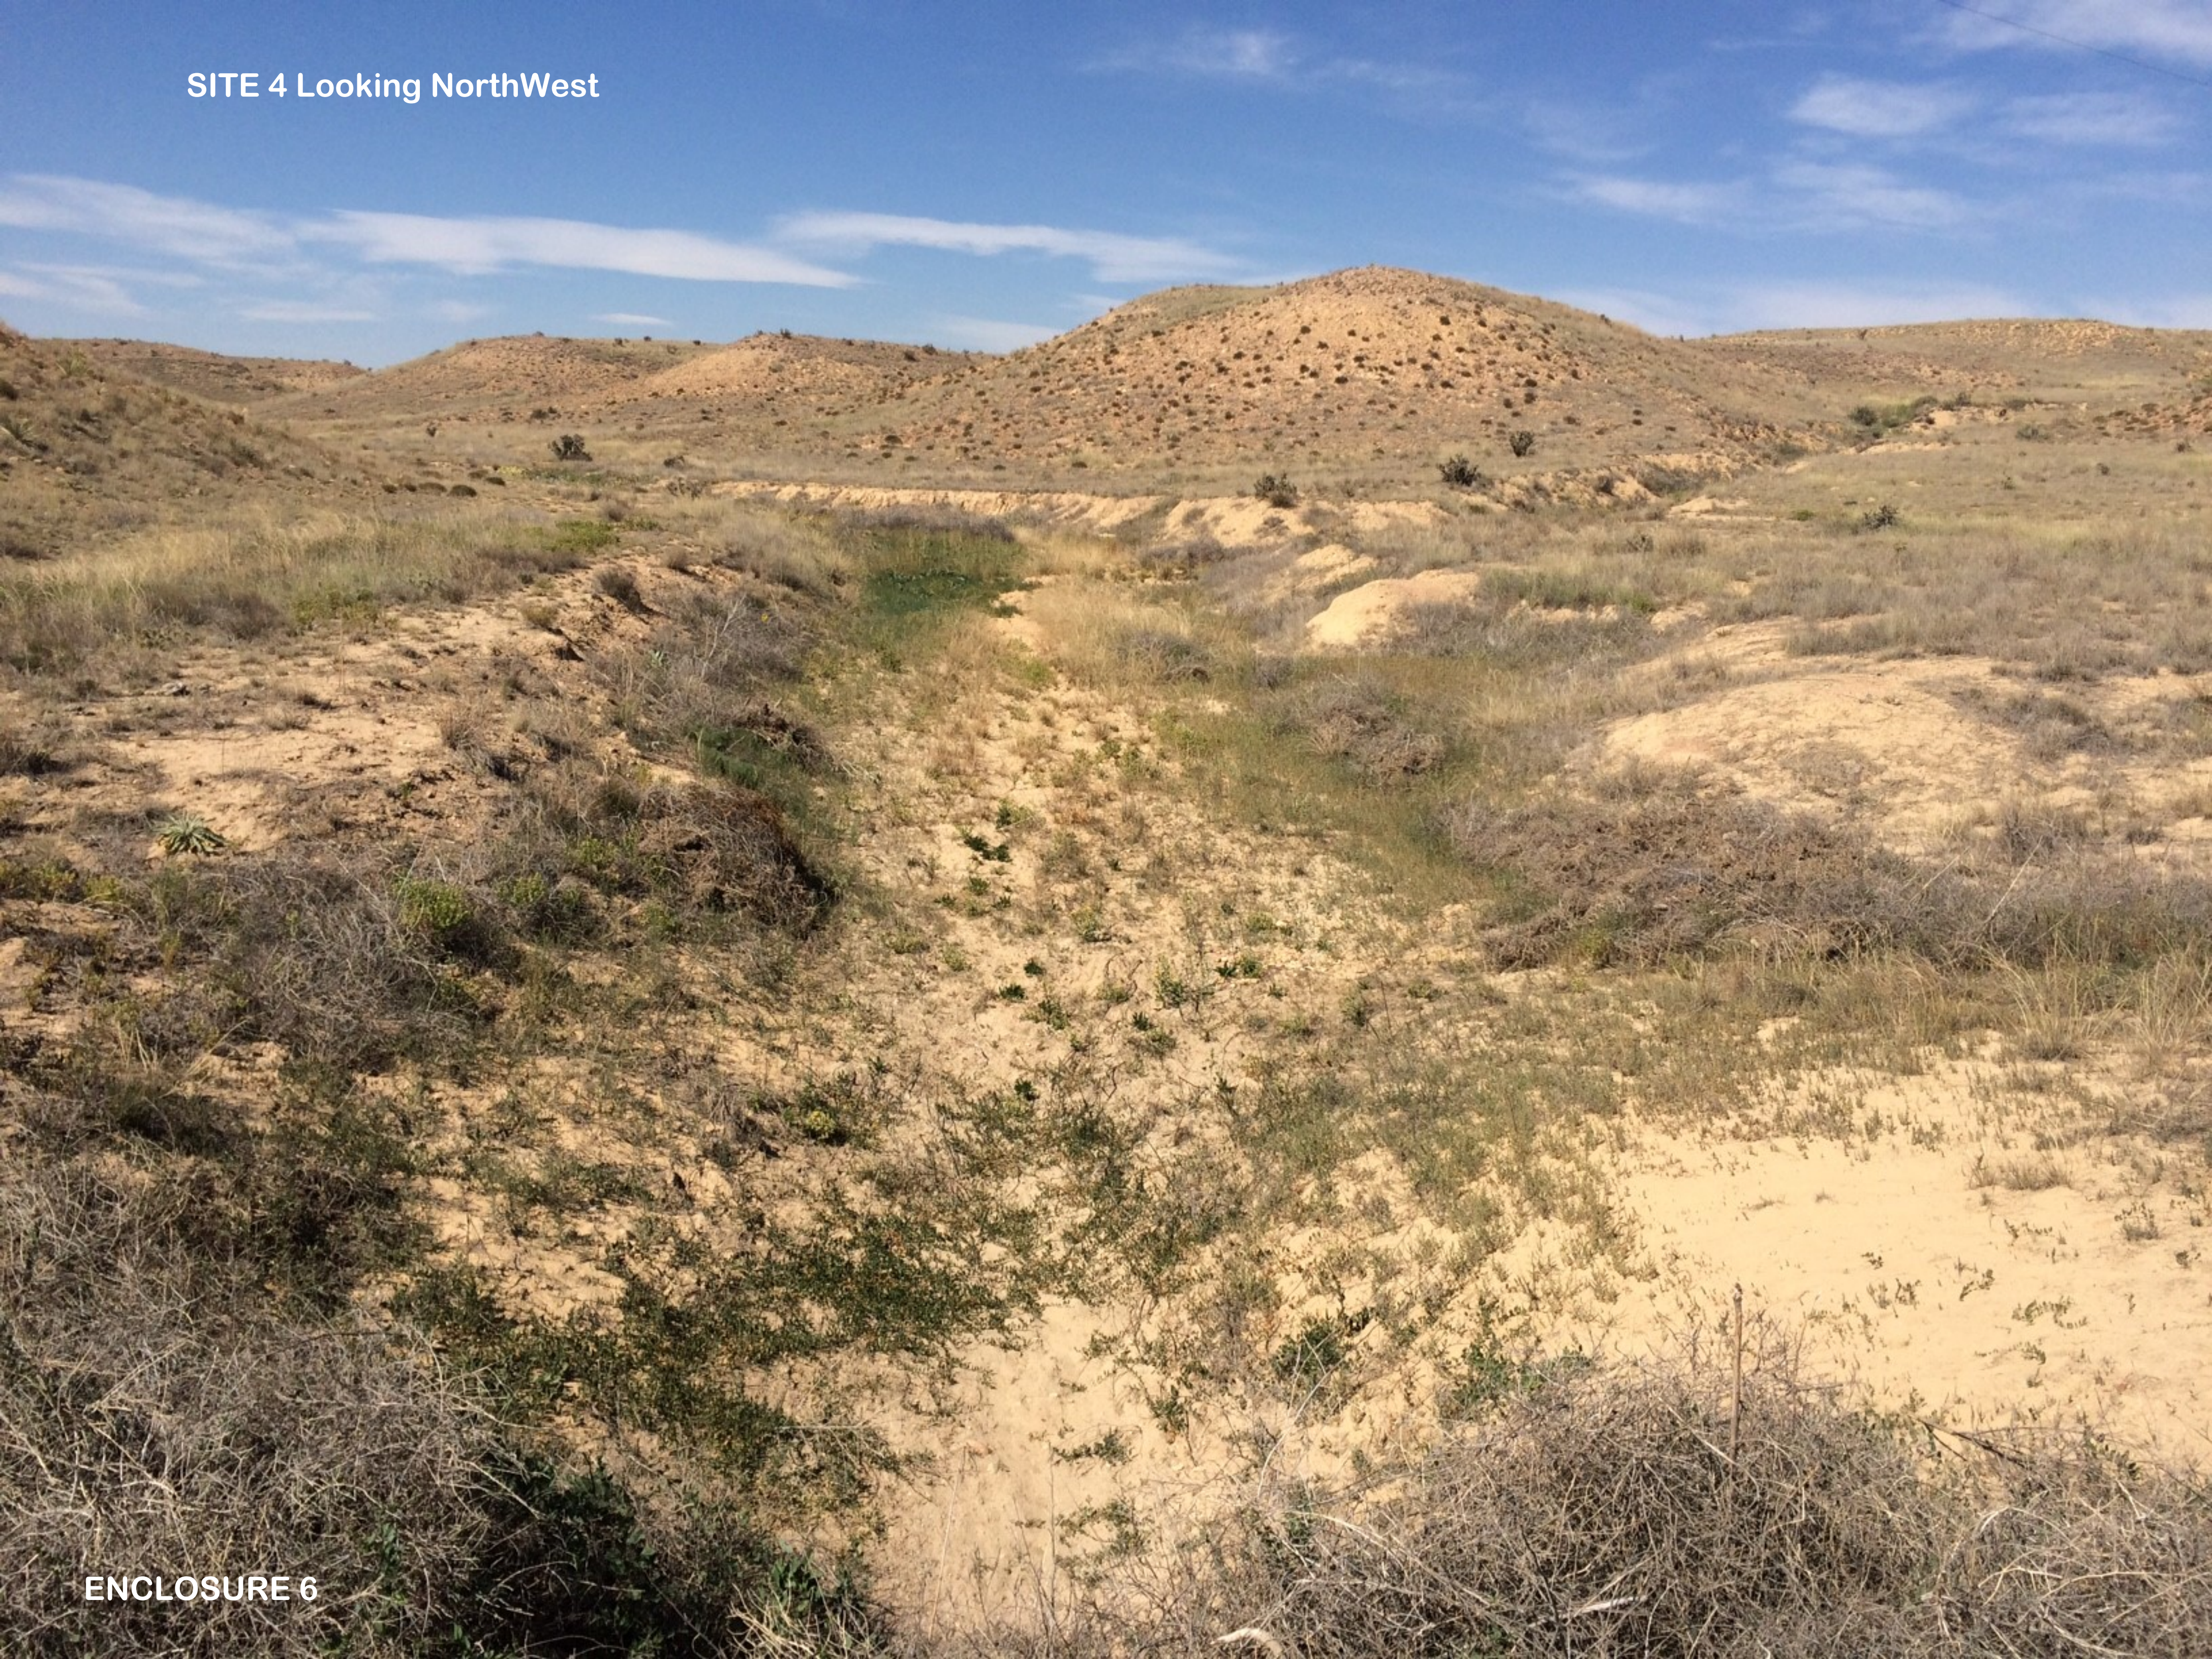
ENCLOSURE 6

SITE 4 Looking NorthWest
