MEMORANDUM FOR RECORD

SUBJECT: US Army Corps of Engineers (Corps) Approved Jurisdictional Determination in accordance with the "Revised Definition of 'Waters of the United States'"; (88 FR 3004 (January 18, 2023) as amended by the "Revised Definition of 'Waters of the United States'; Conforming" (September 8, 2023),<sup>1</sup> SPA-2024-00420

**Corrales Acequia, within the review area – is not a water of the United States.**

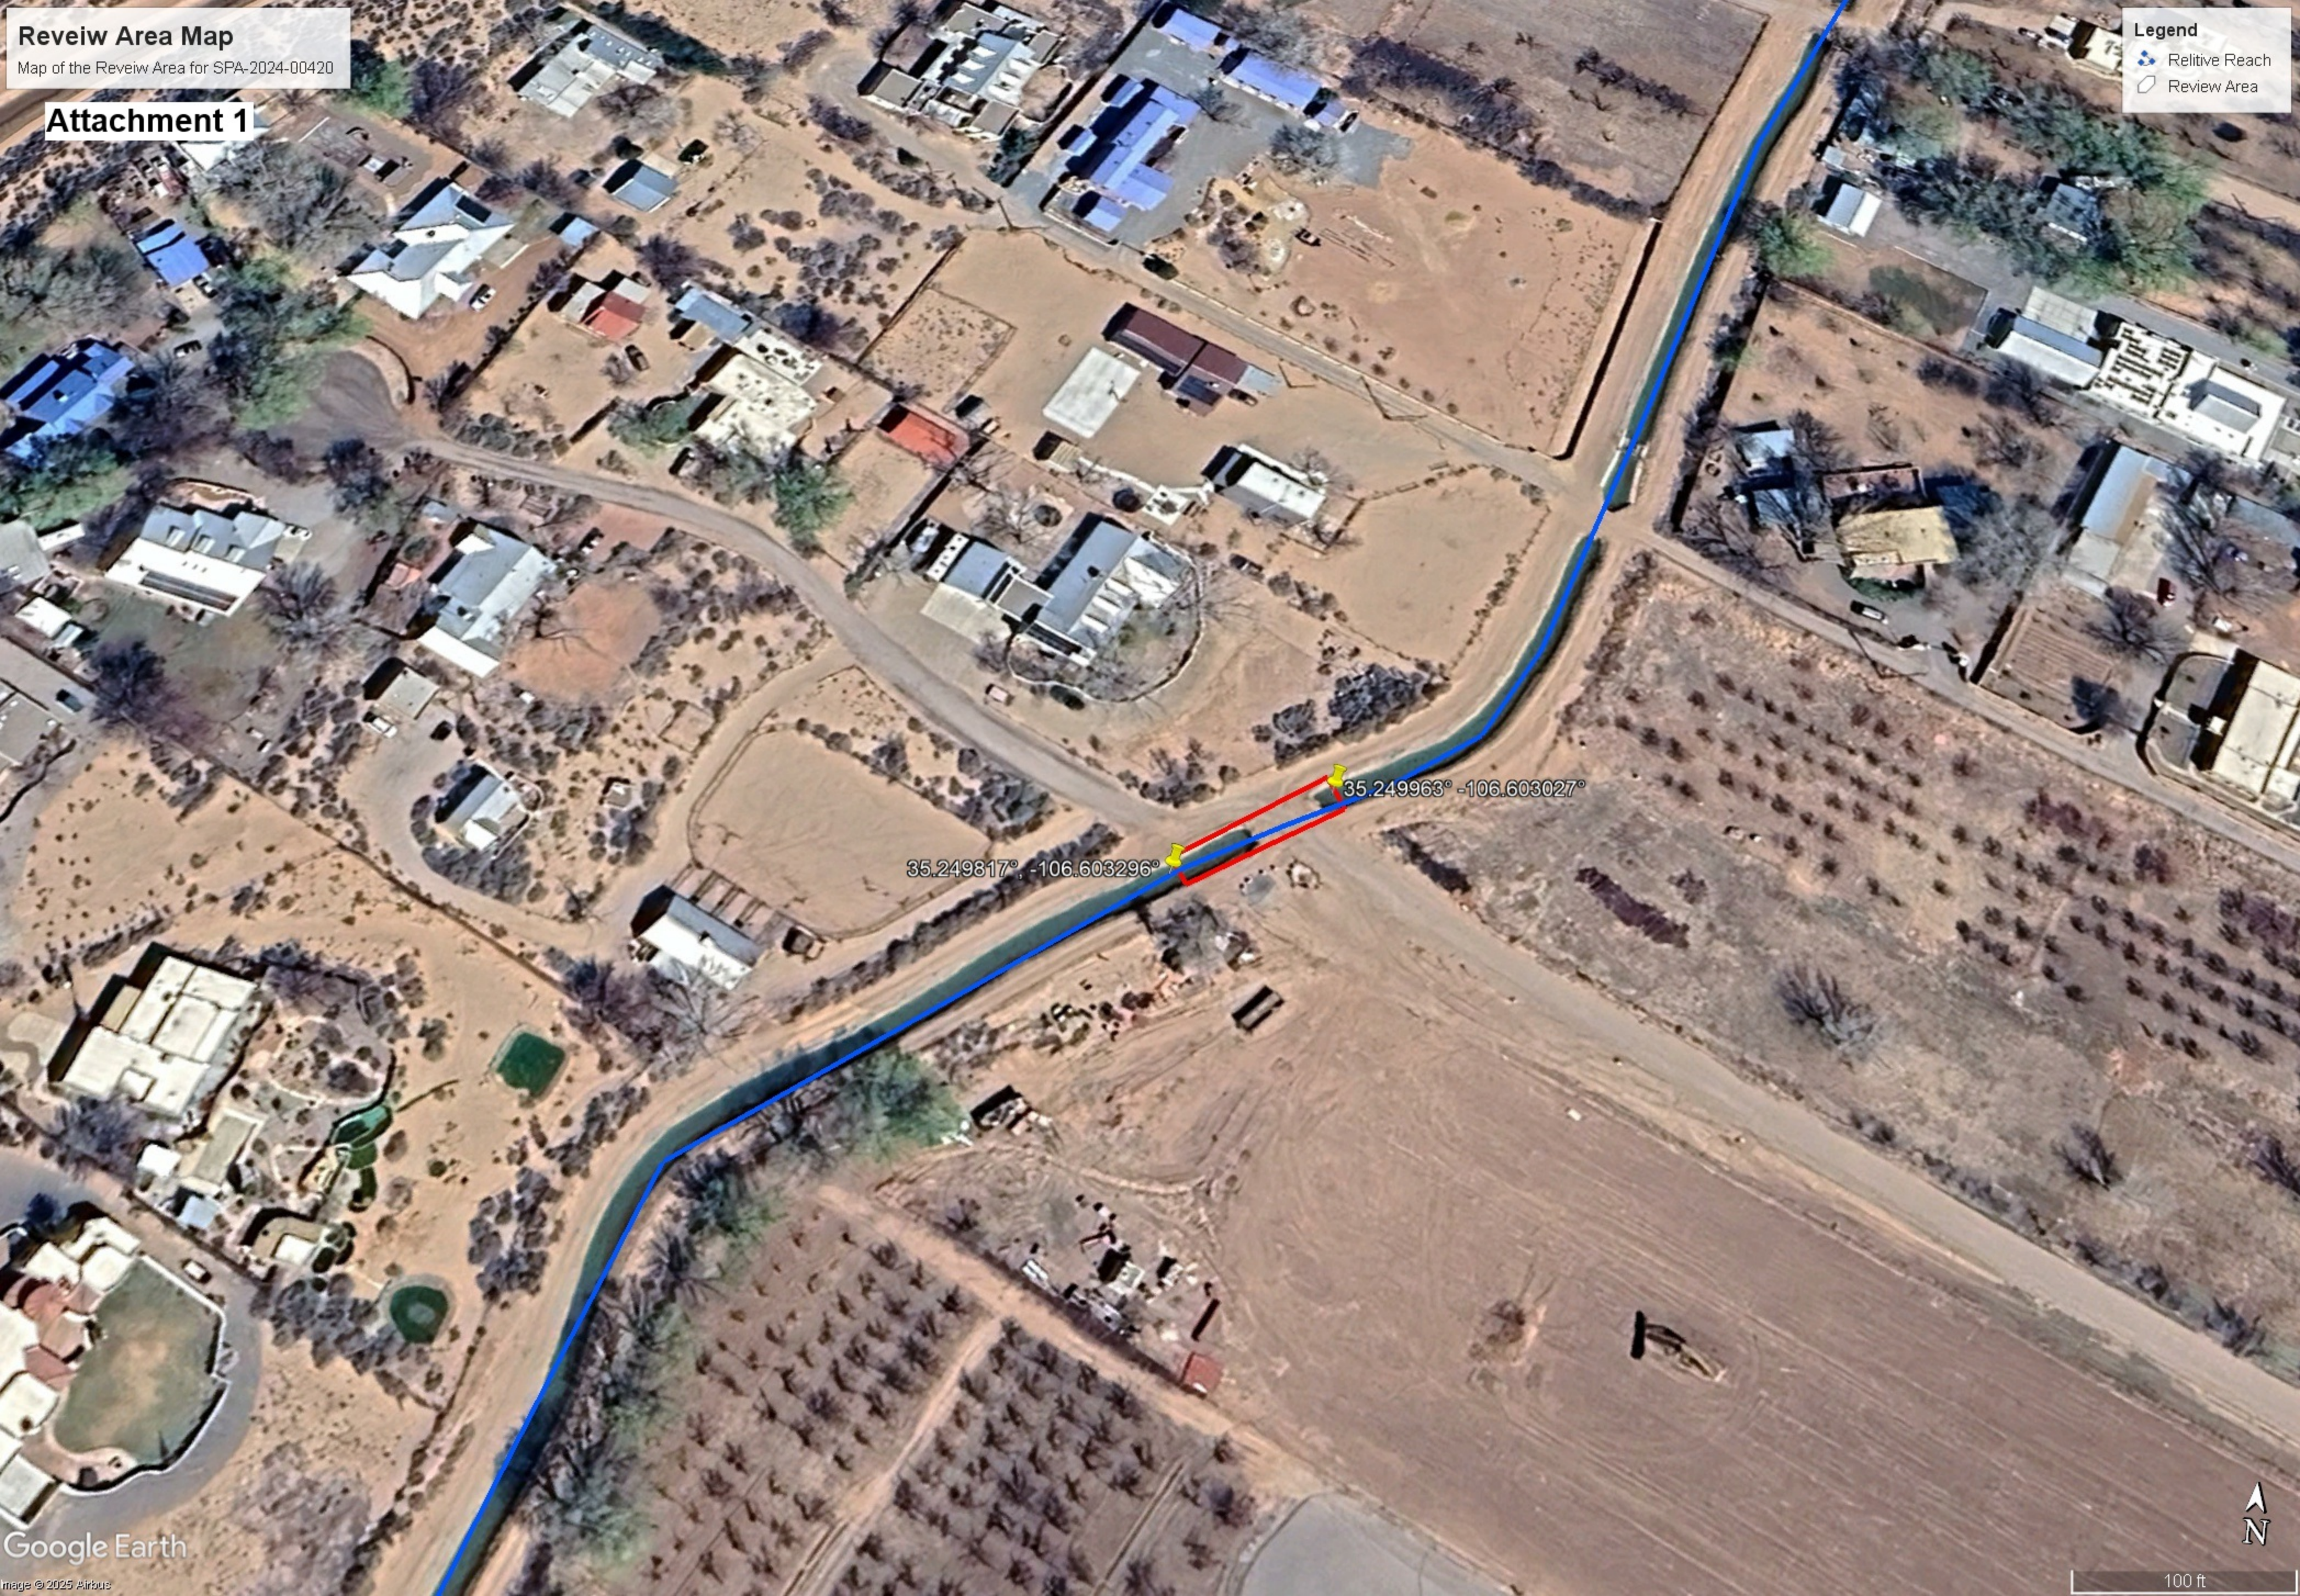
Attachment 1

3. REVIEW AREA. The review area consists of a 95-linear-foot reach of the **Corrales Acequia**, an irrigation canal, and is part of a larger network of irrigation canals (see Attachment 1). The canal is approximately 15 feet in width within the review area. The upstream extent of review area is located at latitude 35.249963°, longitude -106.603027° and extends downstream to latitude 35.249817°, longitude -106.603296°. The review area is situated to the west of the Rio Grande, at Trosello Lane, within the village limits of Corrales, in Sandoval County, New Mexico.

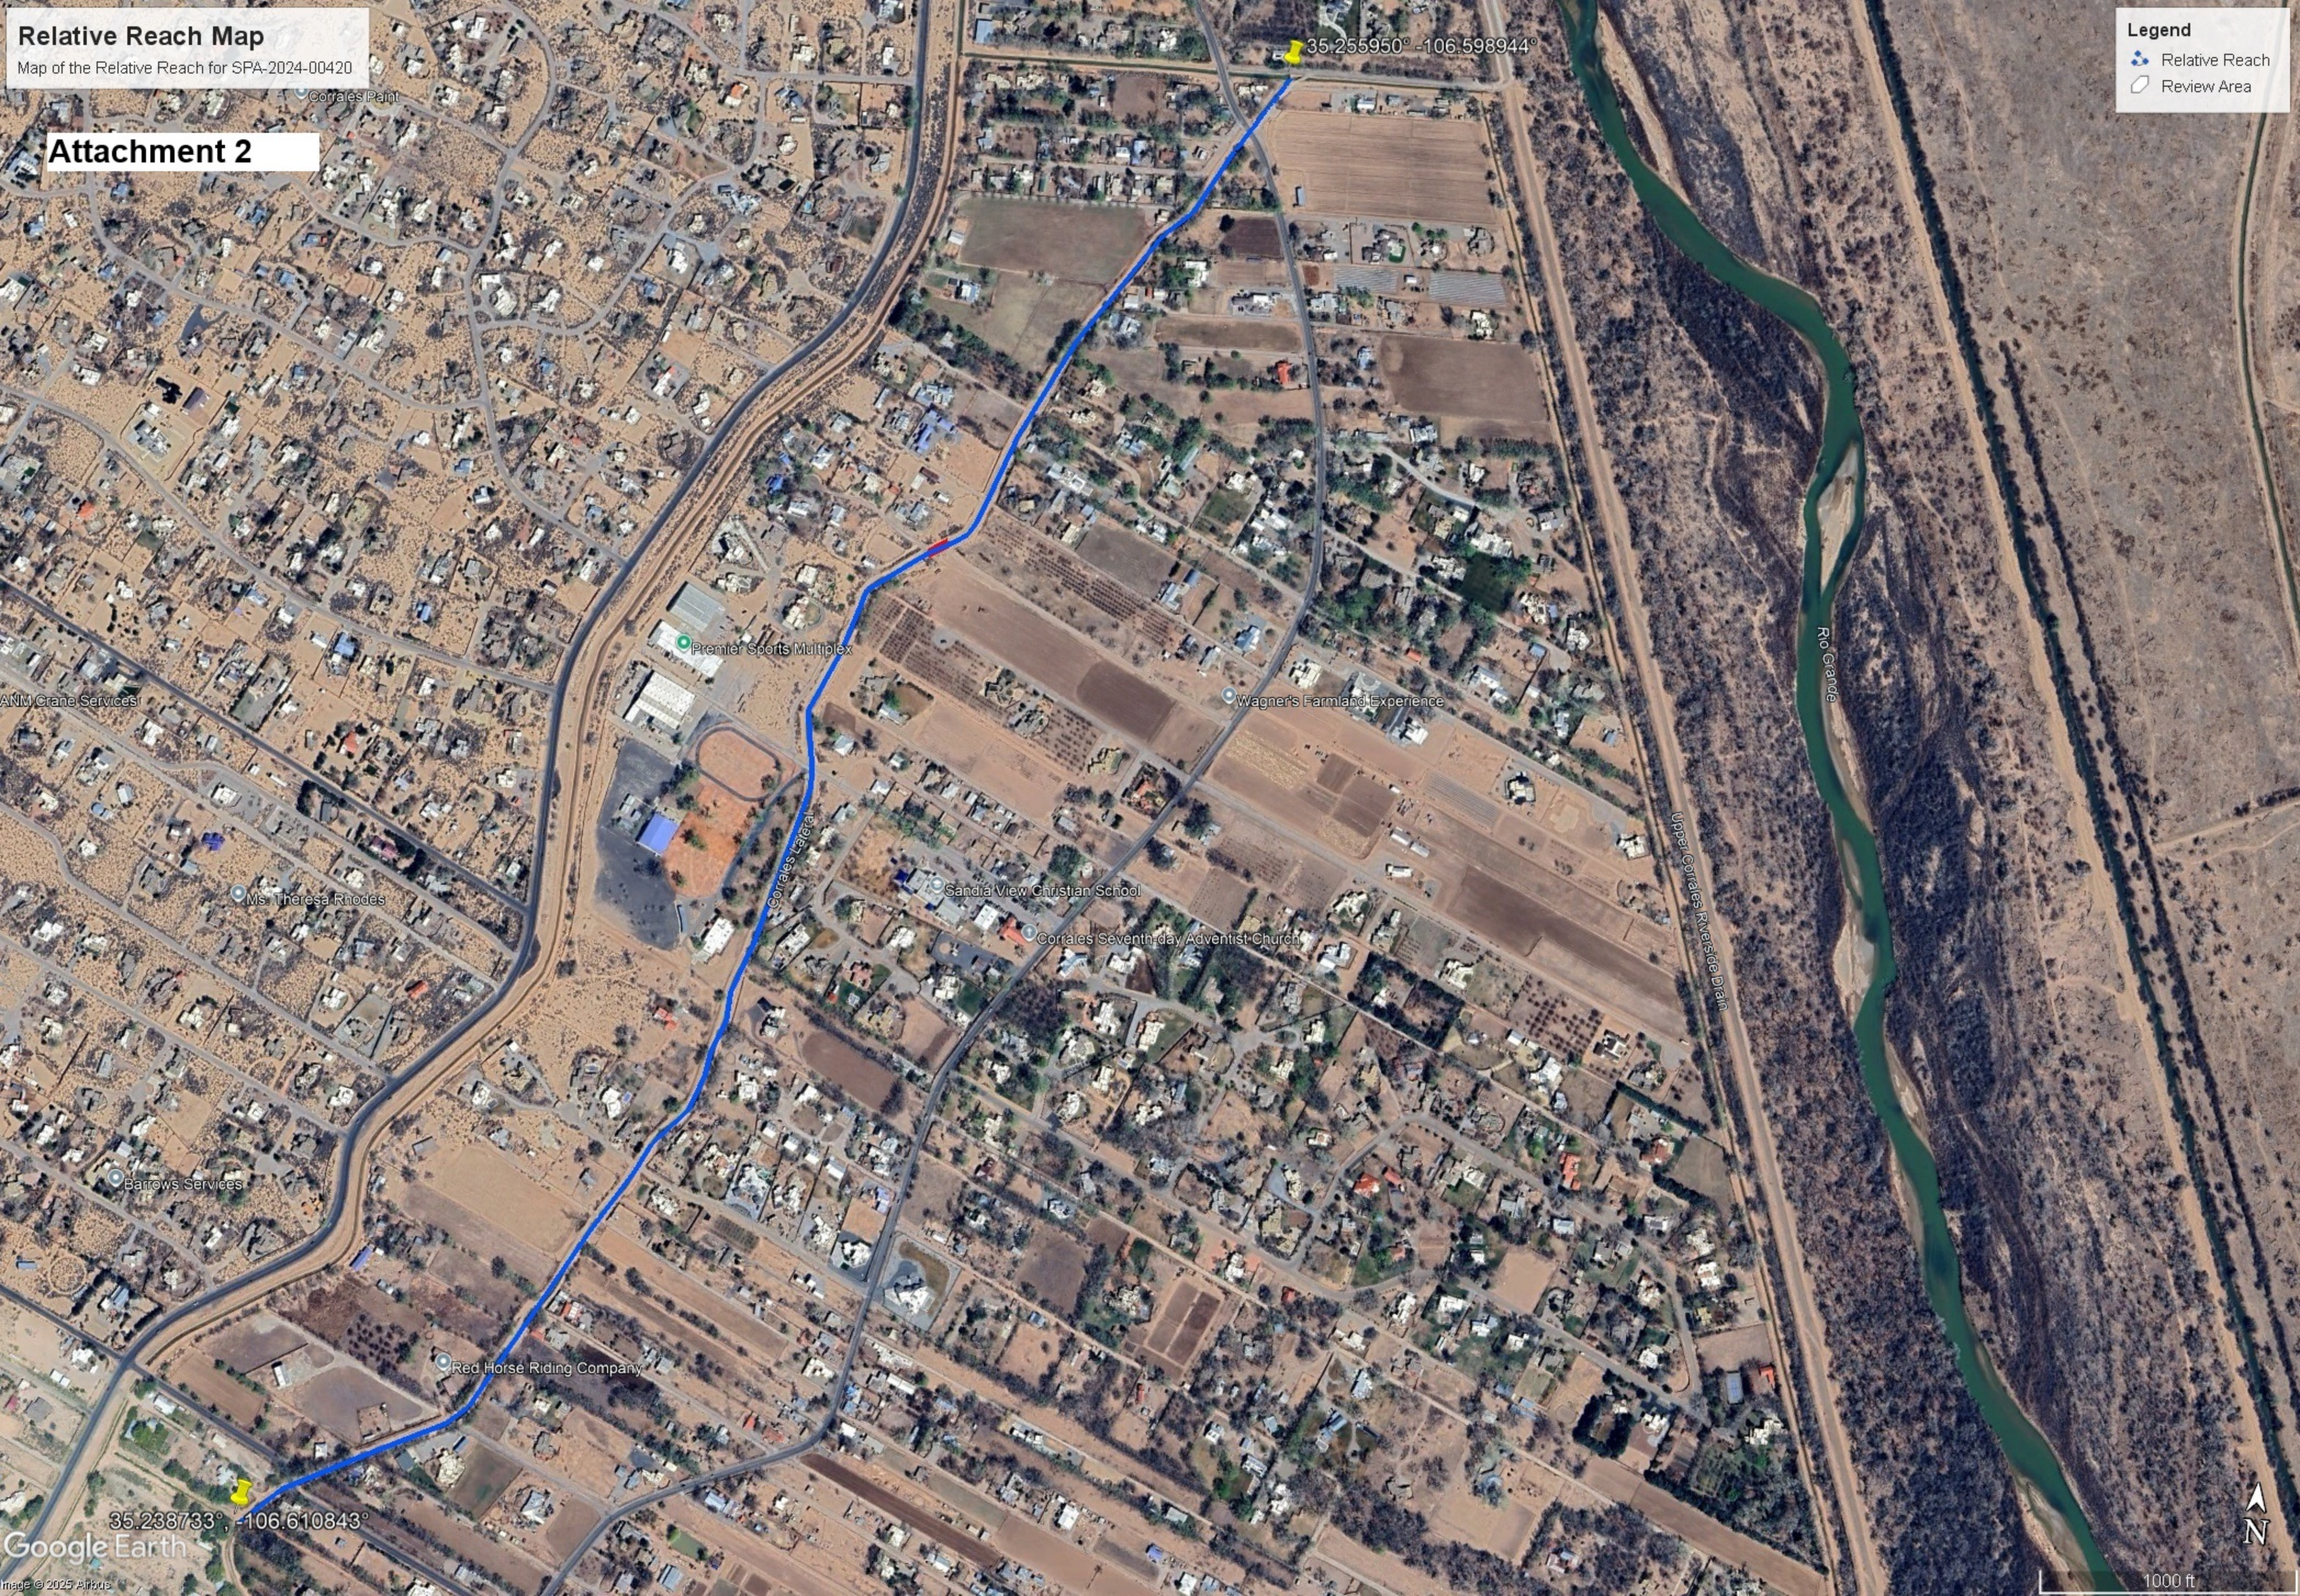
**Attachment 2**

The review area includes a 95-linear-foot portion of the Corrales Acequia. An approximately 1.5-mile-long portion of the Corrales Acequia is the reach of tributary for purposes of this analysis (i.e., the relative reach; see Attachment 2). The relative reach is situated to the west of the Rio Grande. The upstream extent of the relative reach is located at latitude 35.249963°, longitude -106.603027°, approximately 0.5 miles upstream of the review area, where Rio Grande water is periodically diverted to the Corrales Acequia through portions of the Corrales Main Canal and portions of the Sandoval Lateral. At this point the relative reach is the equivalent of a first order stream. The relative reach extends downstream to latitude 35.249817°, longitude -106.603296° where it is joined by another first order equivalent channel, the Corrales Feeder. Consistent with the Strahler stream order concept, the Corrales Acequia is a second order channel below this confluence and therefore a separate reach.

**The relative reach for this jurisdictional determination begins at the start of the Corrales Acequia, located at latitude 35.2559°, longitude -106.5989°. The end of the reach is at latitude 35.2387°, longitude -106.6108°, where the North Diversion Feeder Channel discharges into the Corrales Acequia (see Attachment 2).**
