**DRY LAND APPROVED JURISDICTIONAL DETERMINATION FORM<sup>1</sup>**  
**U.S. Army Corps of Engineers**

**B. DISTRICT OFFICE, FILE NAME, AND NUMBER: Albuquerque District, Spanish Peaks Solar LLC/Spanish Peaks Solar Farm, SPA-2020-00227-SCO**

# Spanish Peaks Solar - County Road 75 and west portion

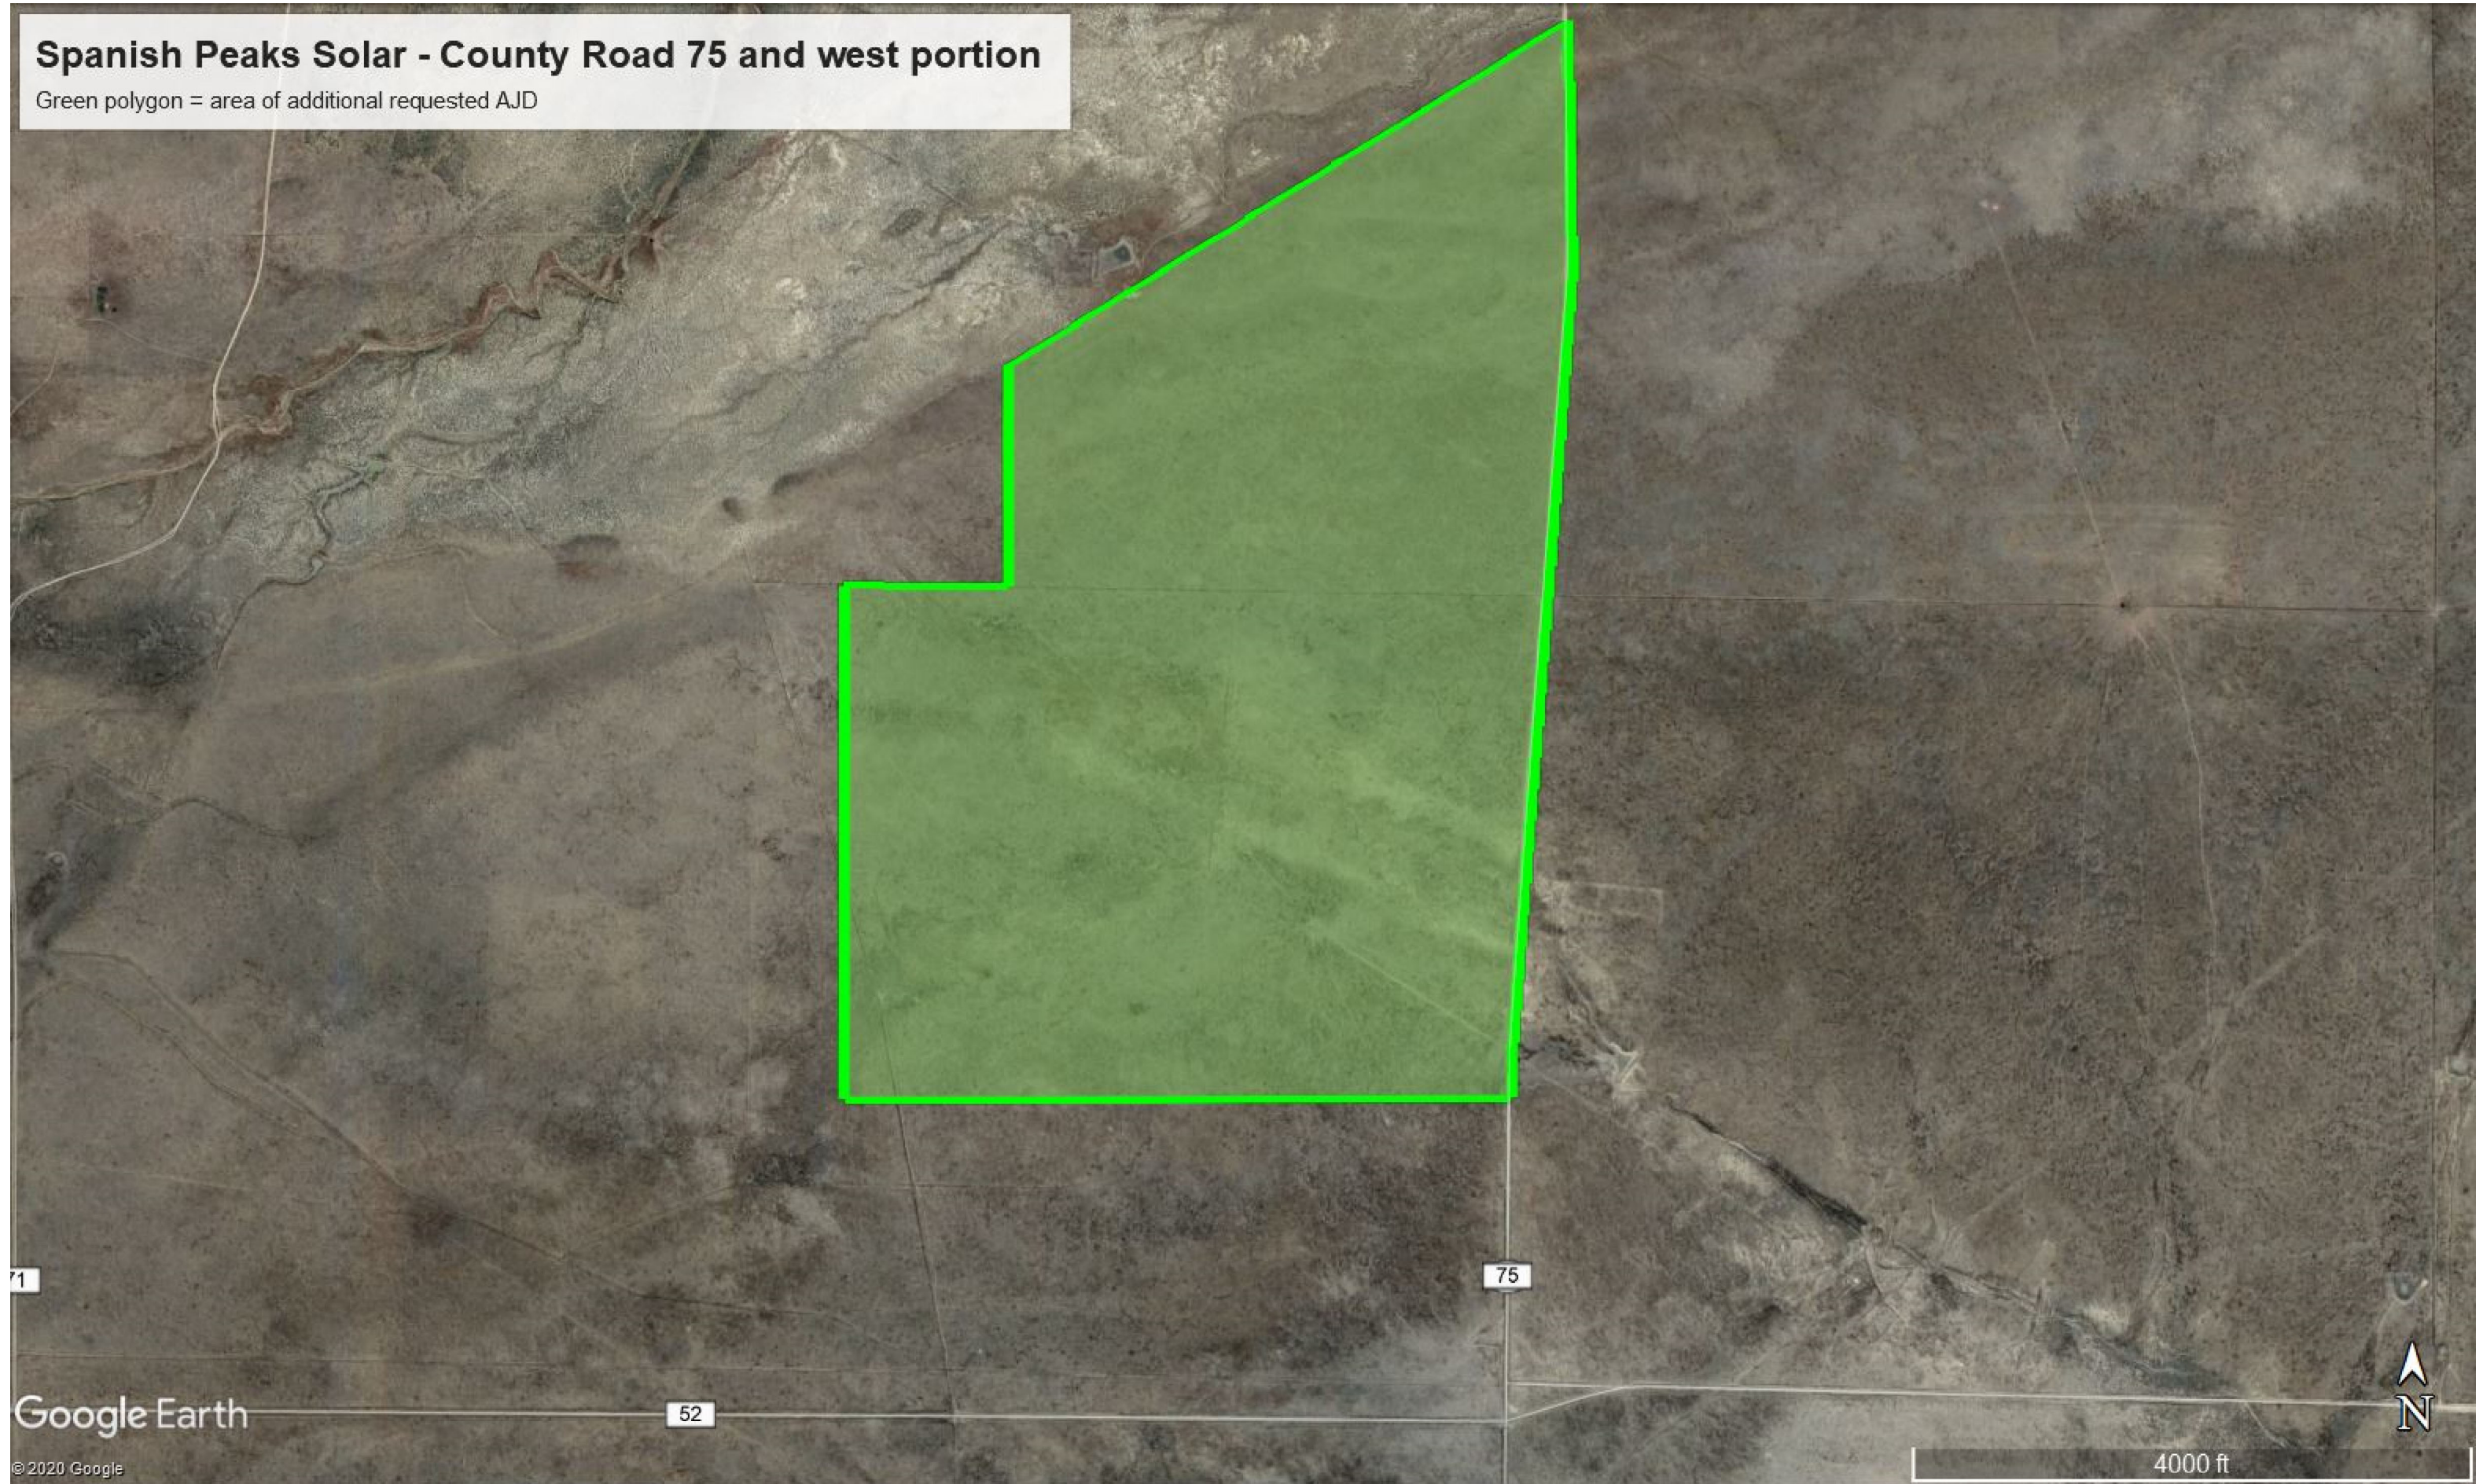
Green polygon = area of additional requested AJD

**B. REQUIRED ADDITIONAL COMMENTS TO SUPPORT JD. EXPLAIN RATIONALE FOR DETERMINATION THAT THE REVIEW AREA ONLY INCLUDES DRY LAND:** The review area associated to this dry-land JD encompasses an approximate 675-acre portion of the leased property west of County Road (CR) 75 (see map) in Los Animas County, Colorado. The review area was predominately composed of mixed salt desert scrub species, which include Blue grama (*Bouteloua gracilis*-UPL), Tree cholla (*Cylindropuntia imbricate*-UPL),
