**U.S. ARMY CORPS OF ENGINEERS
REGULATORY PROGRAM
APPROVED JURISDICTIONAL DETERMINATION FORM (INTERIM)
NAVIGABLE WATERS PROTECTION RULE**

ORM Number: SPA2020-211

Review Area Location¹: State/Territory: New Mexico City: Rio Rancho County/Parish/Borough: Sandoval

Excluded waters ((b)(1) – (b)(12)): ⁴			
Exclusion Name	Exclusion Size	Exclusion ⁵	Rationale for Exclusion Determination
Black Arroyo Location 3	1500 linear feet	(b)(3) Ephemeral feature, including an ephemeral stream, swale, gully, rill, or pool.	See Section III. C below for information supporting the exclusion determination.

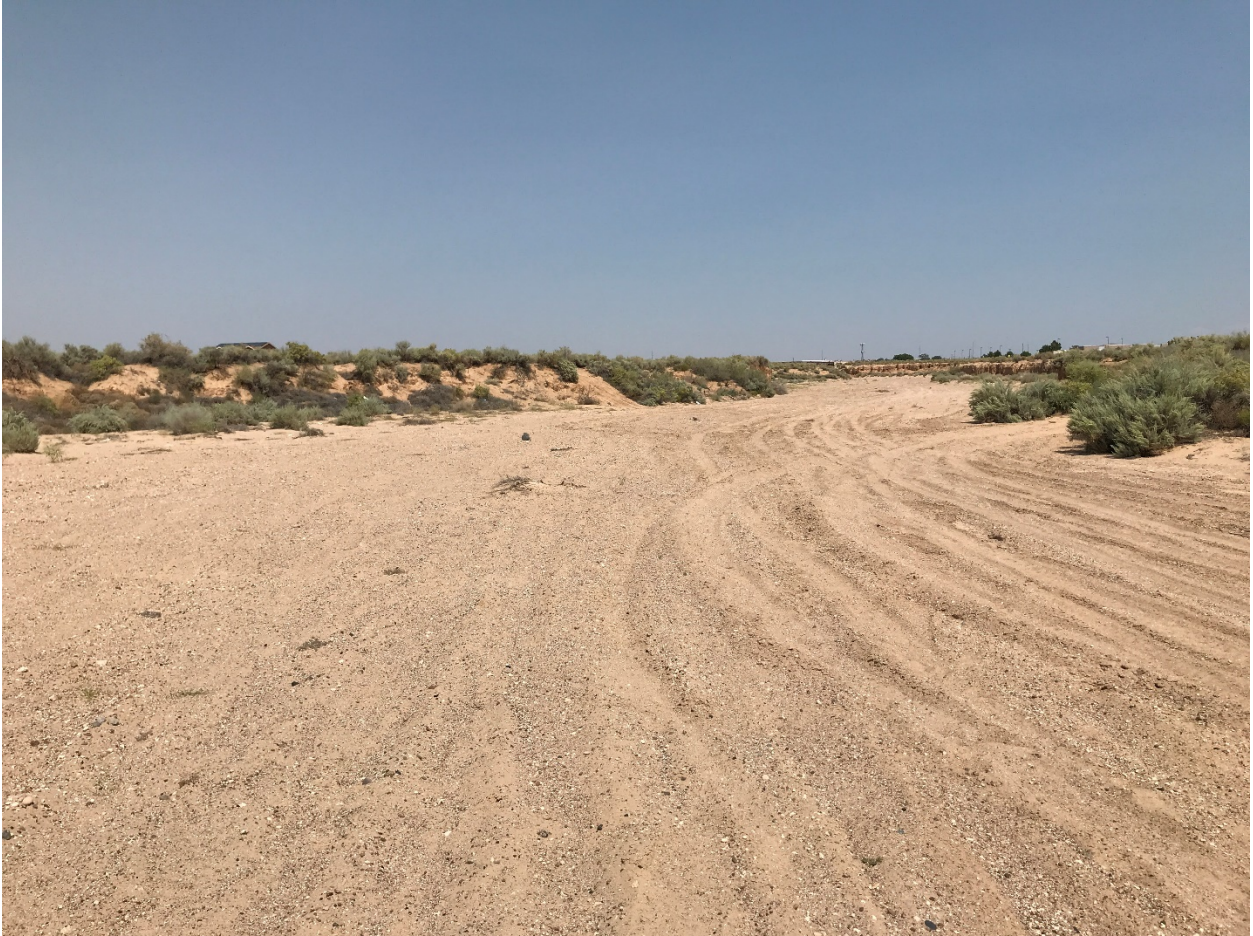
Black Arroyo Location 3 Site Visit 8/21/2020

Southern area of review site near Vargas Road SE looking upstream.

A field assessment of the review area was conducted on July 24, 2020, which was the day after a 0.25 inch rainfall in the area. However, no surface water was observed in the stream channel. Additionally, the banks and bed of the stream channel are mostly devoid of any vegetation, nor is there a riparian corridor present. The vegetation observed is typical high desert plant community. A second site visit was conducted on August 21, 2020 and no flow or indications of recent hydrology was observed (see attached photos).

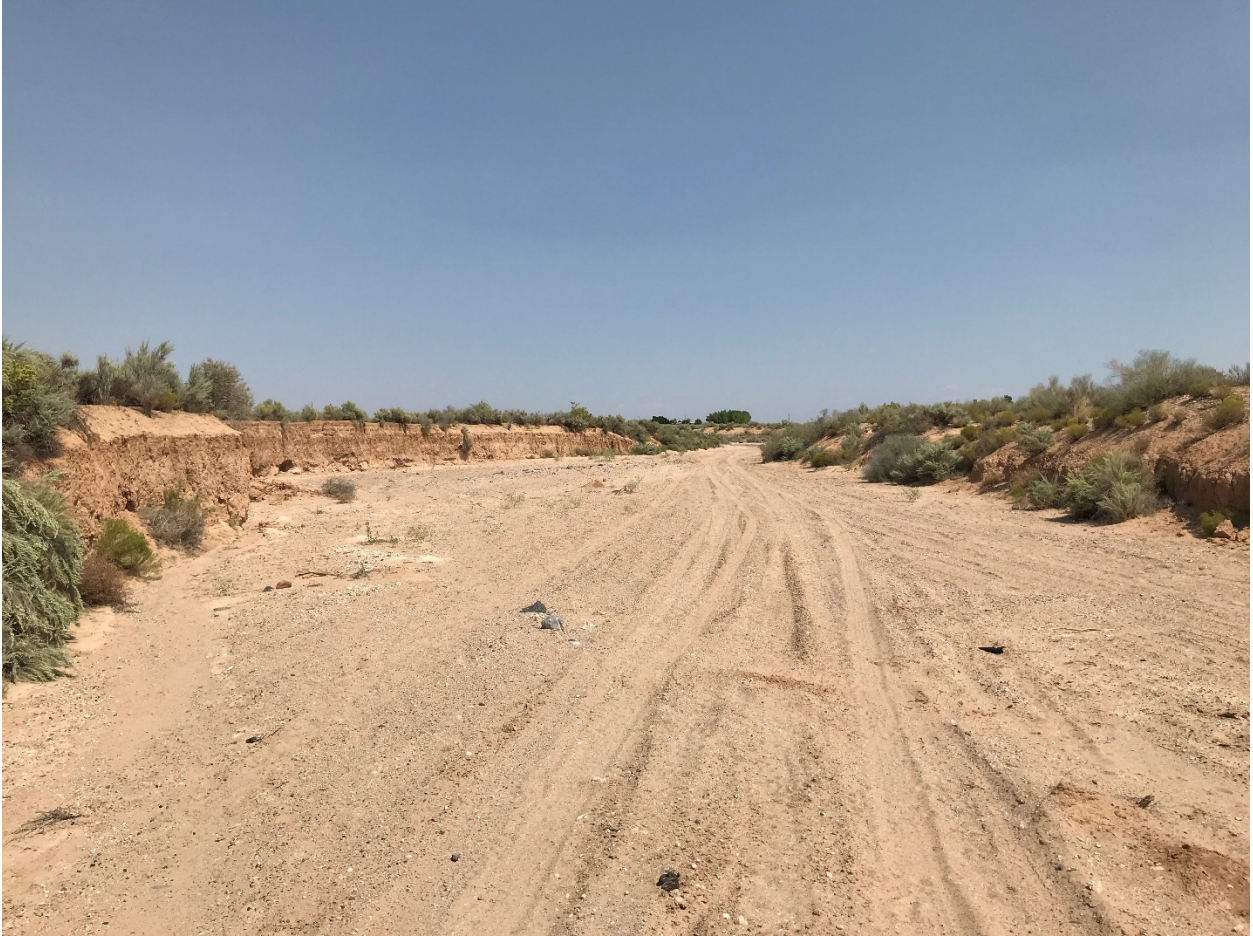
Black Arroyo Location 3 Site Visit 8/21/2020

Middle area of review site near 19th St SE looking upstream.

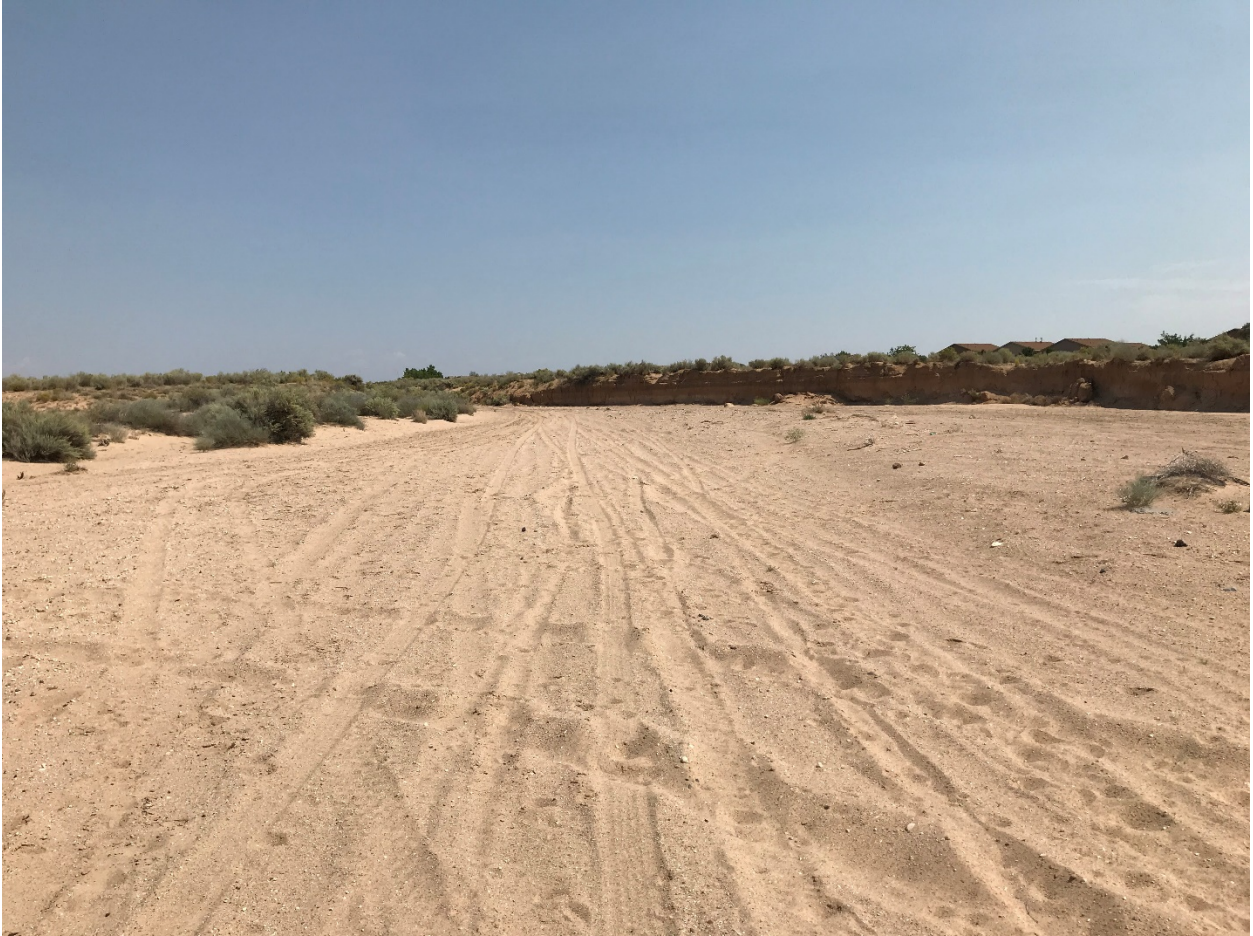
Black Arroyo Location 3 Site Visit 8/21/2020

Middle area of review site near 19th St SE looking upstream.

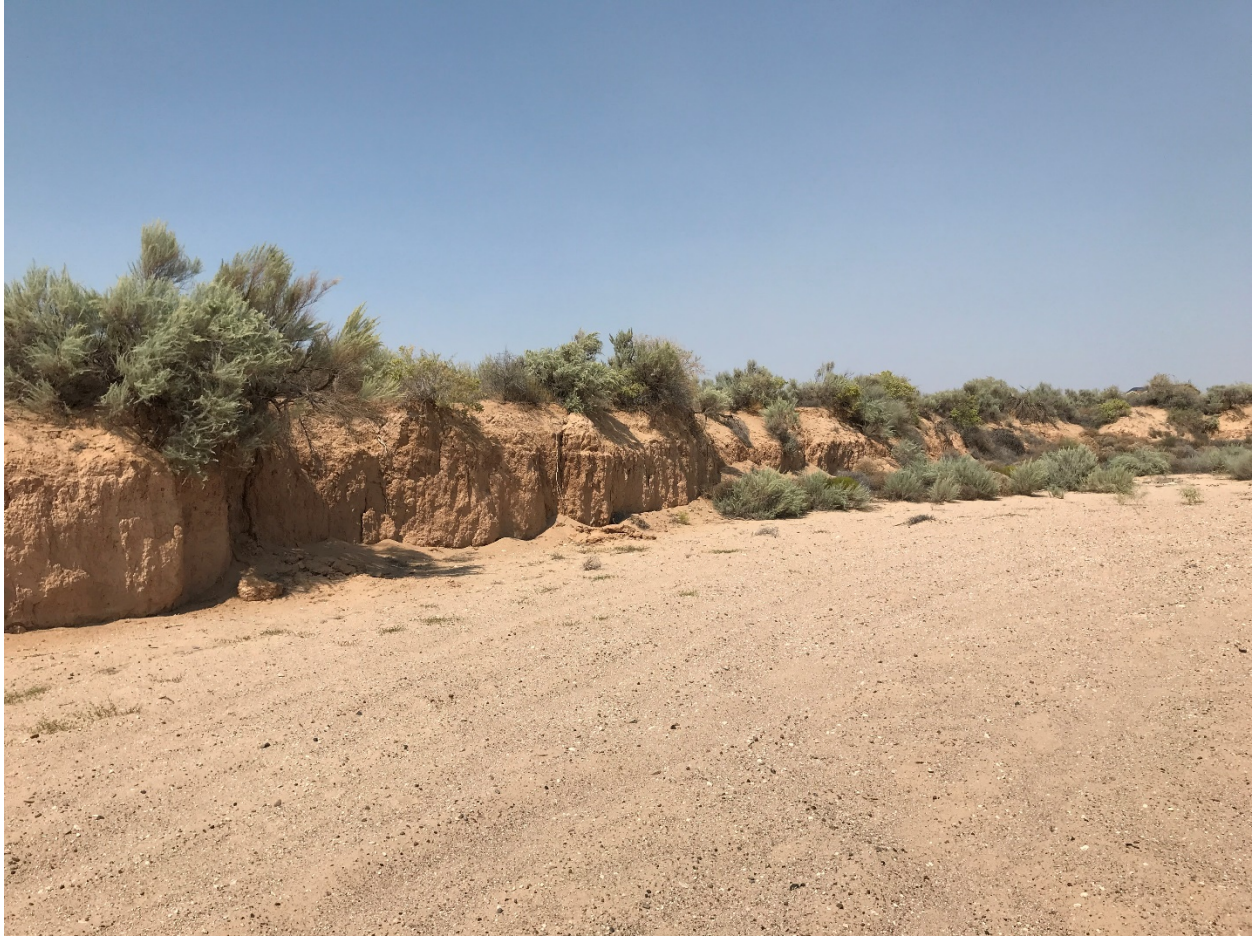
Black Arroyo Location 3 Site Visit 8/21/2020

Norther area of review site near 19th St SE looking upstream.

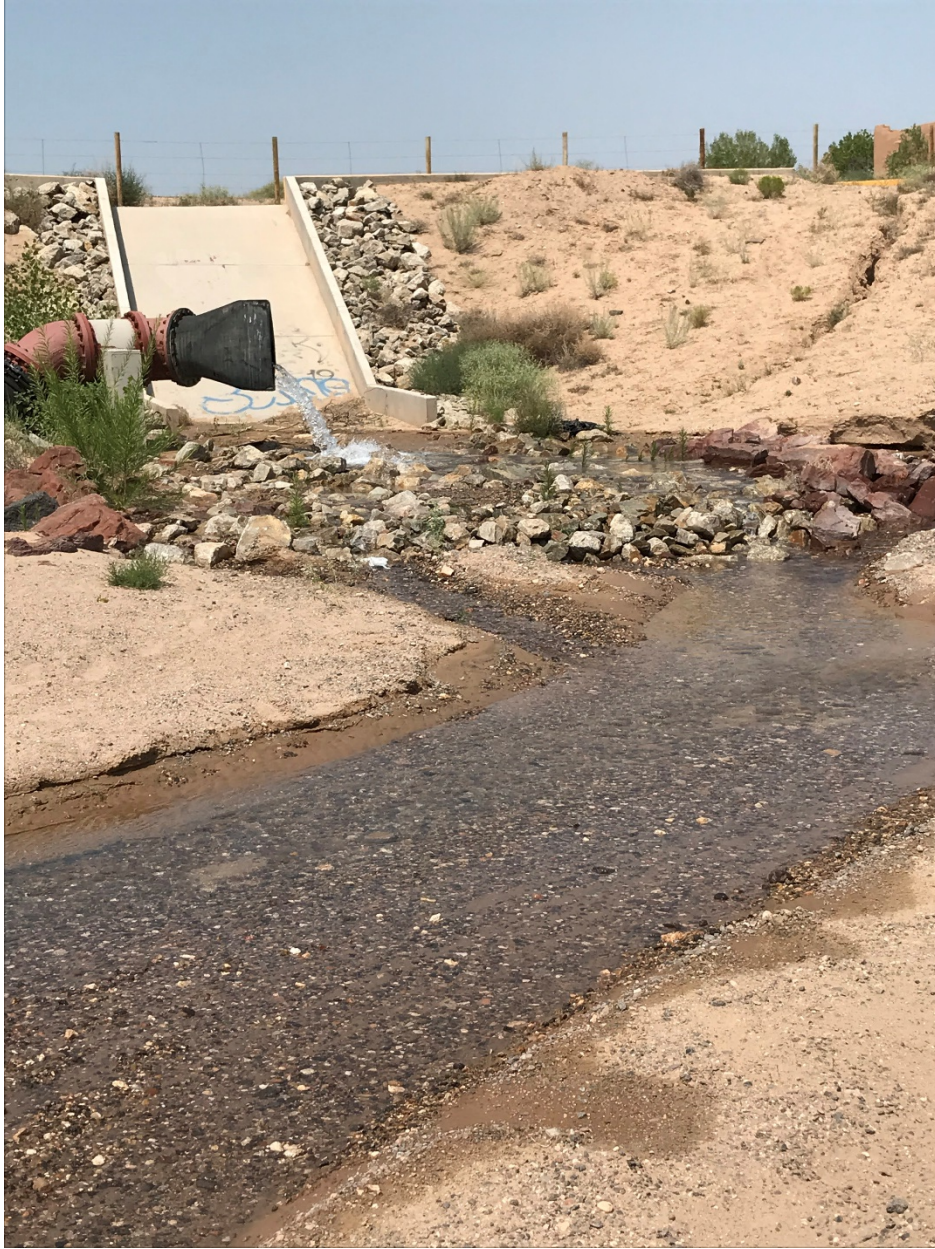
Black Arroyo Location 3 Site Visit 8/21/2020

Southern area of review site near Vargas Road SE looking at the City of Rio Rancho well discharge. When starting up the well, the City of Rio Rancho pumps some of the initial groundwater withdrawn out and discharges it to the surface of the Black Arroyo. This water travel approximately 1.1 miles before no traces of the discharge water can be identified. If the water were to travel further, there would have to be enough water collected to fill up the basin and gain enough elevation to go through the culverts at the Black Dam impoundment to the east of the discharge site. The Black Dam is approximately 4.25 miles from the Rio Grande. This would not be a jurisdictional water because it has no surface water connections to the Rio Grande or another A1-A3 water. This water also only flows related to groundwater pumping procedure performed by the City of Rio Rancho.

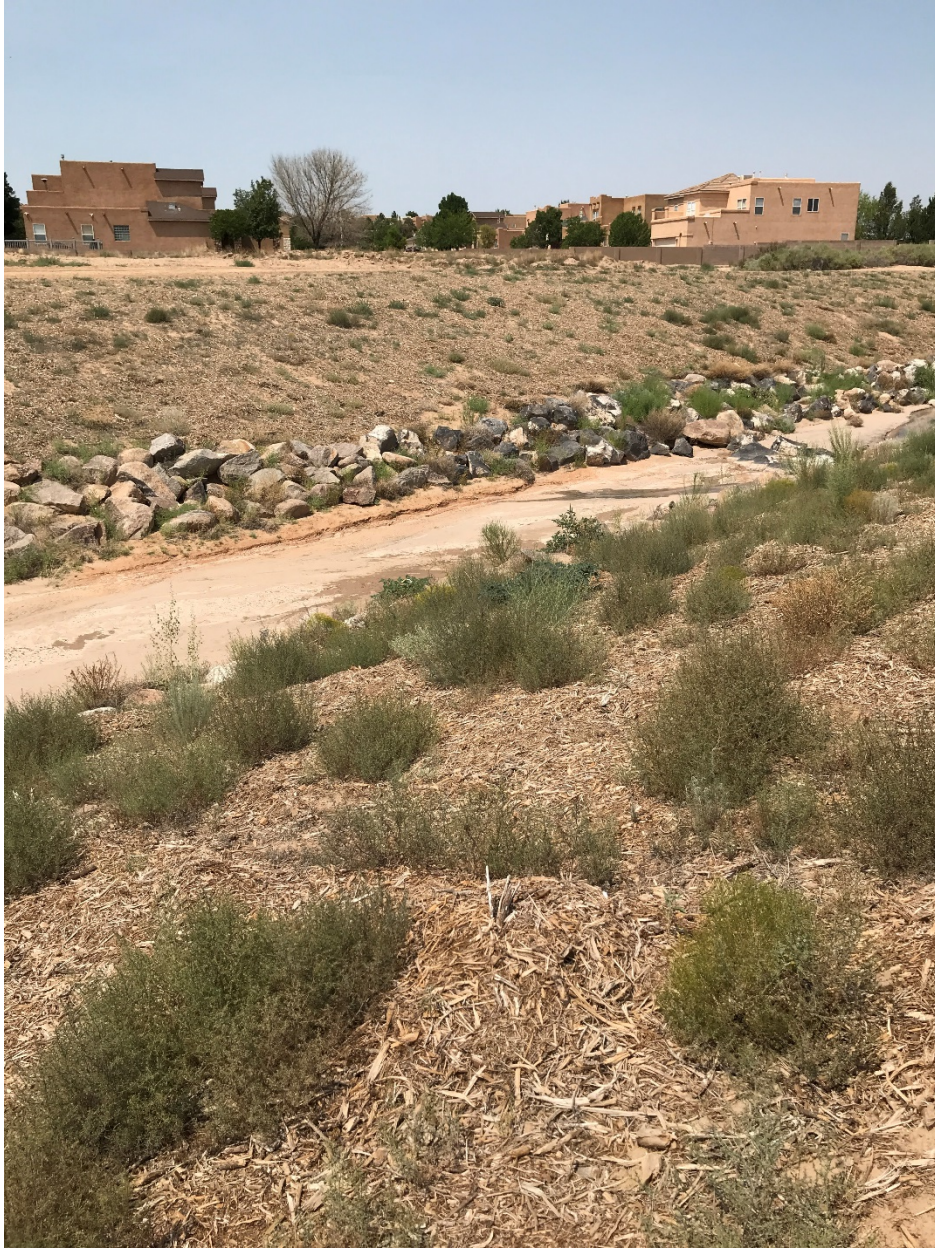
Black Arroyo Location 3 Site Visit 8/21/2020

Near Black arroyo Dam, you can see the furthest extent of the water, approximately 1.2 miles from the pipe discharging the water

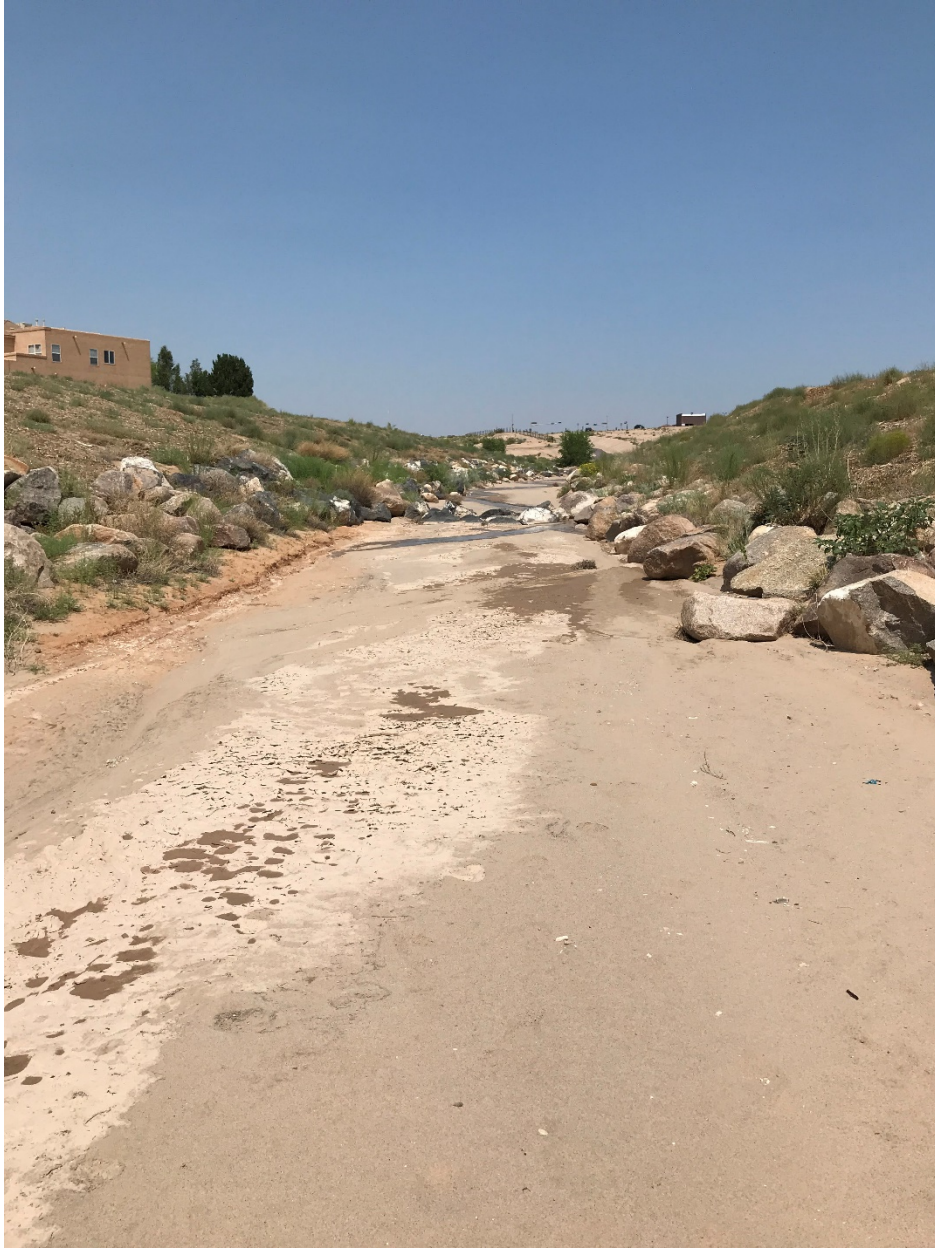
Black Arroyo Location 3 Site Visit 8/21/2020

Near Black arroyo Dam, you can see the furthest extent of the water, approximately 1.2 miles from the pipe discharging the water

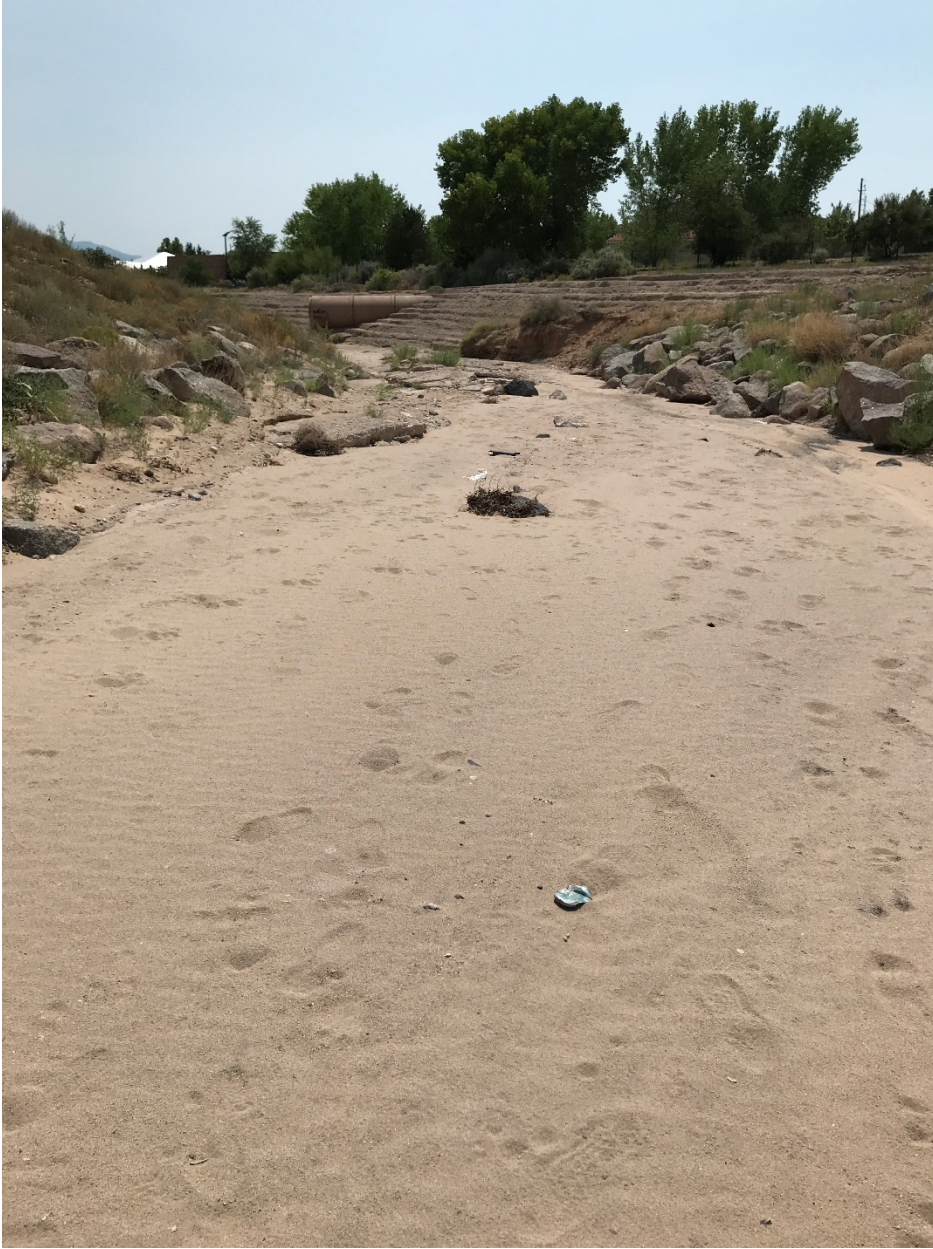
Black Arroyo Location 3 Site Visit 8/21/2020

Near Black arroyo Dam, looking downstream you can see no water has gone beyond this point approximately 1.2 miles from the pipe discharging the water

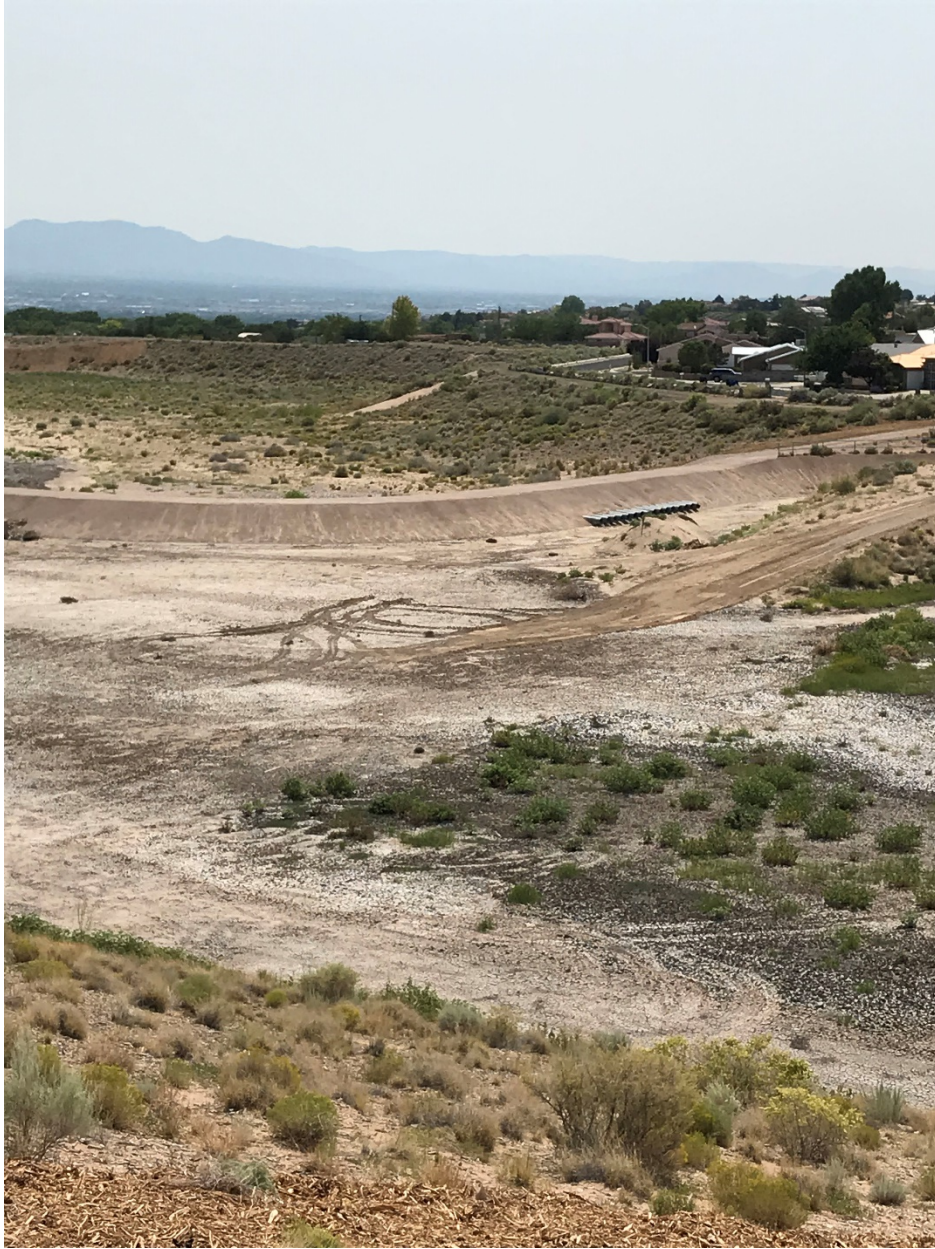
Black Arroyo Location 3 Site Visit 8/21/2020

Path of water from
City well

Looking at Black Arroyo Dam, the foreground of the photo is the water storage area. There is no water present. The water discharged from the city well would enter from the top right of the photo.
