**U.S. ARMY CORPS OF ENGINEERS
REGULATORY PROGRAM
APPROVED JURISDICTIONAL DETERMINATION FORM (INTERIM)
NAVIGABLE WATERS PROTECTION RULE**

ORM Number: SPA2020-169

Review Area Location¹: State/Territory: New Mexico City: Unincorporated County/Parish/Borough: Cibola

C. Additional comments to support AJD: The review area for this AJD includes the location of the St. Anthony Mine Closure Project. The review area is located on private land within a 615.4-acre project site approximately 40 miles west of Albuquerque and 4.6 miles southeast of Seboyeta in Cibola County, New Mexico. United Nuclear Corporation obtained the services of SWCA Environmental Consultants (SWCA) to conduct fieldwork and research to support this AJD, which resulted in the preparation of the Aquatic Resources Delineation Report.

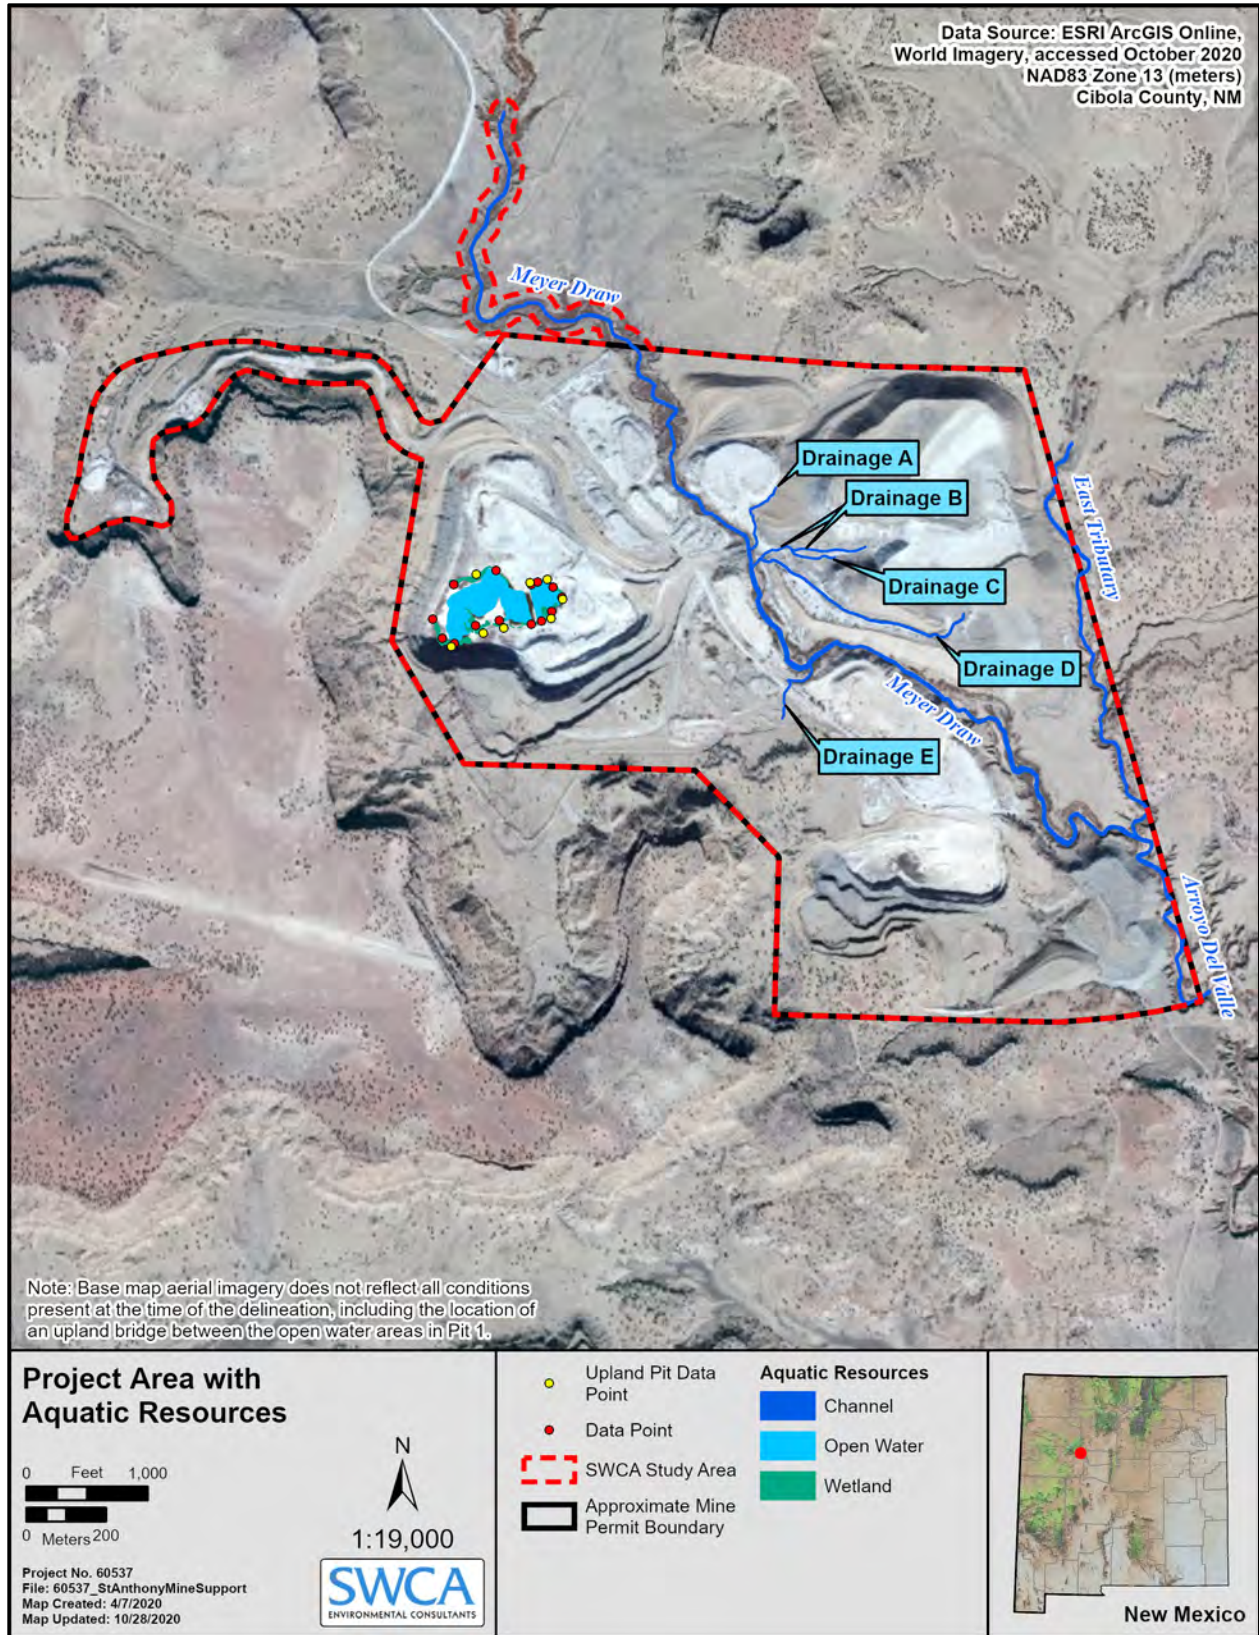
Figure A-2. Site aquatic resources inventory map.

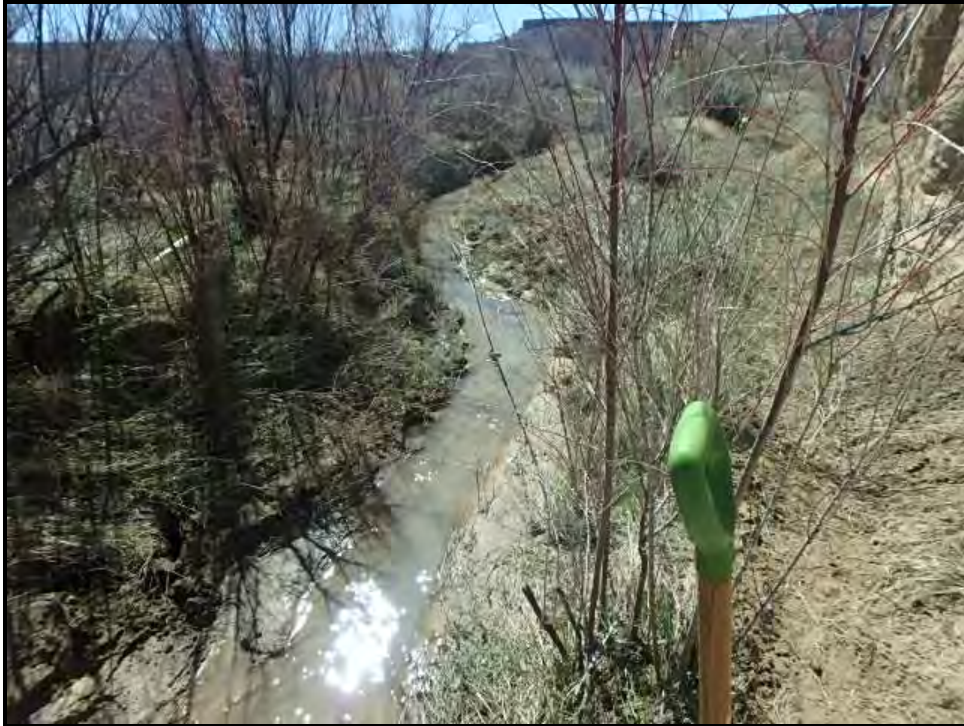
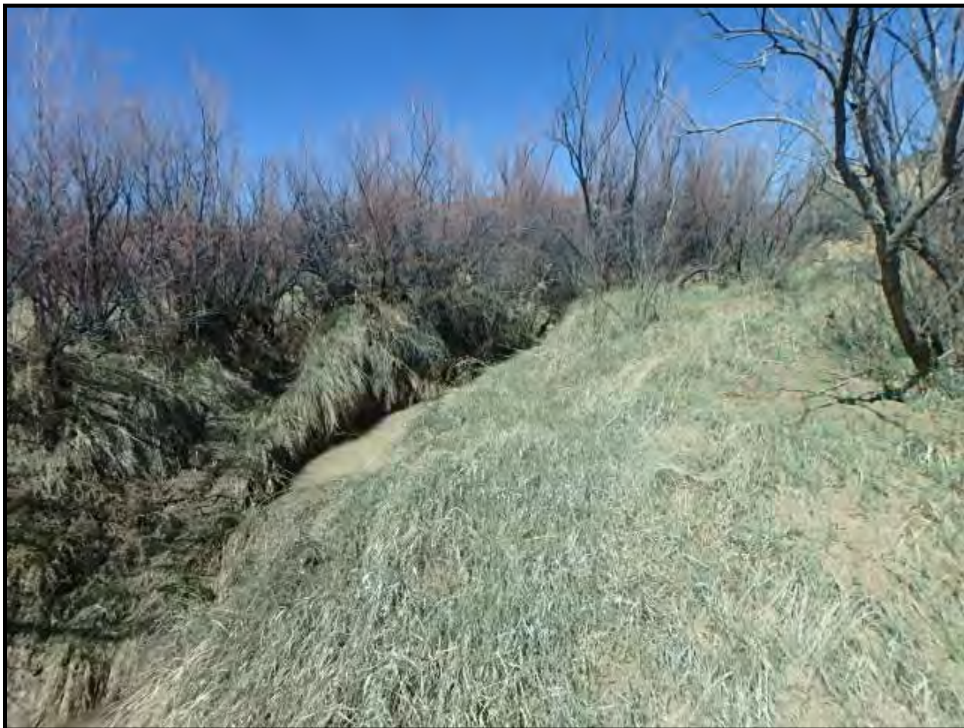
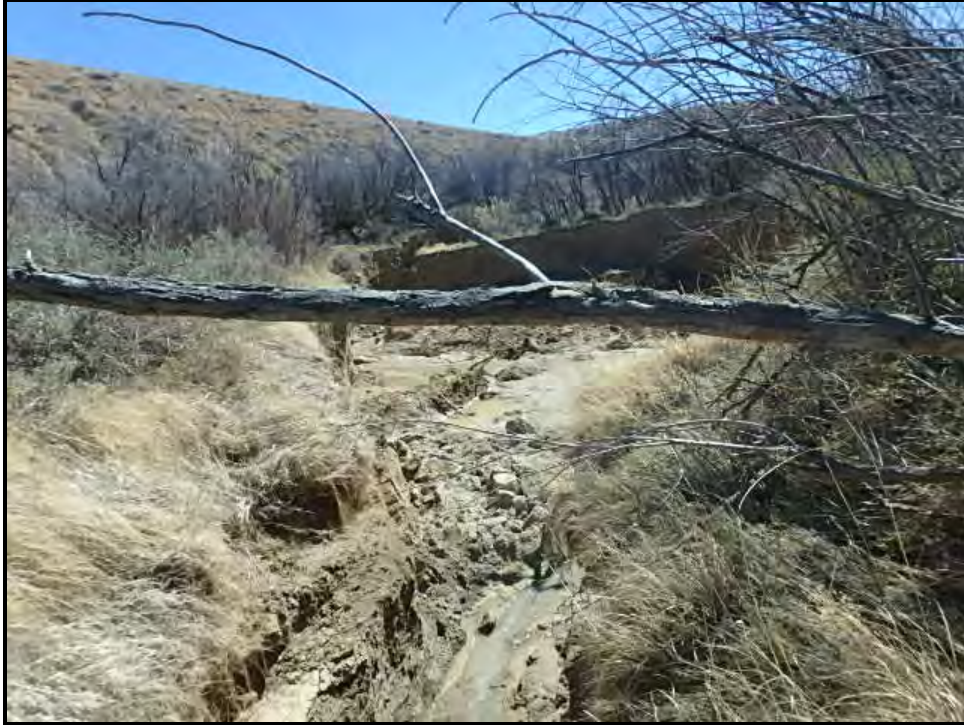
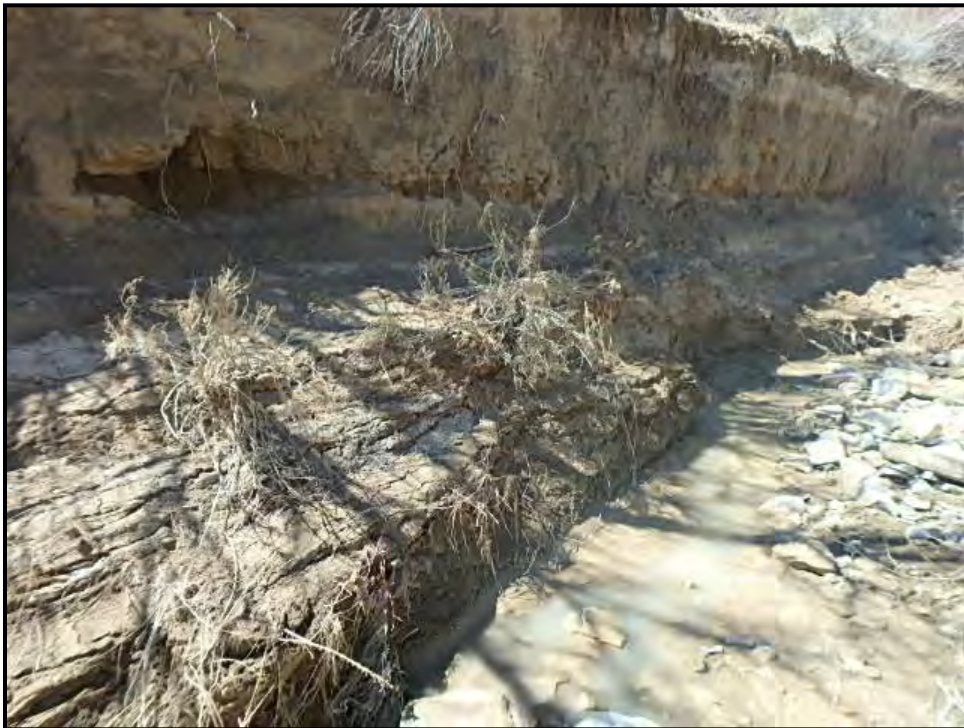
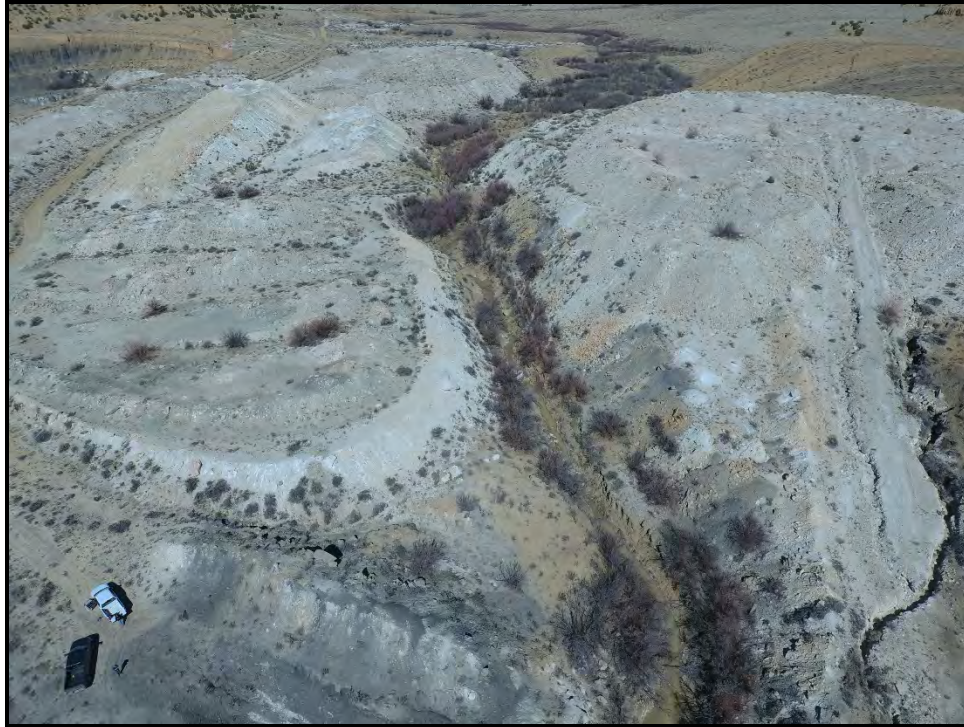
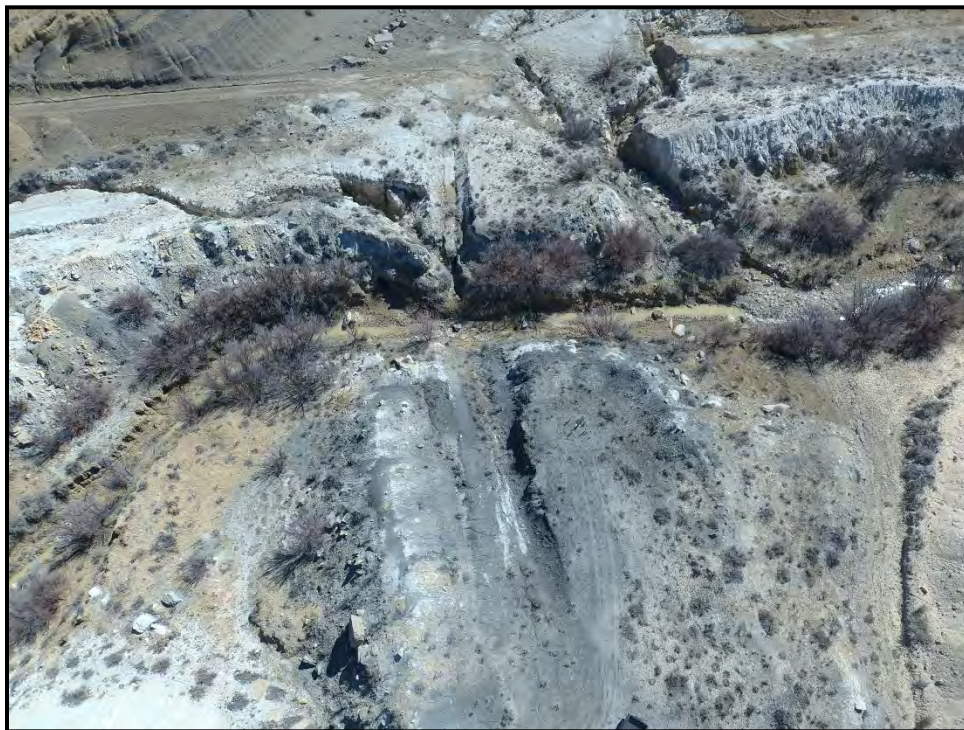
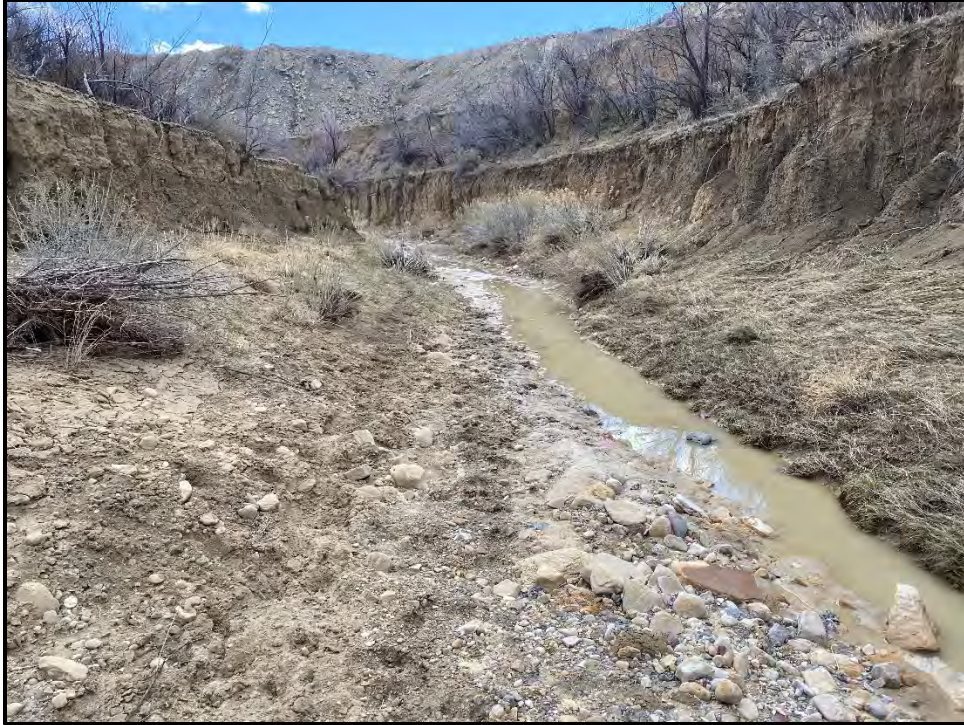
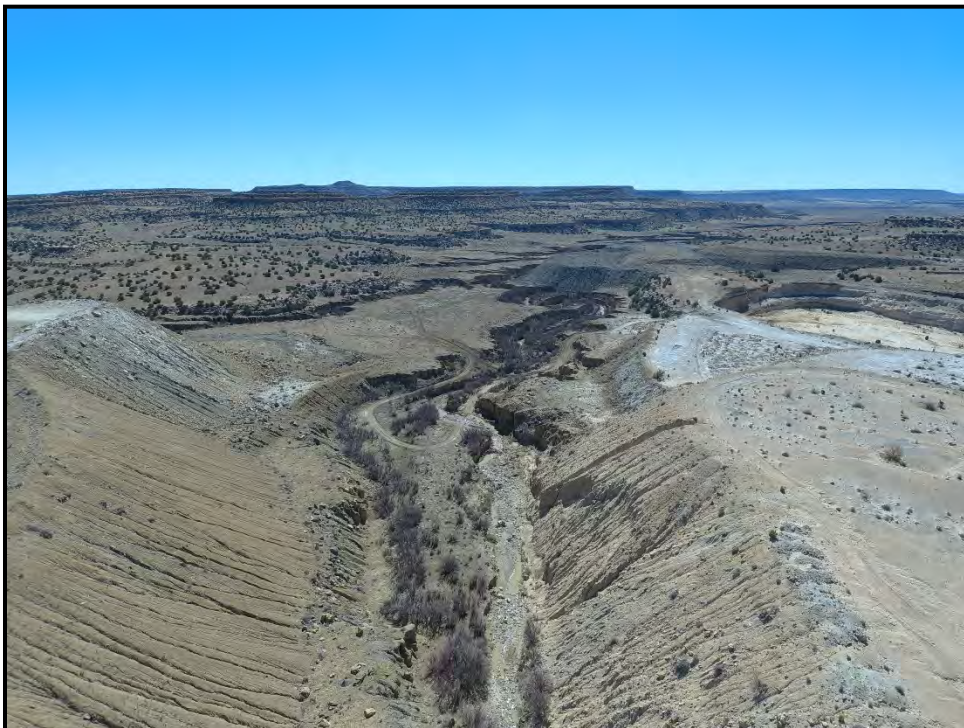
SWCA reported that over the dates of March 20, 23 and 24 of 2020 Meyer Draw contained flows of approximately 0.25–0.5 cubic feet per second (cfs) in portions of the channel along with dry reaches interspersed throughout the site (see Photographs B-1 through B-8, with standing or flowing water more prevalent within its northern end (see Photographs B-1 and B-2). However, it was noted that the water observed within the stream channel is attributable to upstream groundwater pumping with some influence of local precipitation (this is further discussed below). Furthermore, groundwater elevations in proximity to Meyer Draw range from approximately 50 feet at Monitoring Well [MW]-3 to 108 feet at MW-1 below the surface elevation (Intera 2020).

Photograph B-1. North end of Meyer Draw, facing south.

Photograph B-2. Meyer Draw just inside north of Site, facing south.

Photograph B-3. Meyer Draw where head-cutting starts just below north road crossing.

Photograph B-4. Meyer Draw roughly midway through the Site.

Photograph B-5. Meyer Draw roughly midway through the Site, facing north from roughly 150 feet. Drainage A merges into Meyer Draw from the east.

Photograph B-6. Meyer Draw roughly midway through the Site, facing east.

Photograph B-7. Meyer Draw near the southern road crossing.

Photograph B-8. Meyer Draw roughly midway through the Site, facing south toward the confluence with East Tributary and formation of Arroyo del Valle.

Review of satellite imagery from January 20, 2013, which falls within the wet season, showed surface water and ice within the Rio San Jose, which is downstream of the mine site. However, no surface water was present in Meyer Draw. Based on the information provided in SWCA’s report and other information reviewed, it has been determined that Meyer Draw is an ephemeral stream channel.

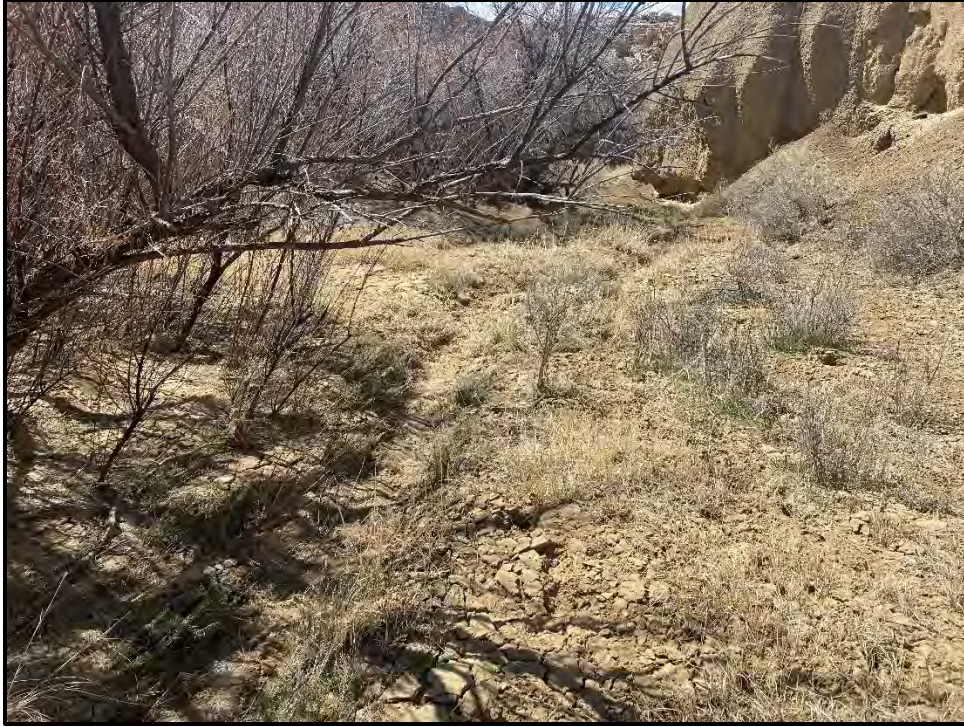
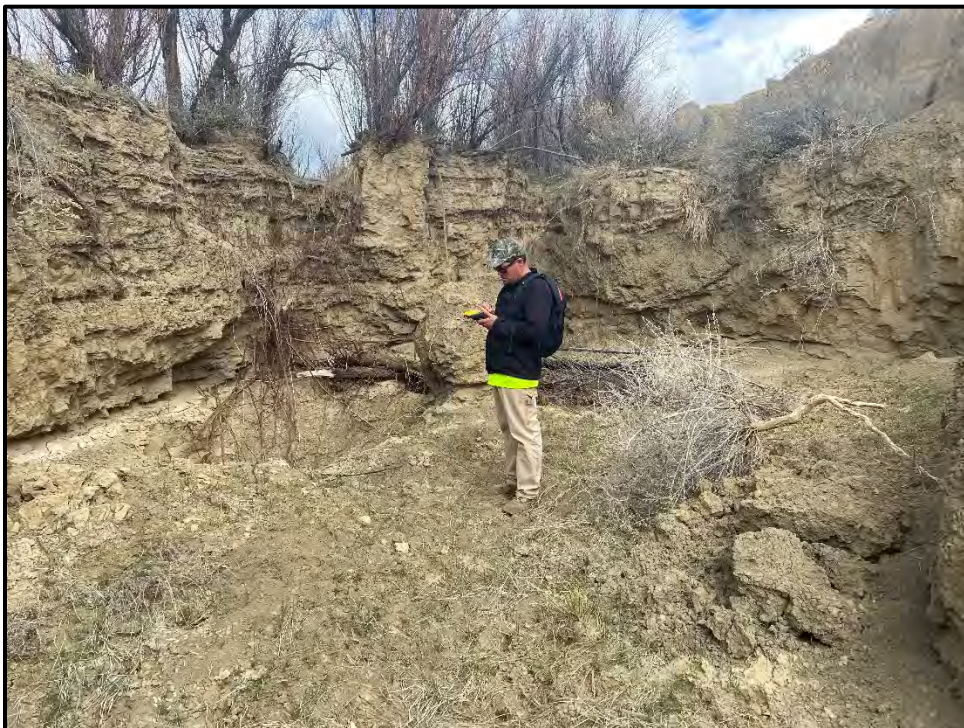
During fieldwork conducted by SWCA on March 20, 23, and 24, 2020, no evidence of recent flow along the East Tributary was observed, nor were any indicators of seasonal flows present. Photographs B-11 and B-12 in Appendix B of the SWCA’s report depict typical conditions along the channel and demonstrate the lack of a riparian corridor, marginal channel morphology, and presence of upland vegetation within the mapped ordinary high water mark (OHWM); and no adjacent wetlands are present.

Photograph B-11. East Tributary near confluence with Meyer Draw.

Photograph B-12. Head-cut area at top of the East Tributary.

In addition to SWCA's field assessment, the APT was run for the following additional dates in conjunction with reviewing satellite imagery of the review area: January 20, 2013 and December 10, 2004 (see document 2020-169 ATP Batch Result East Tributary.pdf, St. Anthony - East Tributary - Satellite image 2013-01-20.PNG and St. Anthony - East Tributary - Satellite image 2004-12-10.PNG). The date of January 20, 2013 was selected because it is in the wet season with satellite imagery available. The date of December 10, 2004 was selected because it is in the wet season with satellite imagery available and the APT was listed as "Normal Conditions". Additionally, within the previous 30 days there were 5 precipitation events, including one event with over 1 inch of recorded precipitation. No surface water or indication of recent flows were observed in the stream channel for these dates. As such, and in consideration of the other information provided above, it has been determined that this stream channel only experiences flows in response to rain events and, therefore, is ephemeral.

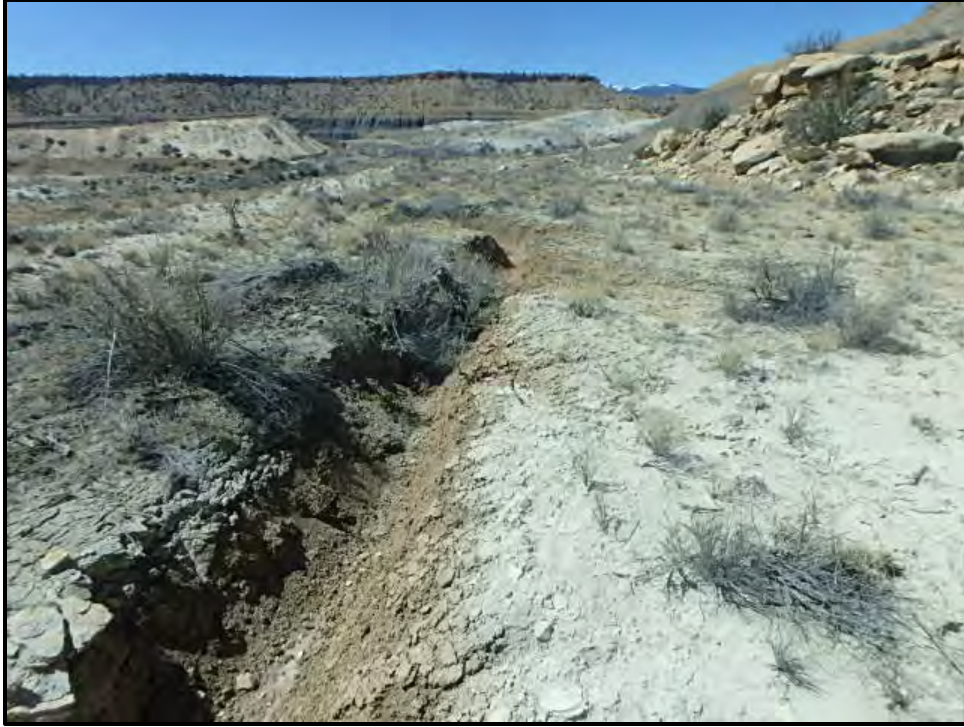
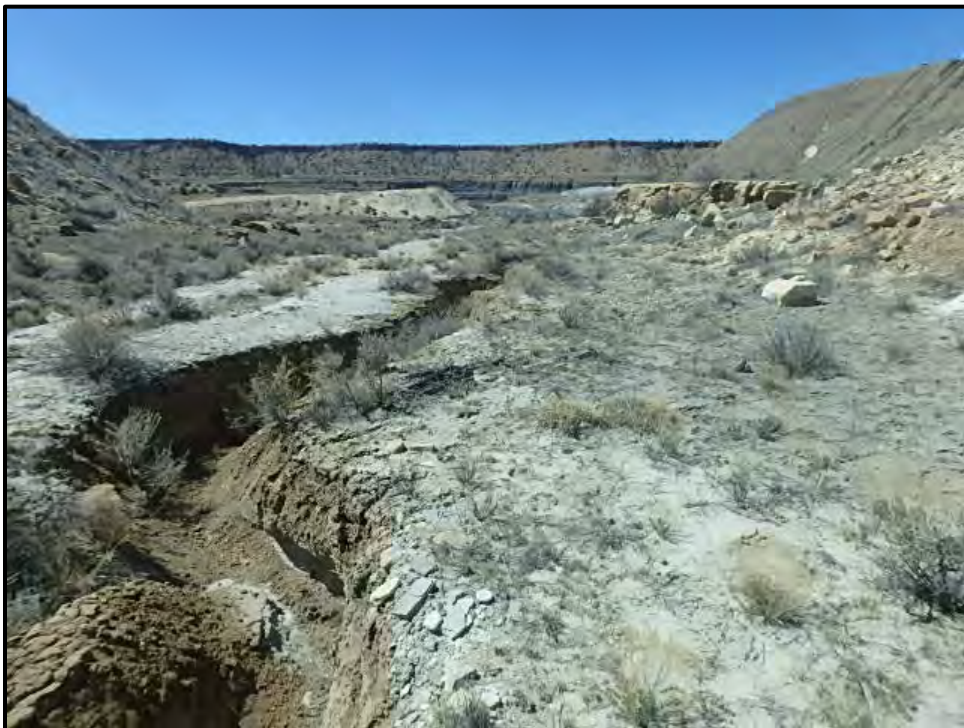
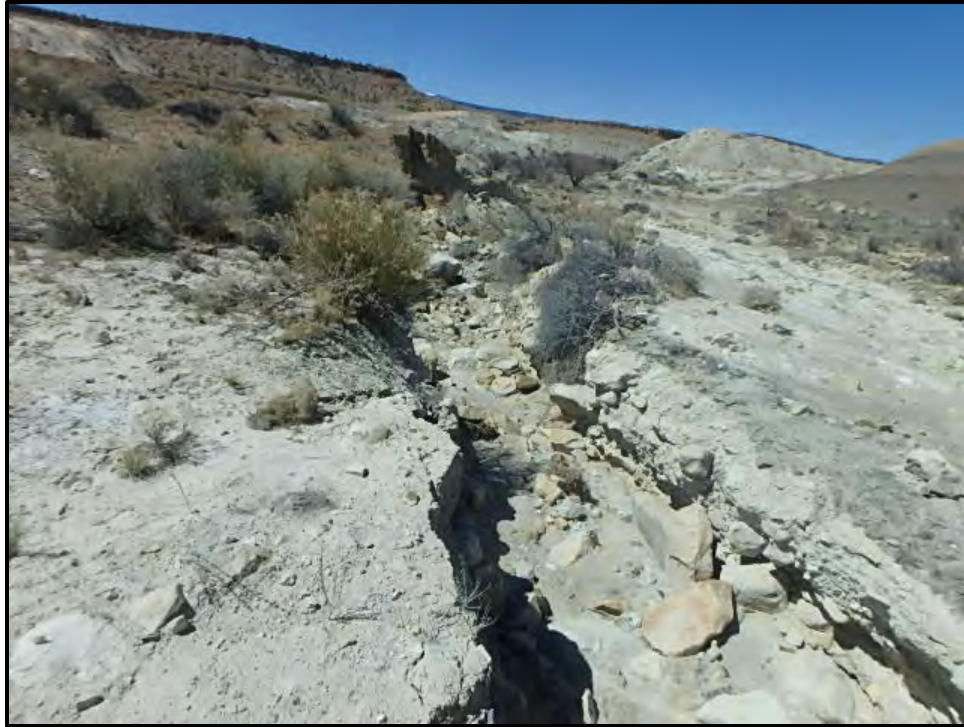
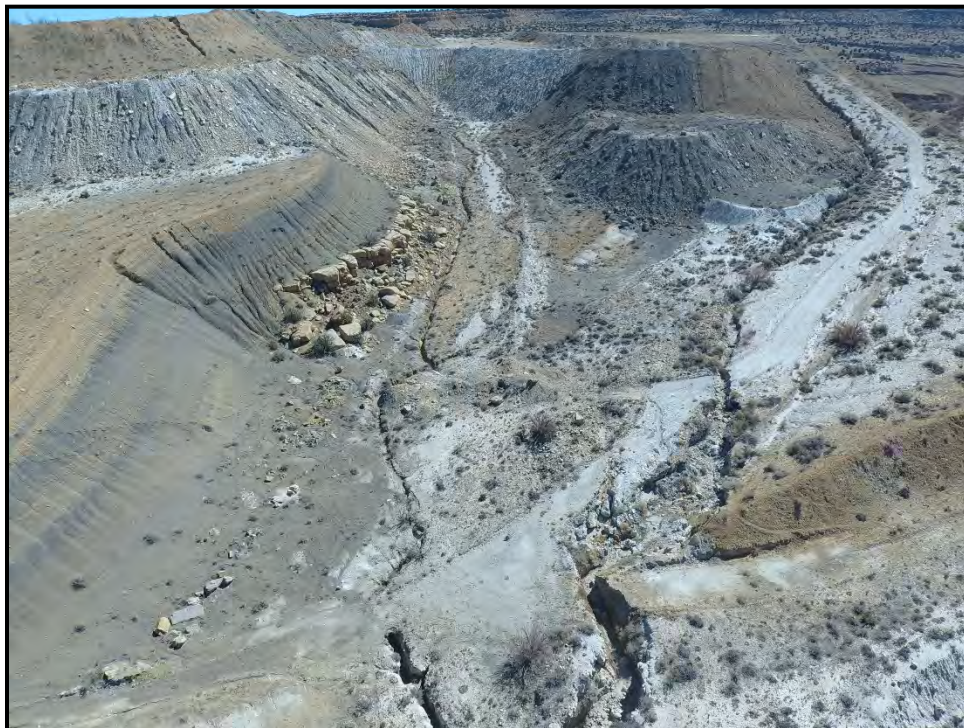
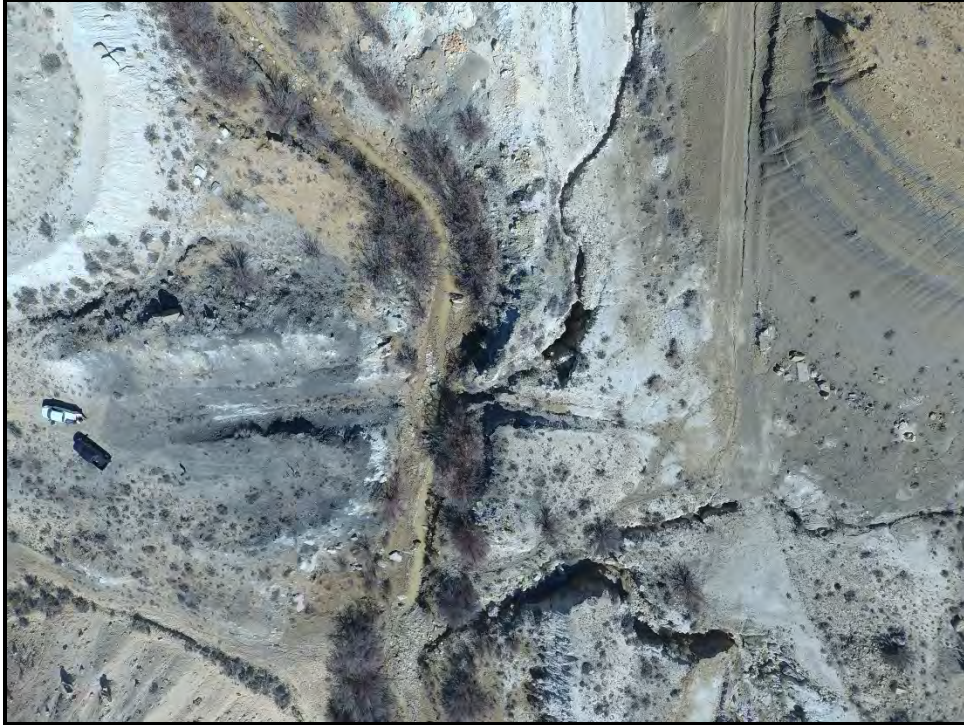
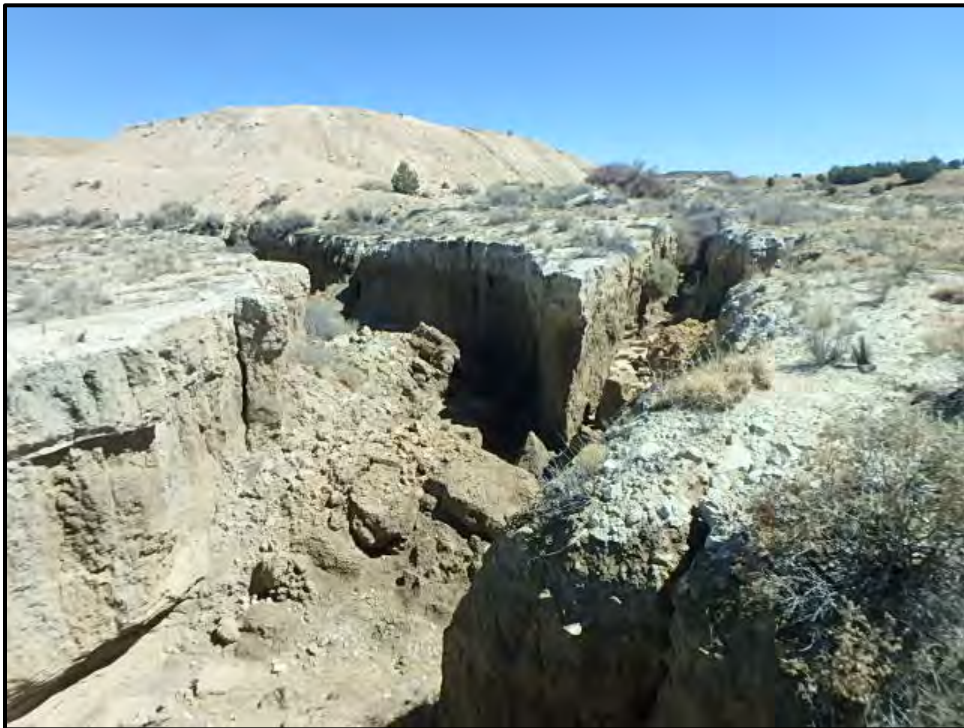
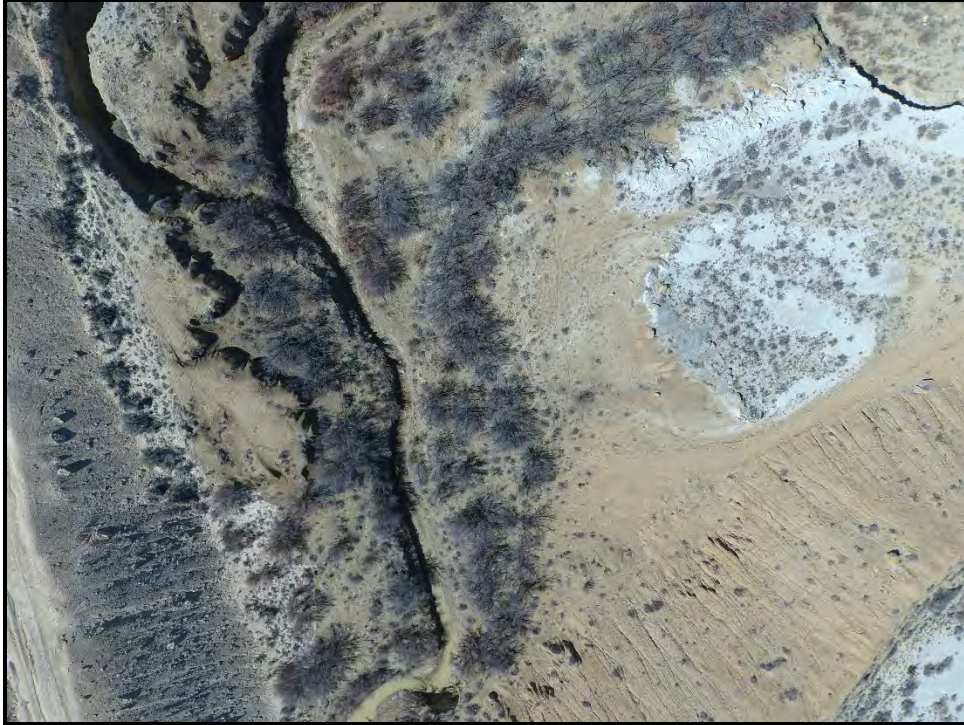
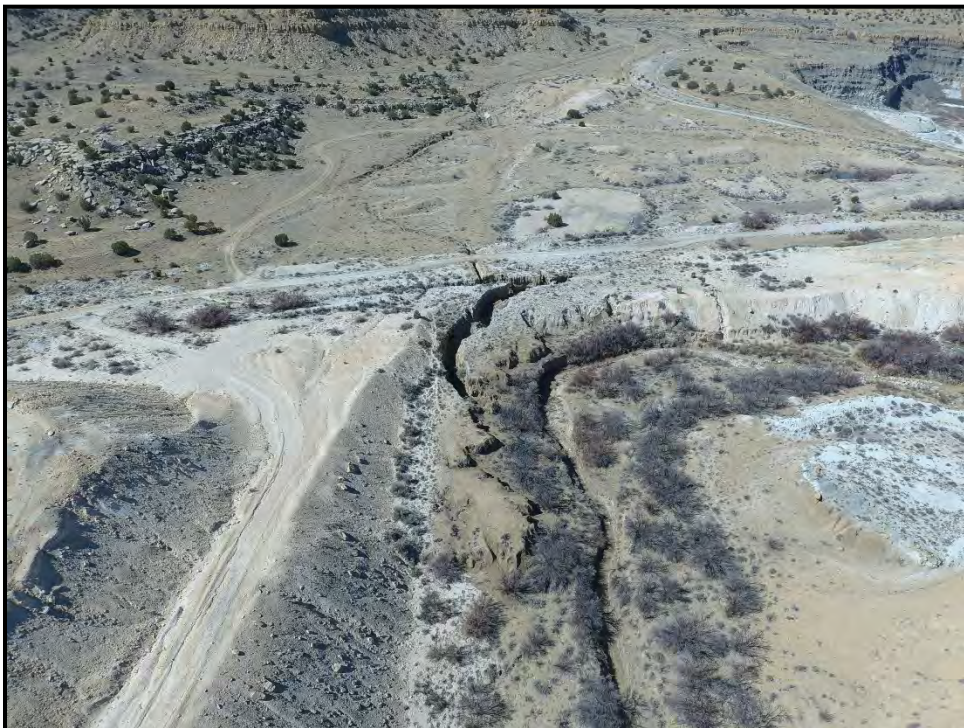
According to the Aquatic Resources Delineation Report, Drainages A through E were formed from stormwater flows down steep mine slopes with highly erodible soils. Upon examining the photographs in the report, these features do not exhibit a bed and bank and, therefore, are not waters of the U.S (WOTUS).

Photograph B-15. Drainage B, facing northwest.

Photograph B-16. Drainage C, facing northwest.

Photograph B-17. Drainage D, facing north.

Photograph B-18. Overview of Drainages B, C, and D, facing southeast.

Photograph B-19. Drainages A, B, C, and D at their outfalls to Meyer Draw from the east.

Photograph B-20. Drainage E, facing south.

Photograph B-21. Drainage E at the outfall to Meyer Draw.

Photograph B-22. Overview of Drainage E, facing west-northwest.
