### I. ADMINISTRATIVE INFORMATION

ORM Number: SPA2020-212

Review Area Location<sup>1</sup>: State/Territory: New Mexico City: Rio Rancho County/Parish/Borough: Sandoval

## Venada Location 4 map

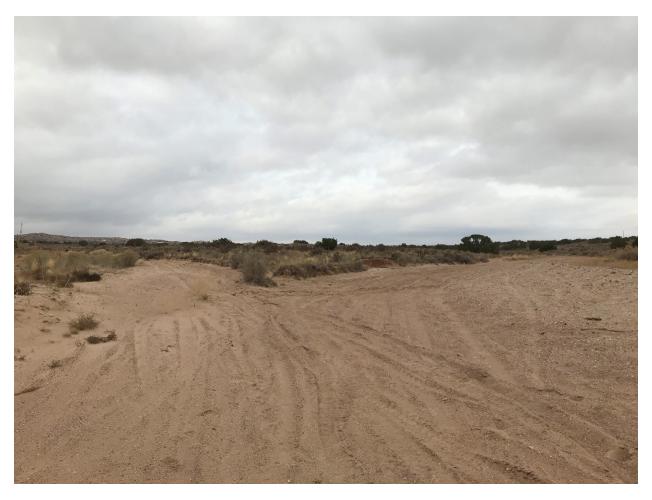
Venada Arroyo Location 4 site visit 11-24-2020

South East corner of project location looking north at the confluence of the North and West branches of the Venada Arroyo

A field assessment of the review area was conducted on July 24, 2020, which was the day after a 0.25 inch rainfall in the area. However, no surface water was observed in the stream channel. Additionally, the banks and bed of the stream channel are mostly devoid of any vegetation, nor is there a riparian corridor present. The vegetation observed is typical high desert plant community. A second site visit was conducted on November 23, 2020 and no flow or indications of recent hydrology was observed (see attached photos).

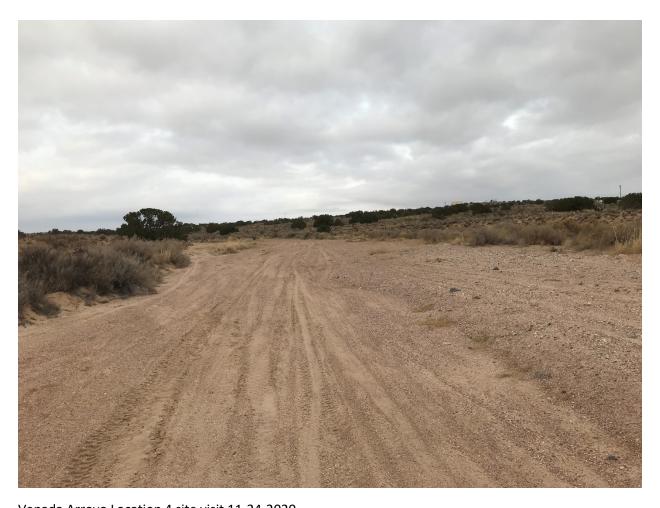
Venada Arroyo Location 4 site visit 11-24-2020

South East corner of project location looking north at the North branch of the Venada Arroyo

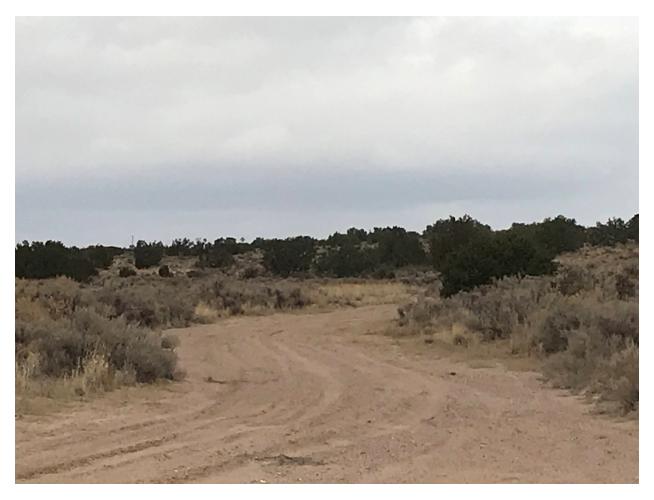
Venada Arroyo Location 4 site visit 11-24-2020

Approximately halfway upstream of the North branch of the Venada location looking north in the North branch of the Venada Arroyo

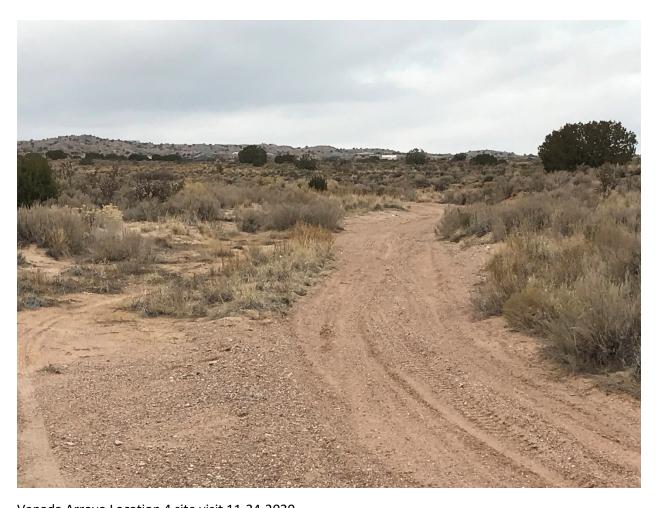
Venada Arroyo Location 4 site visit 11-24-2020

South East corner of project location looking north at the West branches of the Venada Arroyo
