**U.S. ARMY CORPS OF ENGINEERS
REGULATORY PROGRAM
APPROVED JURISDICTIONAL DETERMINATION FORM (INTERIM)
NAVIGABLE WATERS PROTECTION RULE**

ORM Number: SPA2020-214

Review Area Location¹: State/Territory: New Mexico City: Rio Rancho County/Parish/Borough: Sandoval

Excluded waters ((b)(1) – (b)(12)): ⁴			
Exclusion Name	Exclusion Size	Exclusion ⁵	Rationale for Exclusion Determination
Venada Arroyo Location 3	6300 linear feet	(b)(3) Ephemeral feature, including an ephemeral stream, swale, gully, rill, or pool.	See Section III. C below for information supporting the exclusion determination.

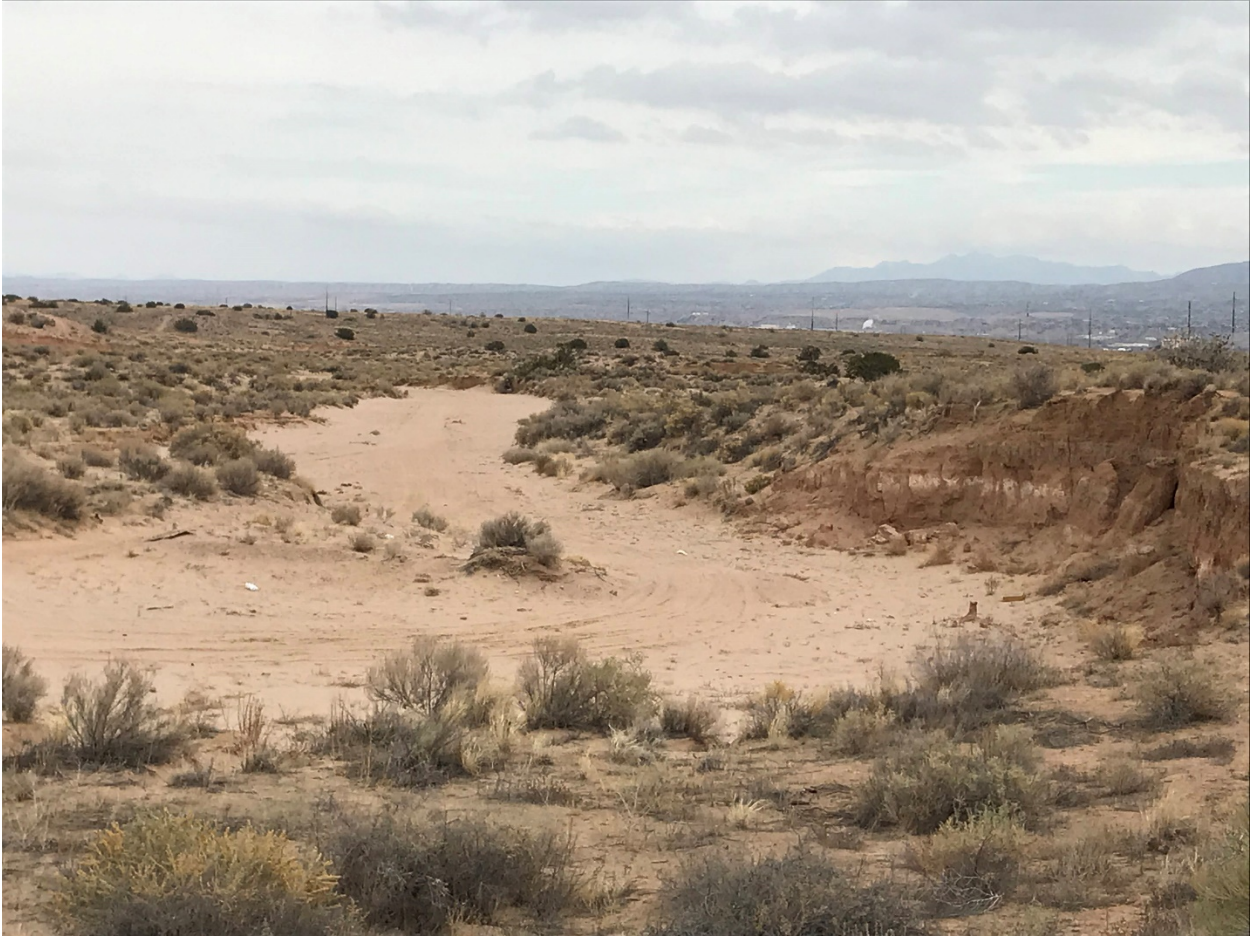
Venada Arroyo Location 3 site visit 11-24-2020

A field assessment of the review area was conducted on July 24, 2020, which was the day after a 0.25 inch rainfall in the area. However, no surface water was observed in the stream channel. Additionally, the banks and bed of the stream channel are mostly devoid of any vegetation, nor is there a riparian corridor present. The vegetation observed is typical high desert plant community. A second site visit was conducted on November 23, 2020 and no flow or indications of recent hydrology was observed (see attached photos).

West end of the project site looking East.

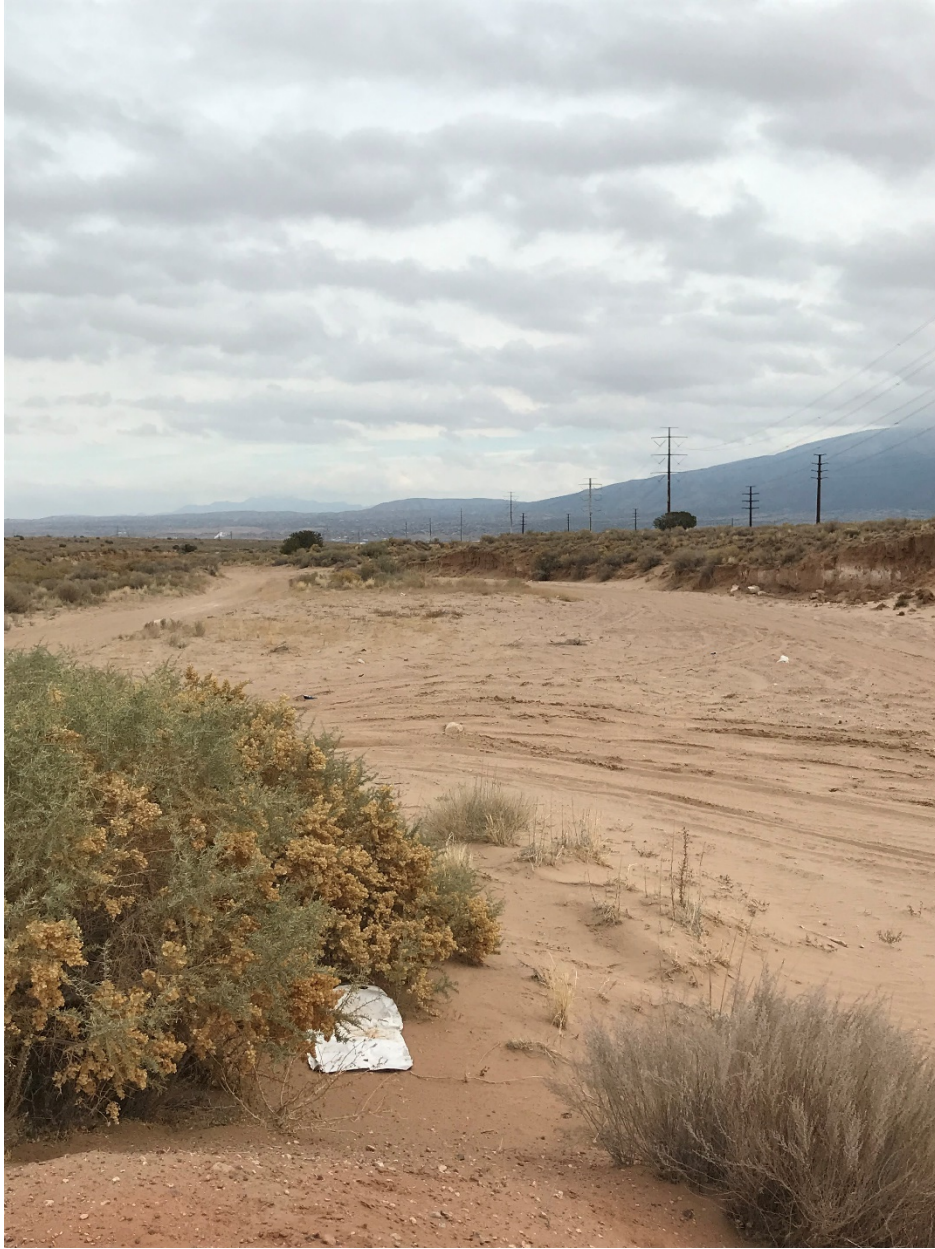
Venada Arroyo Location 3 site visit 11-24-2020

Approximately midpoint of the project site looking East. Arroyo is in the left part of the photo the sandy area in the foreground is a result of OHV.

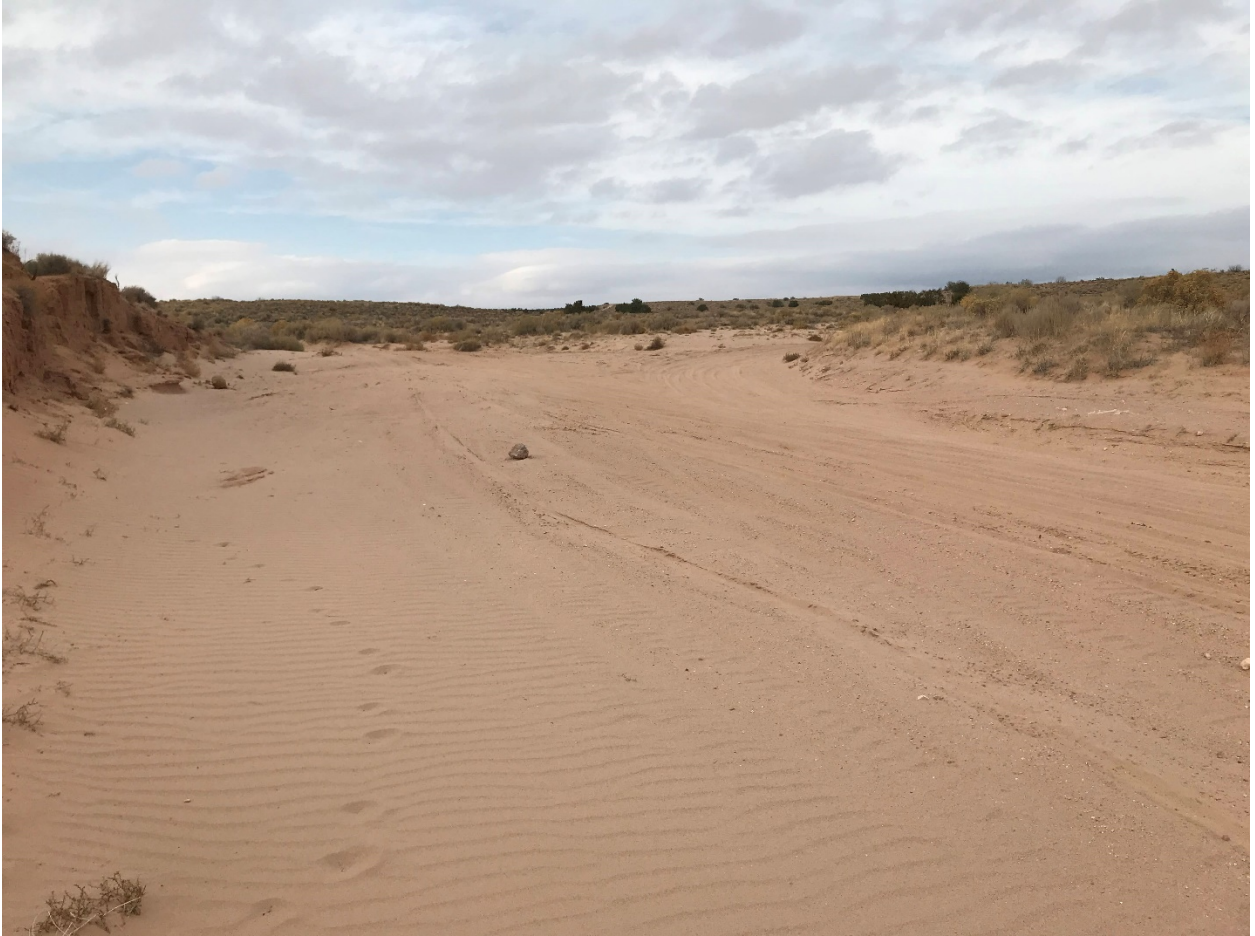
Venada Arroyo Location 3 site visit 11-24-2020

East end of project site looking west.
