# FOUNTAIN CREEK MITIGATION BANK PROSPECTUS

Prepared By: **SCP CONSERVATION, LLC**

June 17<sup>th</sup>, 2018

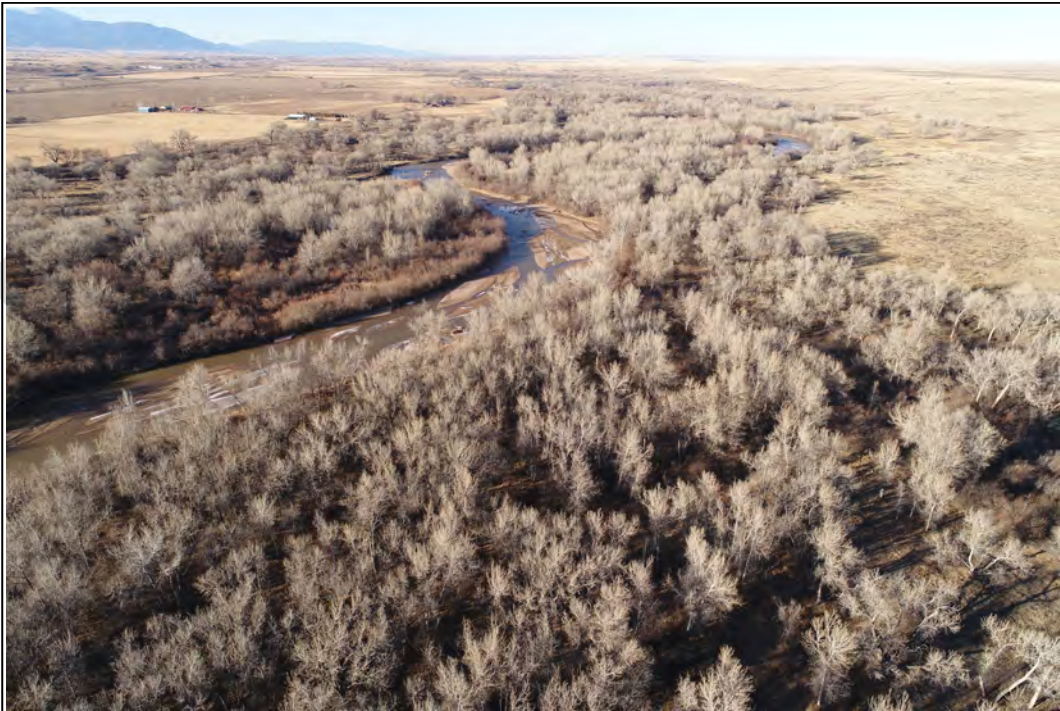
**Photo A-2:** Aerial view of the grazed pasture located along the eastern edge of the Bank

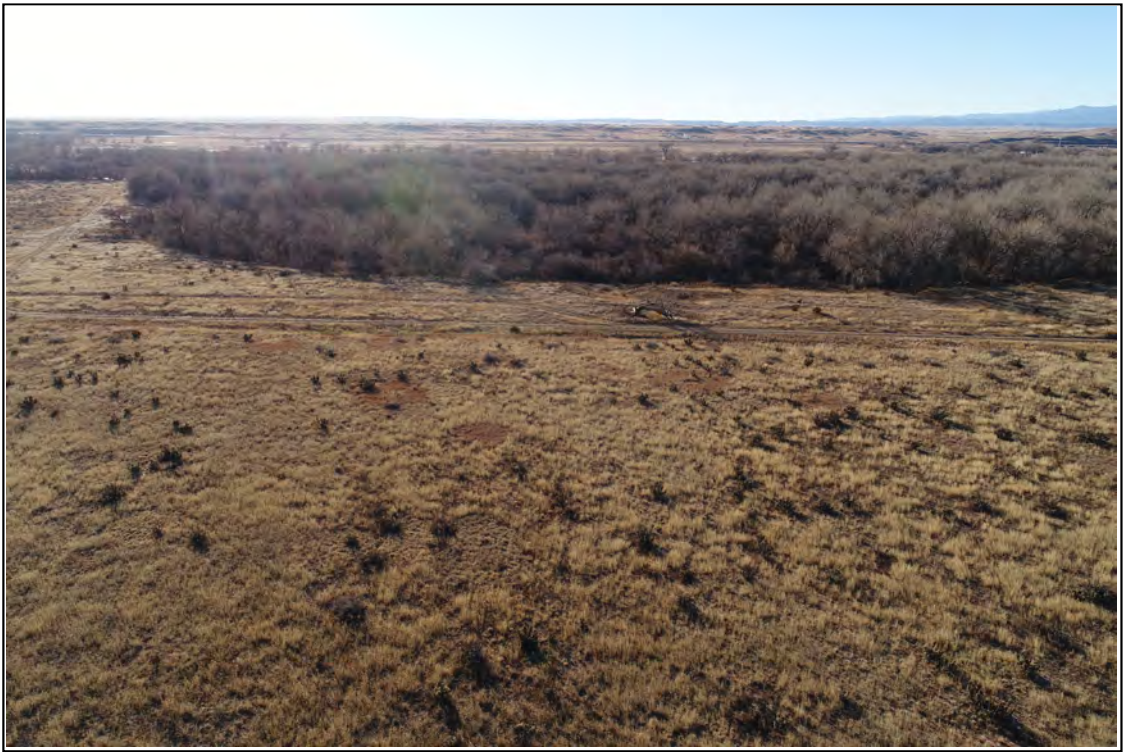
**Photo A-3:** Aerial view of the grazed pasture located along the eastern edge of the Bank

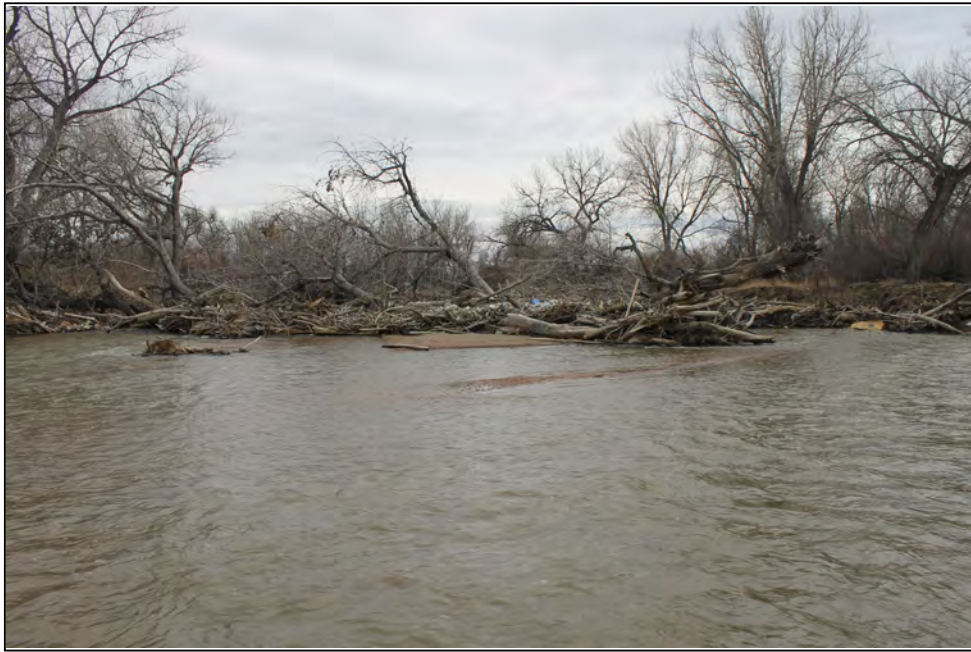
**Photo A-5:** Log debris and trash in the middle of Fountain Creek at the southern boundary of the Bank.

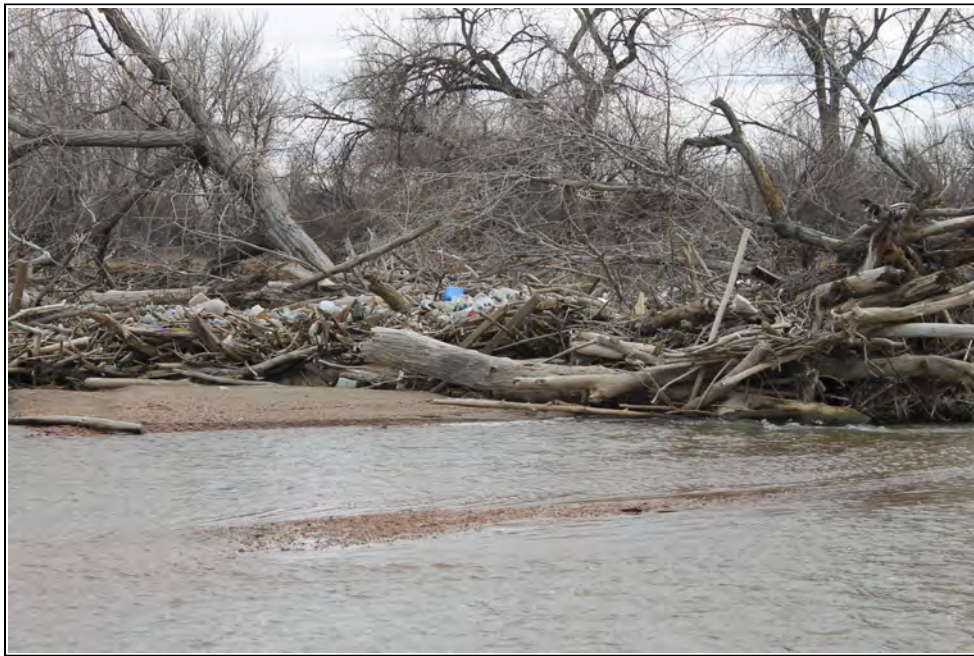
**Photo A-6:** Exposed trash within the debris dam in Fountain creek

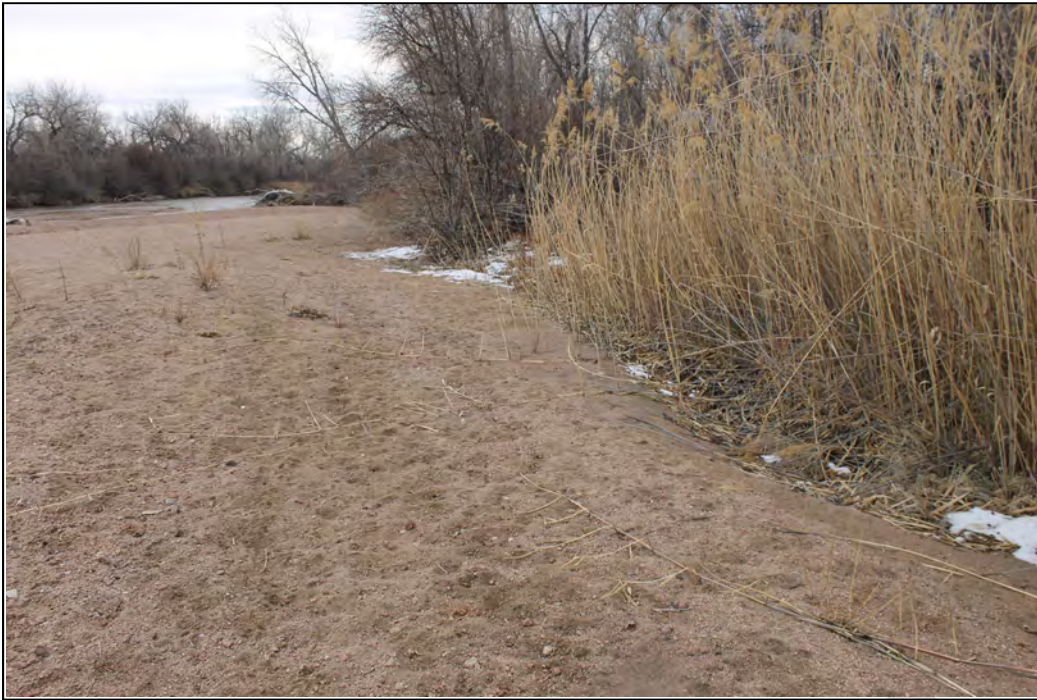
**Photo A-7:** Invasive *Phragmites australis* along the right descending bank of Fountain Creek

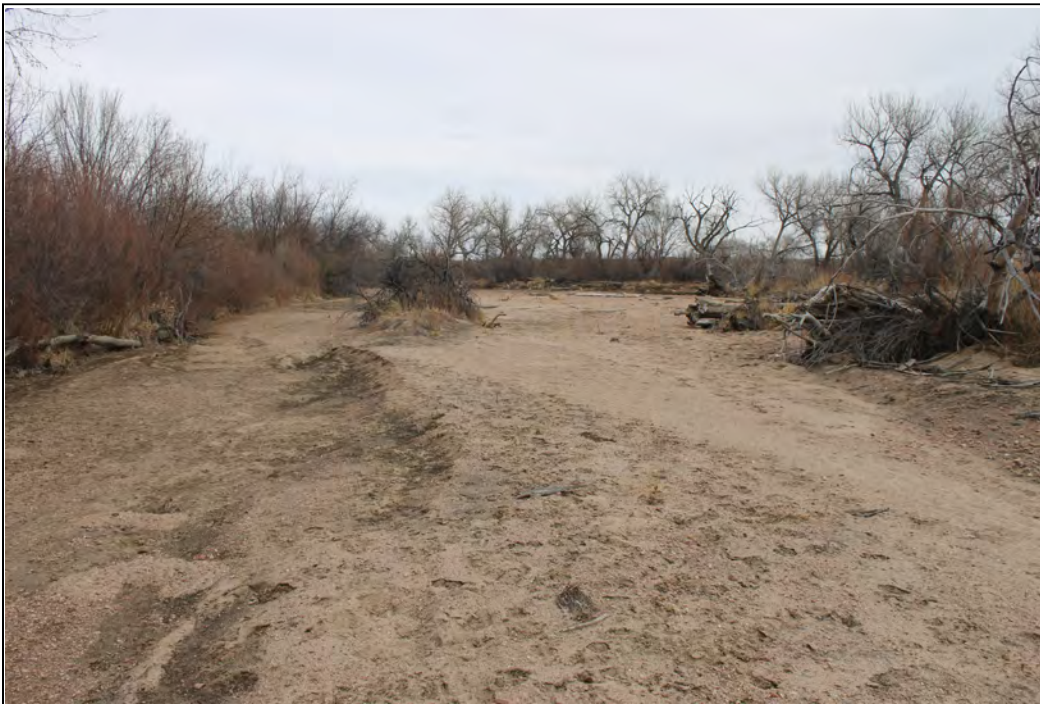
**Photo A-8:** Relic channel bed located in the western floodplain

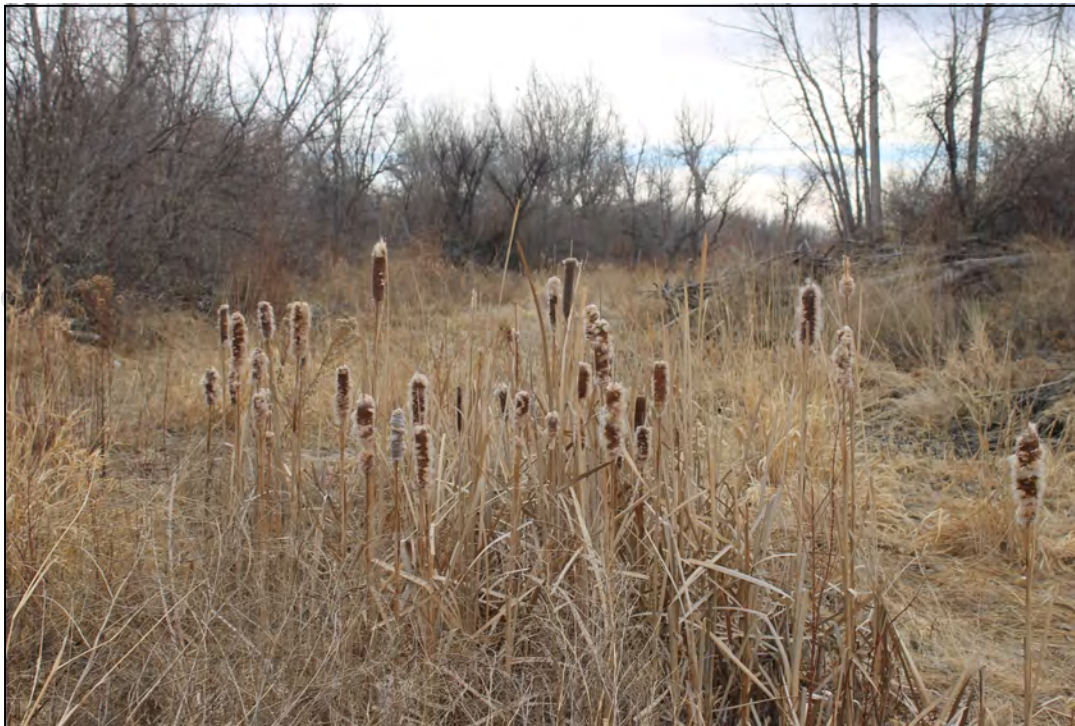
**Photo A-14:** Cattails in the western floodplain of the Bank
