Prospectus for Judge Orr Mitigation Bank

**December 2021
Revised May 2022
Revised July 2022
Revised September 2022**

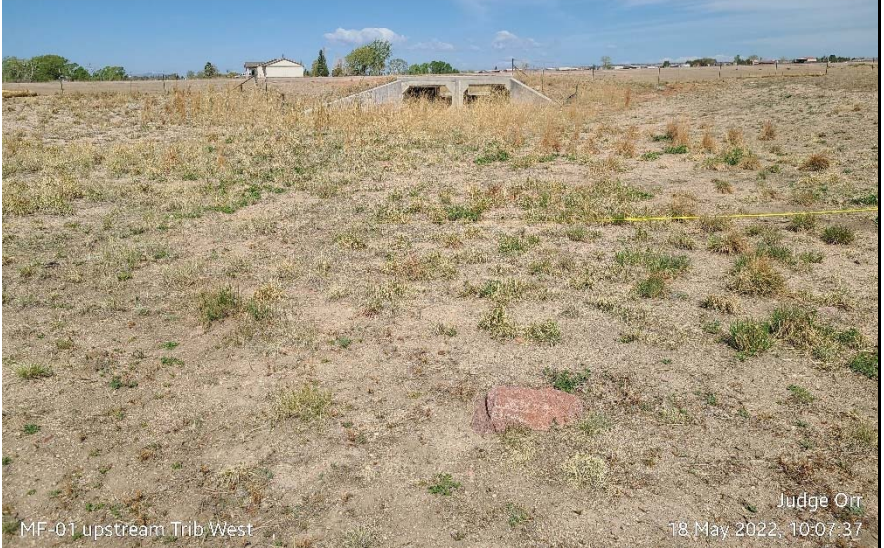
Project Name: Judge Orr Mitigation Bank		Location: El Paso County, Colorado	Project Reference: Prospectus
Photo ID Number: Photo 1. PL22-MF01-1	Date: 05/18/22	<div> <div> W 240 270 300 330 N 0 30 NE </div> <div> 321°NW (T) • 38.95553, -104.552131 ±5 m ▲ 2055 m </div> </div>

<div> MF-01 upstream Trib West </div> <div> Judge Orr 18 May 2022, 10:07:37 </div>	
Site ID: Pete Lien, Judge Orr Site			
Description: Photo collected at MF-01 showing the upstream characteristics of Tributary-West and the culvert under Stapleton Rd. where the tributary enters the Site property. Foreground (left) shows very limited OHWM and drainage patterns within the larger relief. Tape marks the cross-section collected at WOTUS-01.

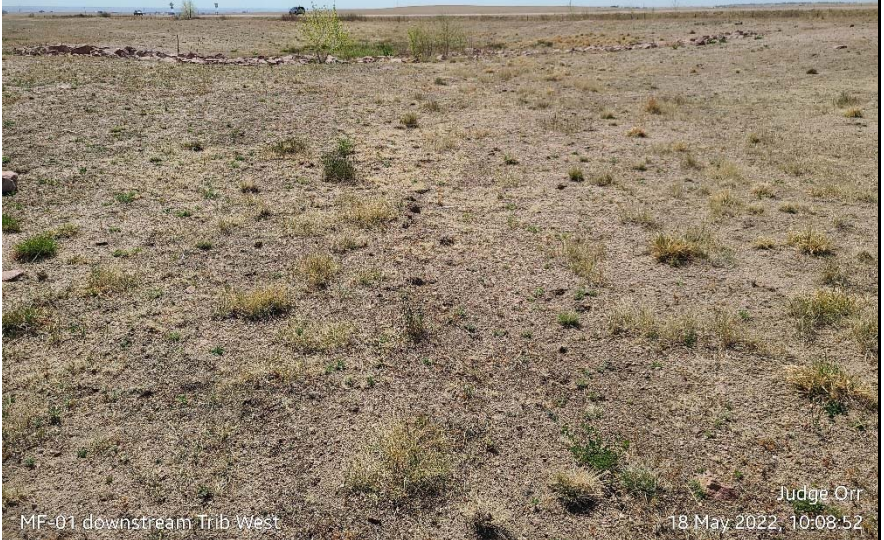
Project Name: Judge Orr Mitigation Bank		Location: El Paso County, Colorado	Project Reference: Prospectus
Photo ID Number: Photo 2. PL22-MF01-2	Date: 05/18/22	<div> <div> NE 60 E 90 SE 120 150 S 180 210 </div> <div> 129°SE (T) • 38.955524, -104.55213 ±3 m ▲ 2050 m </div> </div>

<div> MF-01 downstream Trib West </div> <div> Judge Orr 18 May 2022, 10:08:52 </div>	
Site ID: Pete Lien, Judge Orr Site			
Description: Photo collected at MF-01 showing the downstream characteristics of Tributary-West and the concrete-rock water bar. Foreground (right) shows very limited OHWM and drainage patterns within the larger relief.

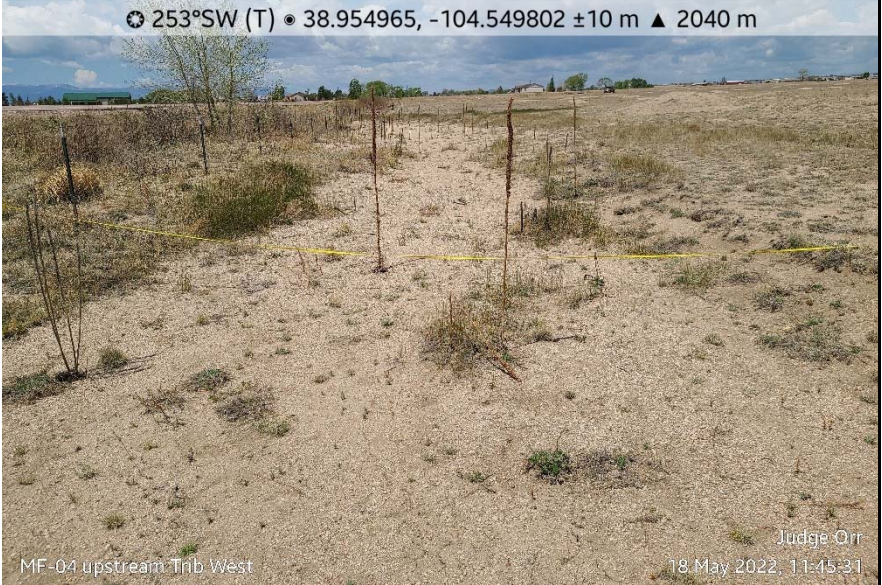
Project Name: Judge Orr Mitigation Bank		Location: El Paso County, Colorado	Project Reference: Prospectus
Photo ID Number: Photo 7. PL22-MF04-1	Date: 05/18/22	<div> <div>S 180 210 SW 240 W 270 NW 300 330</div> <div>253°SW (T) • 38.954965, -104.549802 ±10 m ▲ 2040 m</div> </div>

Site ID: Pete Lien, Judge Orr Site			
Description: Photo collected at MF-04 showing the upstream characteristics of the South Ditch (left) and diversion of Tributary-West (right). Distinct OHWM and drainage patterns present within the larger relief of Tributary-West, separate from the South Ditch. Tape marks the cross-section collected at WOTUS-03.		<div>MF-04 upstream Trib West</div> <div>Judge Orr 18 May 2022, 11:45:31</div>

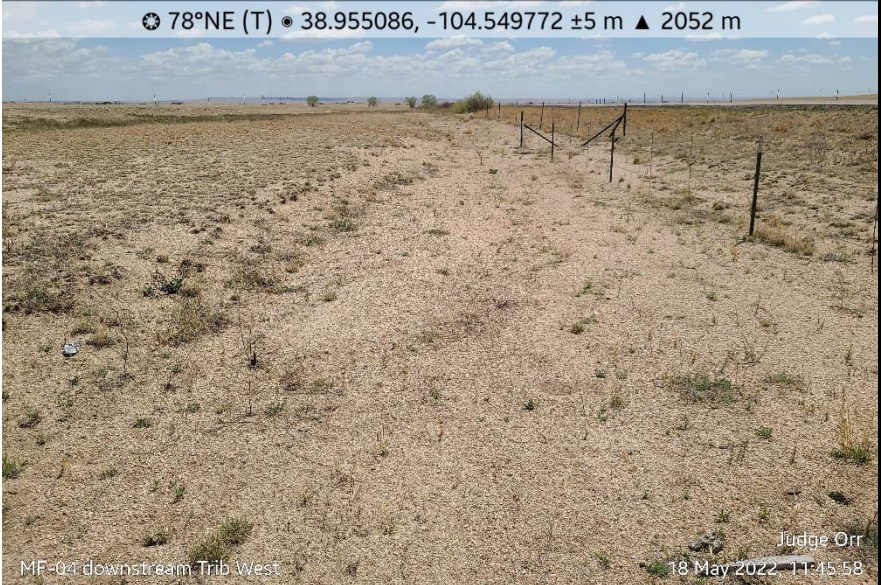
Project Name: Judge Orr Mitigation Bank		Location: El Paso County, Colorado	Project Reference: Prospectus
Photo ID Number: Photo 8. PL22-MF04-2	Date: 05/18/22	<div> <div>N 0 30 NE 60 E 90 SE 120 150</div> <div>78°NE (T) • 38.955086, -104.549772 ±5 m ▲ 2052 m</div> </div>

Site ID: Pete Lien, Judge Orr Site			
Description: Photo collected at MF-04 showing the downstream characteristics of the South Ditch (right) and diversion of Tributary-West (left). Distinct OHWM and drainage patterns present within the larger relief of Tributary-West, occasionally merging with the South Ditch.		<div>MF-04 downstream Trib West</div> <div>Judge Orr 18 May 2022, 11:45:58</div>

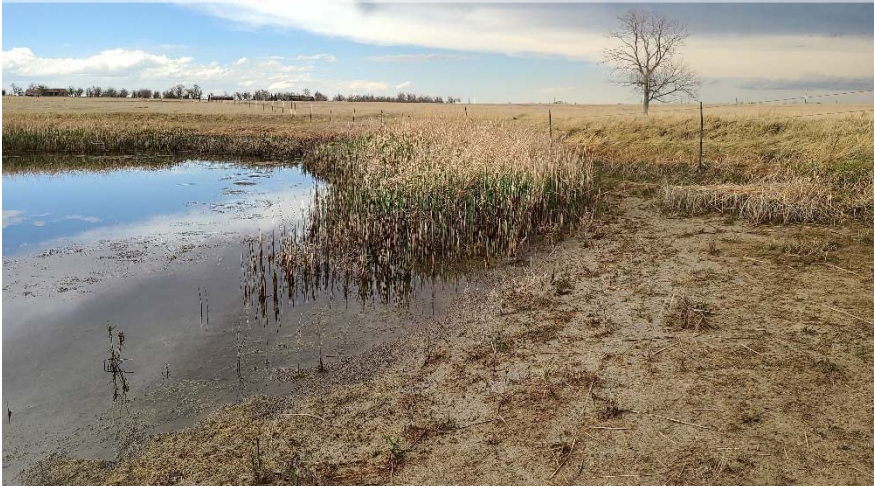
Description: Photo collected at MF-011 showing the characteristics of the pond below OHWM (left) and the Site boundary (fence). Songbirds are pictured along the fence and perched on the cattails.		<div>MF-11 songbirds</div> <div>Judge Orr 18 May 2022, 16:13:42</div>

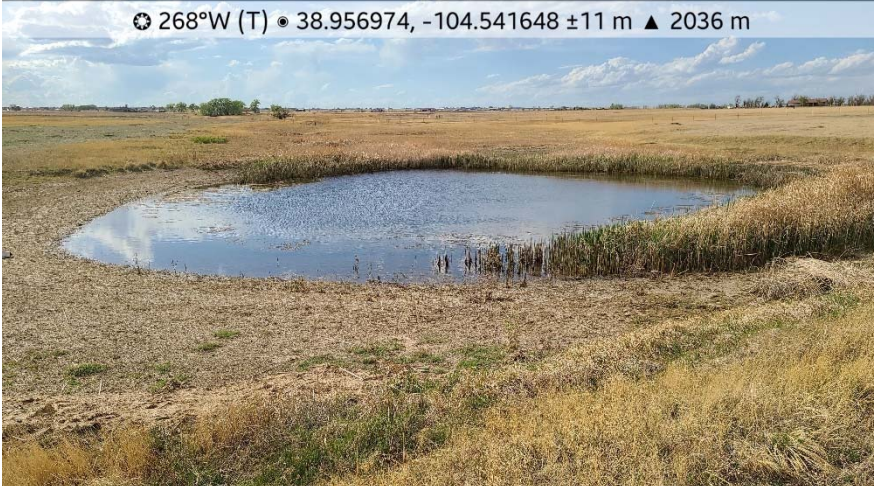
Description: Photo collected at MF-012 showing the characteristics of the pond below OHWM and the inlet of Tributary-East (background, center).		<div>MF-12 Pond</div> <div>Judge Orr 18 May 2022, 17:23:13</div>

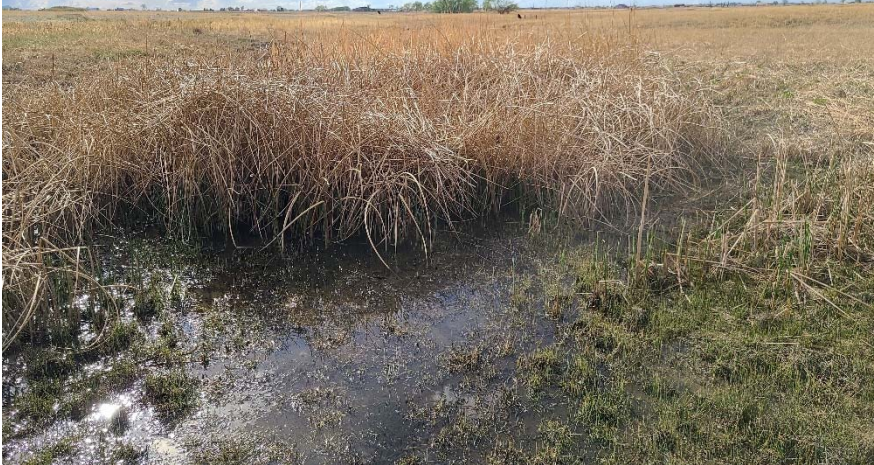
Project Name: Judge Orr Mitigation Bank		Location: El Paso County, Colorado	Project Reference: Prospectus
Photo ID Number: Photo 15. PL22-MF13-1	Date: 05/18/22	<div> <div>SW210240W270300NW330N0</div> <div>280°W (T) • 38.957414, -104.542188 ±5 m ▲ 2024 m</div> </div>

<div> <div>MF-13 upstream Trib East</div> <div>Judge Orr 18 May 2022, 17:28:38</div> </div>	
Site ID: Pete Lien, Judge Orr Site			
Description: Photo collected at MF-13 showing the upstream characteristics of Tributary-East. Distinct OHWM and flowing water present within the larger relief of Tributary-East. The cross-section collected at WOTUS-05 was collected in the foreground (Tape line missing).

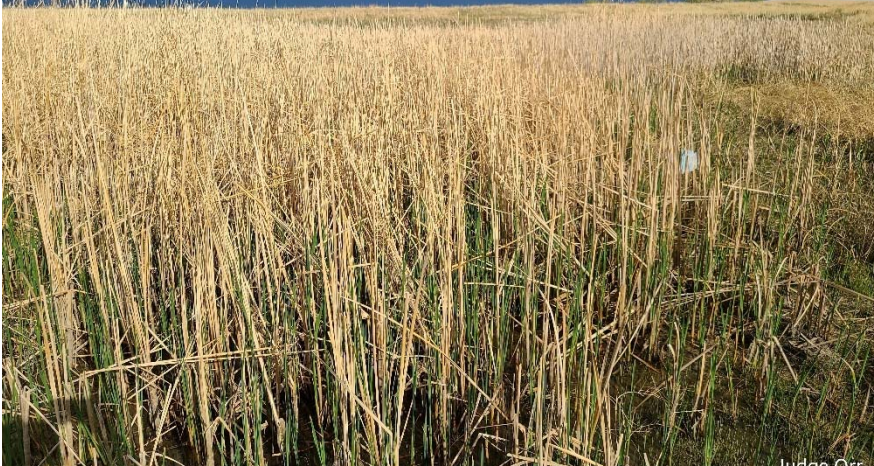
Project Name: Judge Orr Mitigation Bank		Location: El Paso County, Colorado	Project Reference: Prospectus
Photo ID Number: Photo 16. PL22-MF13-2	Date: 05/18/22	<div> <div>NE3060E90120SE150S180</div> <div>117°E (T) • 38.957423, -104.542237 ±4 m ▲ 2027 m</div> </div>

<div> <div>MF-13 downstream Trib East</div> <div>Judge Orr 18 May 2022, 17:29:26</div> </div>	
Site ID: Pete Lien, Judge Orr Site			
Description: Photo collected at MF-13 showing the downstream characteristics of Tributary-East. Distinct OHWM and flowing water present within the larger relief of Tributary-East.

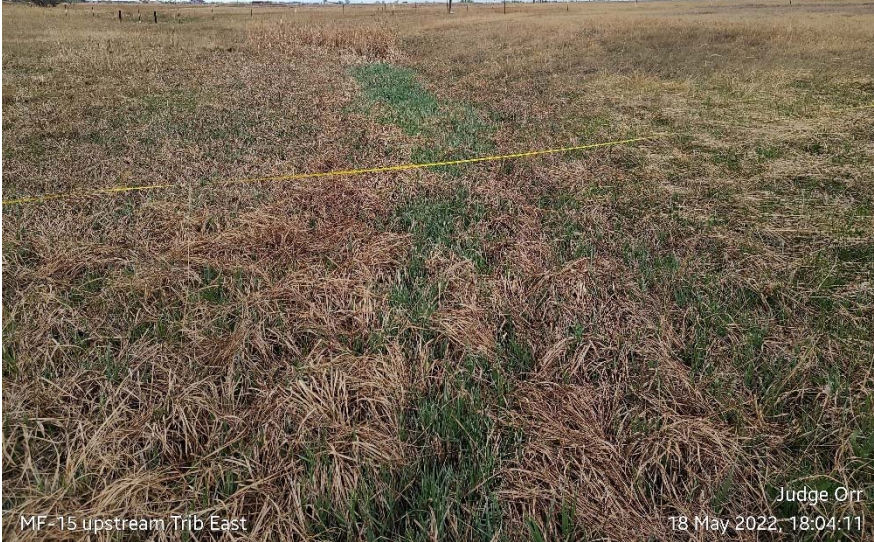
Description: Photo collected at MF-15 showing the upstream characteristics of Tributary-East. Distinct OHWM and flowing water present within the larger relief of Tributary-East. Tape marks the cross-section collected at WOTUS-06.

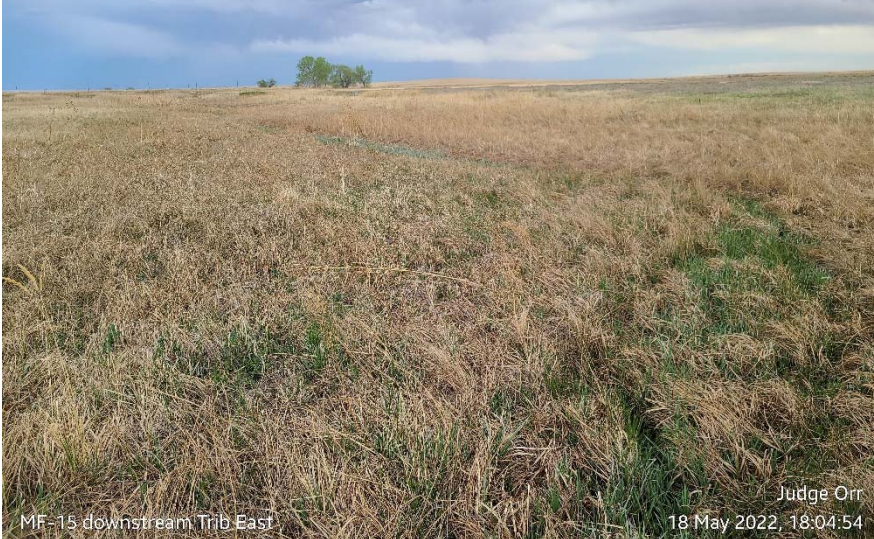
Description: Photo collected at MF-15 showing the downstream characteristics of Tributary-East. Distinct OHWM and flowing water present within the larger relief of Tributary-East.

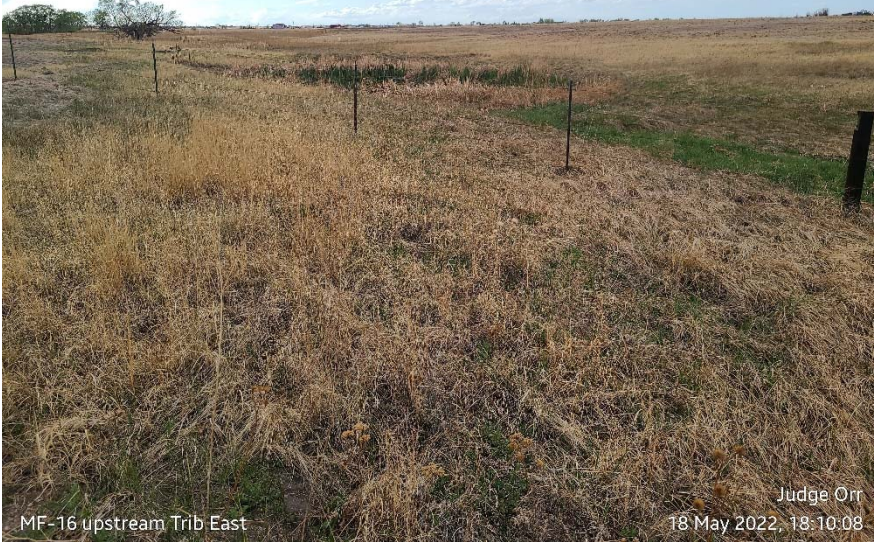
MF-16 upstream Trib East

Description: Photo collected at MF-16 showing the upstream characteristics of Tributary-East. Distinct OHWM and flowing water present within the larger relief of Tributary-East. Shows where Tributary-East enters the site and the continuation of OHWM and associated wetlands continuing upstream of the Site boundary (fence).

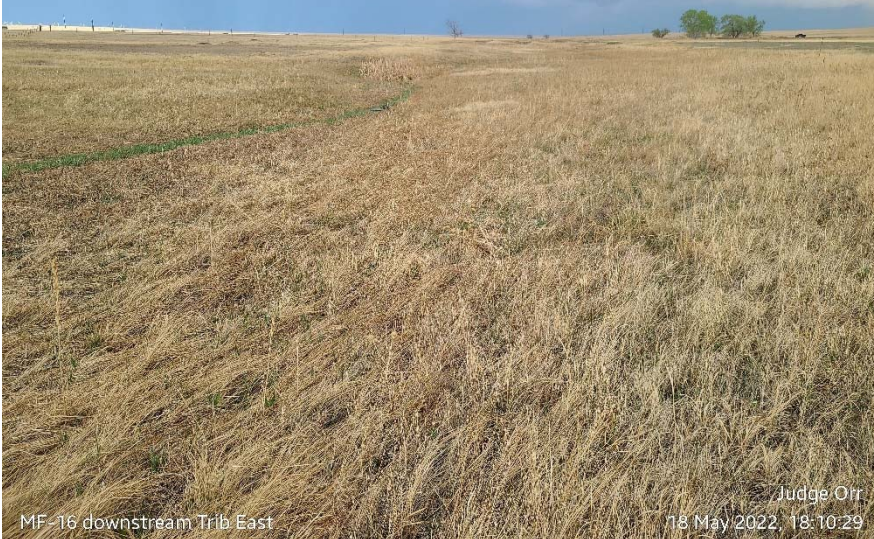
MF-16 downstream Trib East

Description: Photo collected at MF-16 showing the downstream characteristics of Tributary-East. Distinct OHWM and flowing water present within the larger relief of Tributary-East.

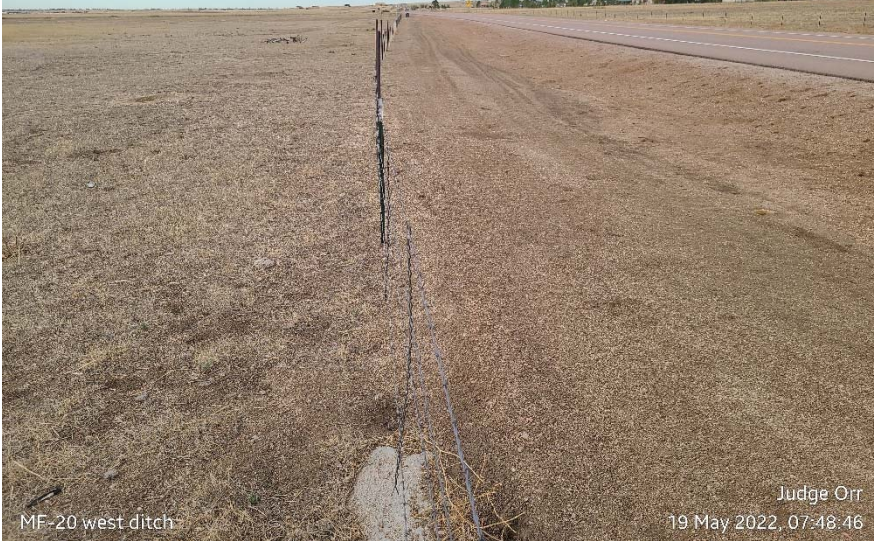
Description: Photo collected at MF-20 showing the West Ditch parallel to the Stie boundary (fence) and Stapleton Rd. (right). No definitive OHWM within the larger relief. Evidence of disturbance present, fresh earth work and lack of vegetation is notable within the ditch.

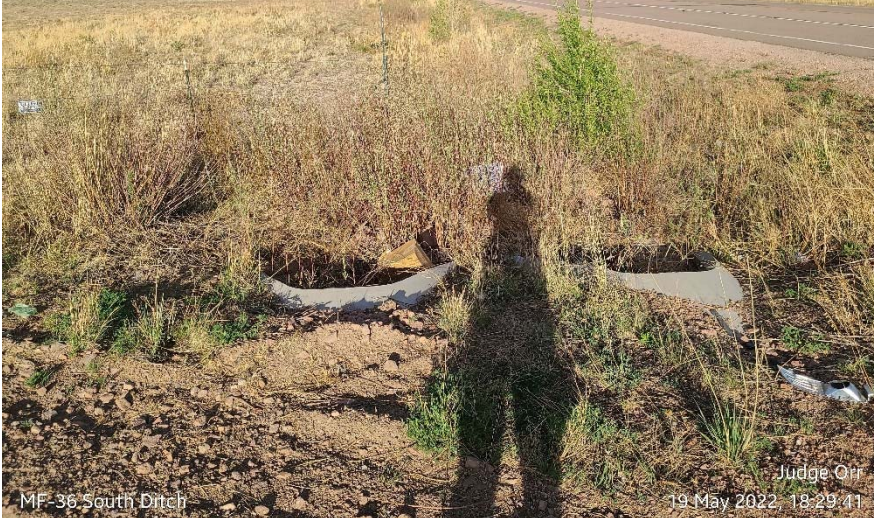
Description: Photo collected at MF-36 showing the South Ditch parallel to the Stie boundary (fence) and Judge Orr Rd. (right). Notable change in vegetation cover and species present between the Site and the ditch.

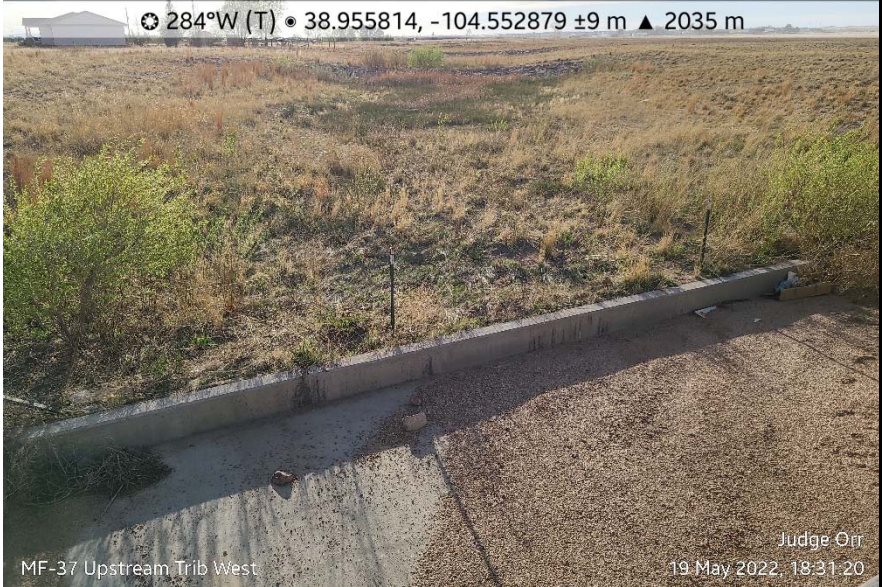
Site ID: Pete Lien, Judge Orr Site			
Description: Photo collected at MF-37 showing the upstream characteristics of Tributary-West (off-site). Distinct drainage patterns and change in vegetation species present within the larger relief of Tributary-East. Shows patches of hydrophytic vegetation in channel upstream of the Site.			
		<div>MF-37 Upstream Trib West</div> <div>Judge Orr 19 May 2022, 18:31:20</div>

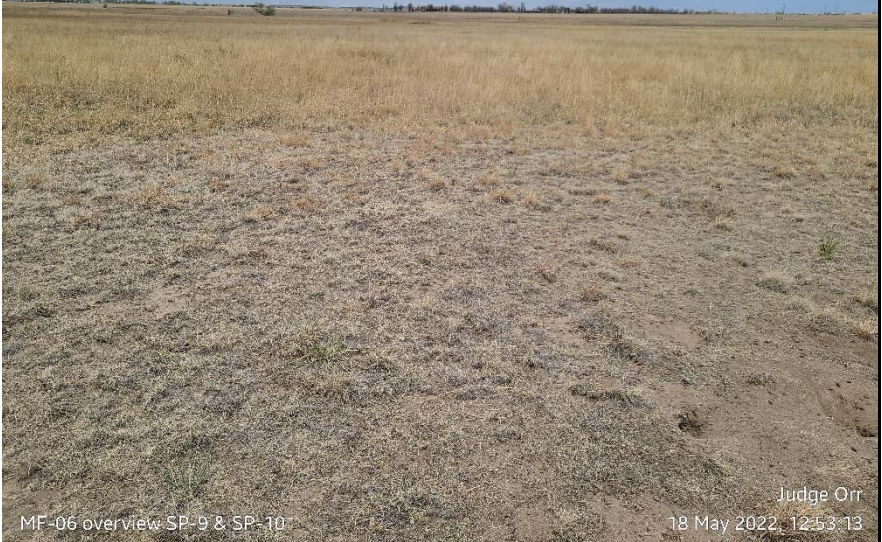
<div> <div>MF-06 overview SP-9 & SP-10</div> <div>Judge Orr 18 May 2022, 12:53:13</div> </div>	
Site ID: Pete Lien, Judge Orr Site			
Description: Photo collected at MF-06 showing an overview of habitats associated with SP-9 (WL-1 background) and SP-10 (upland foreground).

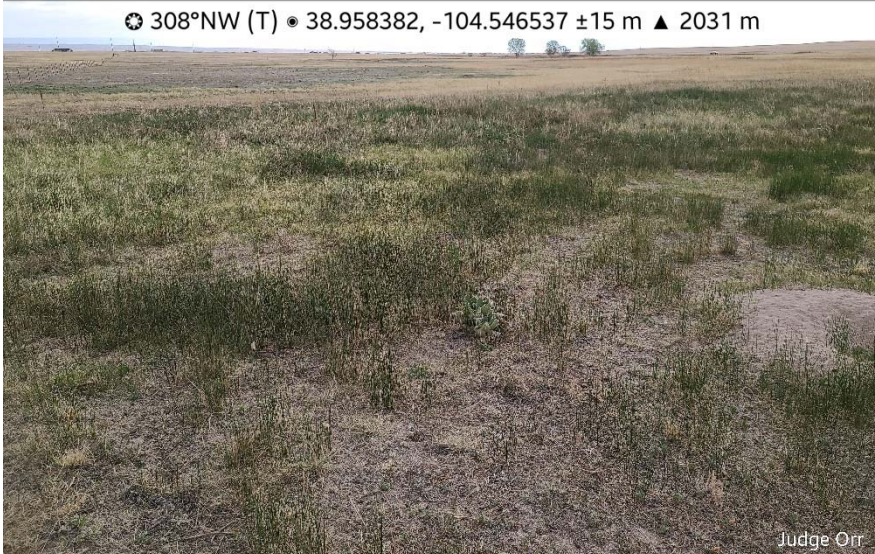
Site ID: Pete Lien, Judge Orr Site			
Description: Photo collected at MF-08 showing an overview of habitats associated with SP-1 (upland foreground) and SP-2 (WL-1 and seepage area midground).		<div>MF-08 Overview SP-1 & SP-2</div> <div>Judge Orr 18 May 2022, 14:14:29</div>

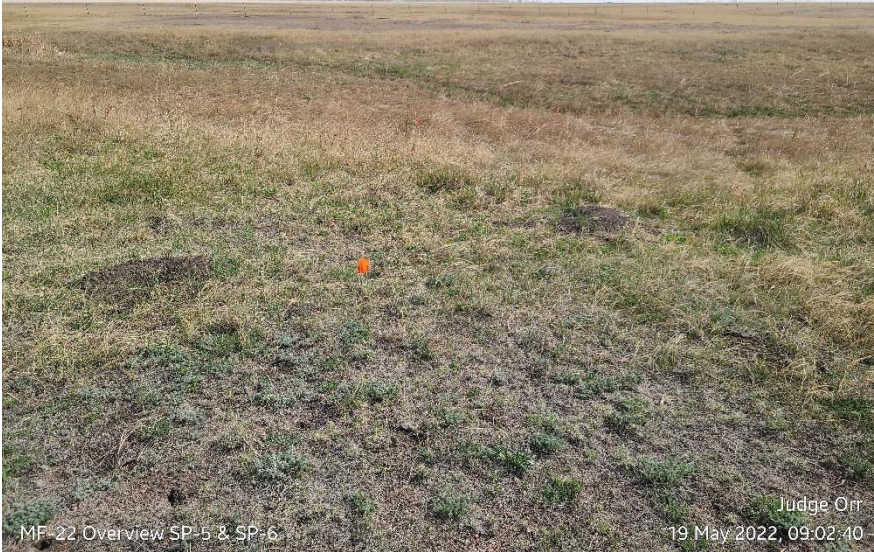
<p style="text-align: right;">Judge Orr</p> <p>MF-22 Overview SP-5 & SP-6 19 May 2022, 09:02:40</p>

Description: Photo collected at MF-22 showing an overview of habitats associated with SP-5 (WL-4 background) and SP-6 (upland foreground). SP locations denoted by orange flags.

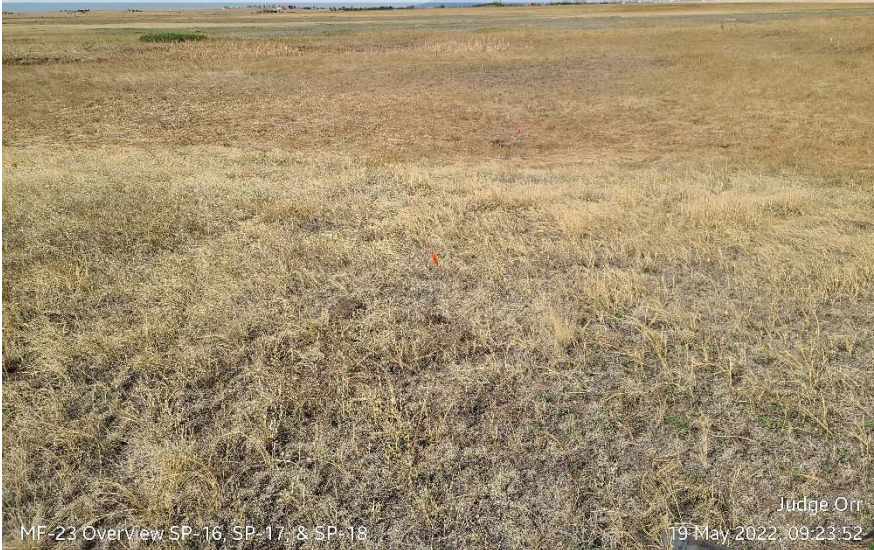
<p style="text-align: right;">Judge Orr</p> <p>MF-23 Overview SP-16, SP-17, & SP-18 19 May 2022, 09:23:52</p>

Description: Photo collected at MF-23 showing an overview of habitats associated with SP-16 (WL-4 background left), SP-17 (WL-4 midground) and SP-18 (upland foreground). SP locations denoted by orange flags.

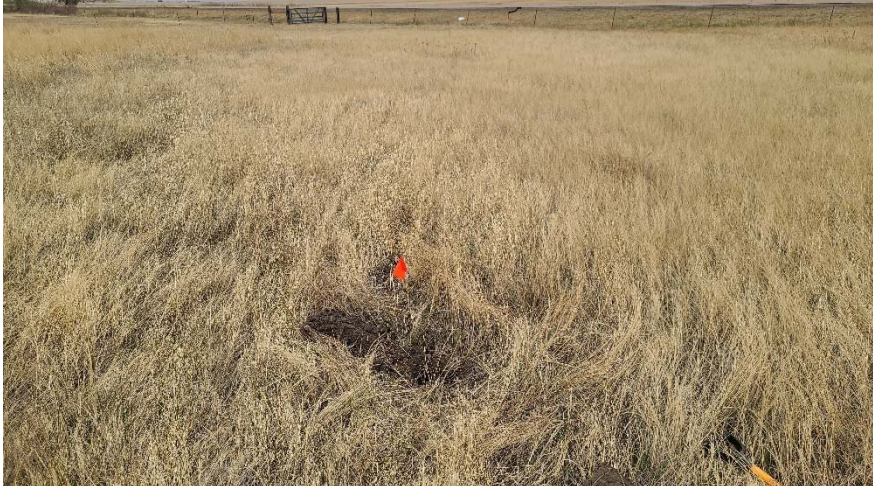
Site ID: Pete Lien, Judge Orr Site			
Description: Photo collected at MF-26 showing an overview of habitats associated with SP-20 (WES-3 foreground) and neighboring WL-1 (background). SP locations denoted by orange flags.			
		<div>MF-26 Overview: SP-20</div> <div>Judge Orr 19 May 2022, 11:07:48</div>

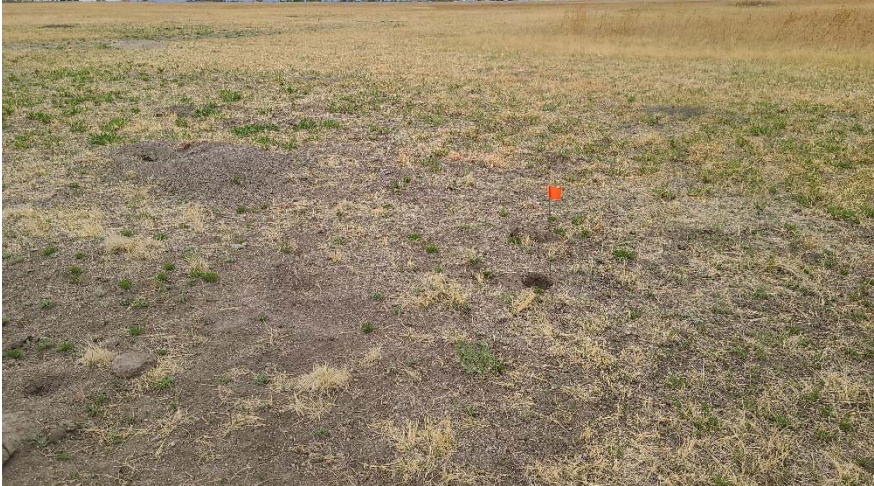
Description: Photo collected at MF-28 showing an overview of habitats associated with SP-14 (WL-1 background right), SP-24 (WES-4 midground right) and SP-25 (upland foreground). SP locations denoted by orange flags.			
		Judge Orr <small>MF-28 Overview SP-14, SP-24, & SP-25</small> <small>19 May 2022, 13:11:56</small>

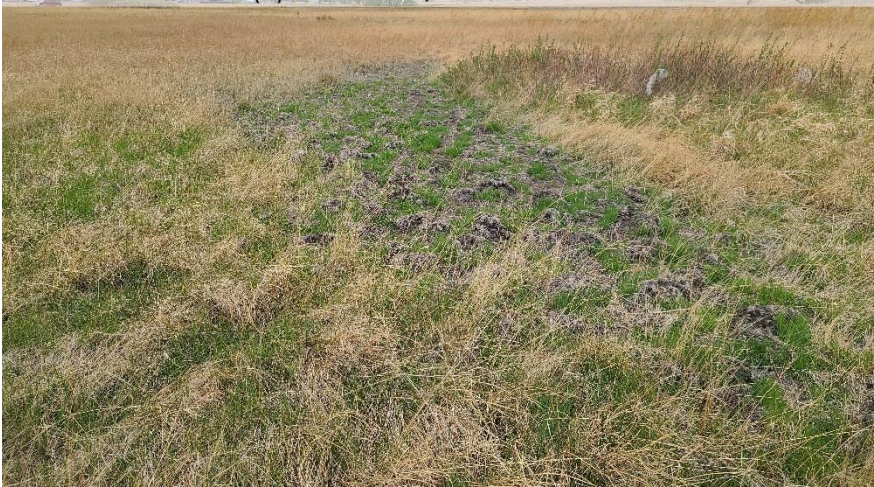
Description: Photo collected at MF-29 showing portion of WL-1 where hoof-shears and tussocks are present.			
		Judge Orr <small>MF-29 Tussock</small> <small>19 May 2022, 13:42:09</small>

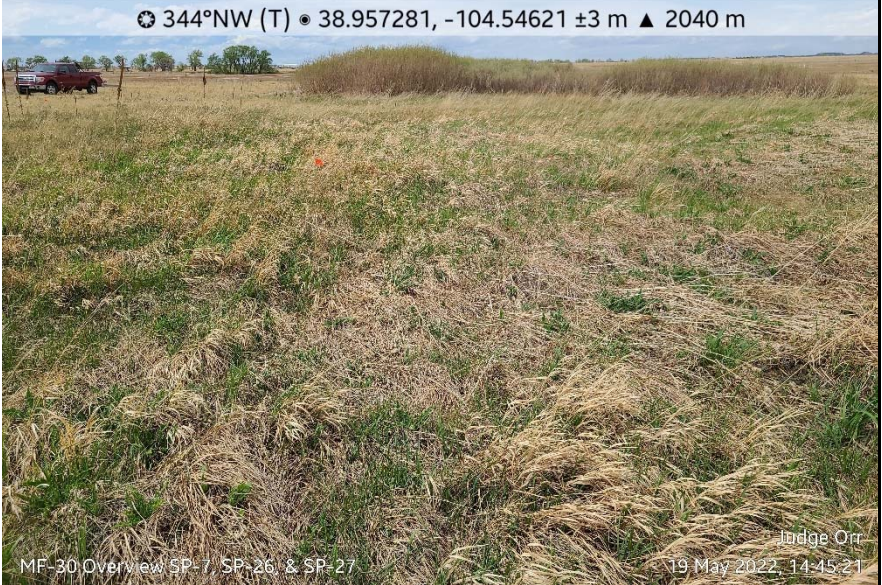
<div> MF-30 Overview SP-7, SP-26 & SP-27 </div> <div> Judge Orr 19 May 2022, 14:45:21 </div>	
Site ID: Pete Lien, Judge Orr Site			
Description: Photo collected at MF-30 showing an overview of habitats associated with SP-7 (WL-1 foreground), SP-26 (WL-2 background willows) and SP-27 (upland background left). SP locations denoted by orange flags.

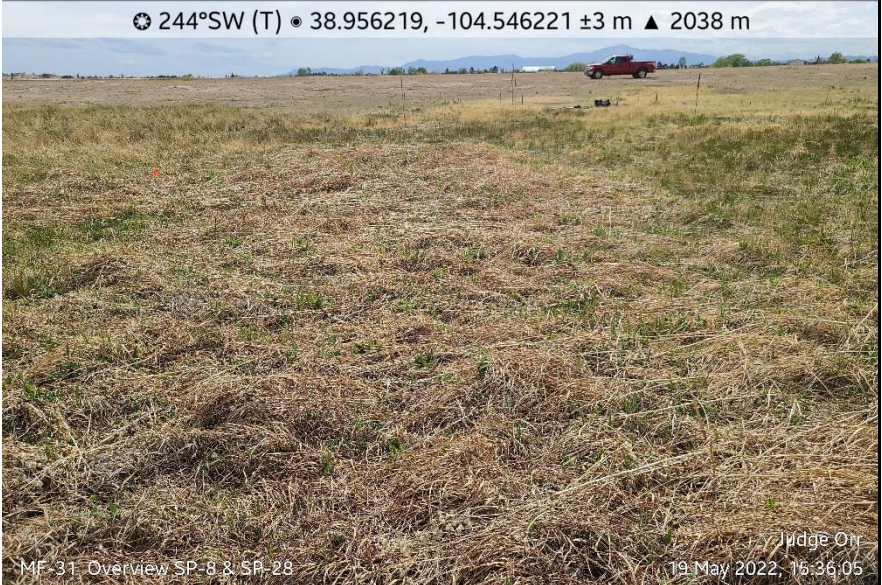
<div> MF-31 Overview SP-8 & SP-28 </div> <div> Judge Orr 19 May 2022, 15:36:05 </div>	
Site ID: Pete Lien, Judge Orr Site			
Description: Photo collected at MF-31 showing an overview of habitats associated with SP-8 (WL-1 foreground) and SP-28 (upland background). SP locations denoted by orange flags.

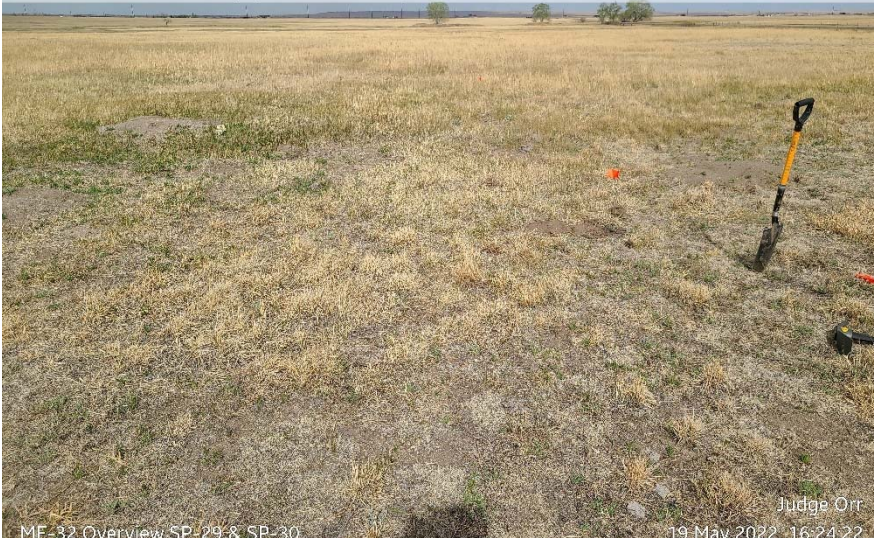
<div style="display: flex; justify-content: space-between; font-size: small; margin-top: 10px;"> MF-32 Overview SP-29 & SP-30 Judge Orr 19 May 2022, 16:24:22 </div>	
Description: Photo collected at MF-32 showing an overview of habitats associated with SP-29 (WES-7 background) and SP-30 (upland foreground). SP locations denoted by orange flags.

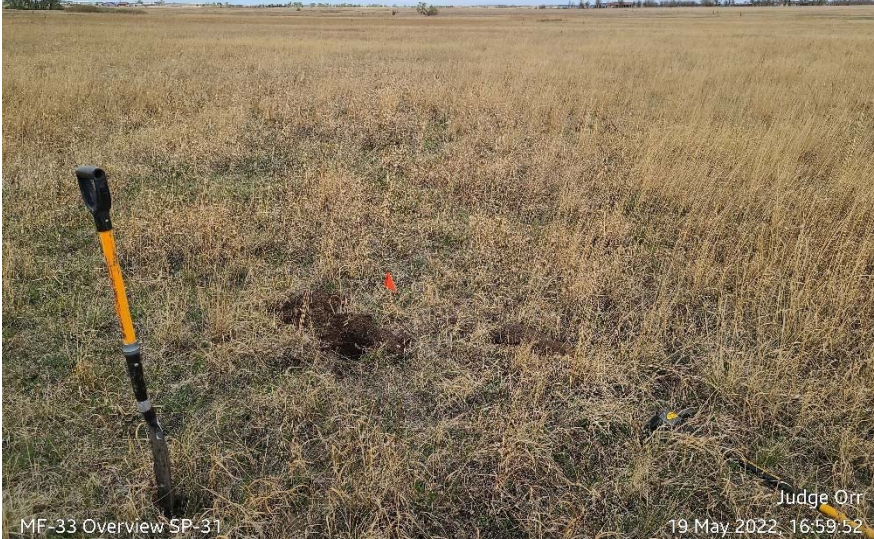
<div style="display: flex; justify-content: space-between; font-size: small; margin-top: 10px;"> MF-33 Overview SP-31 Judge Orr 19 May 2022, 16:59:52 </div>	
Description: Photo collected at MF-33 showing an overview of habitats associated with SP-31 (WES-1 foreground) and neighboring WL-1 (background). SP locations denoted by orange flags.

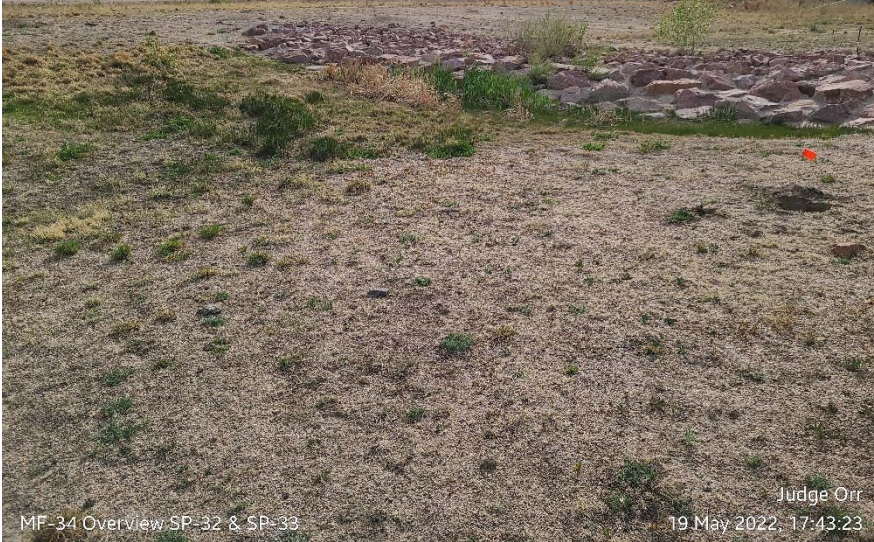
<p style="text-align: center;">MF-34 Overview SP-32 & SP-33</p> <p style="text-align: right;">Judge Orr 19 May 2022, 17:43:23</p>

Description: Photo collected at MF-34 showing an overview of habitats associated with SP-32 (WL-5 midground) and SP-33 (upland foreground). SP locations denoted by orange flags.

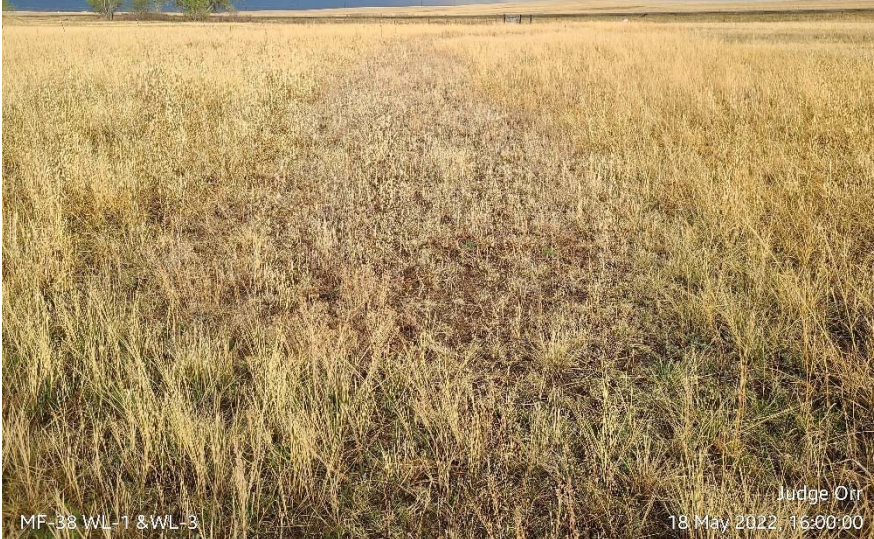
<p style="text-align: center;">MF-38 WL-1 & WL-3</p> <p style="text-align: right;">Judge Orr 18 May 2022, 16:00:00</p>

Description: Photo collected at MF-38 showing an overview of WES-6 (center) as it separates WL-1 (right) and WL-3 (left).

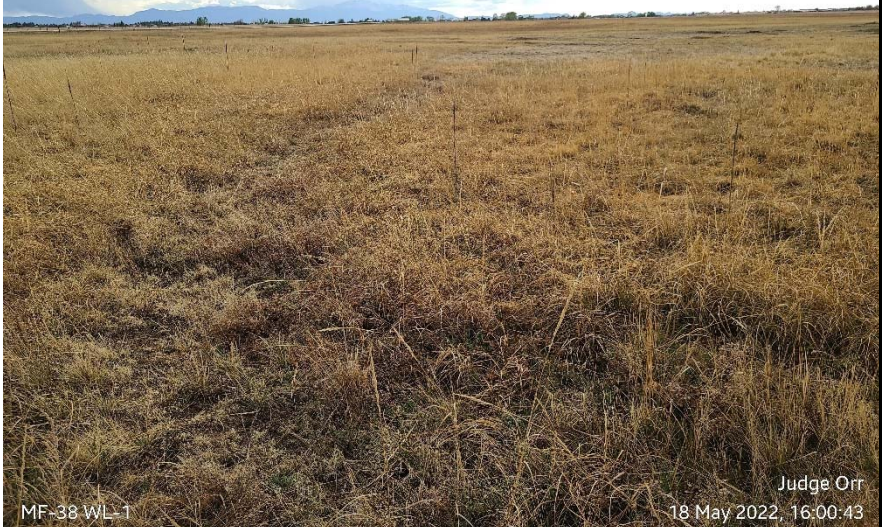
</div>	
Site ID: Pete Lien, Judge Orr Site			
Description: Photo collected at MF-38 showing an overview of WL-1 (foreground) and neighboring uplands (background).		<div>MF-38-WL-1</div> <div>Judge Orr 18 May 2022, 16:00:43</div>

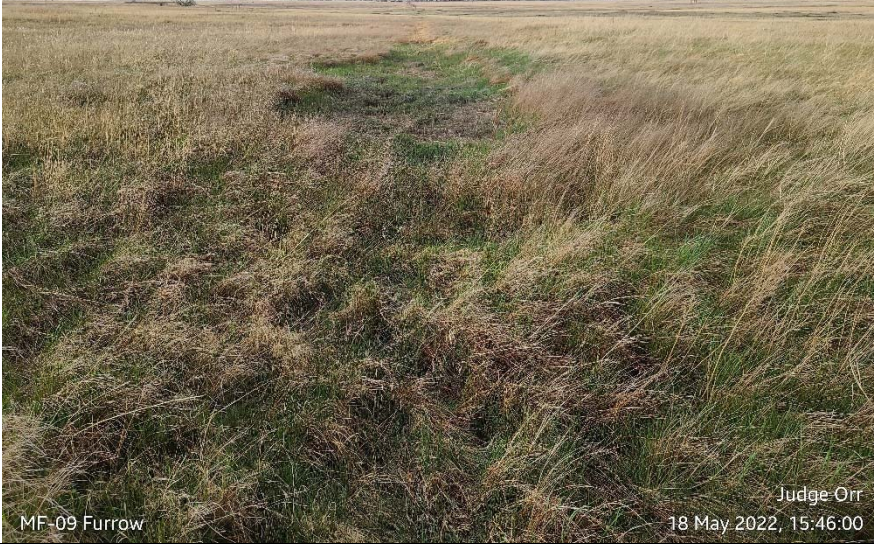
</div>	
Description: Photo collected at MF-09 showing an overview a grass-lined furrow intersecting WL-1.

There are several grass-lined "furrows" located within the upland and occasionally intersecting the pre-existing wetlands. There are four water bars on Site located along the tributaries formed from several materials including earth (earthen water bar), loose stacked rocks (loose-rock water bar), and rocks which have been concreted in place (concrete-rock water bar). There are two roadside ditches which are part of the stormwater detention system, but these ditches do not intersect the Site boundary (Figure 6). Photo locations of the map features including the wetlands and waters are shown on Figure 6.

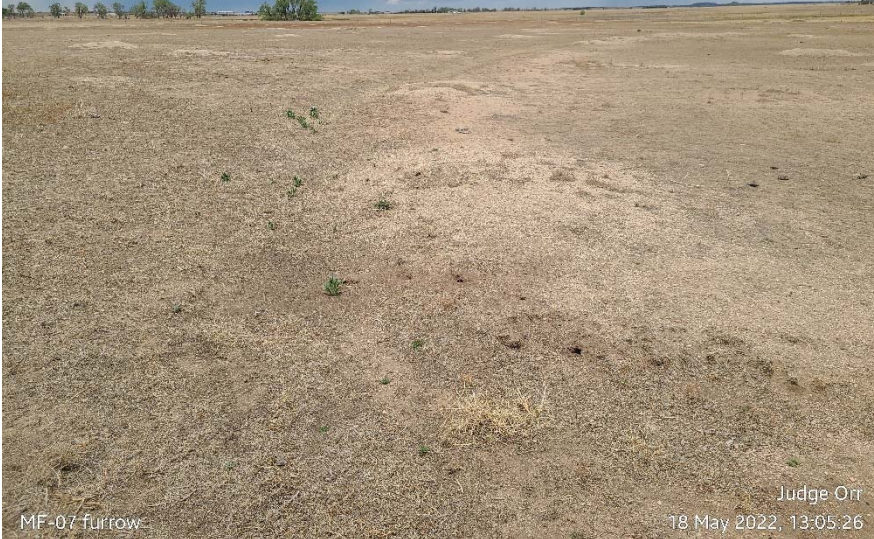
</div>	
Description: Photo collected at MF-07 showing a grass-lined furrow within the upland.

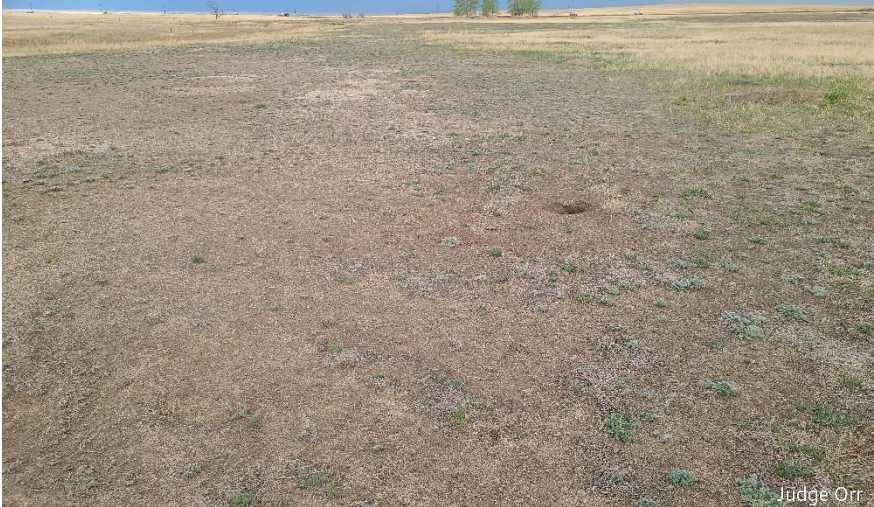
Description: Photo collected at MF-17 showing upland vegetation transition between "thin" areas (left) affected by prairie dogs and historic grazing to elevated cover neighboring the delineated wetlands (right).			
		<div style="display: flex; justify-content: space-between;"> MF-17 Prairie Dogs Judge Orr 18 May 2022, 18:12:27 </div>

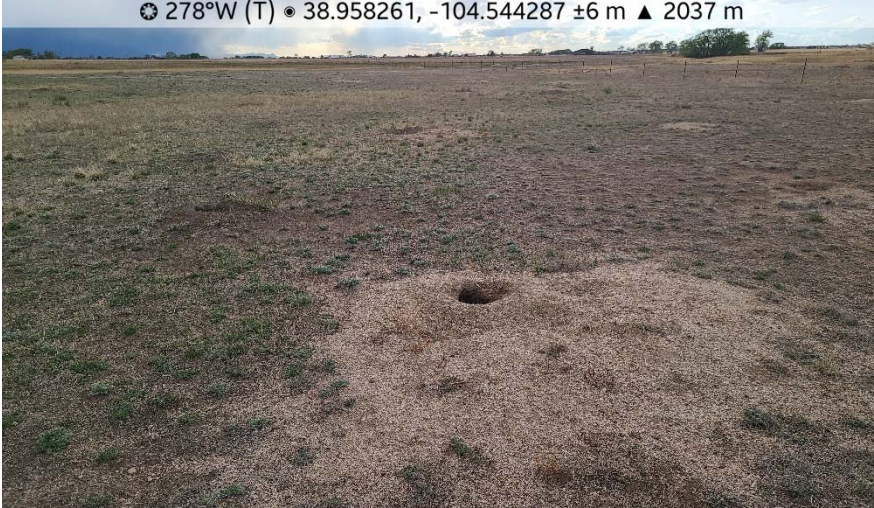
Description: Photo collected at MF-17 showing upland vegetation transition between "thin" areas (right) affected by prairie dogs and historic grazing to elevated cover neighboring the delineated wetlands (left).			
		<div style="display: flex; justify-content: space-between;"> MF-17 Prairie Dogs Judge Orr 18 May 2022, 18:12:52 </div>

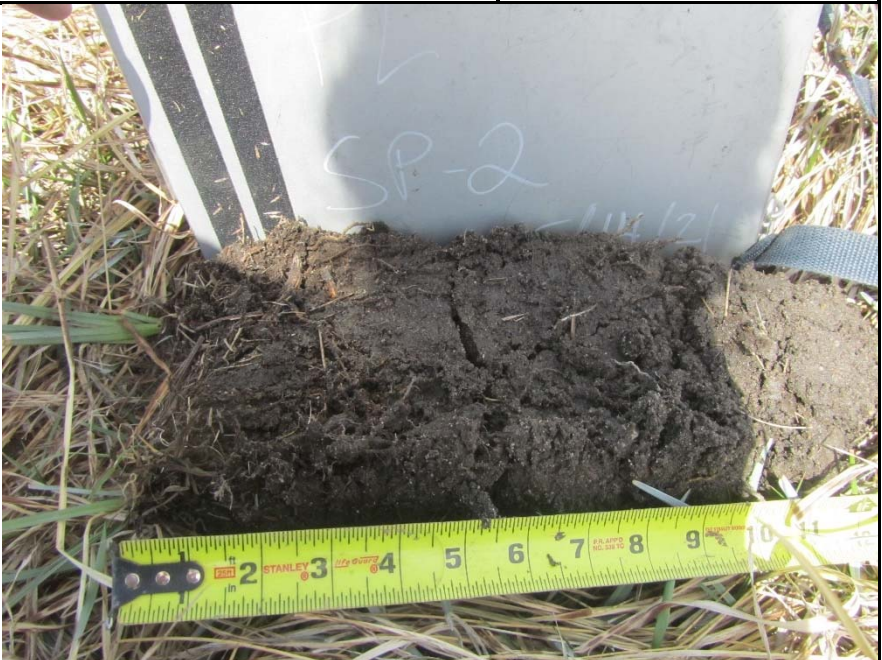
Site ID: Pete Lien, Judge Orr Site			
Description: Soil profile collected at SP-2. Expanded profile to 26 inches (6/29/22): <div style="text-align: center;">

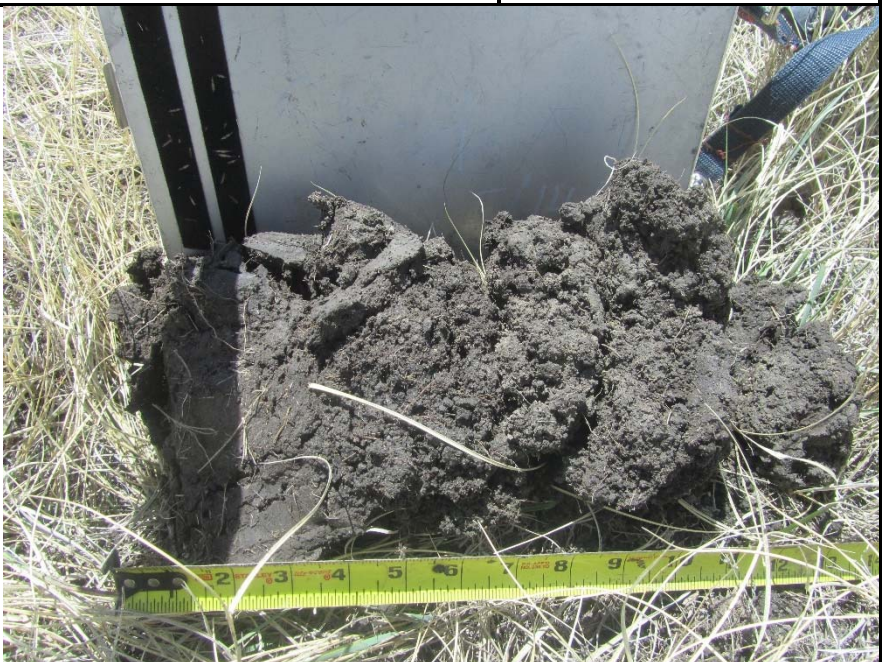
Site ID: Pete Lien, Judge Orr Site			
Description: Soil profile collected at SP-4. Expanded profile to 20 inches (6/29/22):

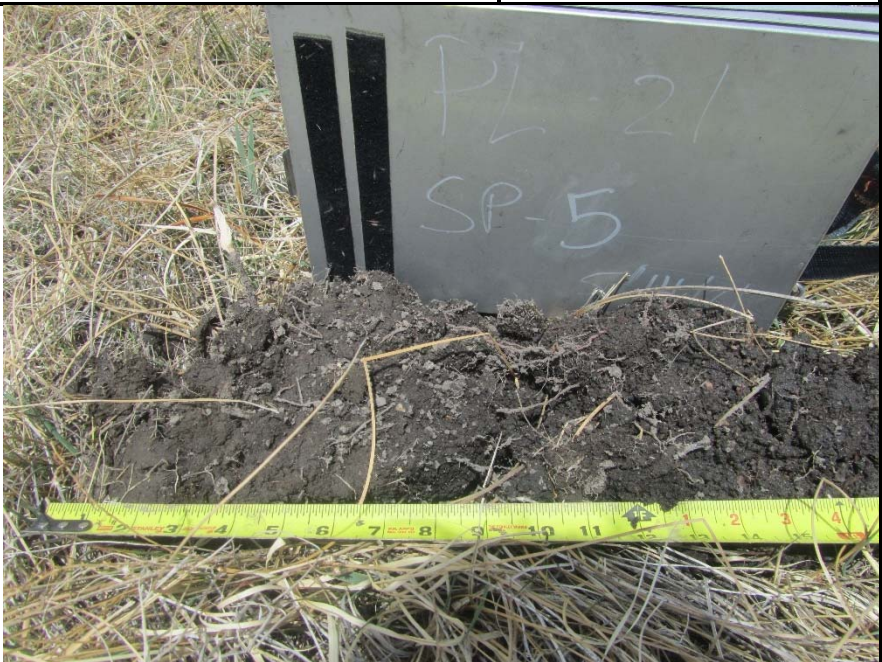
Site ID: Pete Lien, Judge Orr Site			
Description: Soil profile collected at SP-5. Expanded profile to 28 inches (6/29/22):

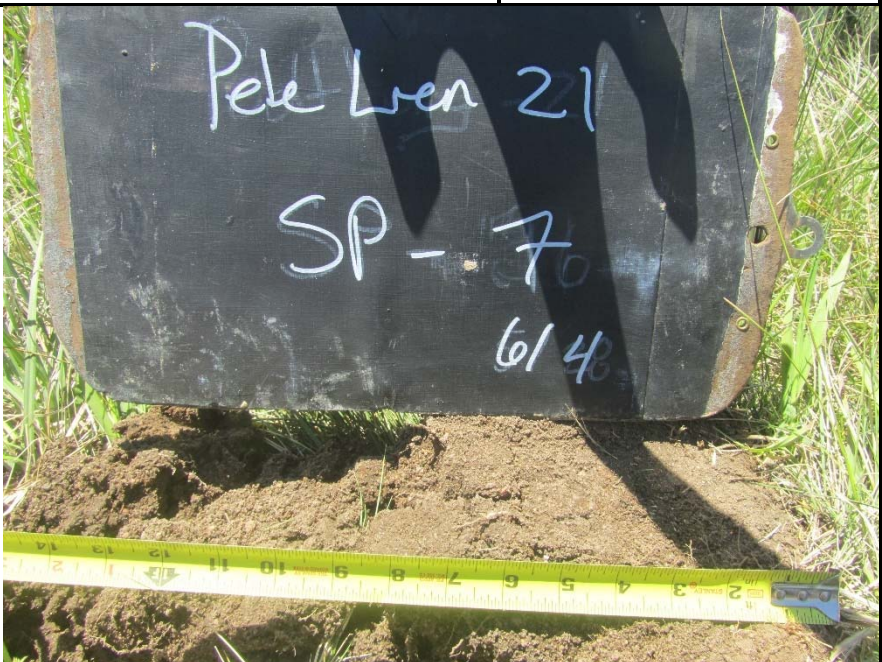
Site ID: Pete Lien, Judge Orr Site			
Description: Soil profile collected at SP-7. Expanded profile to 38 inches (6/29/22):

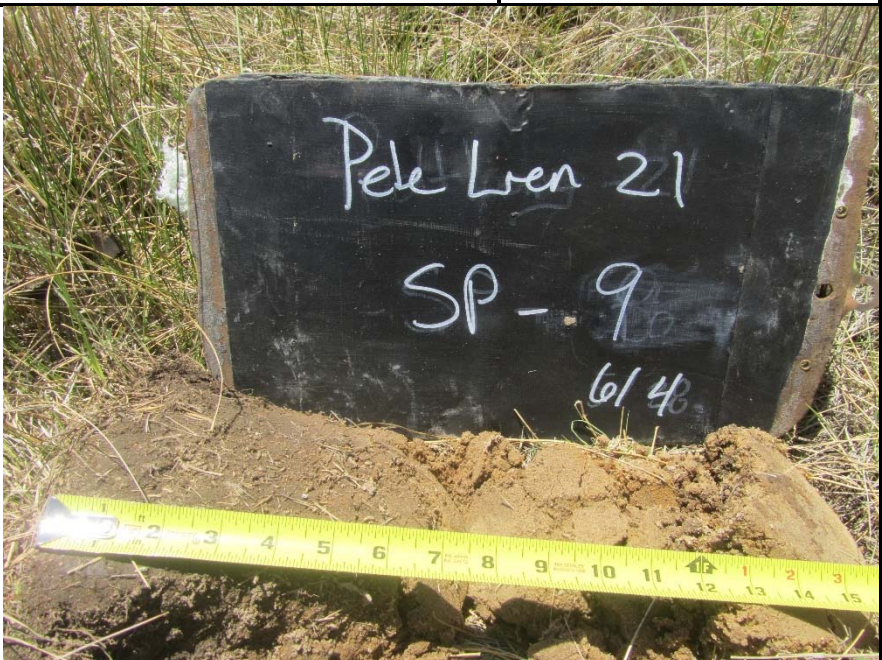
Site ID: Pete Lien, Judge Orr Site			
Description: Soil profile collected at SP-9. Expanded profile to 21 inches (6/29/22):

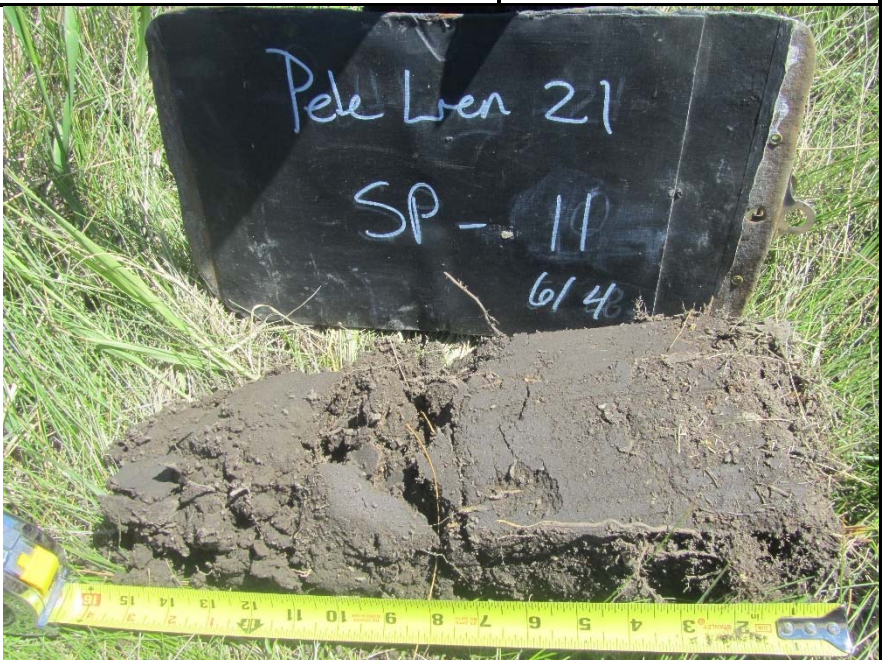
Site ID: Pete Lien, Judge Orr Site			
Description: Soil profile collected at SP-11. Expanded profile to 26 inches (6/29/22):
