Prospectus for Judge Orr Mitigation Bank

**December 2021
Revised May 2022
Revised July 2022
Revised September 2022**

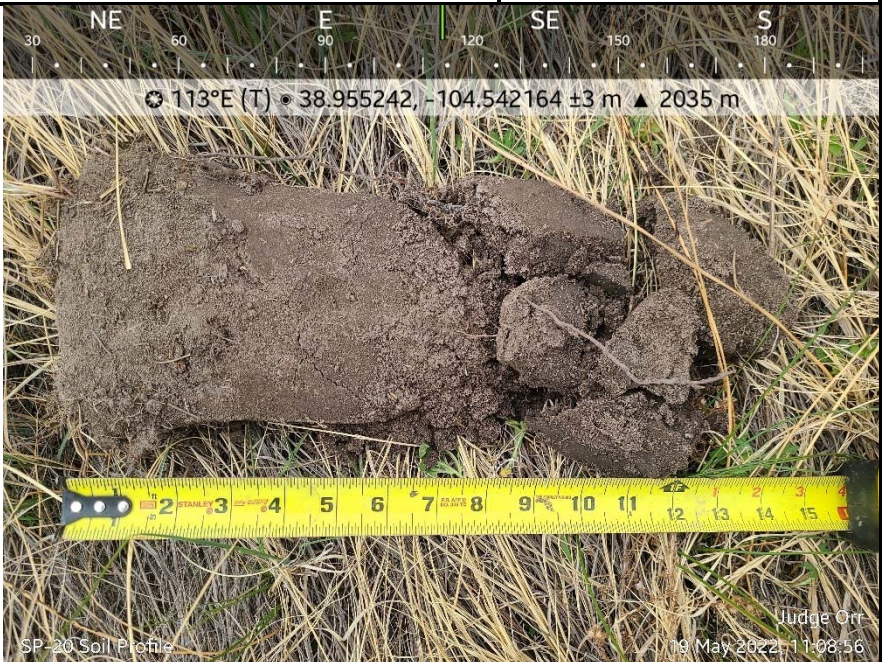
Site ID: Pete Lien, Judge Orr Site			
Description: Soil profile collected at SP-20. Expanded profile to 26 inches (6/29/22):

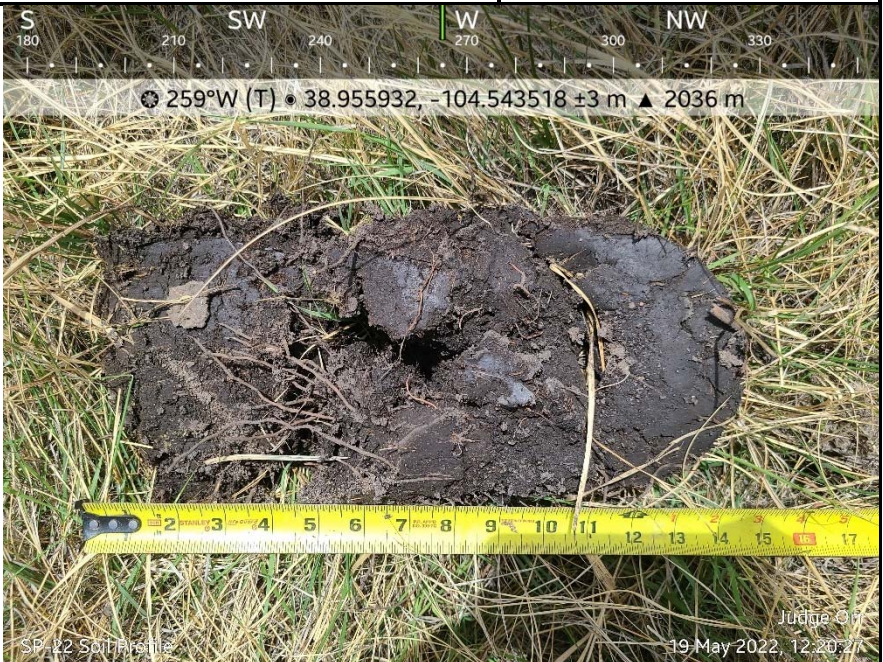
Site ID: Pete Lien, Judge Orr Site			
Description: Soil profile collected at SP-22. Expanded profile to 25 inches (6/29/22):

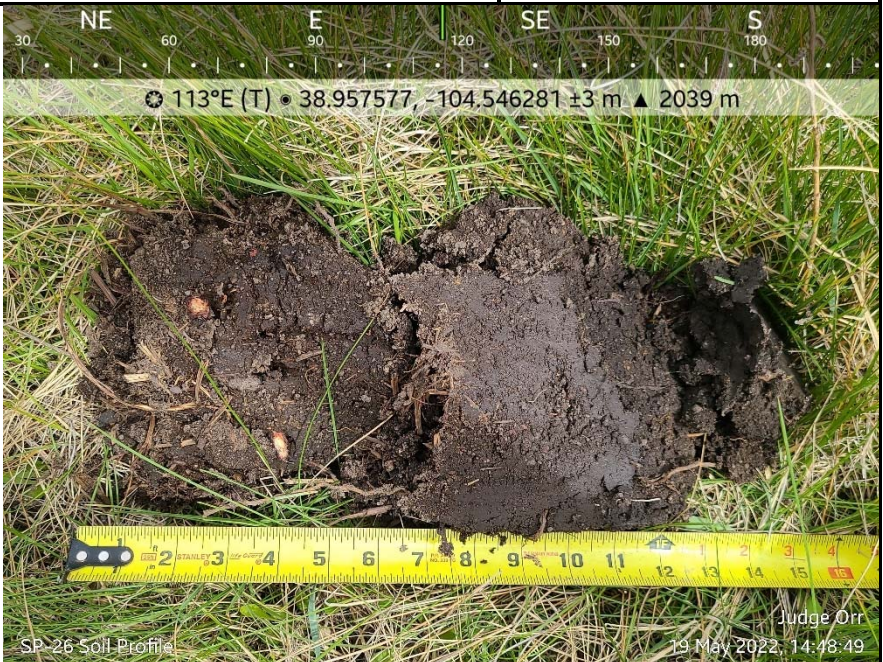
Site ID: Pete Lien, Judge Orr Site			
Description: Soil profile collected at SP-26. Expanded profile to 26 inches (6/29/22):

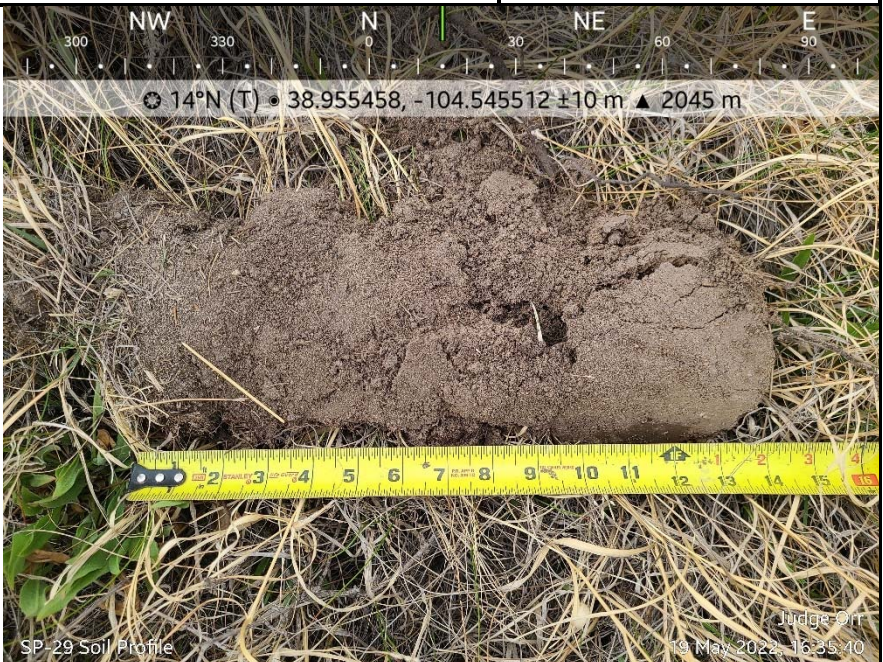
Site ID: Pete Lien, Judge Orr Site			
Description: Soil profile collected at SP-29. Expanded profile to 26 inches (6/29/22):

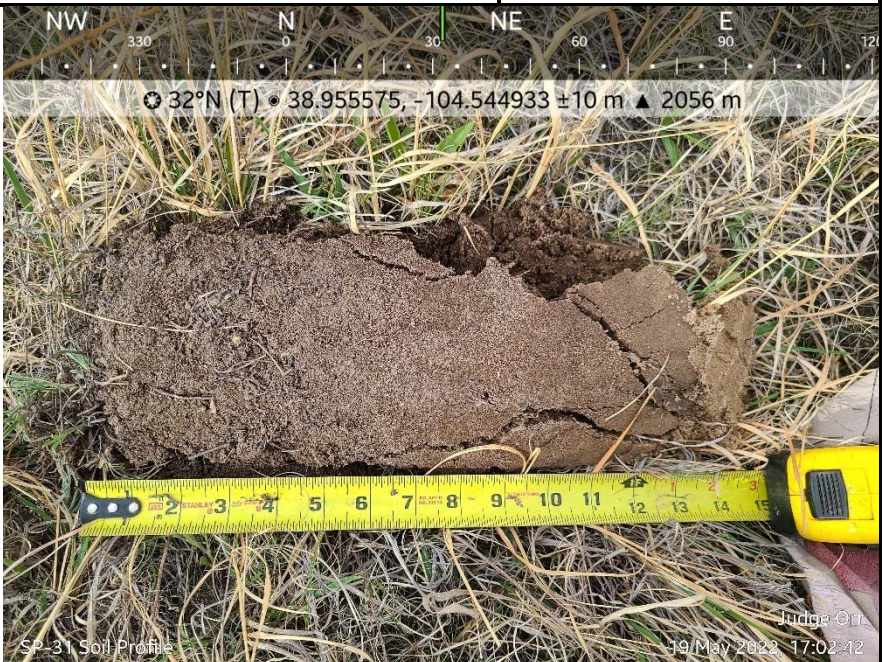
Site ID: Pete Lien, Judge Orr Site			
Description: Soil profile collected at SP-31. Expanded profile to 28 inches (6/29/22):

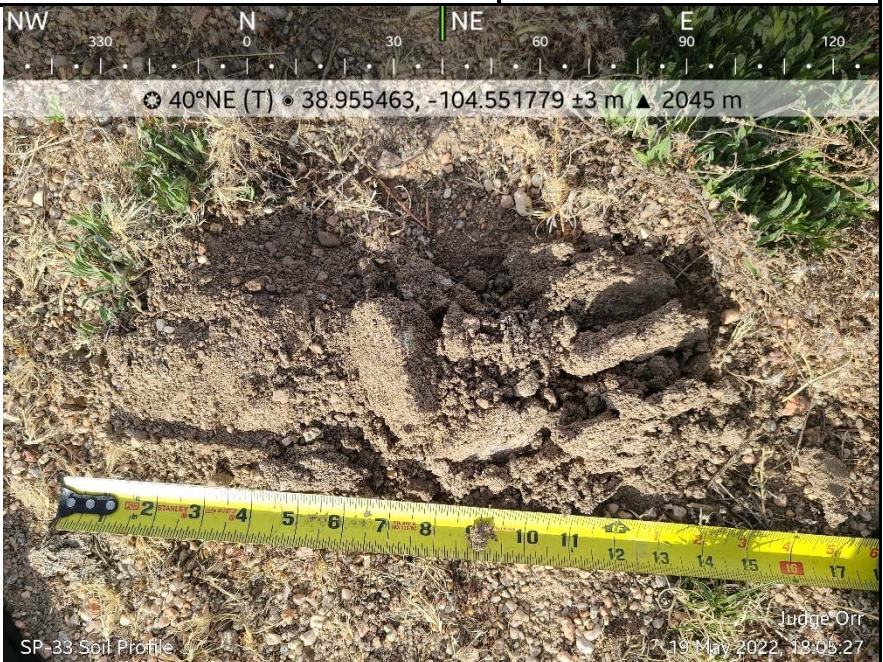
Project Name: Judge Orr Mitigation Bank		Location: El Paso County, Colorado	Project Reference: Prospectus
Photo ID Number: Photo 83. PL22-SP33	Date: 05/19/22

Site ID: Pete Lien, Judge Orr Site			
Description: Soil profile collected at SP-33.
