URGWOM Technical Team  
Spring 2026 Field Trip  
Wrap-Up Report  
April 6, 2026

This is the wrap-up Report summarizing the sites visited and information obtained during the March 31, 2026 URGWOM Technical Team Field Trip. The itinerary of the Technical Team trip is shown below:

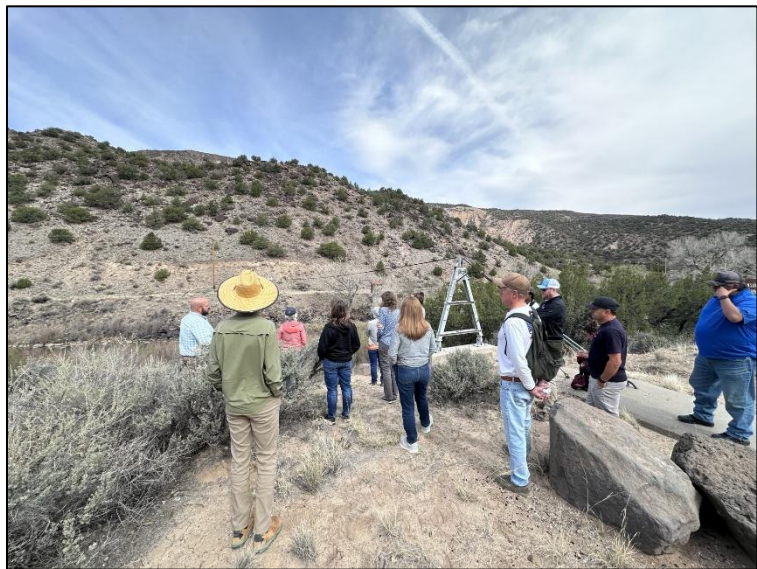
The location of this streamgage is an URGWOM reach boundary which measures nearly all of the runoff originating in the San Juan and Sangre de Cristo Mountains. Discharge at the time of the inspection was about 250 cfs.

Figure 1. USGS gage Rio Grande at Embudo site

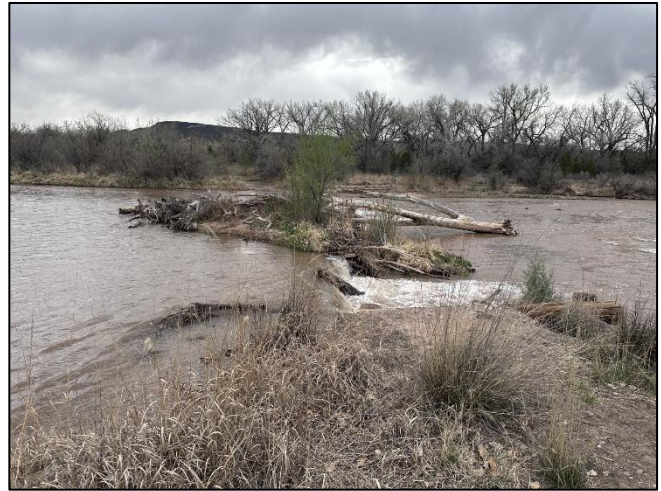
The Team met with Rick Martinez, commissioner, and the Mayordomo Miguel, at the Acequia Salazar diversion on the Rio Chama in Medanales. This diversion dam is a weir that spans the channel and is constructed of treated wooden poles bolted together. The headgate structure is reinforced concrete located on the south bank that includes steel headgates and a sluice gate. This Acequia serves about 465 acres of irrigated land with an early water right priority date of 1600.

Figure 2. Acequia Salazar diversion dam on Rio Chama

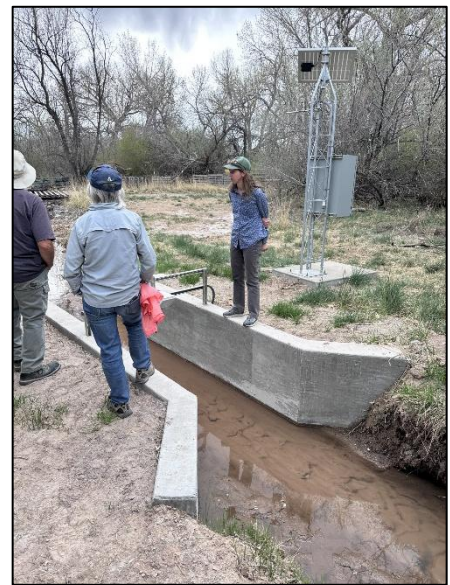
The Team also inspected the recently constructed water measuring station on the Acequia downstream of the headgate. This station consists of a concrete flume section and overhead stage/velocity sensor.

Figure 3. Gage on Acequia Salazar

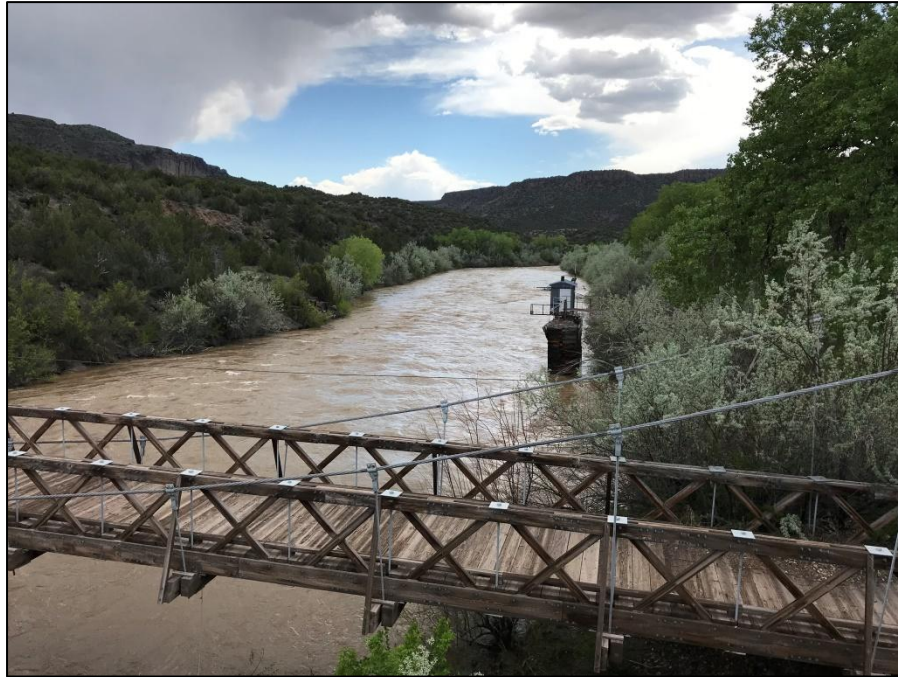
The Team visited this gage located immediately downstream of the NM State Highway 502 Bridge crossing the Rio Grande. This is the Ro Grande Compact New Mexico Index Gage and is also and URGWOM reach boundary. This station measures the flow of the Rio Grande entering the middle Rio Grande Valley. The flow of the Rio Grande at the Otowi Bridge gage at the time of the inspection was approximately 700 cfs. Figure 4 is a photo of the Rio Grande at Otowi stream gage.

Jeb Brown reported to the Team on the data collected at this site (stage and suspended sediment). He also described the equipment and methods used by the USGS to collect data at this site and the impact of material deposited in the Rio Grande channel from the Los Alamos Arroyo, just downstream of the gage site. This material deposited at the mouth of the Arroyo acts as a control section for the stream gage.

Figure 4. USGS stream gage Rio Grande at Otowi Bridge
