**Appendix A**  
Cultural Resource Consultation

Appendix A contains:

- USACE Consultation Letter to Pueblo of Santa Ana Tribal Historic Preservation Office with THPO Concurrence and Enclosures

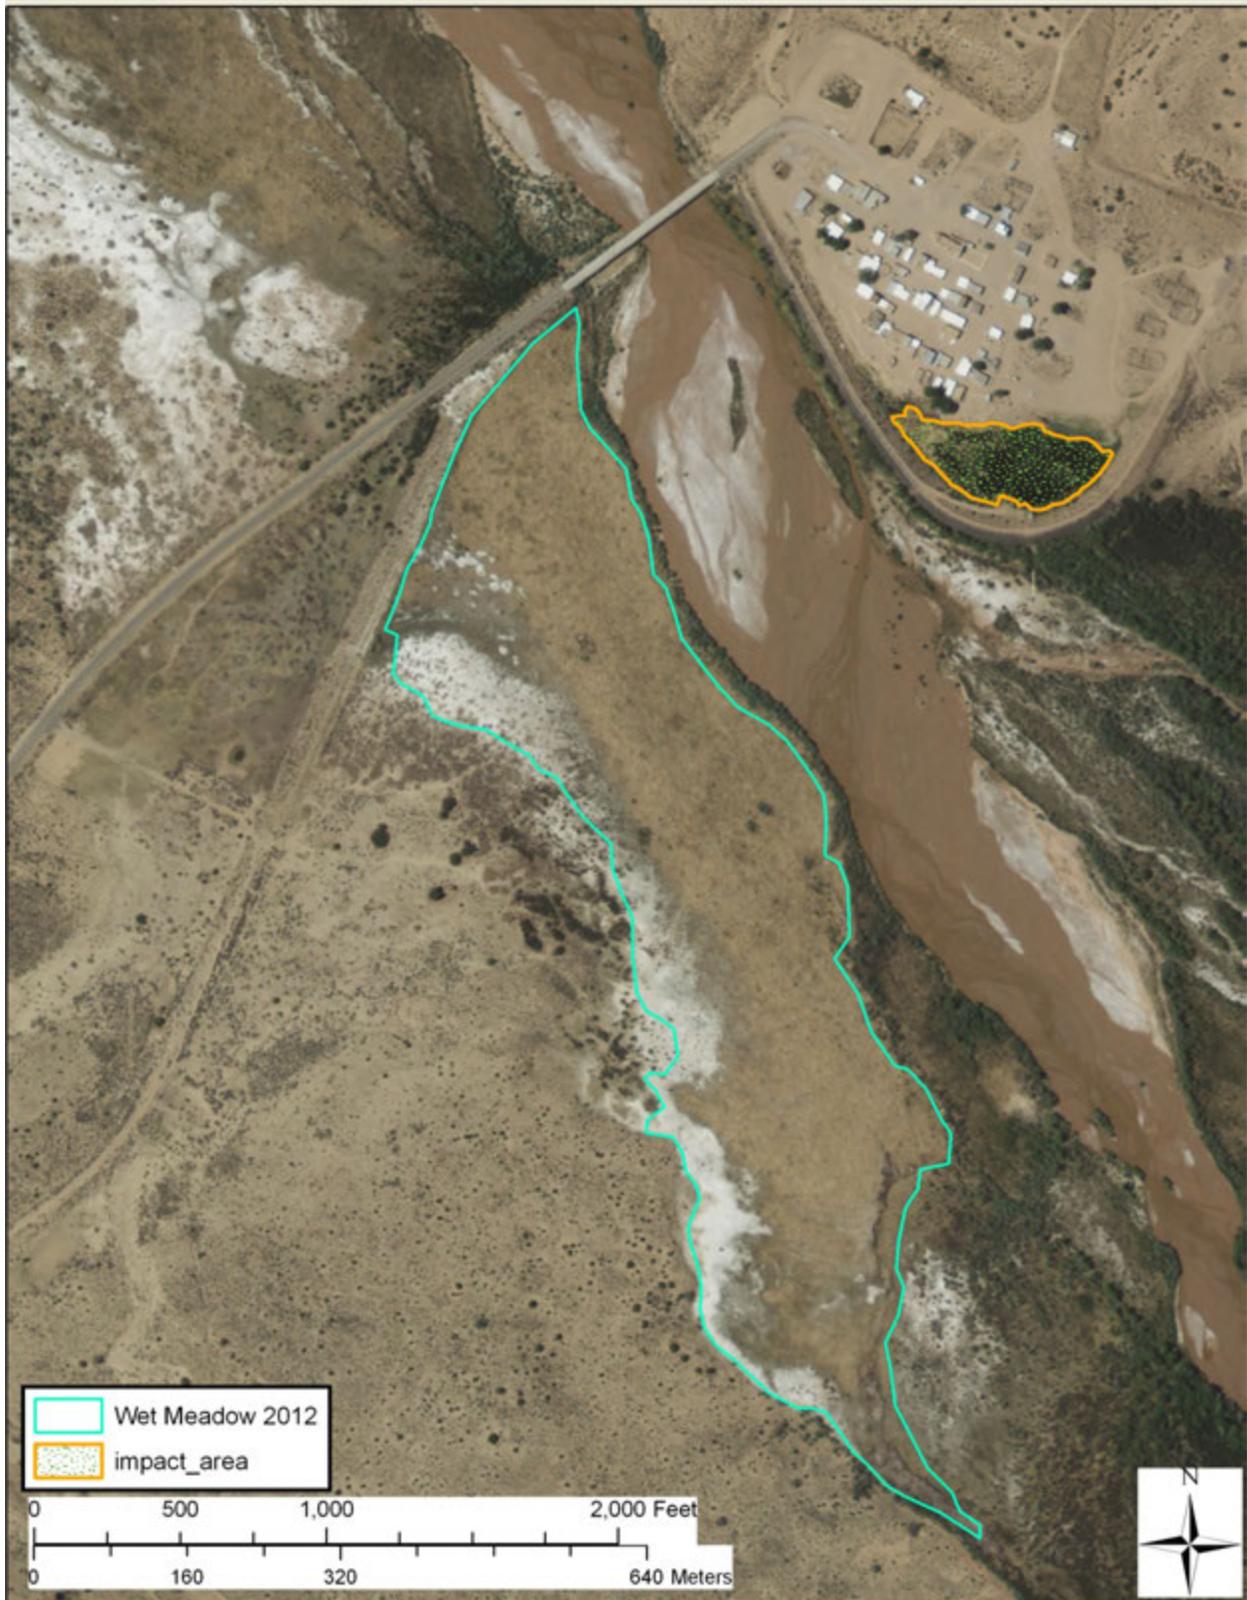
Figure 3: Wetland Preservation Mitigation area (wet meadow)

21 The preservation site is a groundwater-fed wet meadow. Vegetation along the upslope side is  
22 primarily saltgrass with increasing cover of Baltic rush and bulrush towards the river. This  
23 community grades into an almost pure stand of spikerush in the areas with shallowest  
24 groundwater. The saltgrass portion of the meadow has been cleared of saltcedar by the Pueblo. In  
25 March 2012, the soil was moist even in areas with prominent salt crust.

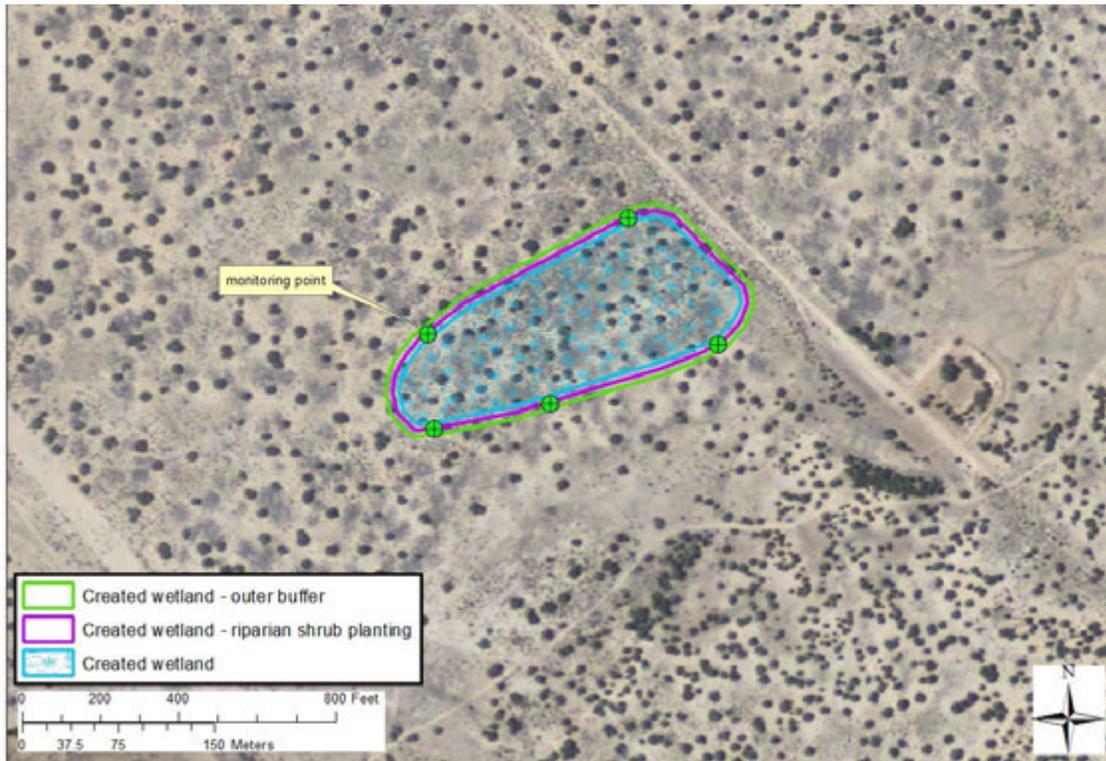
1 **Figure 11: Vegetation Monitoring Point Layout (example).**

2 Actual points will be determined following construction and wetland mapping.
