**Environmental Assessment**

**Conchas Lodge Demolition and Mitigation Project**

**San Miguel County, New Mexico**

Prepared By:  
U. S. Army Corps of Engineers  
Albuquerque District  
October 2025

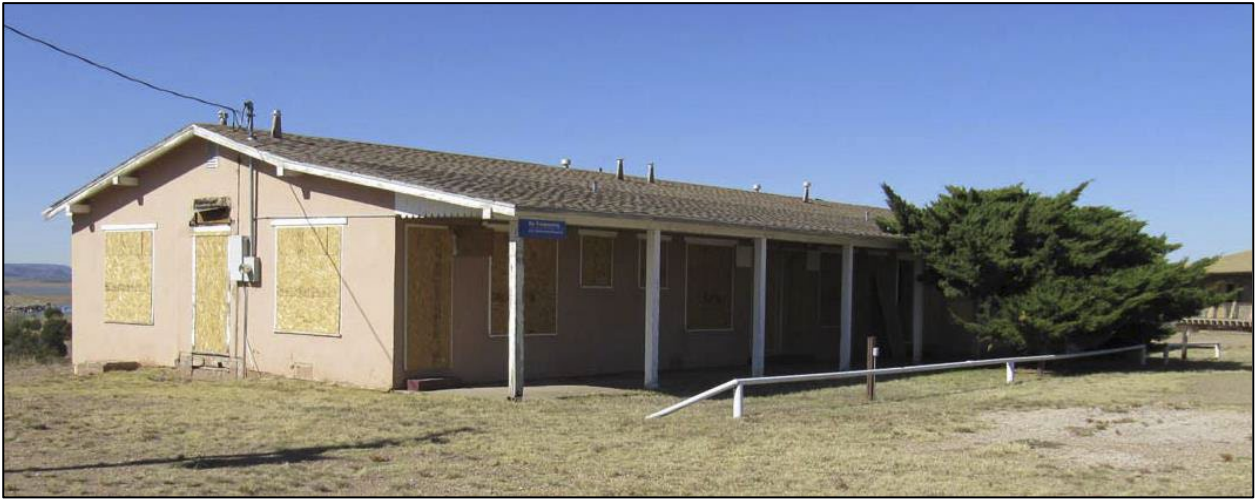
**Figure 4. “Fisherman’s Wharf” was constructed in 1949 as an accessory lodging facility. The building lacks the sandstone masonry character of the original lodge building, but repeats the general scale, gable pitch, and continuous porch. (Photo: “Building Evaluations,” prepared by the Albuquerque District, 2005)**

Two years later in 1949, a free-standing addition to the facility was erected diagonally and to the southwest of the main Lodge. The one-story rectangular structure with gabled roof became known as “Fisherman’s Wharf,” due to its frequent use by anglers. Though outwardly compatible with the lodge building in scale and mass, the Fisherman’s Wharf building was of frame construction clad with stucco and lacked the masonry signature of the New Deal lodge building (Figure 4). While only seven years removed from the Lodge’s completion; Fisherman’s Wharf fell short of the architectural significance established in the Lodge and Adobe Belle, a set of dwellings constructed in the Pueblo Style originally meant to provide employee housing. The building has an incidental relationship to the recreational development around the lake and has lost its integrity of design, materials, and workmanship needed to convey an association with the historical events of the period.

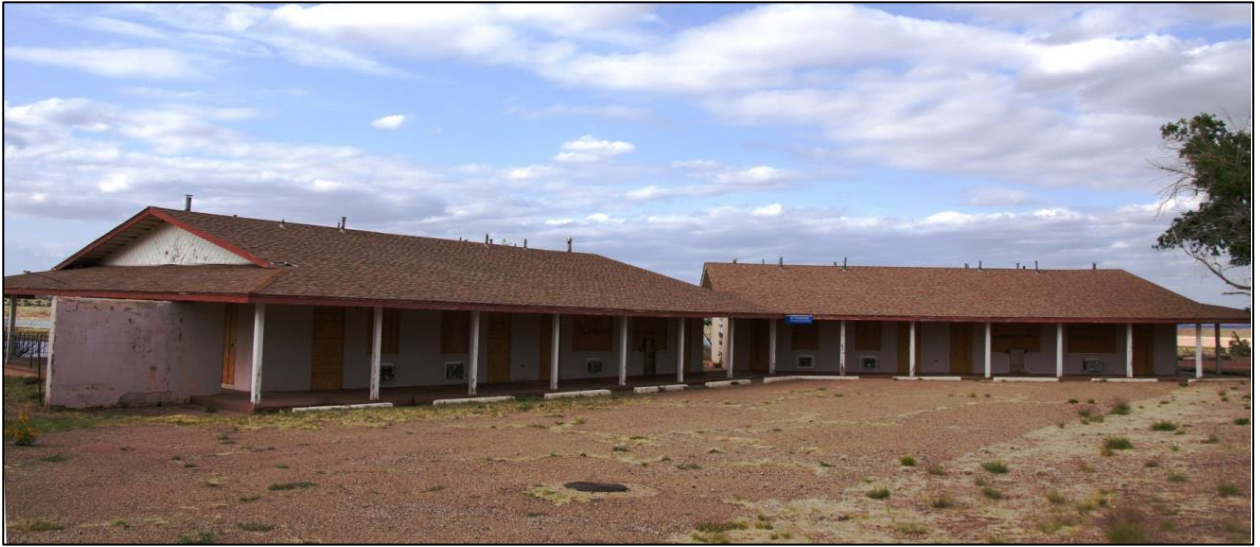
**Figure 5. Two lodging buildings known as the East Annex were constructed in 1959 along the bluff as a pair of intersecting but separate gabled buildings. (Photo: K. Hill, May 2012)**

From 1948 to 1960 additional improvements to the Lodge and South Recreation Area were made, including construction of a park manager’s residence (demolished), as well as picnic and restroom facilities. Some of the later projects began to erode the Lodge’s integrity. In 1959 the east end of the Lodge was extended slightly, to include an insensitive enclosure of the lake-side porch that concealed its design character. This resulted in a reconfiguration of the hipped roof into a gabled roof, and removal of the chimney and original window openings. Construction of the East Annex took place in 1959-60, resulting in a pair of one-story gabled frame buildings with stucco finish that converged to form a broad “V” along the shoreline bluff (Figure 5).

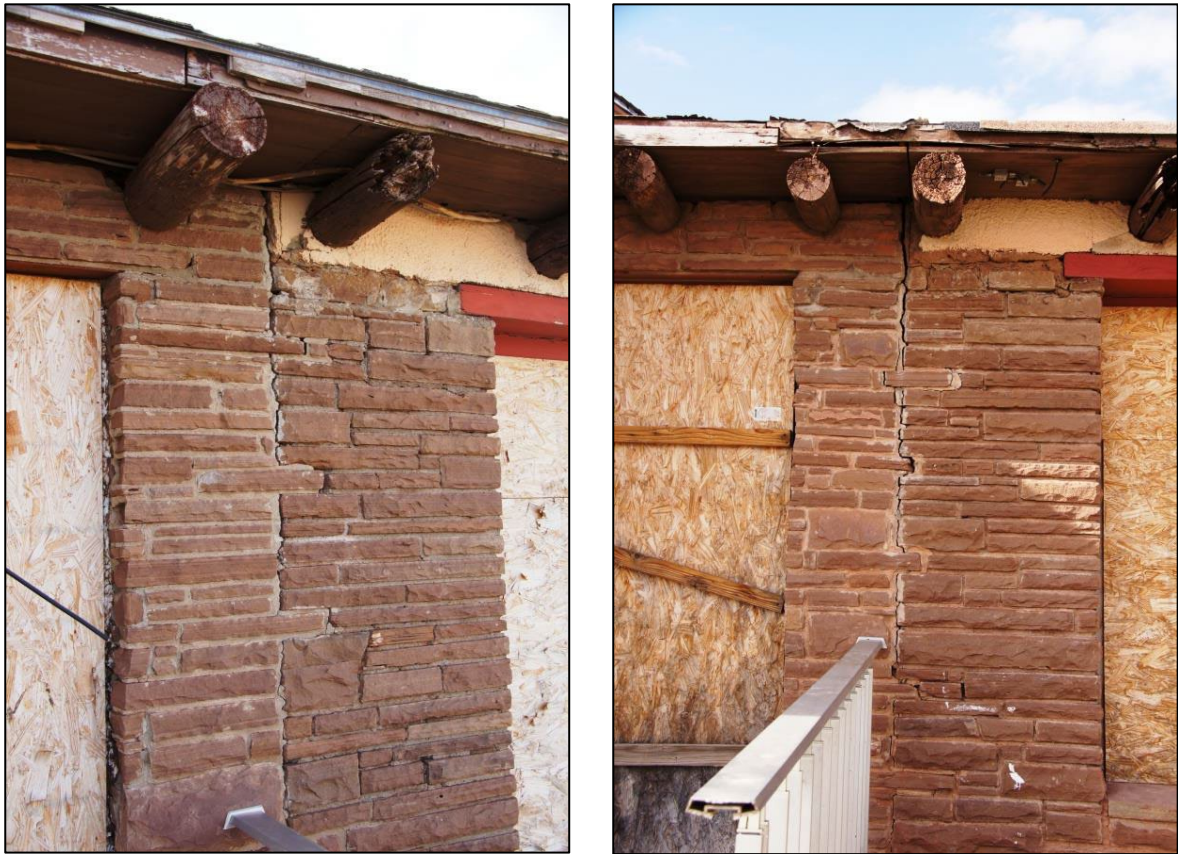
**Figure 6. Original sandstone walls to the left, and right side of the juncture crack. Note the heavier mortar joints and lesser craftsmanship of the veneered addition. (Photo: K. Hill, May 2012)**

The Lodge, at this time, part of Conchas Lake State Park, was to be enlarged from 24 guest rooms to 36 rooms offering first class accommodations. Although visitation figures for the Lodge were expected to grow modestly, the expansion doubled the size of the west end of the building. When completed in 1966, the extended west wing consumed the former hipped roof, which was re-designed to terminate as a gable in the manner of the earlier east end extension. The contemporary extension featured tabular sandstone veneer, although the craftsmanship was not of the same caliber as the original core building (Figure 6). The incompatible addition and enclosed cocktail lounge represented the last major compromise to the Lodge’s original design.

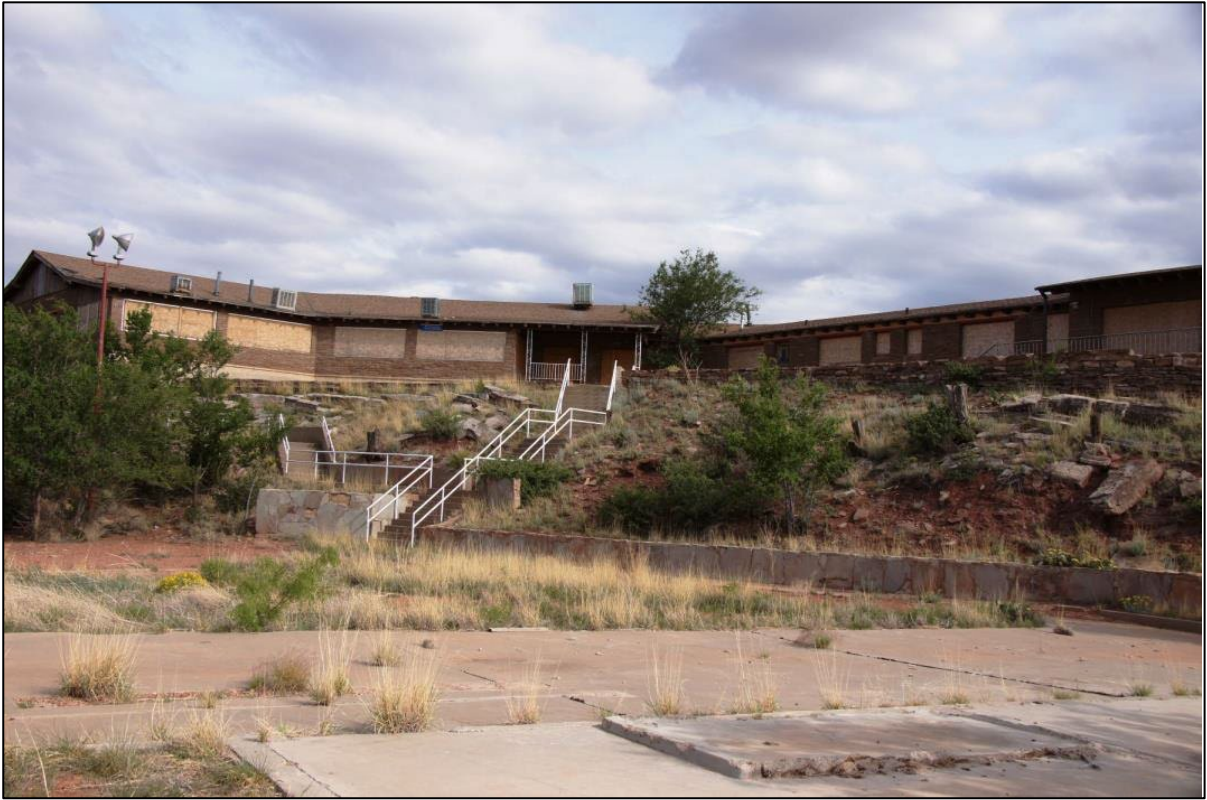
**Figure 7. Foundation remains of the bathhouse and former pool area on the terrace below the lakeside elevation of the lodge. This area has potential for redevelopment as an amphitheater or patio. Left of the staircase is the porch that was extended and enclosed in 1959. (Photo: K. Hill, May 2012)**

Another component of the 1965 plan was the installation of a pool and bathhouse on the terrace just below the Lodge (Figure 7). Now demolished, the pool facility remains as a filled in open area with a concrete pad. Since the last alterations were made to the building, vacancy and vandalism have further marred original fabric and features, though Faust's elegant composition remains mostly intact.

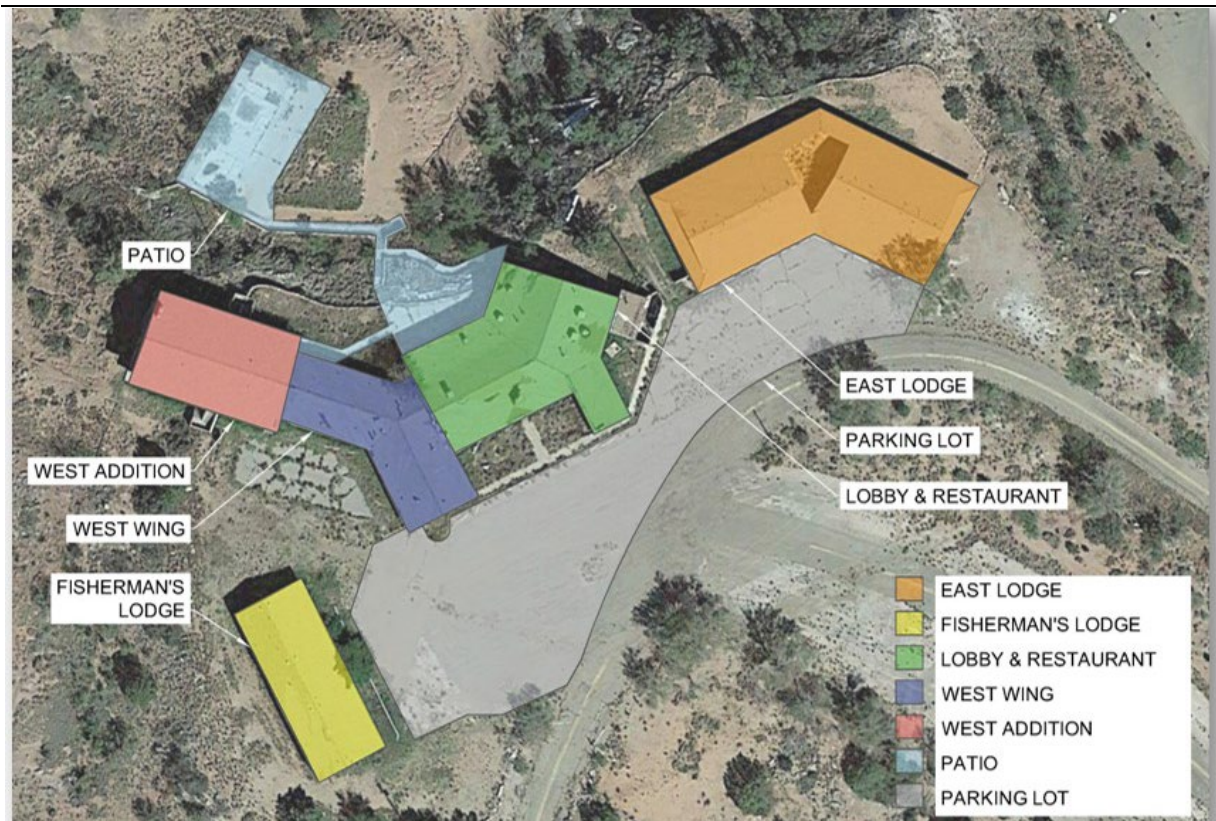
**Figure 9. Aerial view of lodge. The original sections that were proposed to be repaired or restored under the “Original Lodge Facility Restoration” alternative include the Lobby & Restaurant and West Wing. However, USACE determined that restoration is not technically nor economically feasible.**

- Other alternatives that were considered but not analyzed included: 1- restoring the original lodge facility with additional recreation facilities and 2- stabilizing the building without restoring it. Financial limitations and USACE policy preclude adding recreation features at this time, and stabilizing the building would be costly, technically infeasible, and would not address safety concerns.

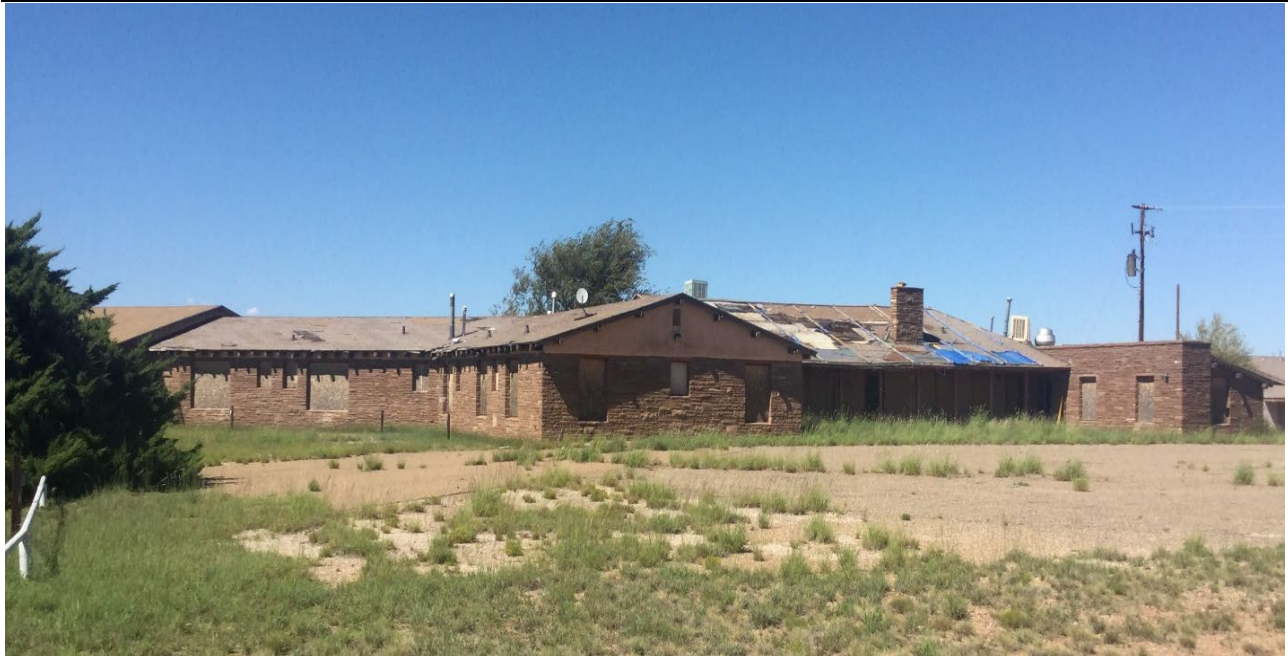
Figure 11. Exterior view of the Lodge showing roof damage.

The Lodge has been closed and disused since the departure of its last concessionaire in 2005 and has experienced ongoing deterioration in the years since. Currently, Conchas Lodge is in dilapidated condition. The roof in the main hall has partially collapsed leading to years of exposure to the elements, water damage and animal infestation. The effects of abandonment and vandalism have become more apparent and public sentiment has grown, raising concern about the Corps' stewardship of Conchas Lodge.

As discussed above, the building is deteriorating and has suffered from some vandalism and biological infestation. Several site visits to the Lodge have occurred during the course of this study and documented deteriorating conditions, with the most recent being 27 February 2024. Photos of the Lodge appear below (**Figure 11** through **Figure 17**).

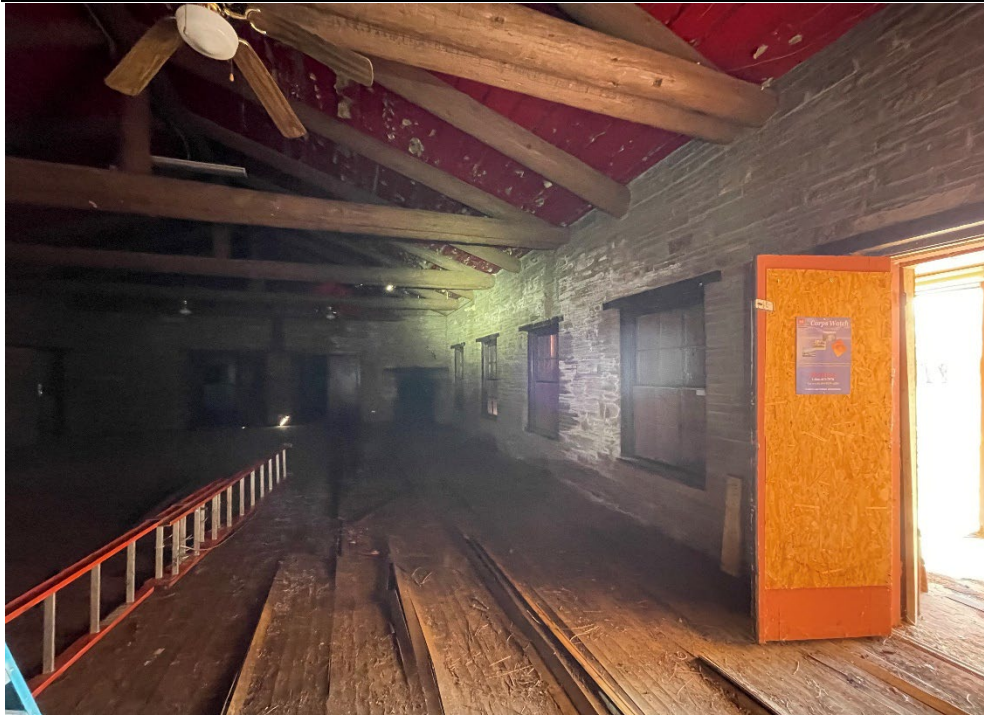
Figure 13. Severe floor and ceiling damage within interior main room of Lodge

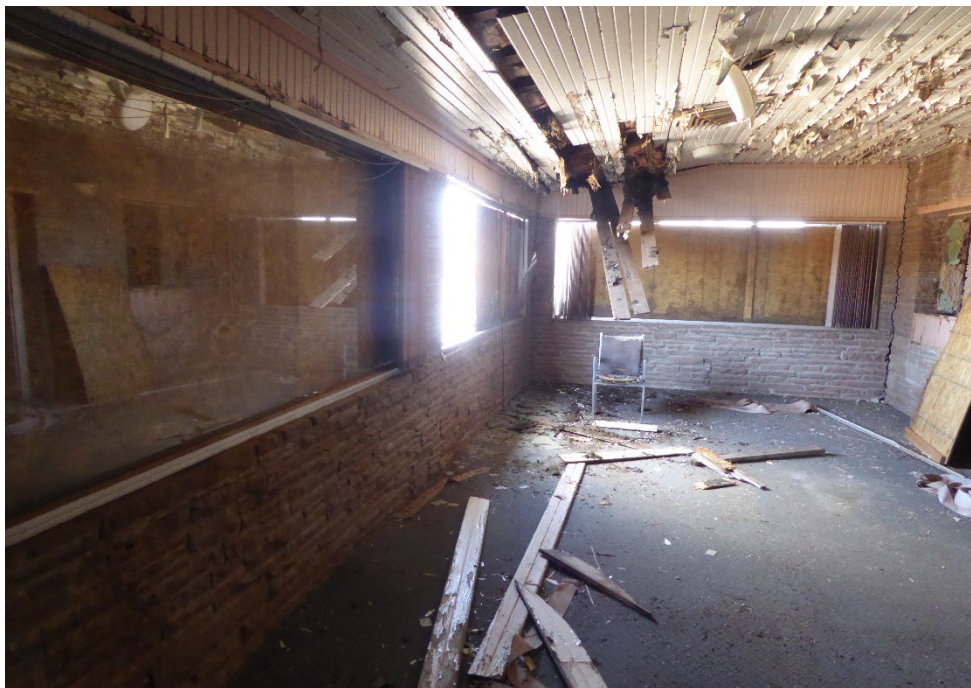
**Figure 14. Interior damage including collapsed ceiling.**

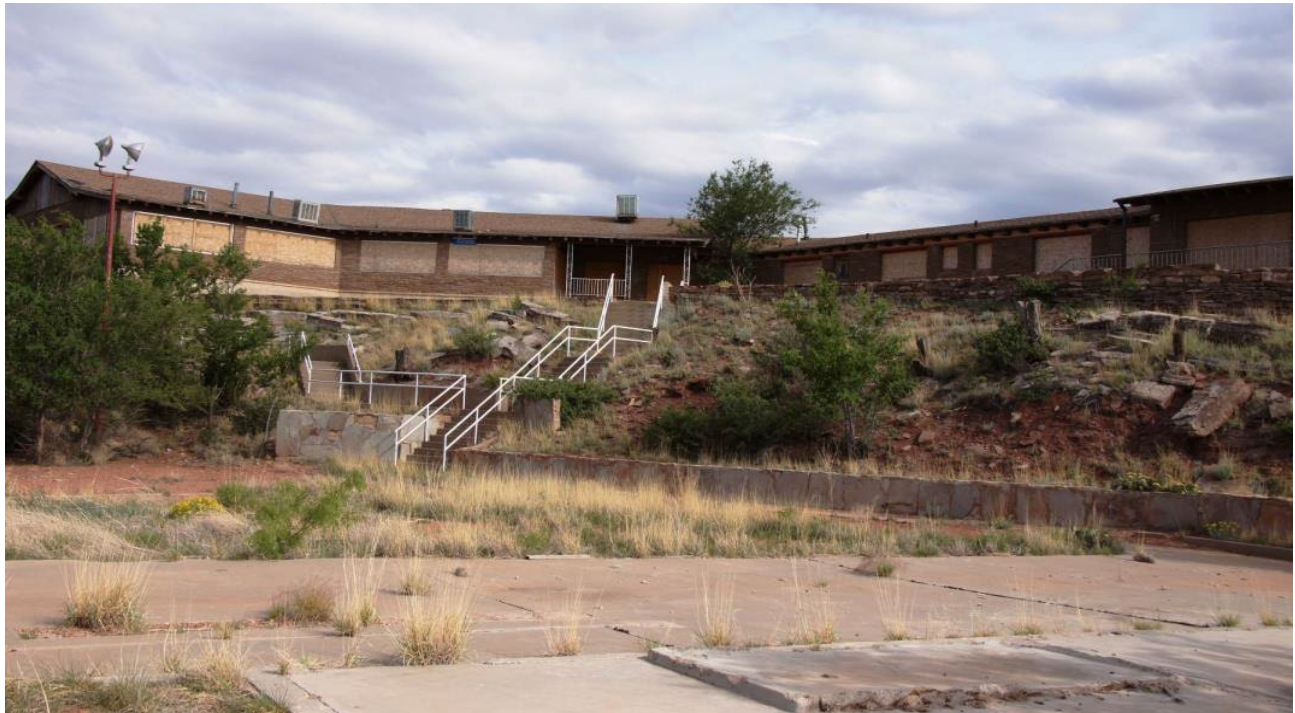
**Figure 16. Lodge setting, concrete patio and filled pool**

The original lodge building is a one-story side gabled building with a gabled wing angled toward the west; a restaurant and kitchen wing is angled toward the east; a former gift shop featuring a shed roof extends at the east side of the porch. Walls are double wythe, masonry bearing of tabular random sandstone. A porch supported by plain square wood columns runs the length of the front elevation, and features triangular pediments at window openings. Original six-over-six double hung sash windows are boarded over but intact on the south/front elevation. Eaves are accented with faux wood vigas; the east gable end features vertical wood boards with scalloped ends. The lake side originally featured a deep porch with multiple French double-door openings. This area is enclosed with tabular sandstone walls and plate glass windows. The primary interior space is an open hall with hard wood floor, located behind the front elevation. Its open ceiling consists of hewn wood pole beam trusses and rafters. An integrated sandstone fireplace is located on the interior of the central great hall and extends through the roof as a chimney. A two-story extension of the west wing consists of tabular sandstone veneer walls; replacement windows are contained in original openings with wood lintels. Two associated non-significant outbuildings are the frame and stucco Fisherman's Wharf, and concrete block East Annex. Original sandstone retaining walls outline the bluff below the Lodge's lake side.

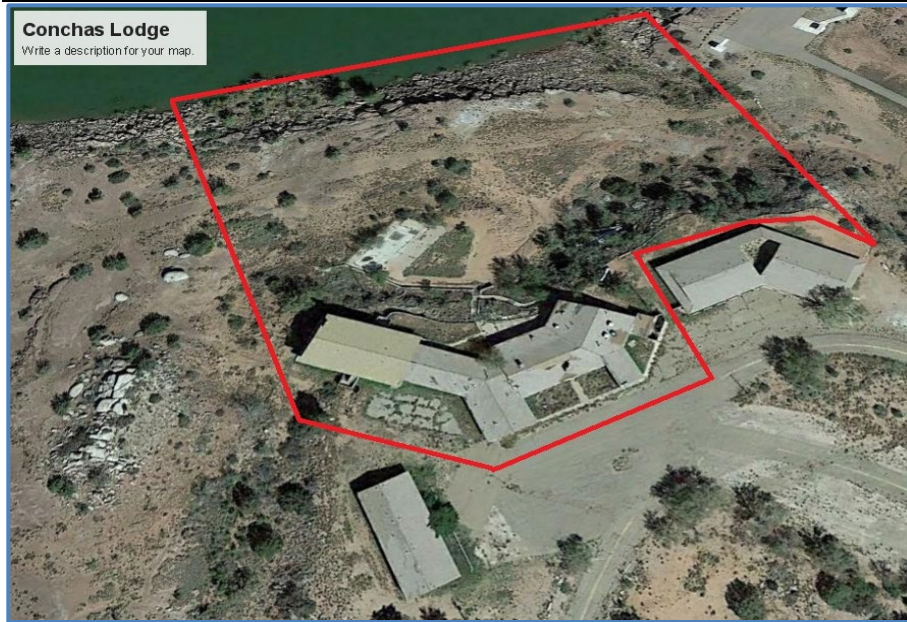
**Figure 19: Aerial View of a recommended National Register boundary to include the significant and original section of the Conchas Lodge (minus the 1959 west wing addition) and original view sheds.**
