APPENDIX A

STANDARD MAPS

**Northgate Diversion Channel
Environmental Assessment
El Paso, Texas**

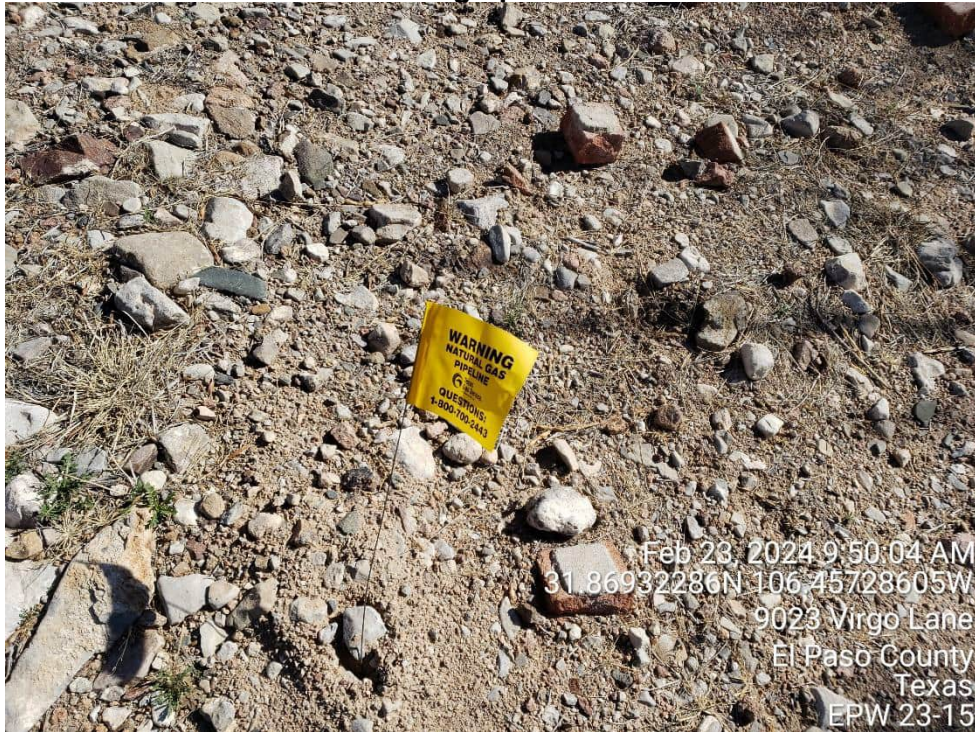
Photograph No. 5

View showing buried natural gas line near Project Site along Virgo Lane.

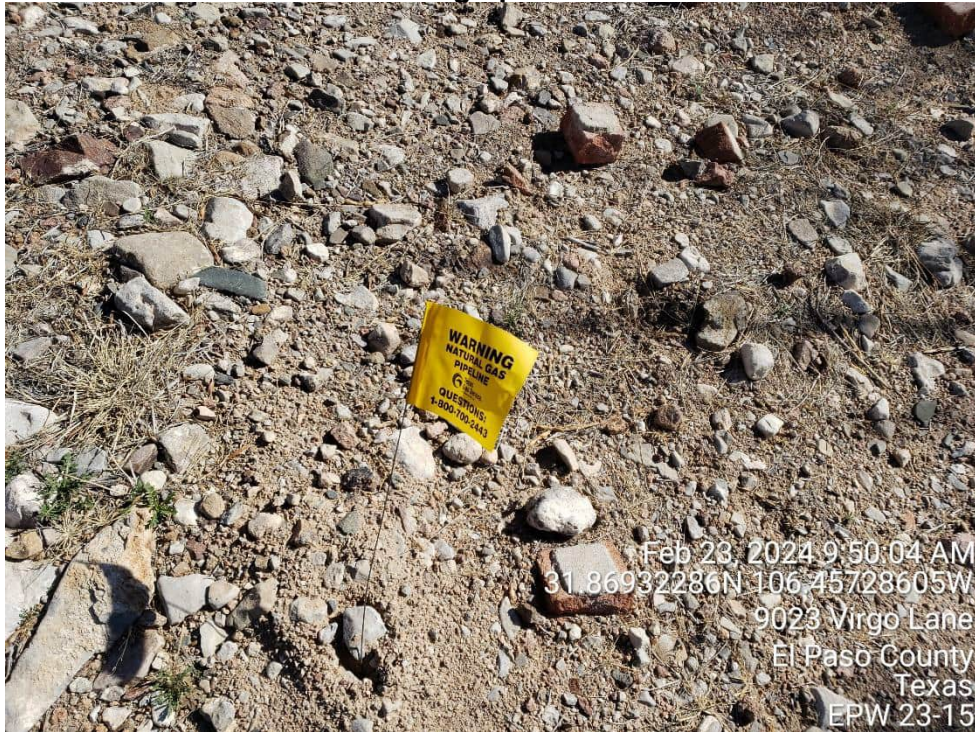
Photograph No. 5

View showing buried natural gas line near Project Site along Virgo Lane.
