Spring Creek

Aquatic Ecosystem Restoration Study

Colorado Springs, CO

Continuing Authorities Program, Section 206
Appendix B – Habitat Evaluation & Modelling

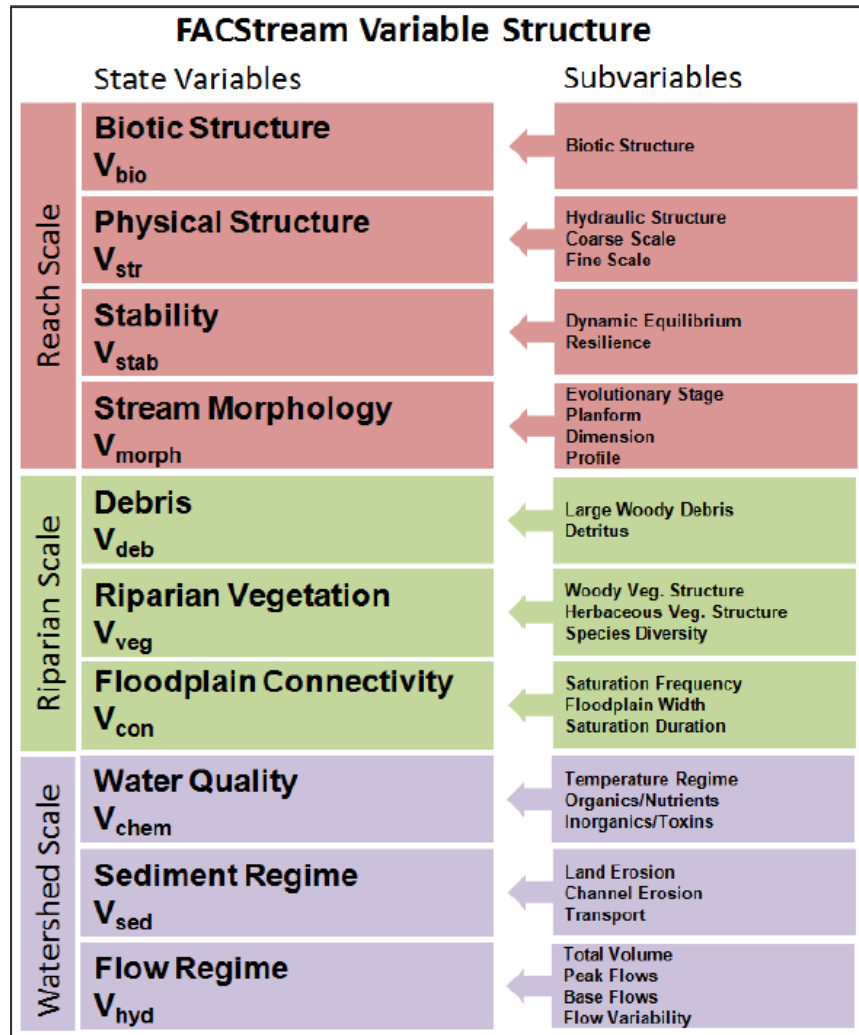
Figure 1 FACStream Variable Structure. Derived from Johnson et al. 2016

The FACStream method is a reach-scale functional assessment tool that rates functional condition based on the degree of impairment in comparison to a reference standard condition. Like FACWet, FACStream is a weight-of-evidence approach that utilizes the best evidence available through desktop analysis and field verification within a rapid assessment timeframe to develop and support ratings for 10 variables and their associated sub-variables (Johnson et al., 2016) (see Figure 2).

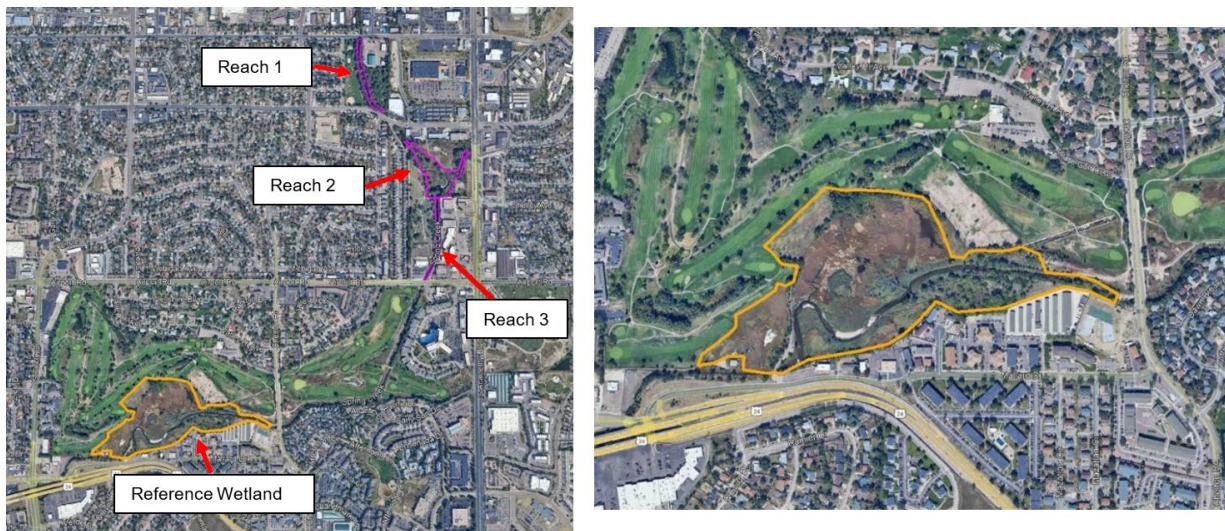
Figure 2 Left: Reference wetland (yellow outline) in relation to the Spring Creek Study Site (purple outline).
Right: Reference Wetland (yellow outline),

The Both FACWet and FACStream require a reference standard condition to be used as a comparison to the Spring Creek project. An area approximately 1 mile downstream was selected for reference of relatively natural conditions (Figure 3. Map of Ref Wetland). This area was selected as a suitable reference standard as it reflects a more natural state of the creek system.

The reference area is comprised of meandering bends, in-stream point bar formations, oxbows, connectivity to its floodplain and a stable riparian corridor that is influenced by stream modifications and two grade-control structures. The scoring process of the model variables was based on the comparison between historical conditions and Future Without Project (FWOP). The study team also considered expert knowledge of natural headwaters stream conditions in Colorado Springs area provided by the City’s Fountain Creek Watershed Project Manager (Berlemann, personal communication) when scoring stream variables. Additionally, aerial images (Google Earth) were used as a reference and evaluation tool by finding the reference site, identifying and delineating the assessment area, habitat connectivity and identification of stressors. It is important to note that the conditions at the reference standard location are not the goals for the Spring Creek project. The reference area is utilized only to identify the severity and extent that the identified stressors have influenced a departure of the project area from a reference standard or expected historical condition.

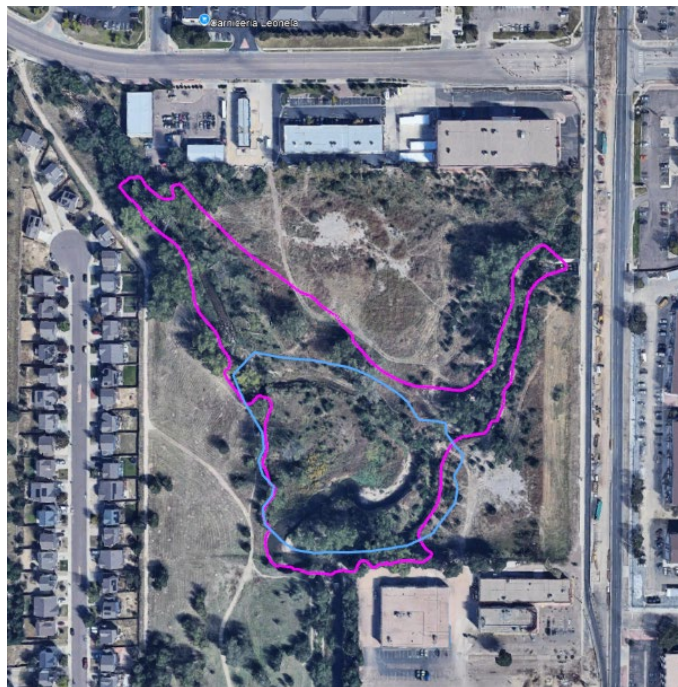
Figure 4 FACStream Assessment Area for Reach 2 (Violet line)(8.65 ac) overlaid with the FACWet Assessment Area for Reach 2 (Blue line)(6.53 ac).

Reach 2, also referred to “Former Wetlands” where the FACStream Area of Assessment was 8.65 ac and the FACWet Area of Assessment was 6.53 ac which represent the stream and wetland components respectively (Figure 5). This land was previously owned by the Audubon Society and has functioned as a wetlands bird sanctuary in the early 1980’s, when it supported a former wetland dominated by sandbar willow, Baltic rush, three square and hairy sedge. This Reach is 535 m long, and it has experienced a significant amount of incision that has led to an environmental shift from an emergent wetland to a riparian grassland (Figure 5.). Reach 2 is classified as a stream type “E” under the Rosgen Stream Classification (Rosgen, 1996) as a low-gradient meandering riffle-pool stream with low width-to-depth ratio and little deposition. The existing condition within Reach 2 consists of a single incised channel with steep or nearly vertical banks, that are not connected to the former wetland and overbank areas. The box culvert at the northern end of the reach where the stream crosses under Pikes Peak Ave. acts as a grade control structure and a second box culvert located in the east deposits’ urban wastewater from residential, municipal, and industrial parcels into the site. The quality, quantity, timing, and distribution of flows in Reach 2 have been severely impaired. This hydrologic regime has further driven the degradation of the stream’s morphology and riparian zone’s vegetative complexity. Overstory trees have persisted at the site and have become established in the former wetland area, with some large cottonwood trees and other loose branches occasionally falling into the channel. Reach 2 currently experiences a profound degree of floodplain disconnect that over time has eliminated the potential occurrence of normal hydroperiods and consequently the duration of saturation of soils throughout the floodplain. Hydroperiods are normally thought of as the length of time which soils are saturated, that is, days out of the year in which an area experiences inundation. Spring Creek’s floodplain has experienced a decrease in hydroperiod frequency as well as a decrease in the area that experiences hydroperiods. This ecological effect has confined most riparian herbaceous and shrub species to the immediate streambank and has increased soil oxidation rates and other soil disturbances in the upland areas of the Reach from constant human activity and regular use of pedestrian trails. A former bog area northwest of the Reach persists
