**Middle Rio Grande Flood Protection
Bernalillo to Belen, New Mexico
Mountain View, Isleta, and Belen Units**

Appendix E
Environmental Resources

December 2019

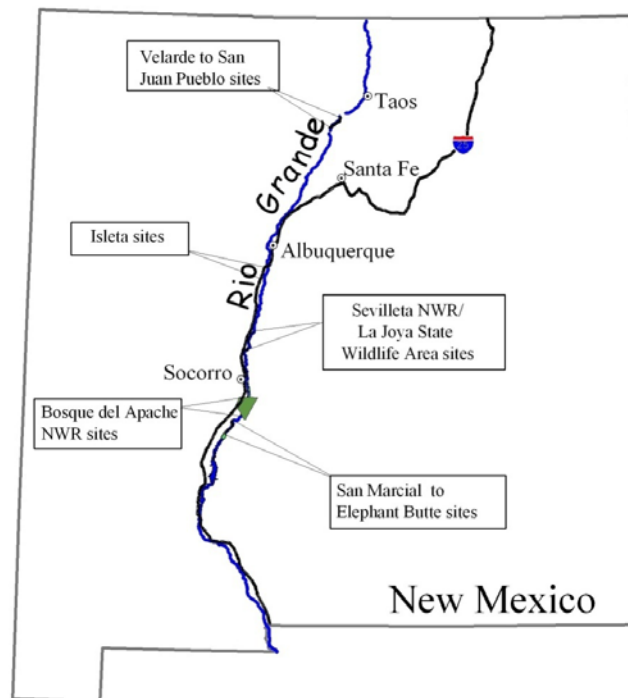
Figure 5. Location of flycatcher populations along the Middle Rio Grande in New Mexico.

Five general locations of flycatcher populations have been established throughout the Middle Rio Grande (Figure 5). These areas have consistently held several territories; however, the number of territories, pairs, nest attempts, and successful nests has varied through the years.

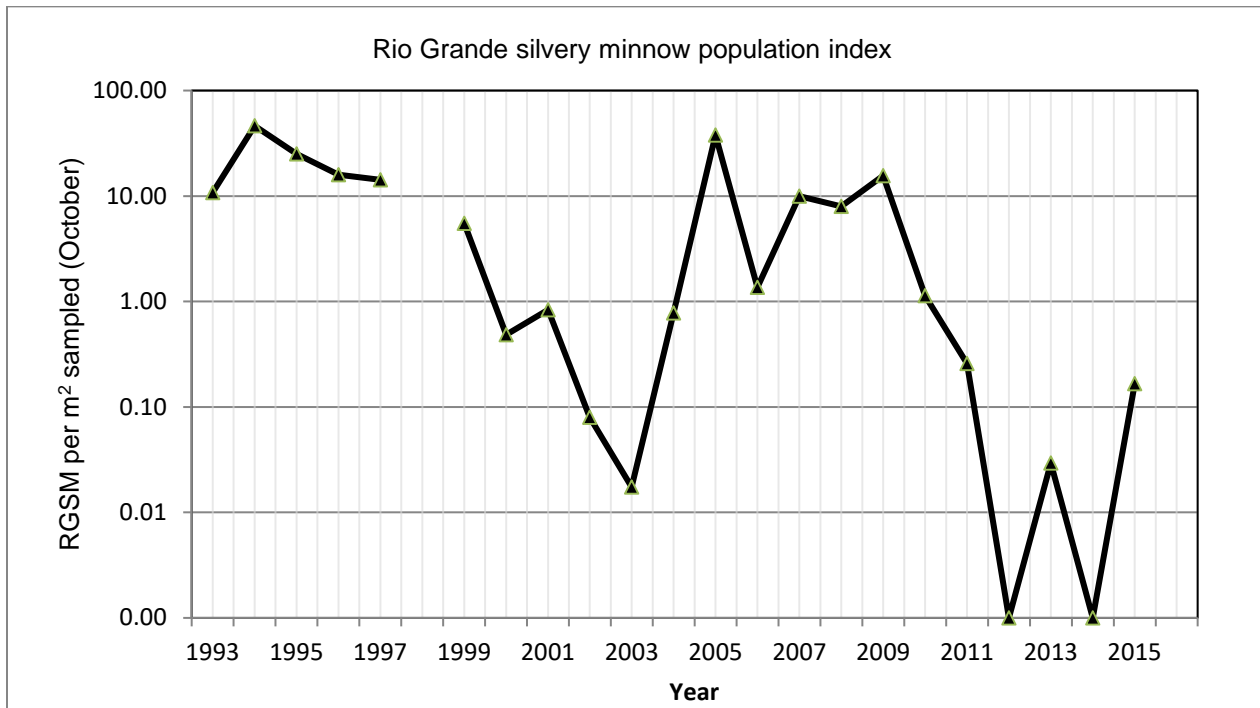
Figure 7. Rio Grande silvery minnow October population index.

The status of the silvery minnow in the action area has been documented by annual surveys. Over the period 1993-2015, October counts were conducted in the Angostura, Isleta, and San Acacia reaches (Dudley and Platania 2015). The density of silvery minnows (CPUE) varies several orders of magnitude across the years in response to spring flow and floodplain inundation (Figure 7).

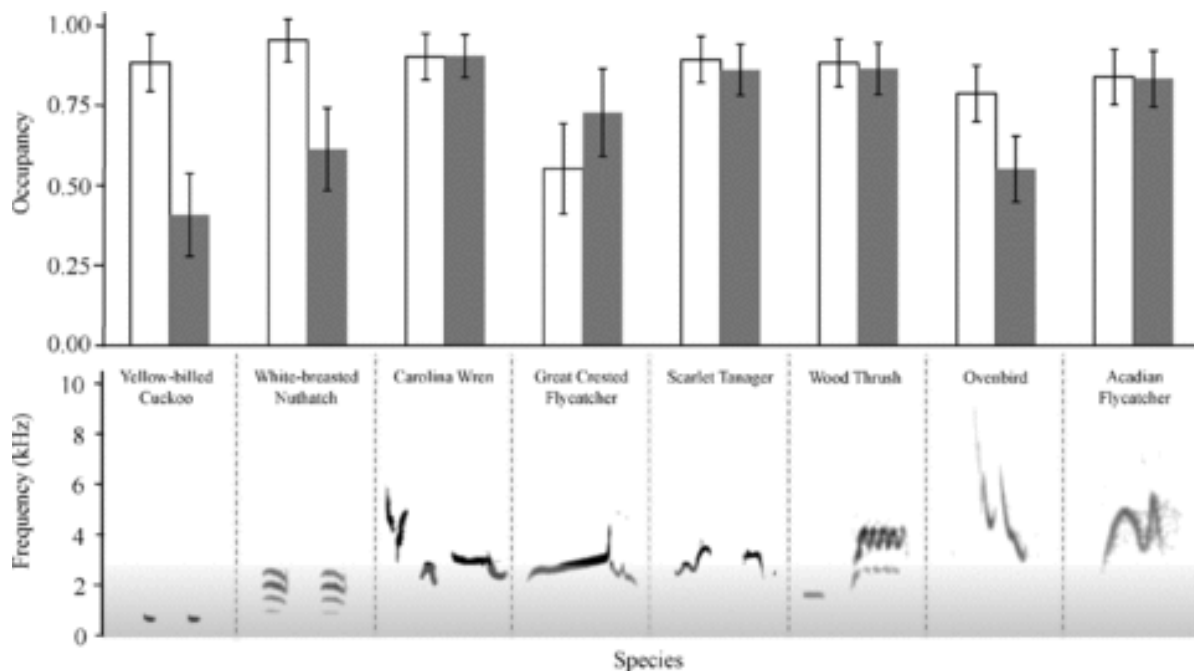
Figure 5. Estimates of bird occupancy in quiet (white bar) and noisy (gray bar) plots, and spectrograms of bird vocalizations or a portion of a vocalization (black) and frequency range of traffic noise (gray) (Goodwin and Shriver 2010).

Goodwin and Shriver 2010 documented that cuckoos are ten times less likely to be found in noisy (44-57dBA) areas than quiet areas. Areas within 250 meters (0.16 mile) of roads were considered “noisy” within the study (Goodwin and Shriver 2010). It was hypothesized that this was due to the traffic noise frequency (<3 kHz) overlapping with that of the cuckoo and, therefore, making communication more challenging for the species (Figure 5). Therefore, we consider chronic noise pollution an important factor affecting bird population distributions including those of cuckoos in the MRG.
