**HISTORICAL DOCUMENTATION OF  
MIDDLE RIO GRANDE FLOOD PROTECTION PROJECTS  
Corrales to San Marcial**

**HISTORICAL DOCUMENTATION**  
**OF**  
**MIDDLE RIO GRANDE FLOOD PROTECTION PROJECTS**  
**Corrales to San Marcial**

U.S. Army Corps of Engineers, Albuquerque District  
Contract No. DACW47-94-D-0019  
Delivery Order No. 0006

OCA/UNM Report No. 185-555

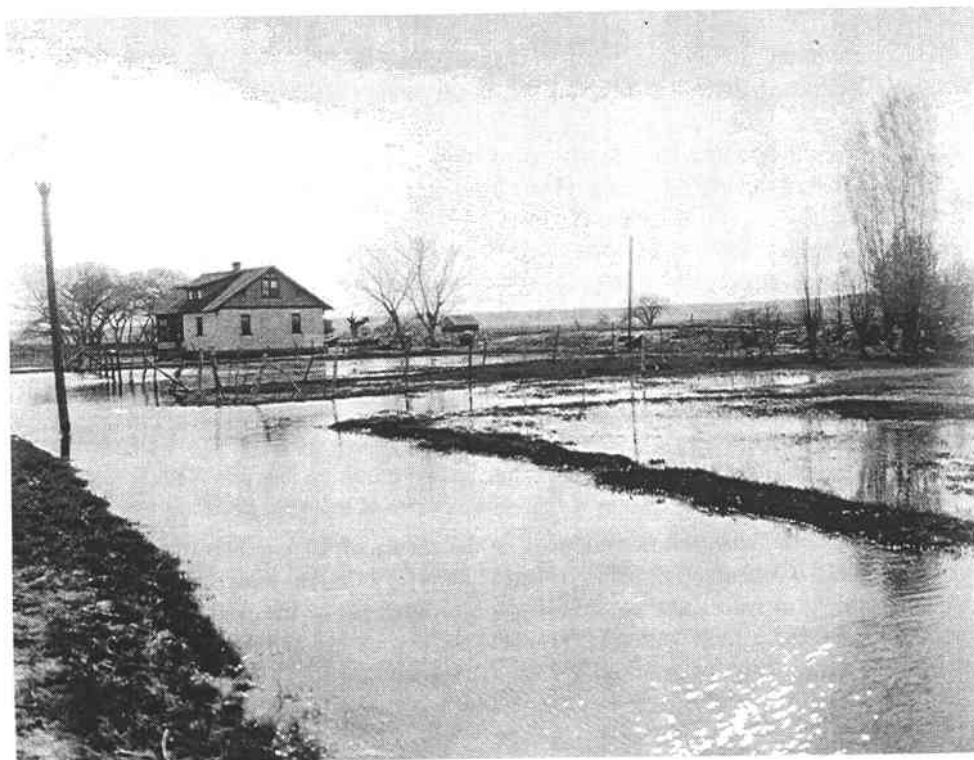
Figure 3

Waterlogging. Original MRGCD caption reads, "View showing seep swamp land in the Corrales District. Property of Francisco Garcia." *Source:* Middle Rio Grande Conservancy District, No. 813, Plate 1

In 1928, the MRGCD's *Official Plan* included sections on "Seeped Areas" and "Causes in Decrease of Cultivated Areas." It was reported that there were 50,000 acres of valley land which was waterlogged and affected by alkalinity (Figure 4), only 2,000 acres which were unaffected. Of the 50,000 acres of valley land approximately 45,000 acres were intended for agricultural use. Table 2 shows the 1926-27 classification of land in the middle Rio Grande valley. Throughout the valley approximately 72% of the agricultural lands had a water table which occurred from 0 to 4 ft below the surface. According to the *Official Plan*, once the water table rises to less than 4 ft from the surface, it is almost impossible to farm the land. During 1926-27, the MRGCD considered 3,038 acres in Corrales as agricultural valley lands. Of the 3,038 acres, 2,227 were considered non-farmable.<sup>45</sup>

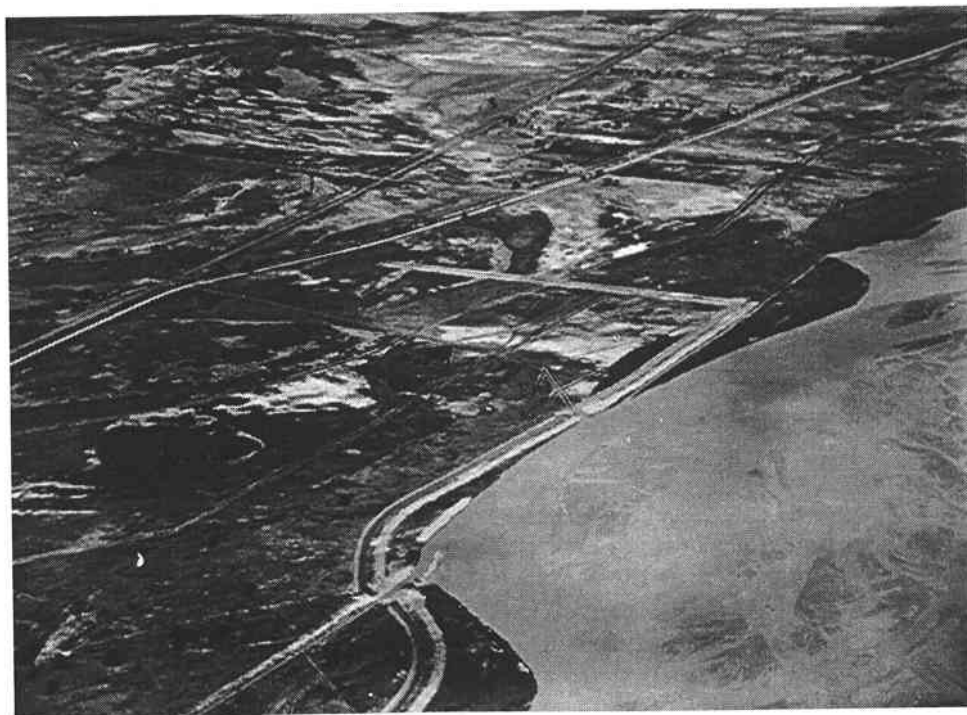
Figure 4

Alkali conditions. Original MRGCD caption reads. "Showing airplane view of Belen Riverside Drain and levee. Scene of the 'Battle of Los Chavez' Note Alkali land. May 26, 1930". *Source:* Middle Rio Grande Conservancy District, No. 202

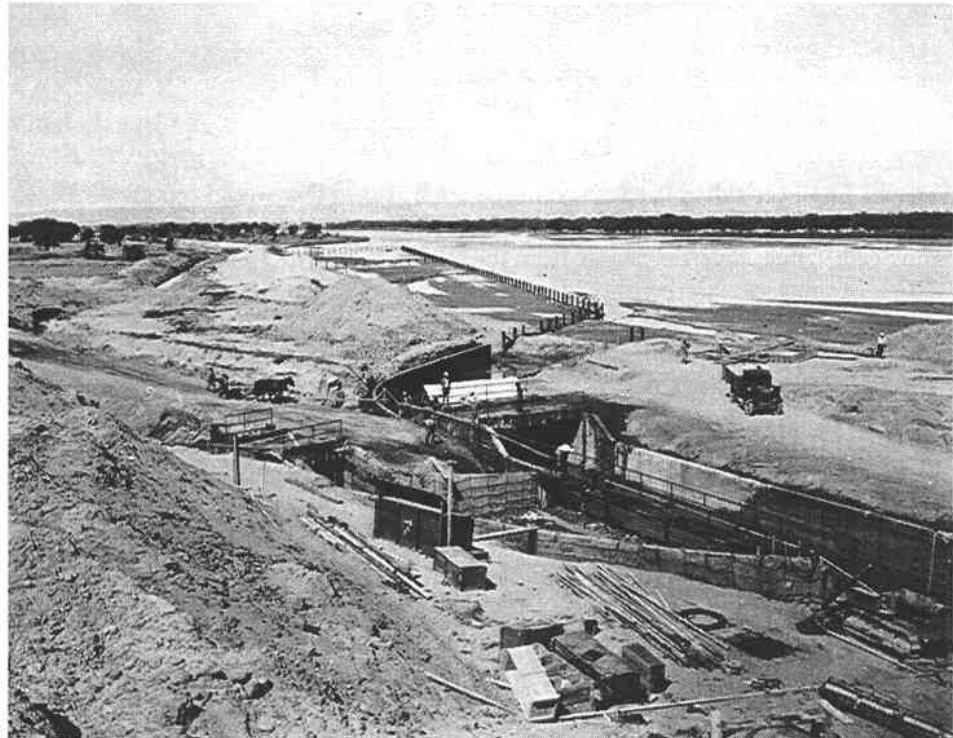
Figure 6

Construction of a diversion channel on the middle Rio Grande. *Source:* Middle Rio Grande Conservancy District, No. 495, Plate 33

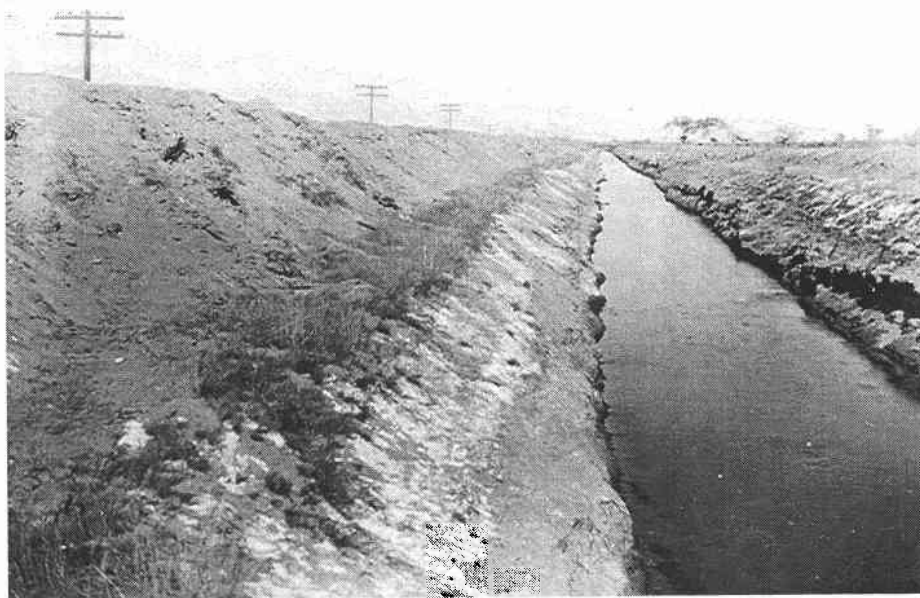
Figure 7

Interior drain. Original MRGCD caption reads, "View showing portion of the Bosque Interior Drain looking North from (Station 86)." *Source:* Middle Rio Grande Conservancy District, No. 706, Plate 1

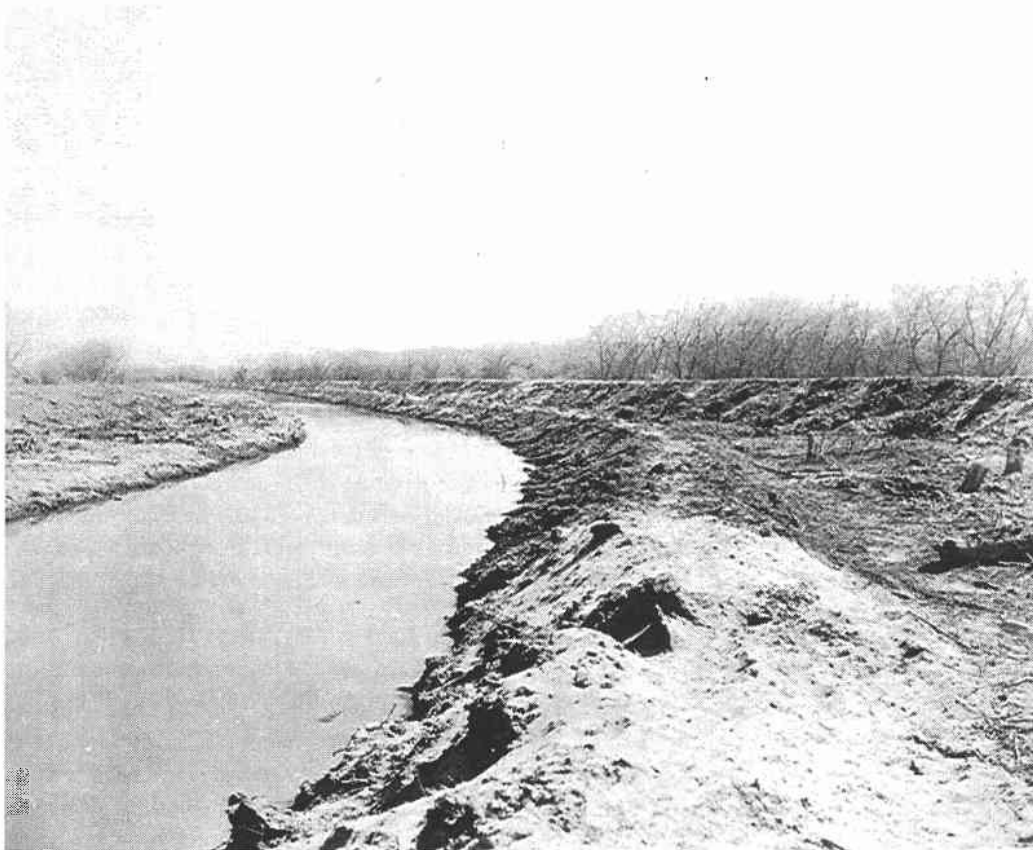
Figure 10 Riverside drain and spoil embankment. Original MRGCD caption reads, "View showing section of floodway with riverside drain near outlet. March 17, 1931." *Source:* Middle Rio Grande Conservancy District
