PRELIMINARY ASSESSMENT/SITE INVESTIGATION FINAL REPORT

APEX AND EL NIDO MINES TONGASS NATIONAL FOREST, ALASKA

OCTOBER 2003

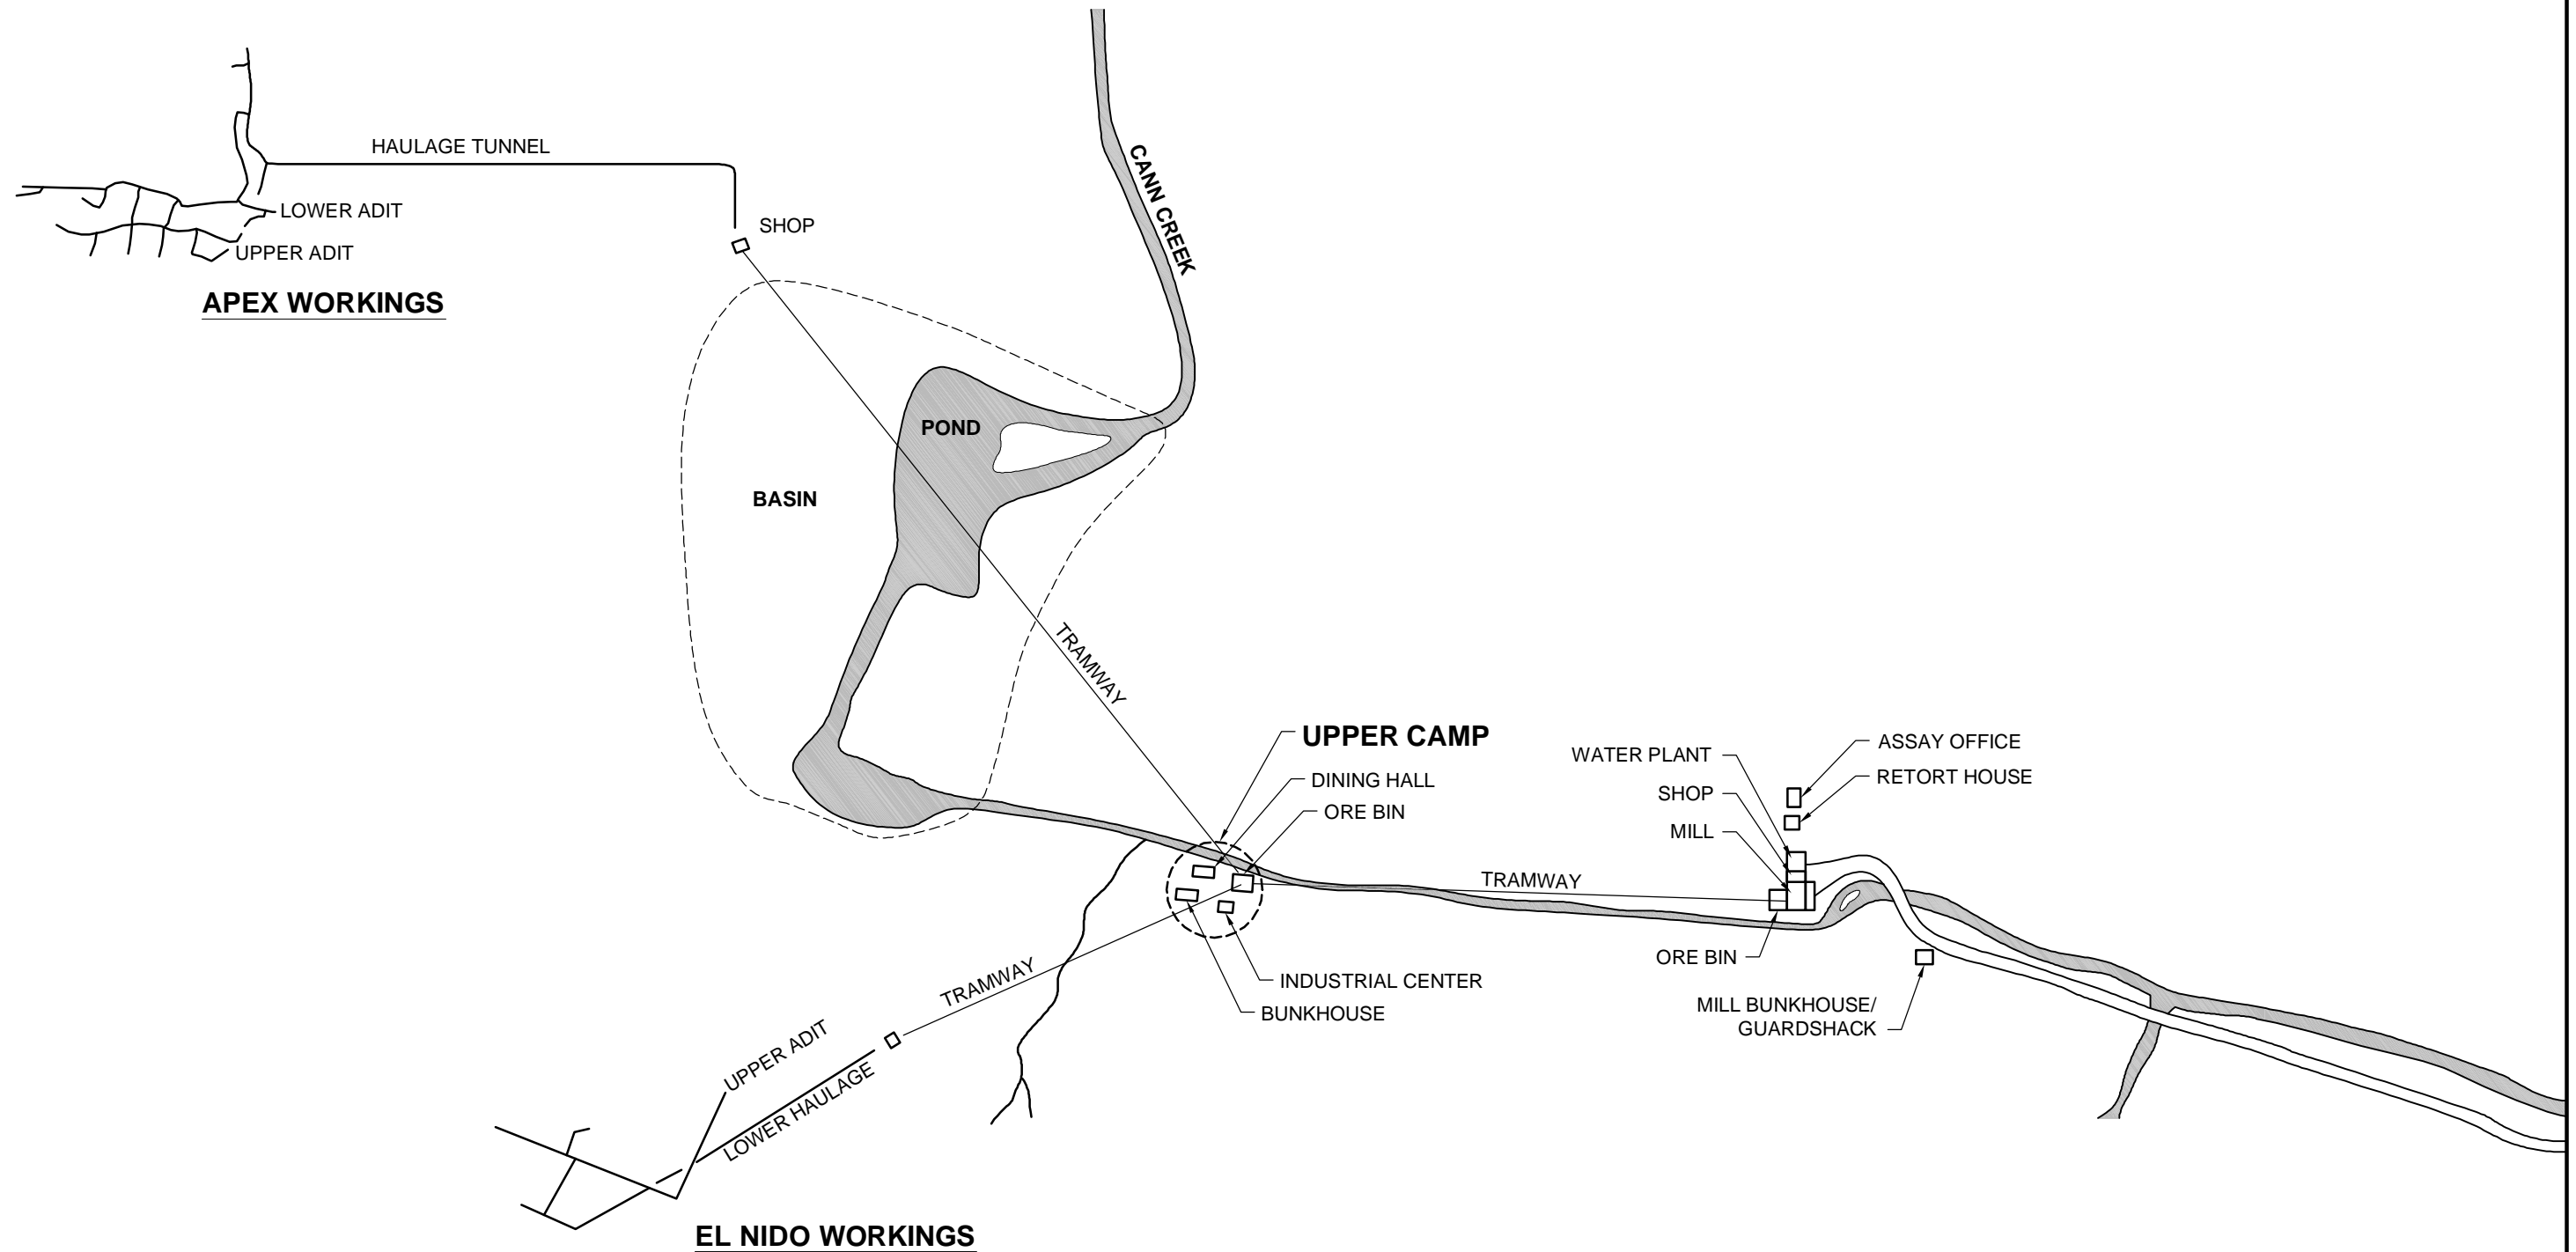
PRELIMINARY ASSESSMENT/SITE INVESTIGATION APEX AND EL NIDO MINES		
MINE WORKINGS, UPPER CAMP AND MILL		URS
TONGASS NATIONAL FOREST, ALASKA		
JOB NO: 26219528	DRAWN: ARN	
DATE: 8/12/03	FILE: FIGS 3 AND 4.DWG	FIGURE 3

SOURCE: REPORT OF G.L. HOLMES, ENGINEER, OCTOBER 1941
FEATURES SHOWN AS PRESENT IN 1941

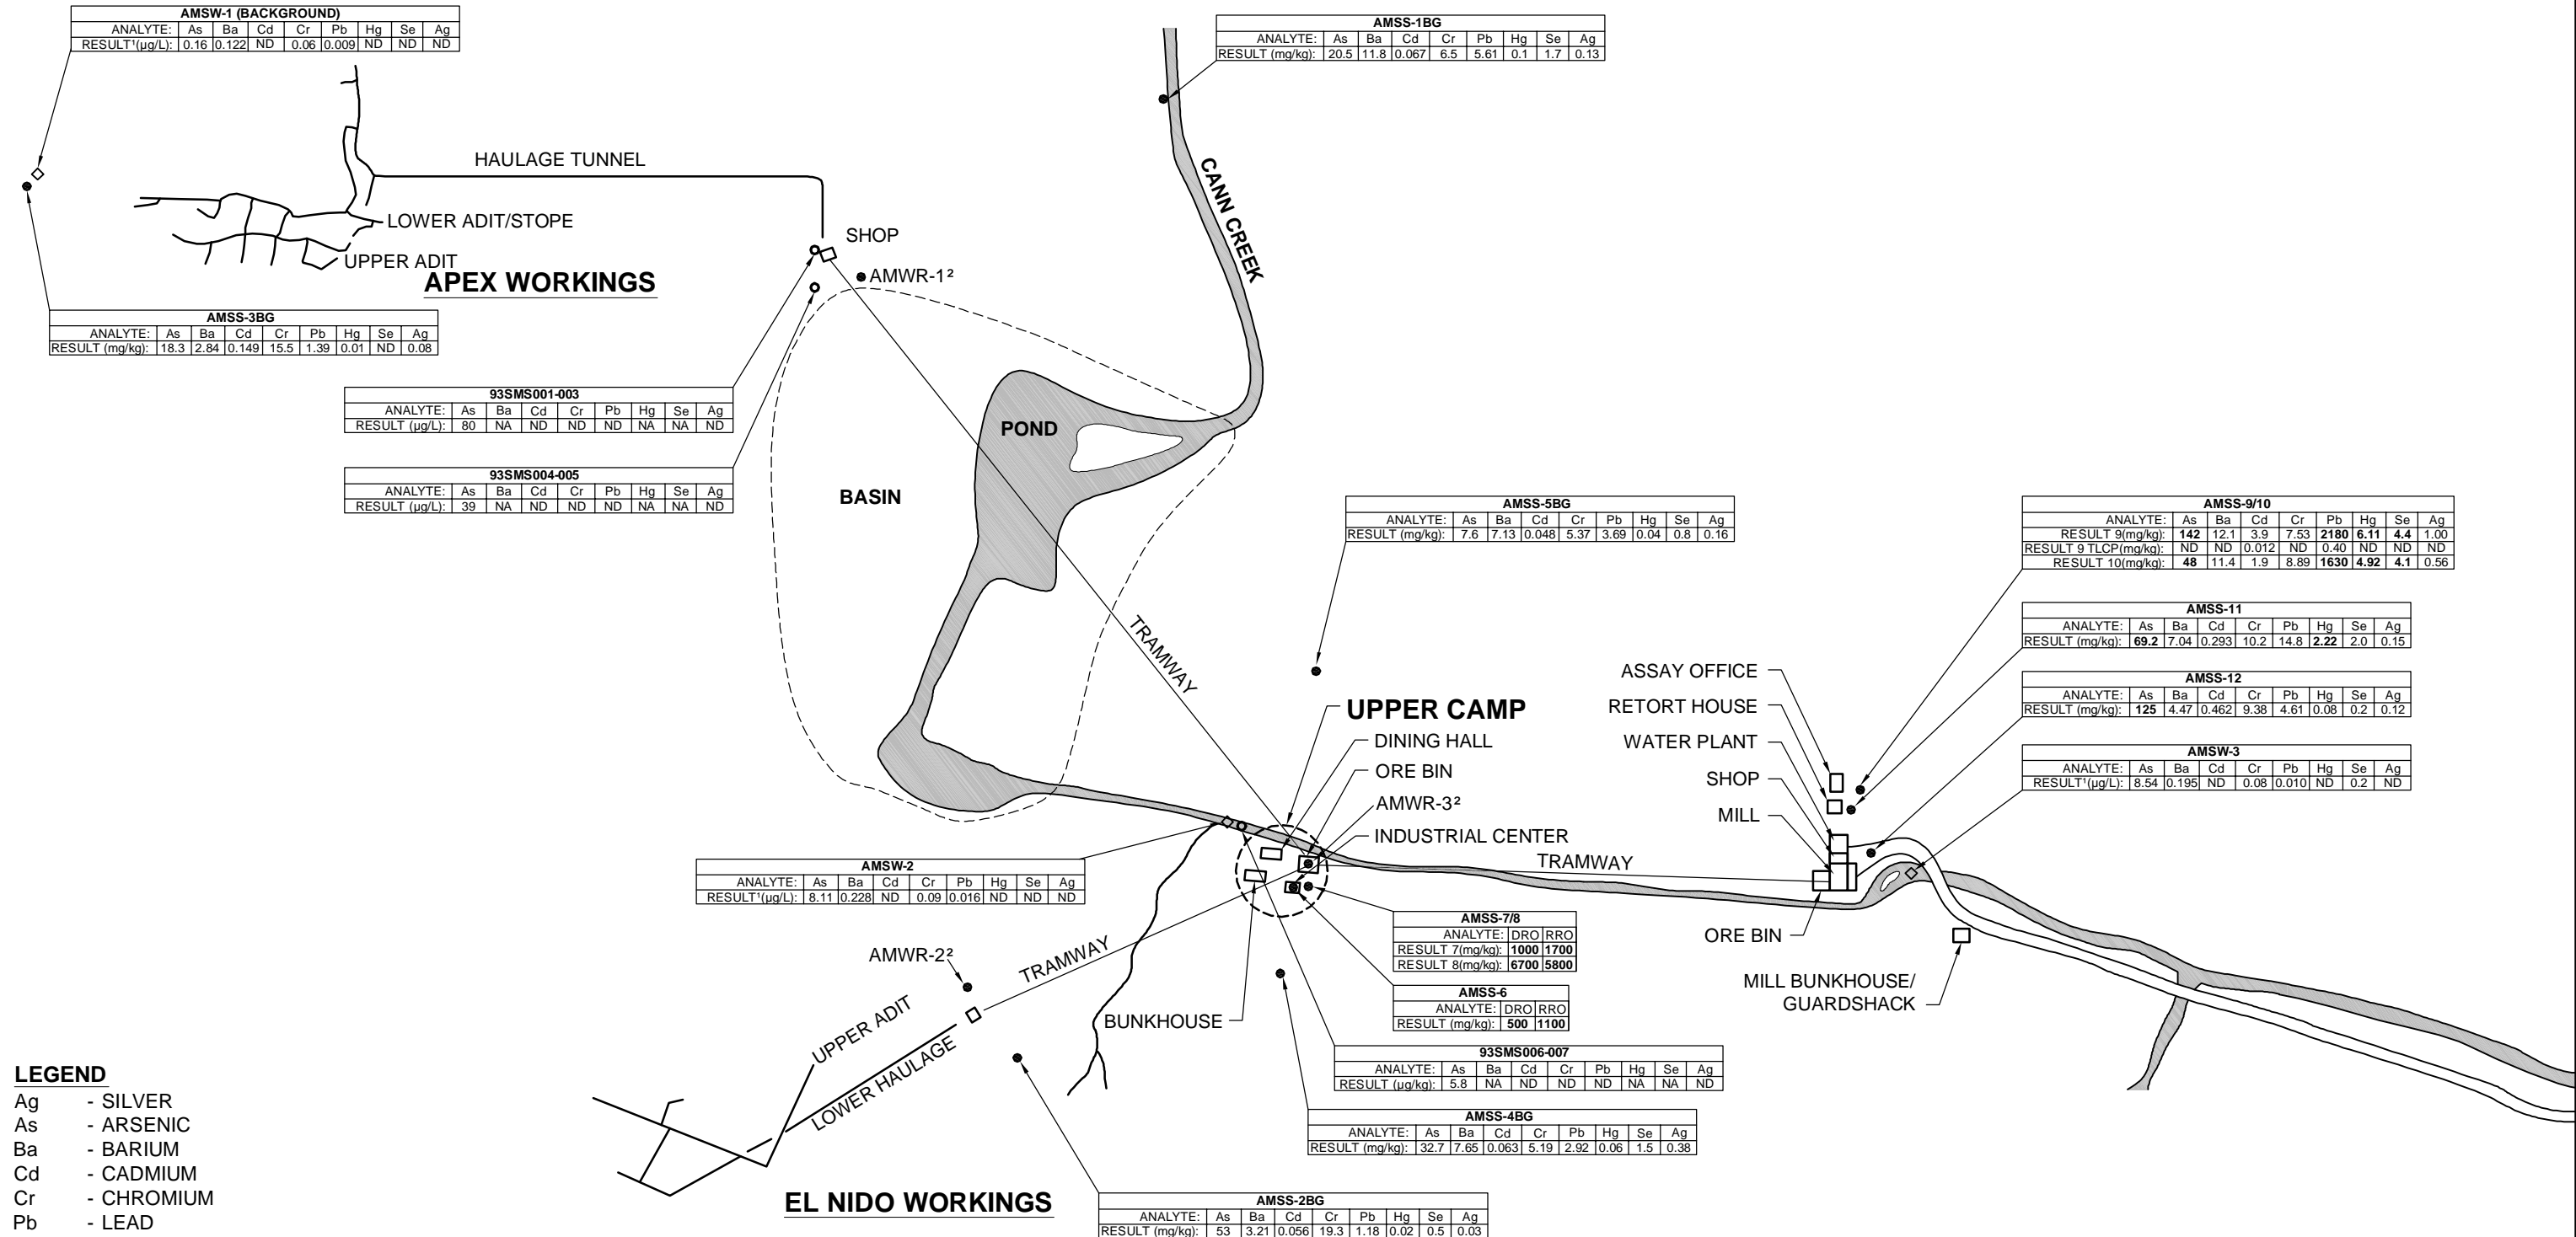
SAMPLE RESULTS UPPER AREA

BOLD VALUES EXCEED ADEC METHOD 2 MGW CLEANUP LEVELS

SOURCE: REPORT OF G.L. HOLMES, ENGINEER, OCTOBER 1941
FEATURES SHOWN AS PRESENT IN 1941

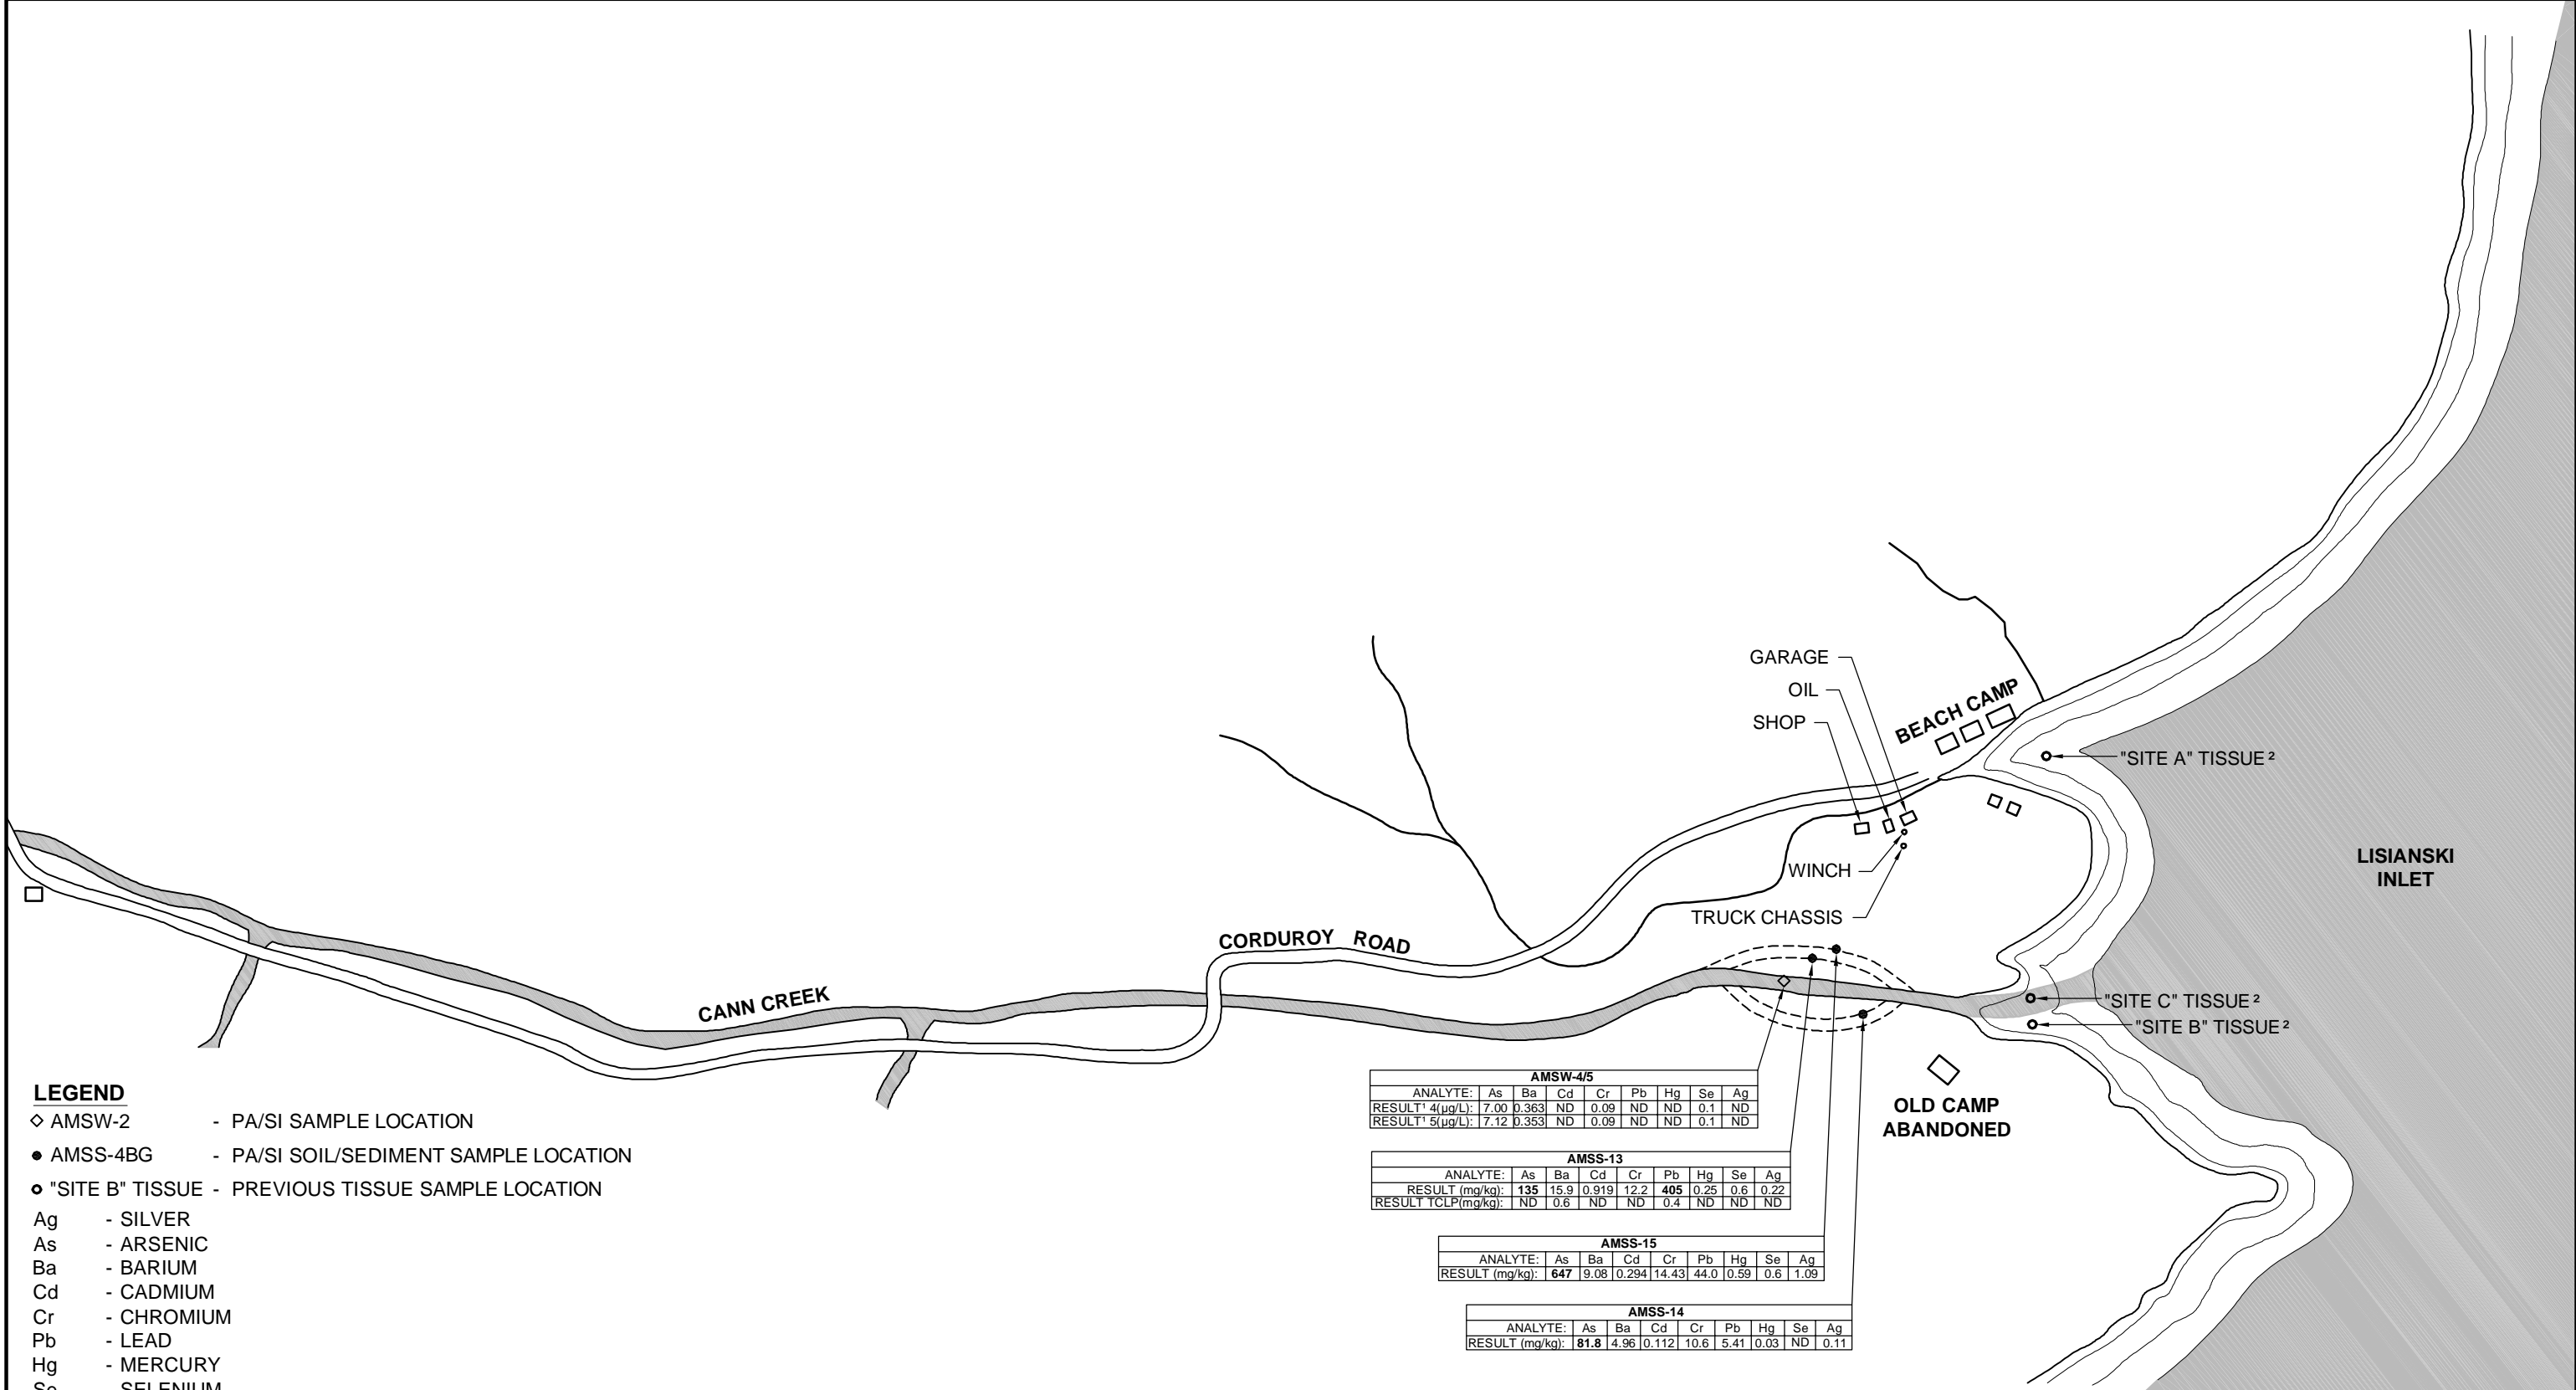
SAMPLE LOCATIONS
LOWER AREA

As, Cd, Pb, DRO AND RRO VALUES SHOULD BE CONSIDERED ESTIMATES
BOLD VALUES EXCEED ADEC METHOD 2 MGW CLEANUP LEVELS
SOURCE: REPORT OF G.L. HOLMES, ENGINEER, OCTOBER 1941
FEATURES SHOWN AS PRESENT IN 1941

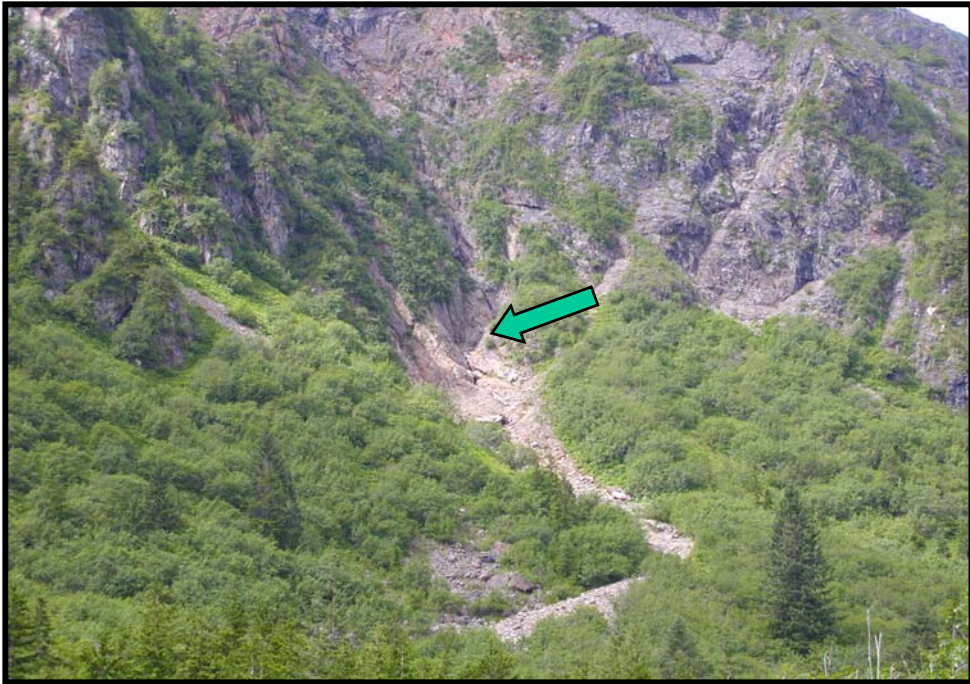
Apex Workings - The Apex haulage tunnel and lower adit were blocked with rocks. Water was flowing from the Apex haulage tunnel at an estimated rate of less than 0.05 cfs. This is apparently less than the flow from the Apex haulage tunnel (referred to as the Apex adit) estimated in 1993. No water was observed to be flowing from the lower Apex adit, and no evidence of past flow from that opening was observed. Water from above the Apex workings was cascading down the rock face adjacent to the lower adit, where it infiltrated into talus along the slope below the adit. The upper Apex adit located above 1,300 feet elevation could not be accessed because of its location on a steep rock face. Several stopes developed along the surface exposure of the Apex vein were either blocked with rotten timbers and lagging, left partially open, or were completely open and supported with stulls. One open stope above the lower Apex adit was observed to be open to a depth of approximately 15 feet horizontally, and supported with intact stulls. The stope is relatively inaccessible due to its location on a steep rock face. The waste rock dump at the Apex haulage tunnel was estimated to contain approximately 7,000 to 8,000 yds³ of material.

1. Apex workings viewed toward southwest.

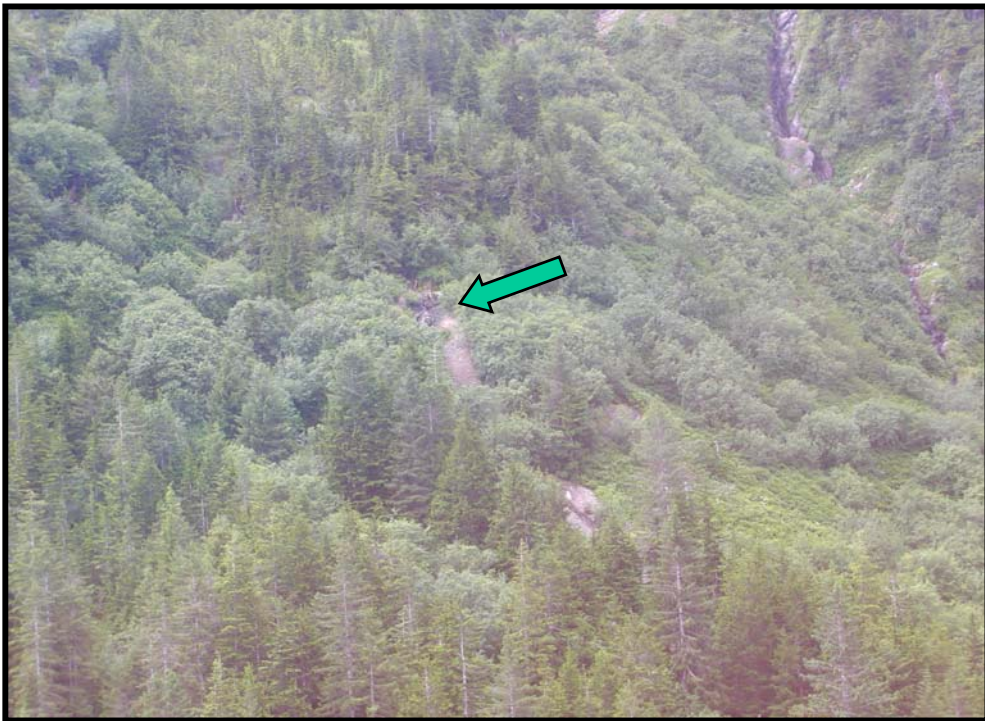
El Nido Workings - The El Nido haulage tunnel was open at the time of the site visit. USFS personnel reported the tunnel to be passable to at least 100 feet, where unstable conditions were encountered. The upper El Nido adit was not visited, but was observed along the east edge of a prominent gully about 500 feet west and 200 feet uphill of the haulage tunnel portage. As reported in the 1993 Watershed Report, water was flowing from the El Nido adit. It is estimated that the flow at the time of the PA/SI visit was less than 0.09 cfs. The waste rock dump at the El Nido workings was estimated to contain approximately 3,000 to 4,000 yds³ of material.

2. El Nido workings viewed toward south.

Additional evaluation of the extent of tailings distribution near the mouth of Cann Creek may be warranted. Consideration should be given to closing the open El Nido adit, or placement of warning signs to discourage entry into the underground workings. Signage may be appropriate to warn potential visitors of general physical hazards associated with the site features in their current condition.

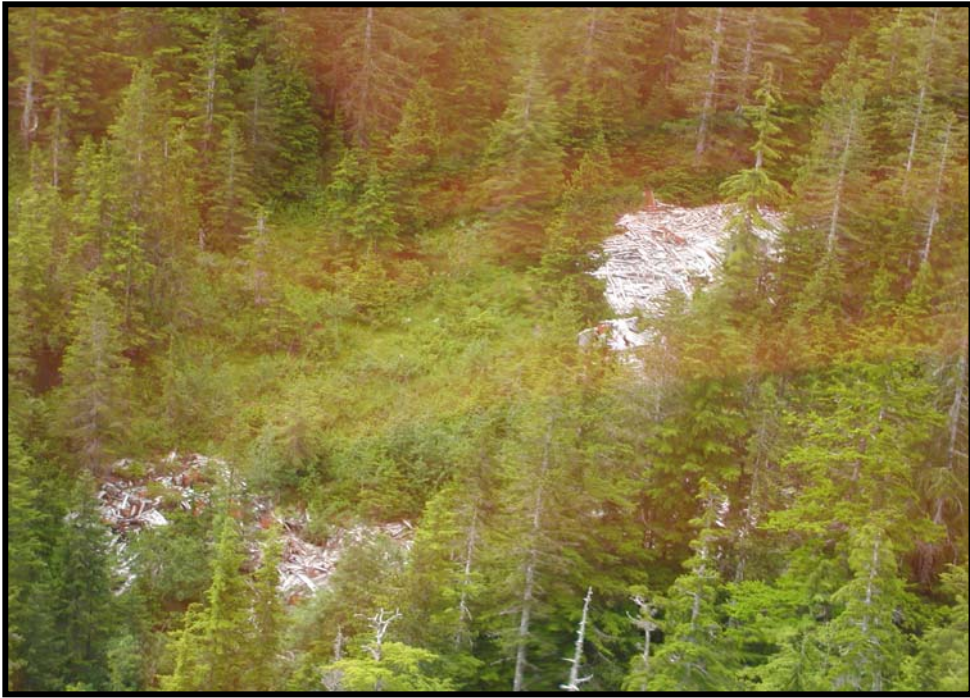
Upper Camp and Upper Cann Creek Area – The upper camp is located approximately 1,600 feet southwest of the mill, up a very steep hill. The upper camp is also located on Cann Creek, near the point that the creek flows out of the upper basin area. The upper camp is much as described in the 1993 Cultural Resource Survey, with some additional degradation of site features apparent since that time. The ruins of a kitchen, bunkhouse, cabin and industrial center are identifiable. Several other smaller features are also present, including an ore bin, a small pile of ore, and various tram components. The small cabin identified as standing in 1993 has collapsed. Several drums are present near the center of the industrial center, along with numerous metal, wood and rubber artifacts.

3. Upper camp.

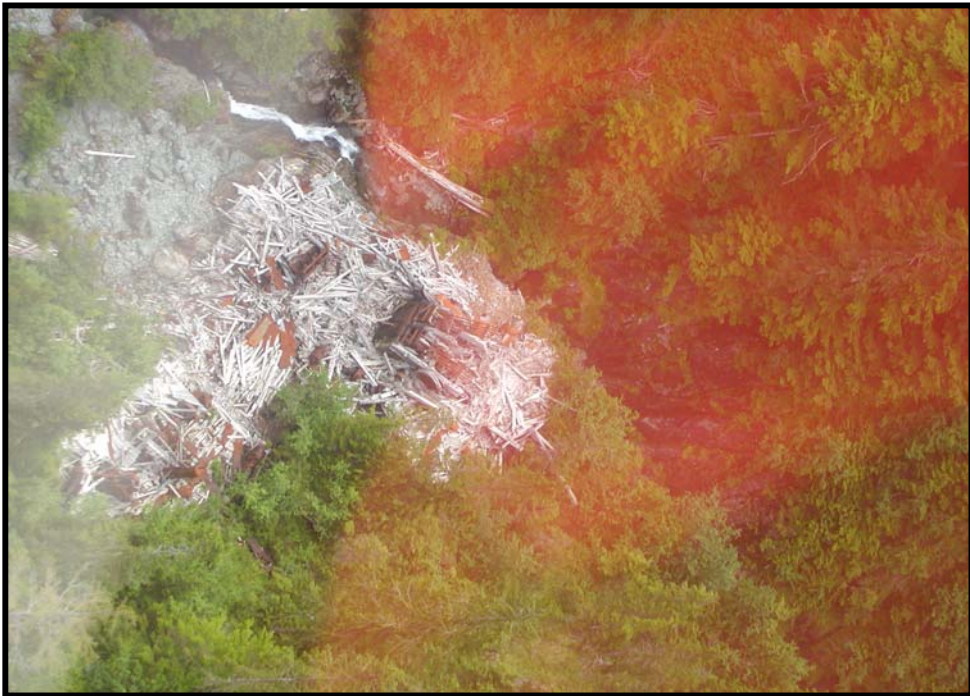
Mill Site and Mid-Cann Creek Area - The mill site is located approximately 1-mile southwest of the former beach camp, up Cann Creek and at the end of the corduroy road. The mill appeared to be much as described in the Cultural Resource Survey. Some additional items not identified in the 1993 survey were observed, including a ball mill and balls, the ruins of a retort house, and the ruins of an assay shop. The locations of the retort house and assay shop were established from the 1941 site map and visible evidence of former structures. Several intact crucibles were found adjacent to the assay shop, further confirming its former function. The ruins of a guard shack and/or small bunkhouse are present across Cann Creek approximately 400 feet from the mill.

4. Mill site.

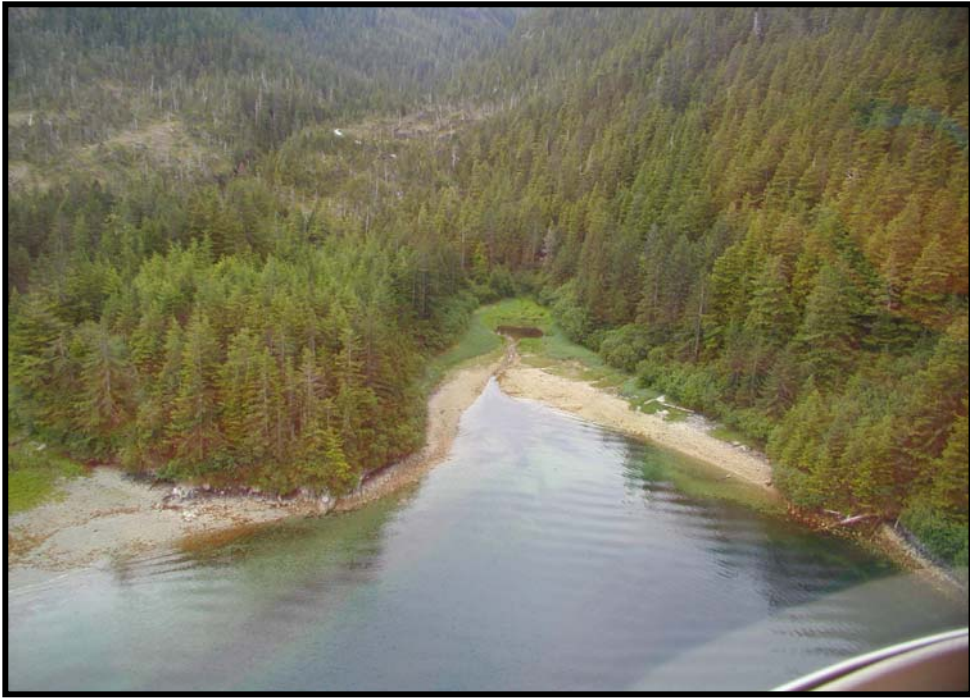
Beach Camp and Lower Cann Creek Area - The beach camp and lower Cann Creek was observed to be much as described in the Cultural Resource Report and USFS EA documents from 1993. The original beach camp site is located in a small cove northwest of the mouth of Cann Creek. Features identified at the beach camp site included dilapidated ruins of three former buildings. Two of the former buildings are believed to be a shop and a garage, based on the G.L. Holmes map. The nature of the third structure is unknown; however, assumed to be housing. Concrete pillars, a truck chassis, a car chassis, a winch, a drum, and other miscellaneous small items area also present. The remains of a platform or dock and a possible ramp are located adjacent to a small pond in the intertidal area. The corduroy road begins near the pond, and winds uphill to the mill site toward the southwest.

5. Beach camp area viewed toward southwest.

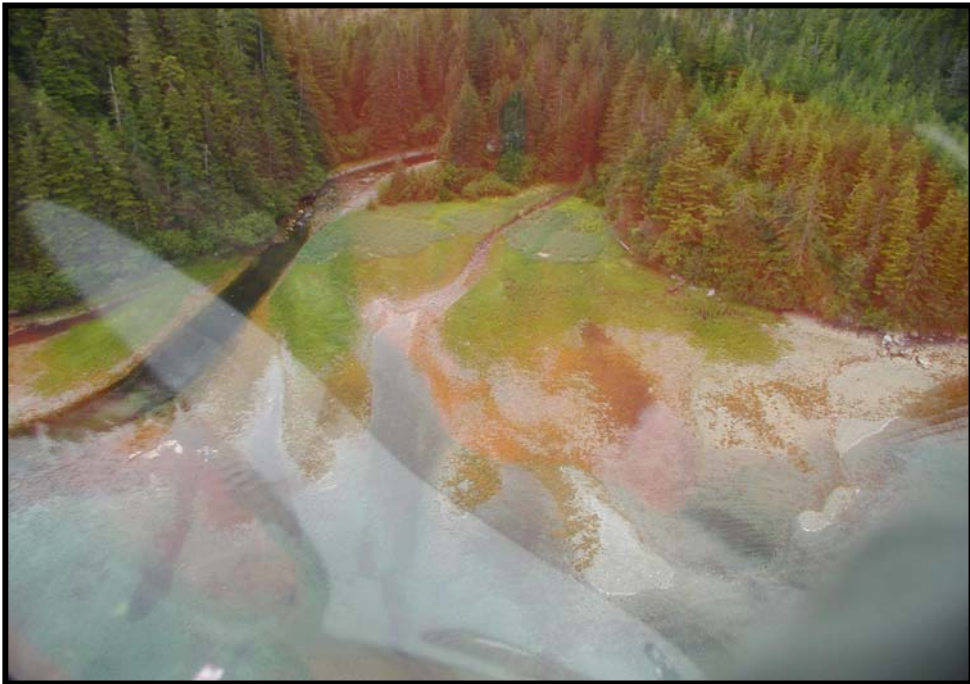
- Assumed tailings deposits near the mouth of Cann Creek do not appear to be extensive, based on the observations made during the site visit. Past sampling of Lisianski Inlet mussels in the area of Cann Creek showed no evidence of impacts from metals found in tailing samples. Based on the apparent lack of impacts to surface water quality or representative shellfish tissue, it is not believed that removal actions are warranted at this location.

6. Mouth of Cann Creek viewed toward southwest.

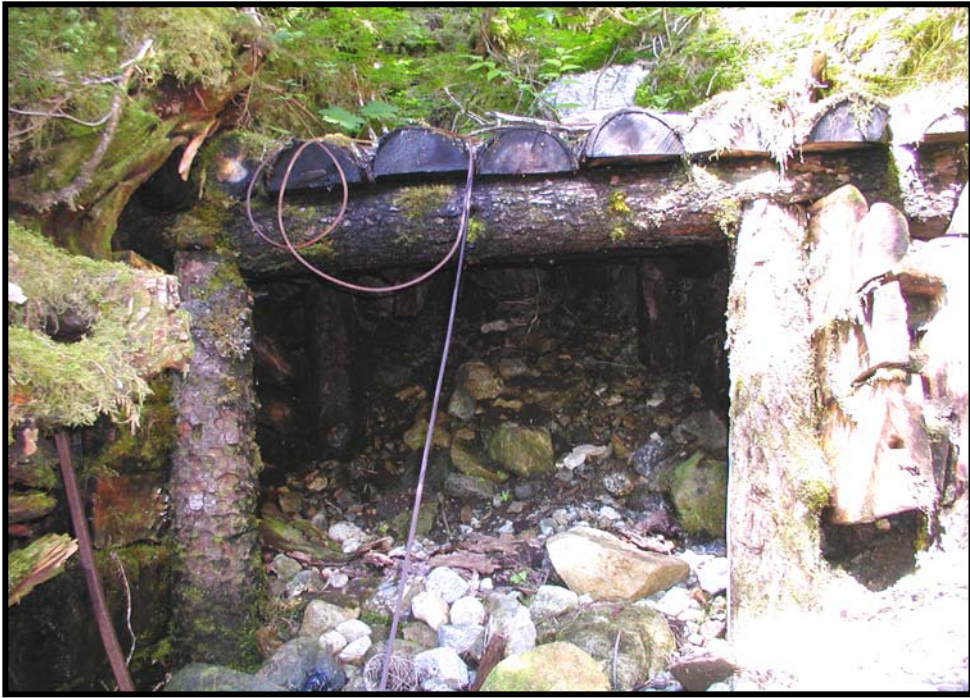
7. Apex haulage tunnel opening.

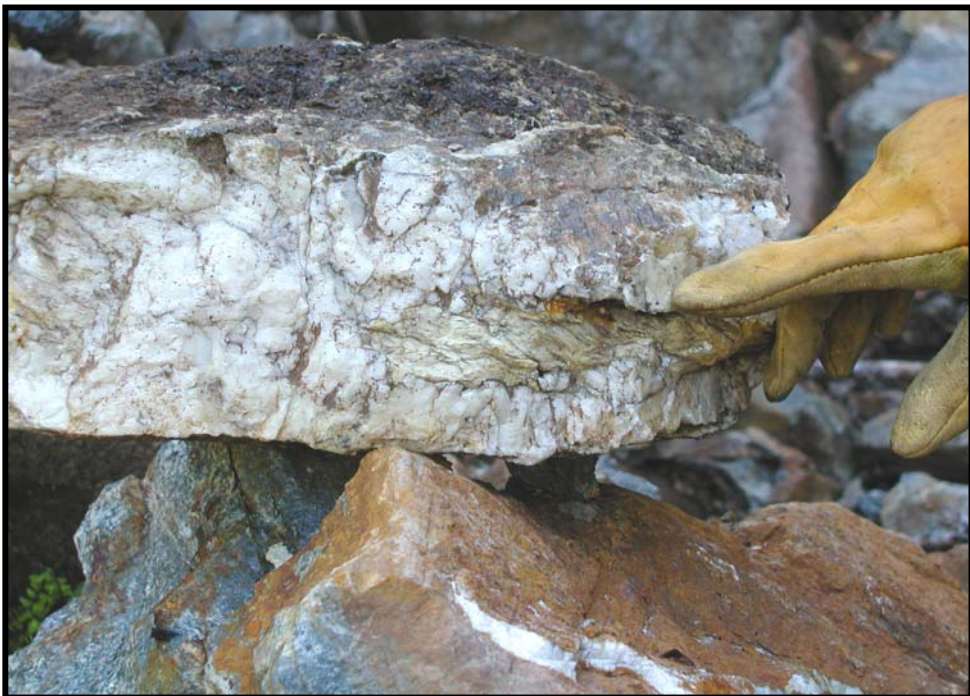
Observations made during the PA/SI site visit indicate the Apex waste rock to consist of approximately 85% to 90% amphibolite with less than 5% diorite and less than 5% quartz vein. The El Nido waste rock consists of approximately 75% to 80% diorite, 5% marble, 5% to 10% amphibolite and 5% quartz vein. Significant free calcium carbonate veins were observed in ore rock and in situ country rock around and above the Apex workings. The presence of calcium carbonate could be expected to provide some buffering of sulfide-related acidity.

10. Calcium carbonate in quartz vein at Apex workings.

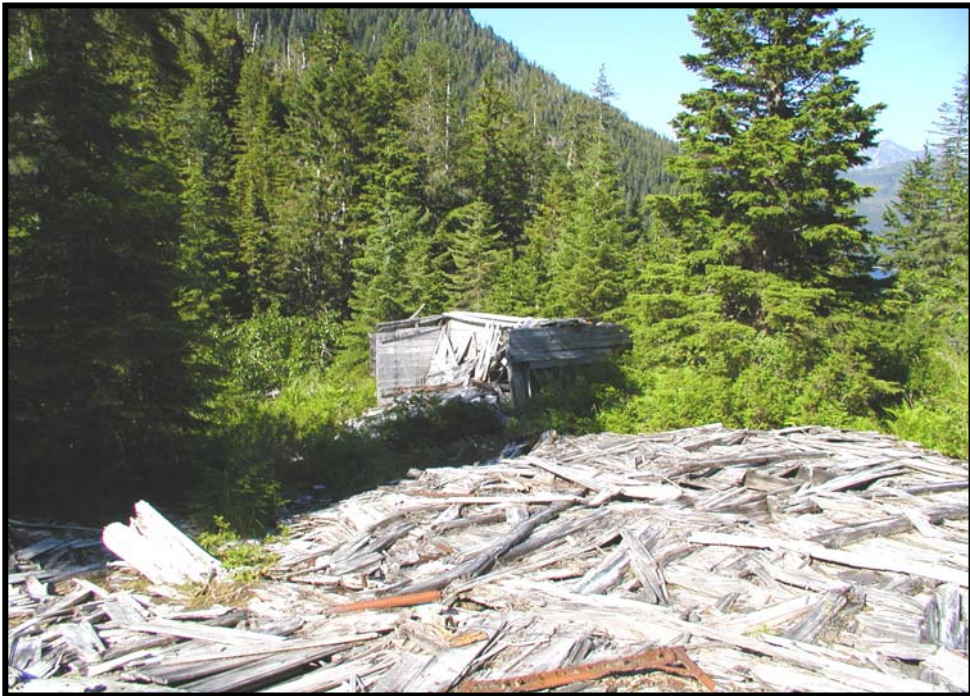
The observed condition of site features were much as described in the 1993 survey. Additional degradation to the upper camp was evidenced by the partial collapse of the cabin reported to be standing

in 1993. That structure was noted to be partially collapsed. The condition of the remainder of the upper camp appeared to be as described in the 1993 survey. A description of current site conditions is as follows:

14. Former cabin at upper camp (standing in 1993).

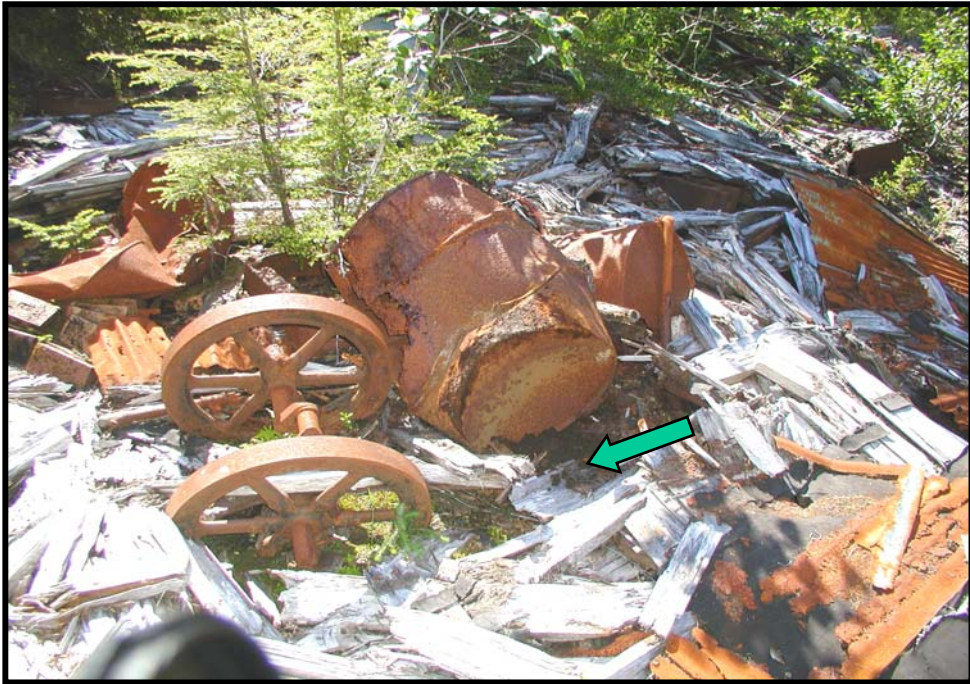
Primary samples AMSS-6 and AMSS-7, and duplicate sample AMSS-8 collected from the industrial center at the upper camp showed potentially elevated concentrations of hydrocarbons. The samples were analyzed for DRO and RRO. The results for the three samples ranged from 500 to 6,700 mg/kg DRO and 1,100 to 5,800 mg/kg RRO. These results should be considered as estimates, based on data validation flags. These results indicate a potential release, and an exceedence of ADEC MGW criteria for DRO. It should be noted that no indication of hydrocarbon contamination (i.e. – no odor or staining) was observed in the field. Typically, hydrocarbon impacted soil showing DRO concentrations in the range reported for these samples will exhibit observable evidence of impacts, including an odor and usually staining. This, combined with the poor duplication of results between AMSS-7 and its duplicate, AMSS-8, suggests that the DRO and RRO results reported for these samples may not accurately reflect site conditions and should be considered as estimates. Soil at the locations sampled was highly organic, and it is likely that this interfered with the analysis and resulted in a high bias in reported results. This is not believed to account for all of the reported DRO and RRO, but the actual hydrocarbon content of the soil is likely less than the reported value. Review of the sample chromatograms by the laboratory indicated the presence of fuel hydrocarbons; however, the chromatogram pattern was not consistent with the diesel standard used in calibration. It is likely that the high organic content of the soil would support alternate cleanup levels that are higher than the reported DRO and RRO concentrations. Additionally, based on observations in the field, the majority of potentially impacted soil at this location is beneath the historic ruins of the industrial center and not accessible.

15. Drum at industrial center at upper camp. Sample AMSS-6.

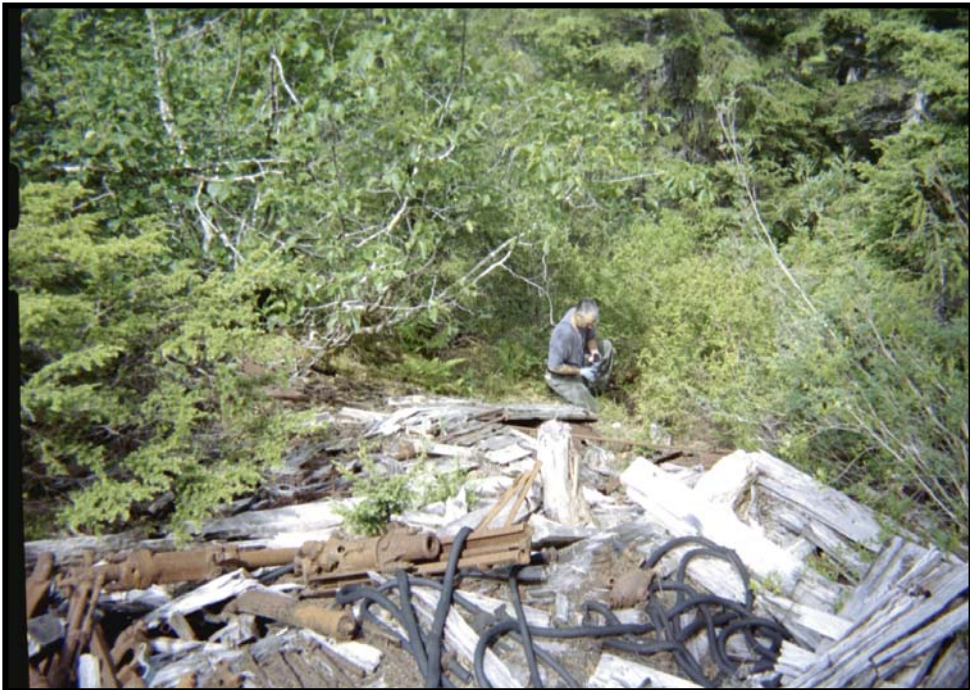
- A non-CERCLA observed release may be present below and adjacent to the industrial center at the upper camp, where DRO concentrations in two soil samples exceeded ADEC MGW criteria. The majority of impacted soil appears to lie beneath the historic ruins of the industrial center, and there is likely an element of organic interference in laboratory results causing a high bias in

16. Industrial center at upper camp. Sample AMSS-7/8.

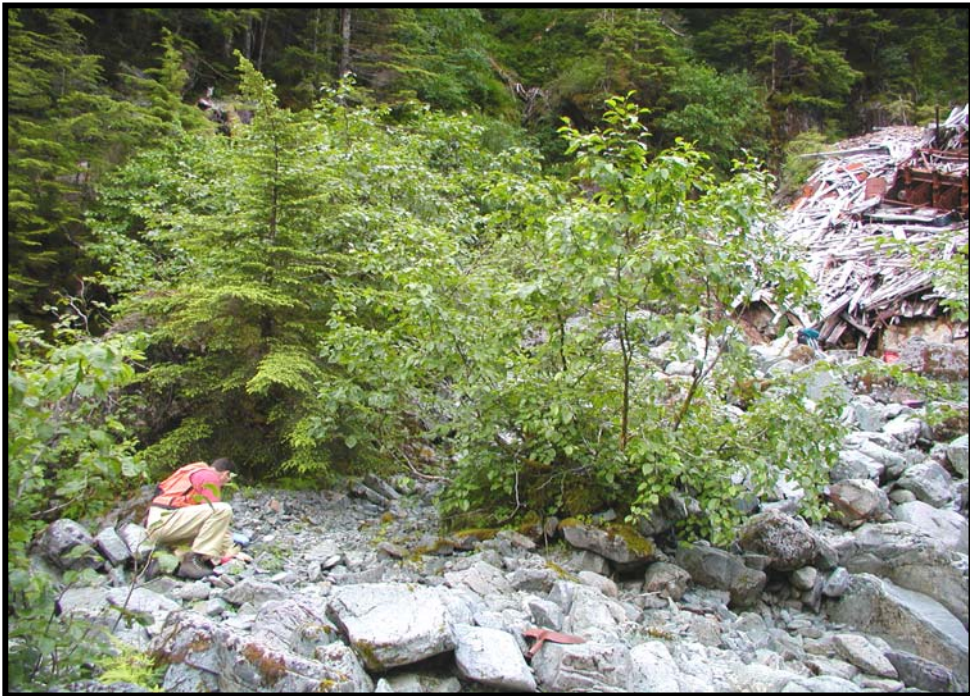
Based on the elevated arsenic concentration found in sample AMSS-12 downstream from the mill, some impact from elevated metals in the vicinity of the mill may have occurred in the past. It should be noted that very little fine sediment is present in the Cann Creek streambed between the mill and the beach camp area, so the significance of an impact to sediment is limited.

22. Cann Creek dry channel below mill. Sample AMSS-12.

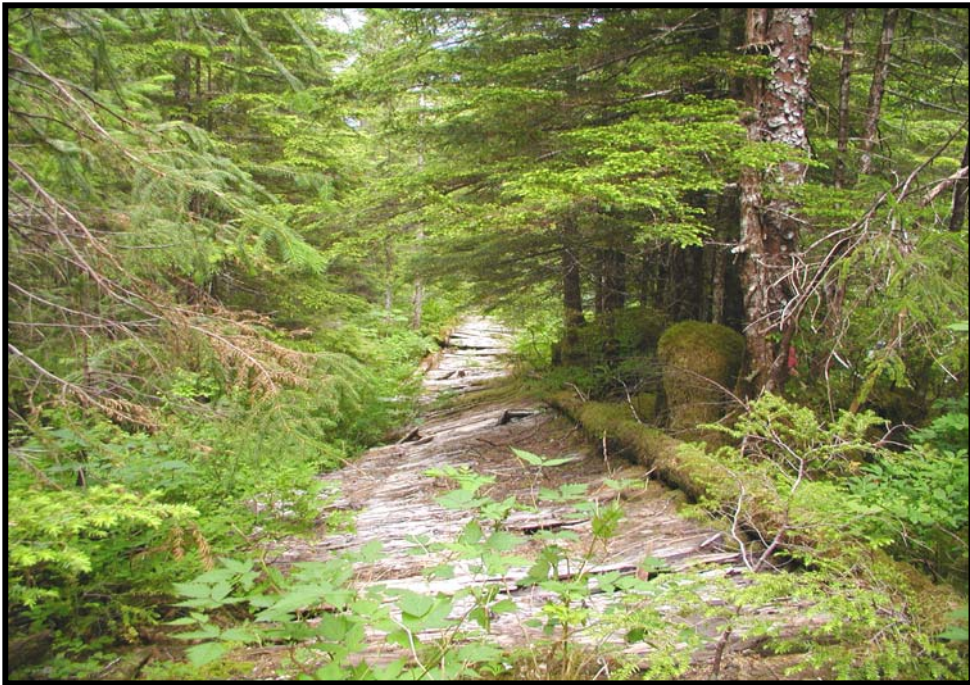
The corduroy road connecting the mill with the beach camp has likely degraded somewhat since 1993, and its condition varies significantly along its length. The road is currently locatable in several discontinuous sections between the mill and beach camp. The corduroy road is approximately 1 ½ miles in length, and crosses Cann Creek three times as it winds up the valley to the mill.

23. Corduroy road below mill bunkhouse.

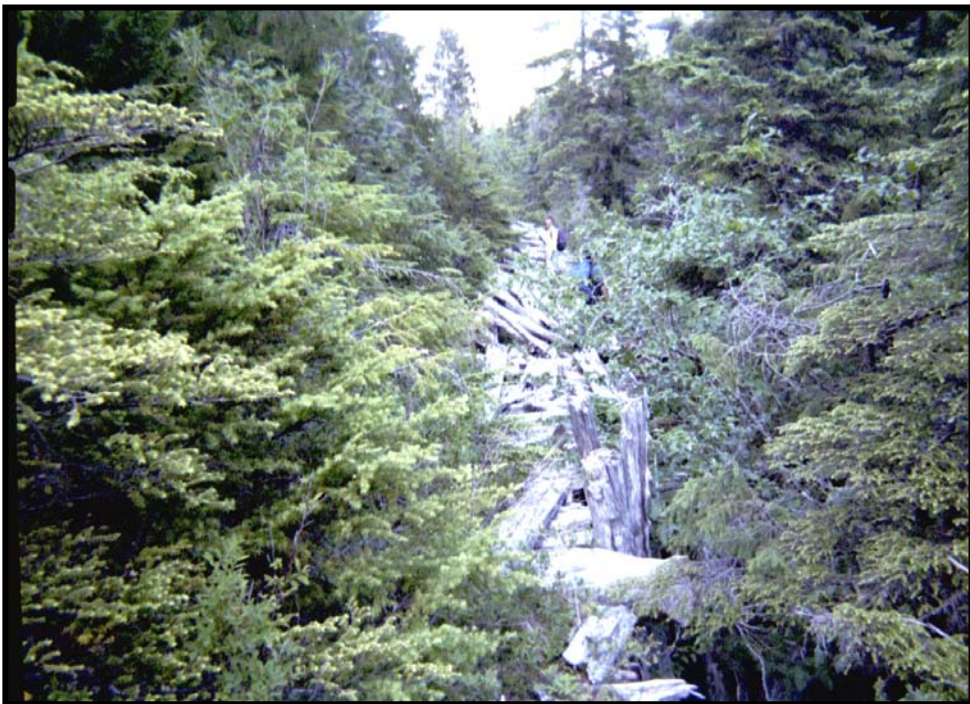
24. Lower corduroy road above beach camp.
