PRELIMINARY ASSESSMENT/SITE INVESTIGATION FINAL REPORT

APEX AND EL NIDO MINES TONGASS NATIONAL FOREST, ALASKA

OCTOBER 2003

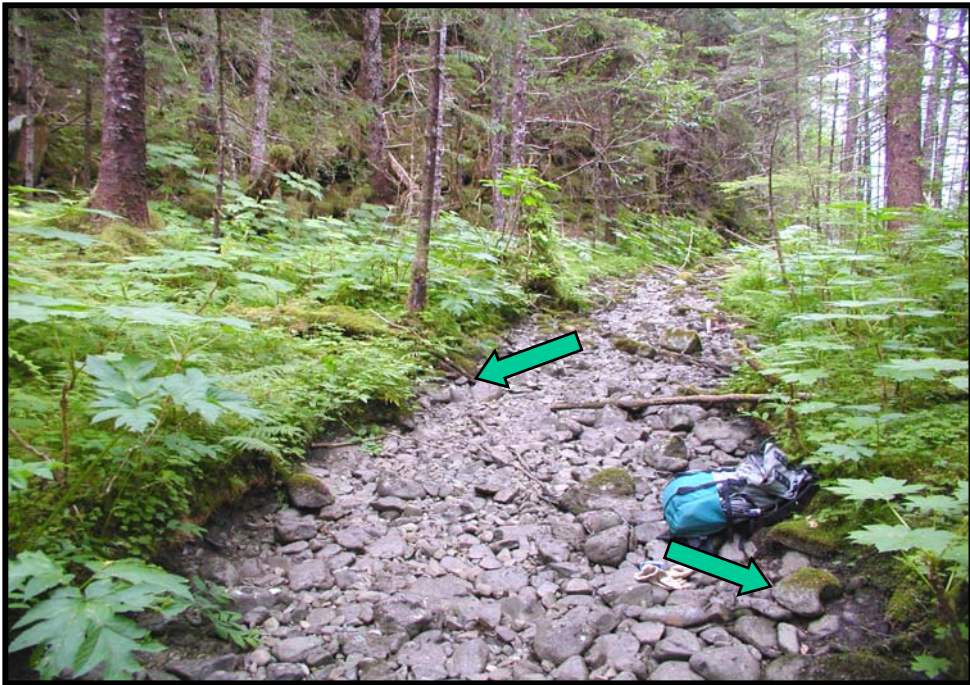
Primary soil samples AMSS-13, AMSS-14 and AMSS-15 were collected from the lower reaches of Cann Creek, near the beach camp. These samples were intended to evaluate the potential presence of tailings and mine-related metals impacts on sediment deposited near the mouth of Cann Creek. Lower Cann Creek, near Lisianski Inlet was the only location where tailings were found. The full extent of tailings in this area was not delineated during this investigation. All three samples from this area were analyzed for RCRA metals. Sample AMSS-13 was further tested for leachable metals using TCLP.

Based on field observations and the results of analysis, tailings deposits may be present in the lower area of Cann Creek, intermixed or beneath forest soil. Quartz-rich sands were observed in a 2 to 6-inch thick layer exposed in a dry flood channel outside of the main Cann Creek channel. The sand layers observed were stratigraphically below 6 inches to 1 foot of unsorted flood deposits. The assumption that the material observed may be tailings is based on lithology, color, texture and analytical results. Because none of the assumed tailings deposits are exposed outside of the dry creek channels, it is difficult to

25. Cann Creek dry channel near beach camp. Samples AMSS-13 and AMSS-15.

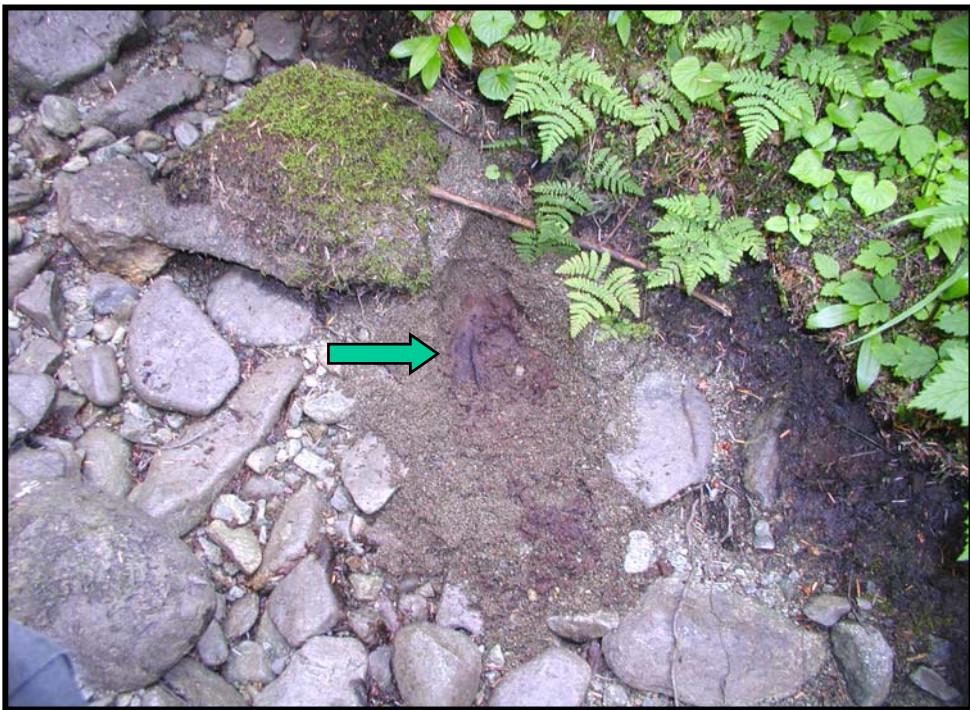
Elevated concentrations of arsenic and lead were present in the assumed tailings material. The concentrations of both of these metals in one or more samples collected from the lower Cann Creek area exceed ADEC MGW criteria. It should be noted that the reported concentrations of arsenic and lead are considered estimates, based on data validation flags. The pattern of high metals concentrations and the texture of the material sampled suggest it to be tailings. Where sampled, the apparent tailings were present in a thin layer, approximately 2 inches thick, exposed in the cut of a dry stream channel. The apparent tailings layer was overlain by approximately 1 foot of non-tailings sand and forest soil. The lateral extent of the apparent tailings away from the stream channel is not known; however, based on the topography of the area, it is unlikely that deposition would have occurred to any significant degree more than a few feet to a few tens of feet from the current dry stream channel. Tailings were not observed on the bank of the current active stream bank, or at any location above the lower-most reaches of Cann Creek.

At a higher water level than was present during the PA/SI site visit, Cann Creek would be in direct contact with the material sampled and identified as apparent tailings. Under those conditions, depending on the time of year, a complete exposure pathway could exist between that material and anadromous fish populations. Discharge of material to Lisianski Inlet could also occur; however, given the relatively small quantity of material exposed and the effect of dilution, it is unlikely that this would have any significant impact on the marine environment. Tissue samples collected in 1993 (Table 2) showed no evidence of elevated arsenic or lead concentrations, the metals found to be elevated in tailings within the Cann Creek flood channels.

26. Lower Cann Creek dry channel containing potential mine tailings. Sample AMSS-15.

Additional evaluation of the extent of tailings distribution near the mouth of Cann Creek may be warranted. Consideration should be given to closing the open El Nido adit, or placement of warning signs to discourage entry into the underground workings. Signage may be appropriate to warn potential visitors of general physical hazards associated with the site features in their current condition.
