**ABANDONED MINE
SITE INVESTIGATION
OF THE
IDORA MINE SITE
ALONG
BEAVER CREEK
IDAHO**

U.S. Army Corps of Engineers, Sacramento District and
U.S. Army Corps of Engineers, Omaha District

Bitterroot Restoration, Inc.
445 Quast Lane
Corvallis, MT 59828

July 28, 2003

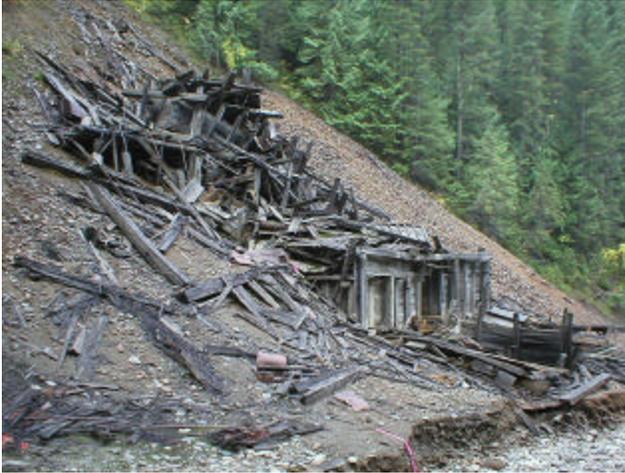
Idora Mine Site on Beaver Creek

Developed in the early twentieth century, the Idora Mine was active through the mid 1950s. The mine produced commercial quantities of silver and zinc, but the primary ore was lead. The mill site and tailings, located in and adjacent to Beaver Creek, are being actively eroded. Preliminary evidence indicates that the site is the source of a significant amount of heavy metal contamination to the downstream reaches, which contain residences, frequent recreation usage, and wildlife habitat.

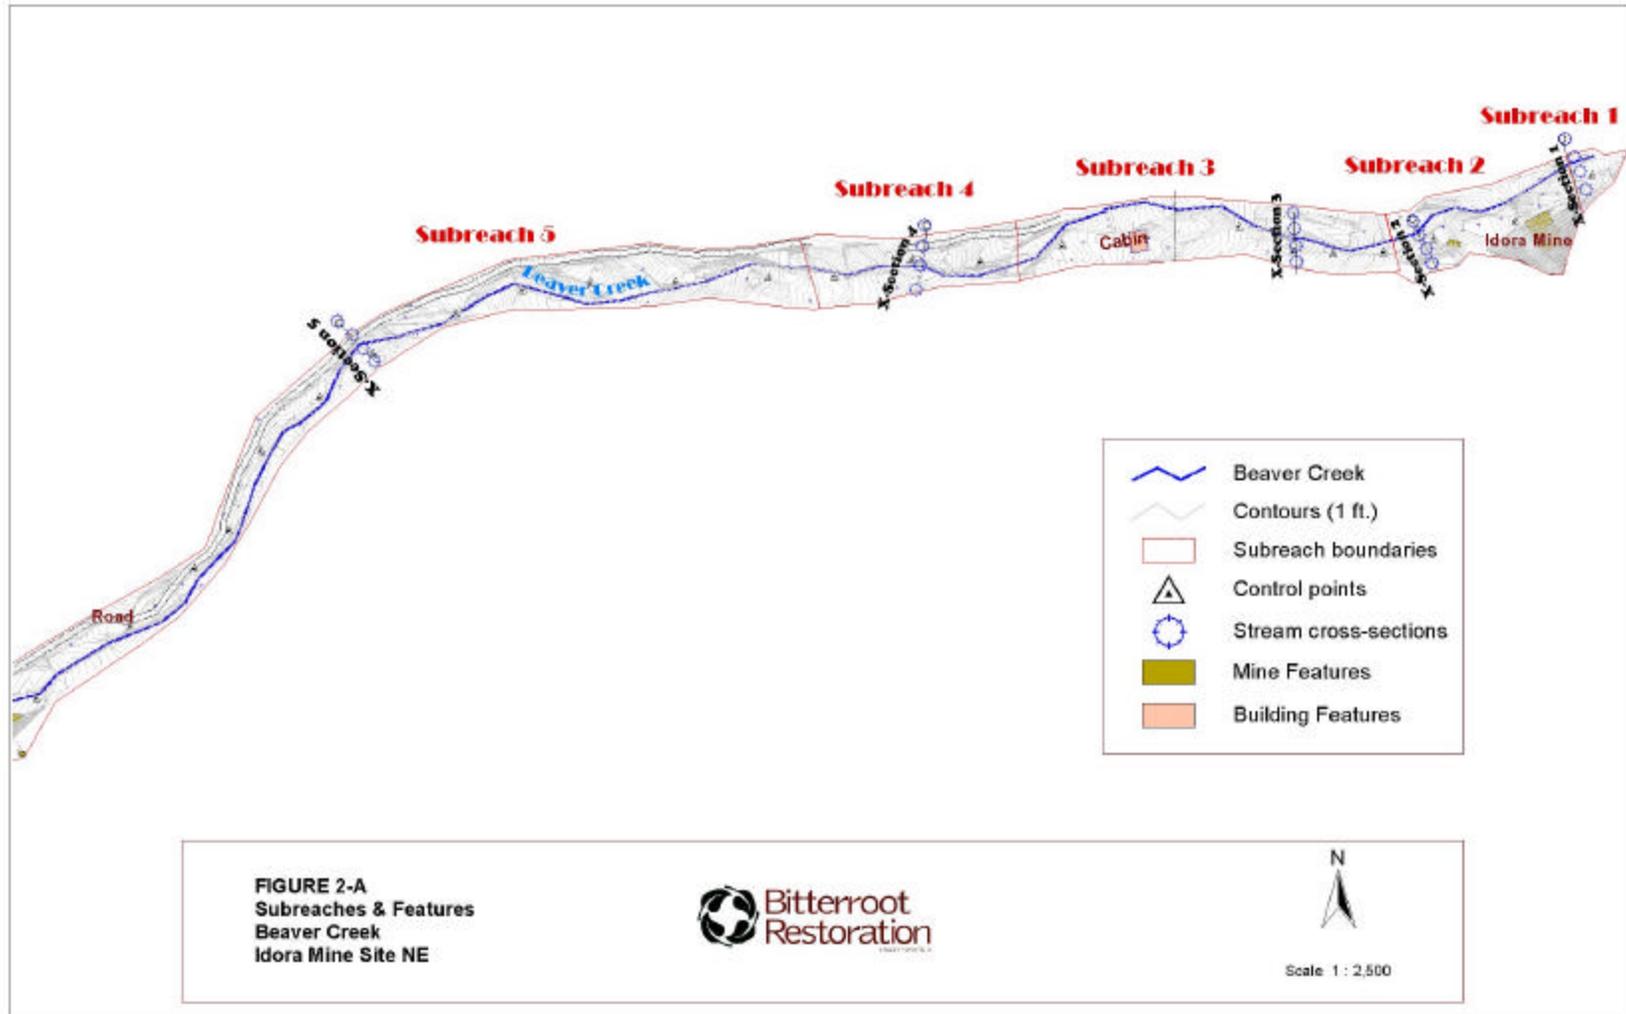
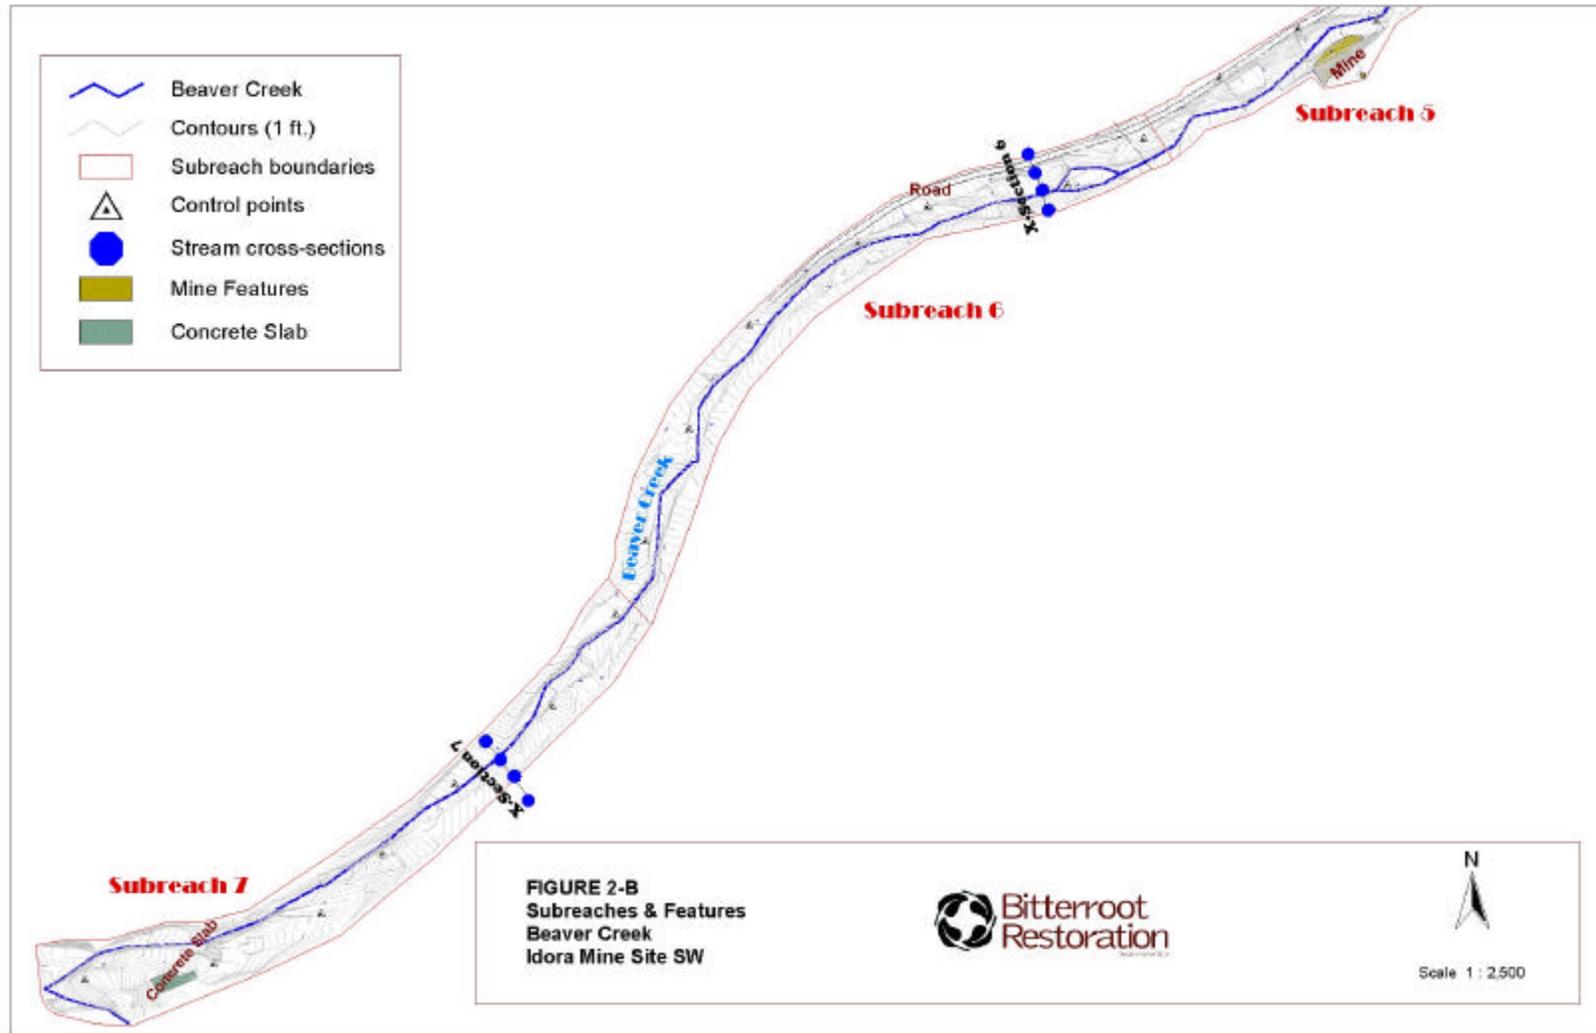
Figure 2-A.

In addition to boundary determinations, seven hydrologic subreaches (displayed in Figures 2-A and 2-B) were delineated across the injured area. Subreach boundaries were based upon hydrologic and geomorphic changes within the stream channel, as well as distinct changes in mine waste deposition. Subreaches are described below sequentially from the top (highest elevation) boundary on Beaver Creek to the lower boundary at the confluence of Beaver and Carbon Creeks.

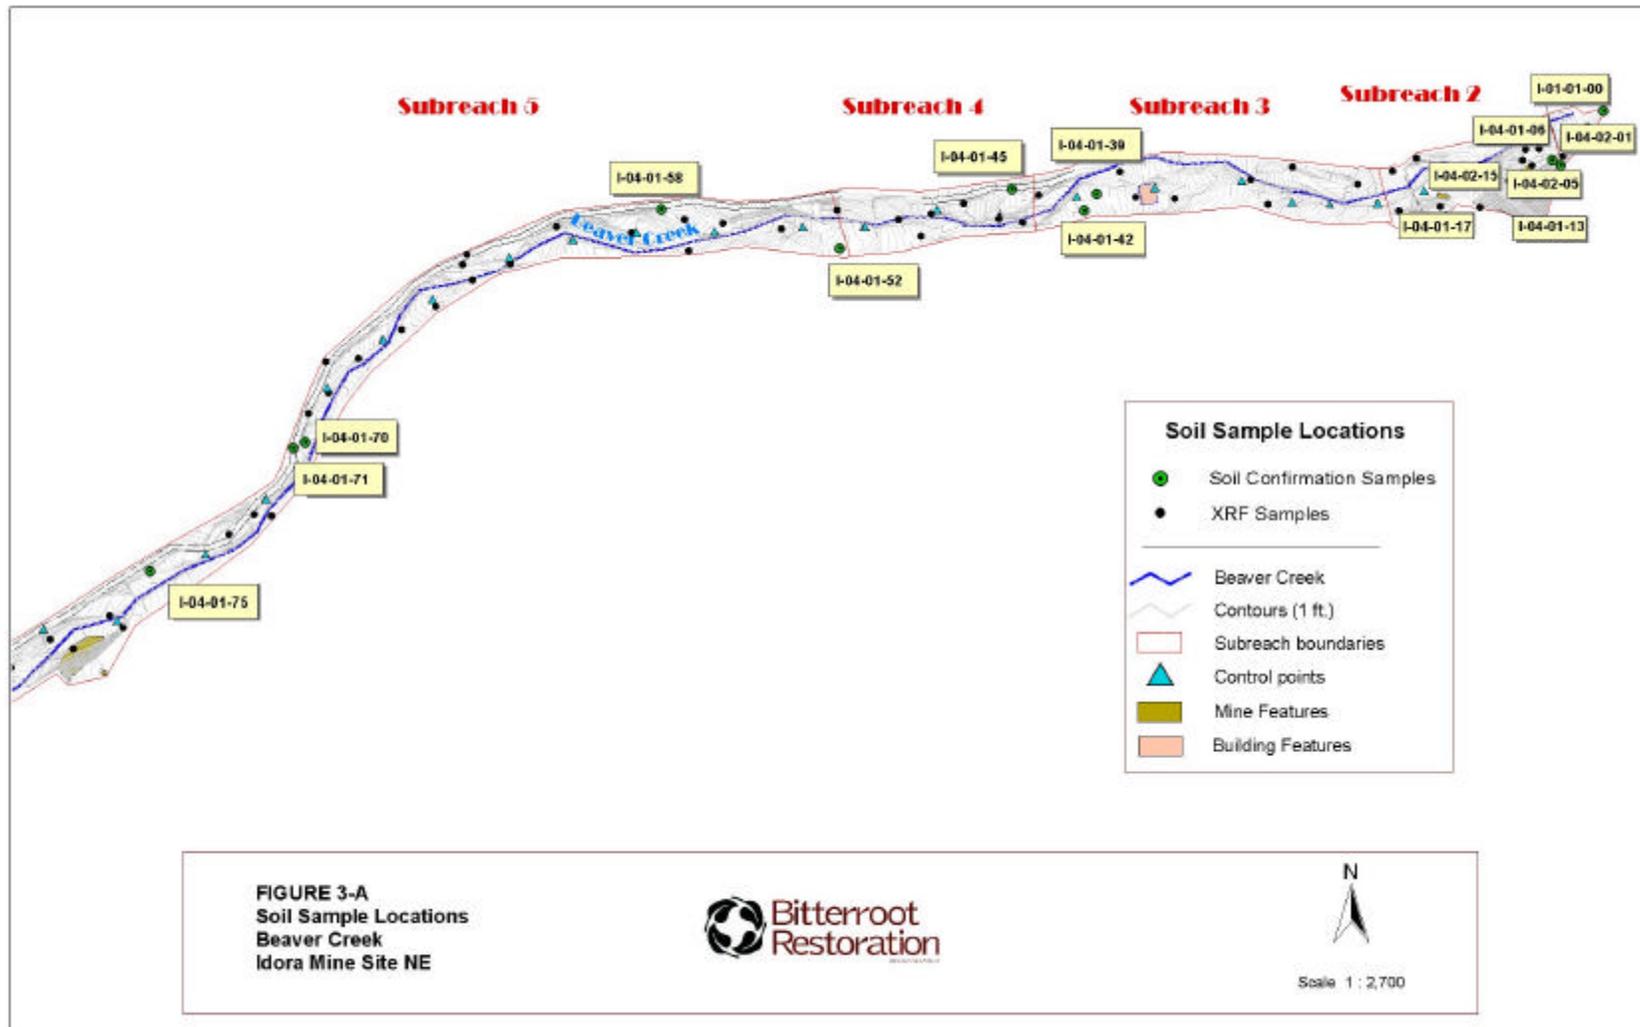
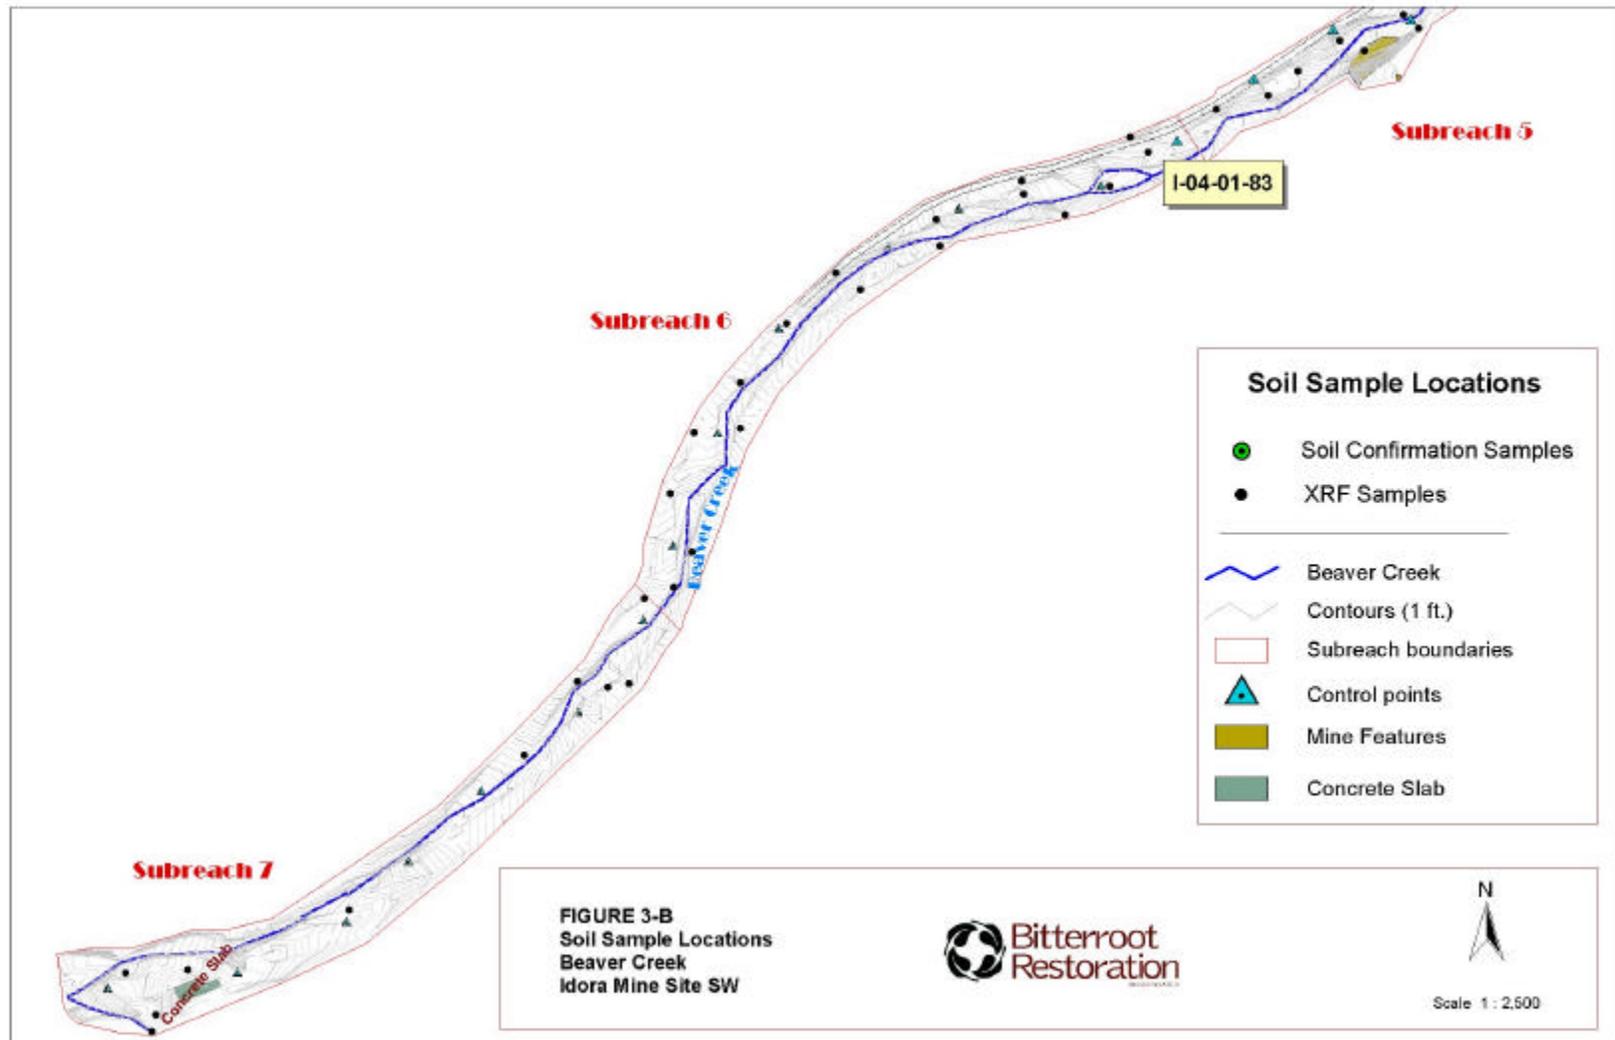
Figure 3-A.

The sampling locations were situated on and around mine waste tailings piles, as well as in areas adjacent to mine waste materials, such as surface soils in places exposed to runoff/erosion from waste areas and/or soils beneath waste piles. The sampling sites, located at cross-sections along the contaminated stream, were designed to determine the types and amounts of contamination. For the most part, sampling locations were evenly distributed throughout the site. Samples were extracted to a maximum depth of one meter (39.4 inches). The samples were composited by mixing them in a clean container (a new heavy gauge plastic “trash compactor” bag for each sample, lining a five-gallon plastic bucket). Sample locations are displayed on maps in Figures 3-A and 3-B.

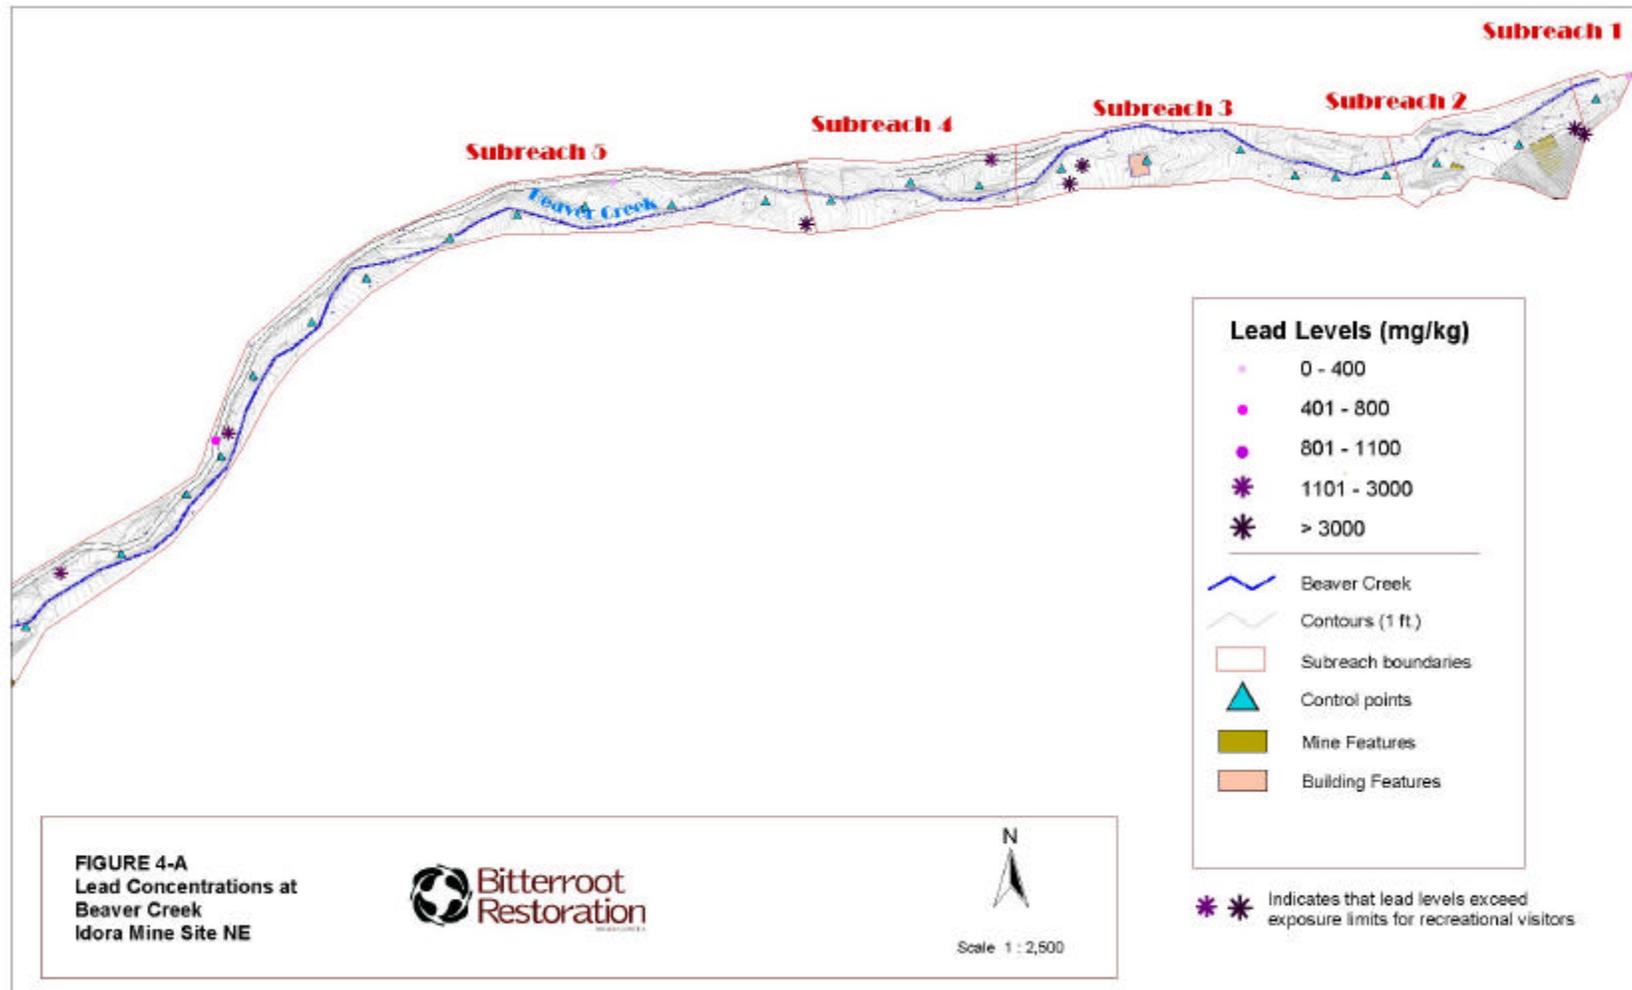
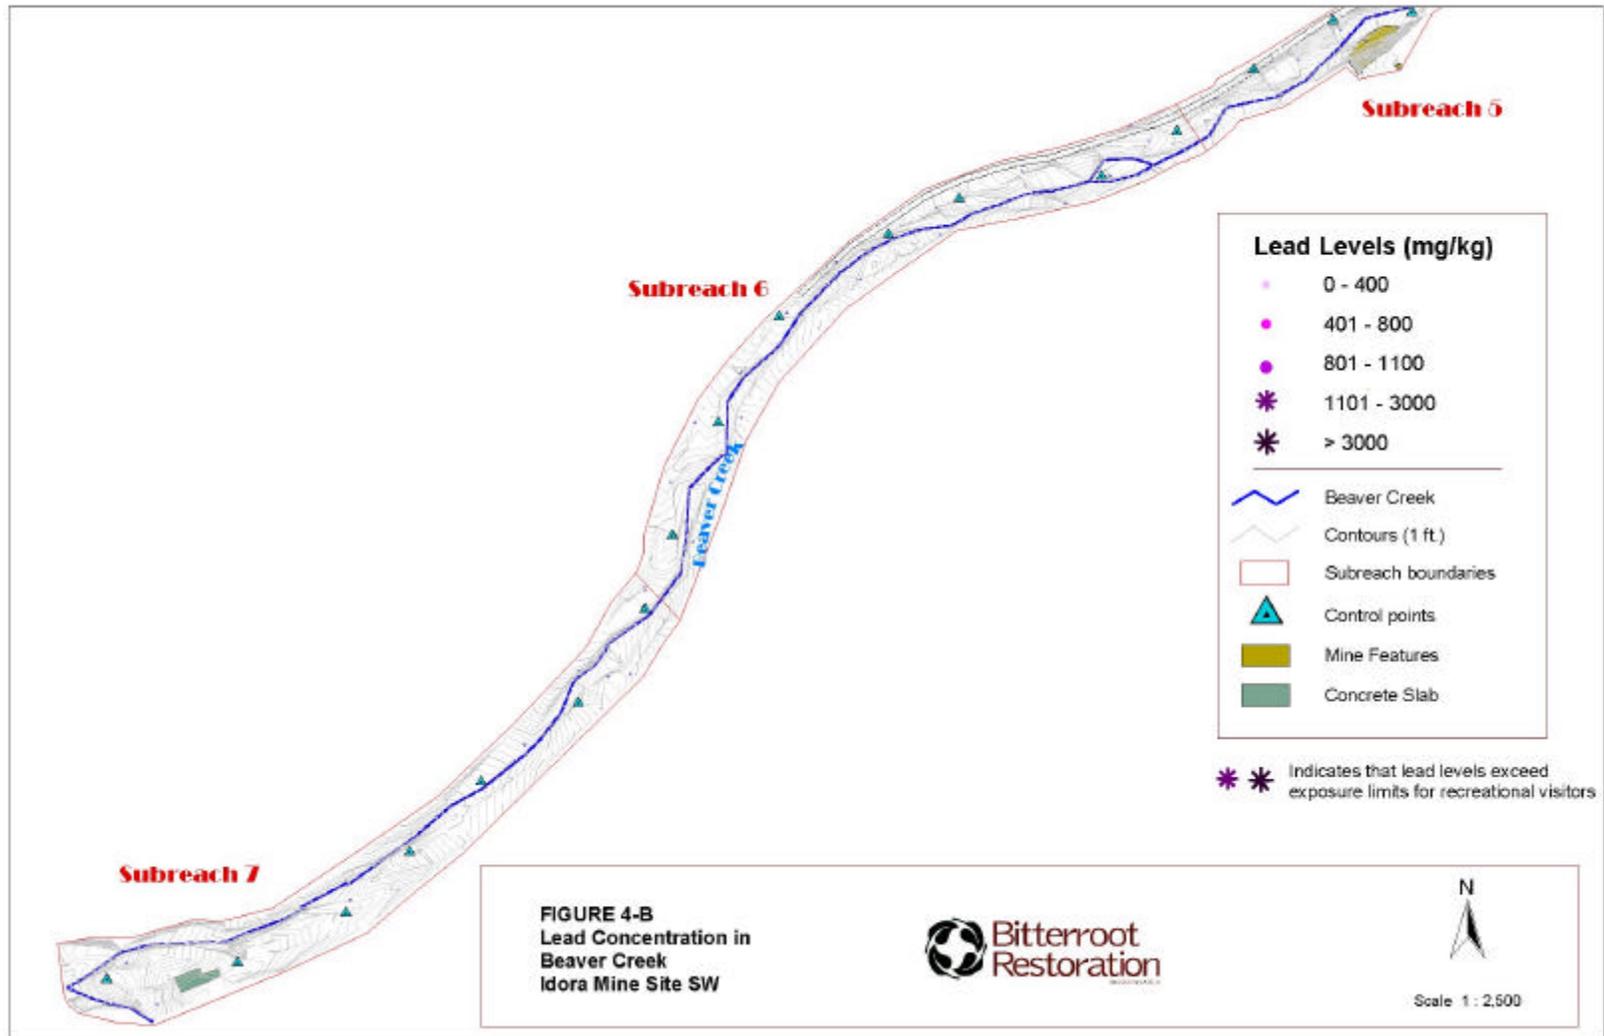
Figure 4-A.

Table 7.1 and Figures 4-A and 4-B present total metal concentrations statistics for the soil/mine waste samples collected from the Idora Mine project site, as analyzed by field XRF. The XRF trends for the trace elements follow the results of the ICP analyses, with lead having the greatest percentage of samples above the COPC limits for recreational visitors.

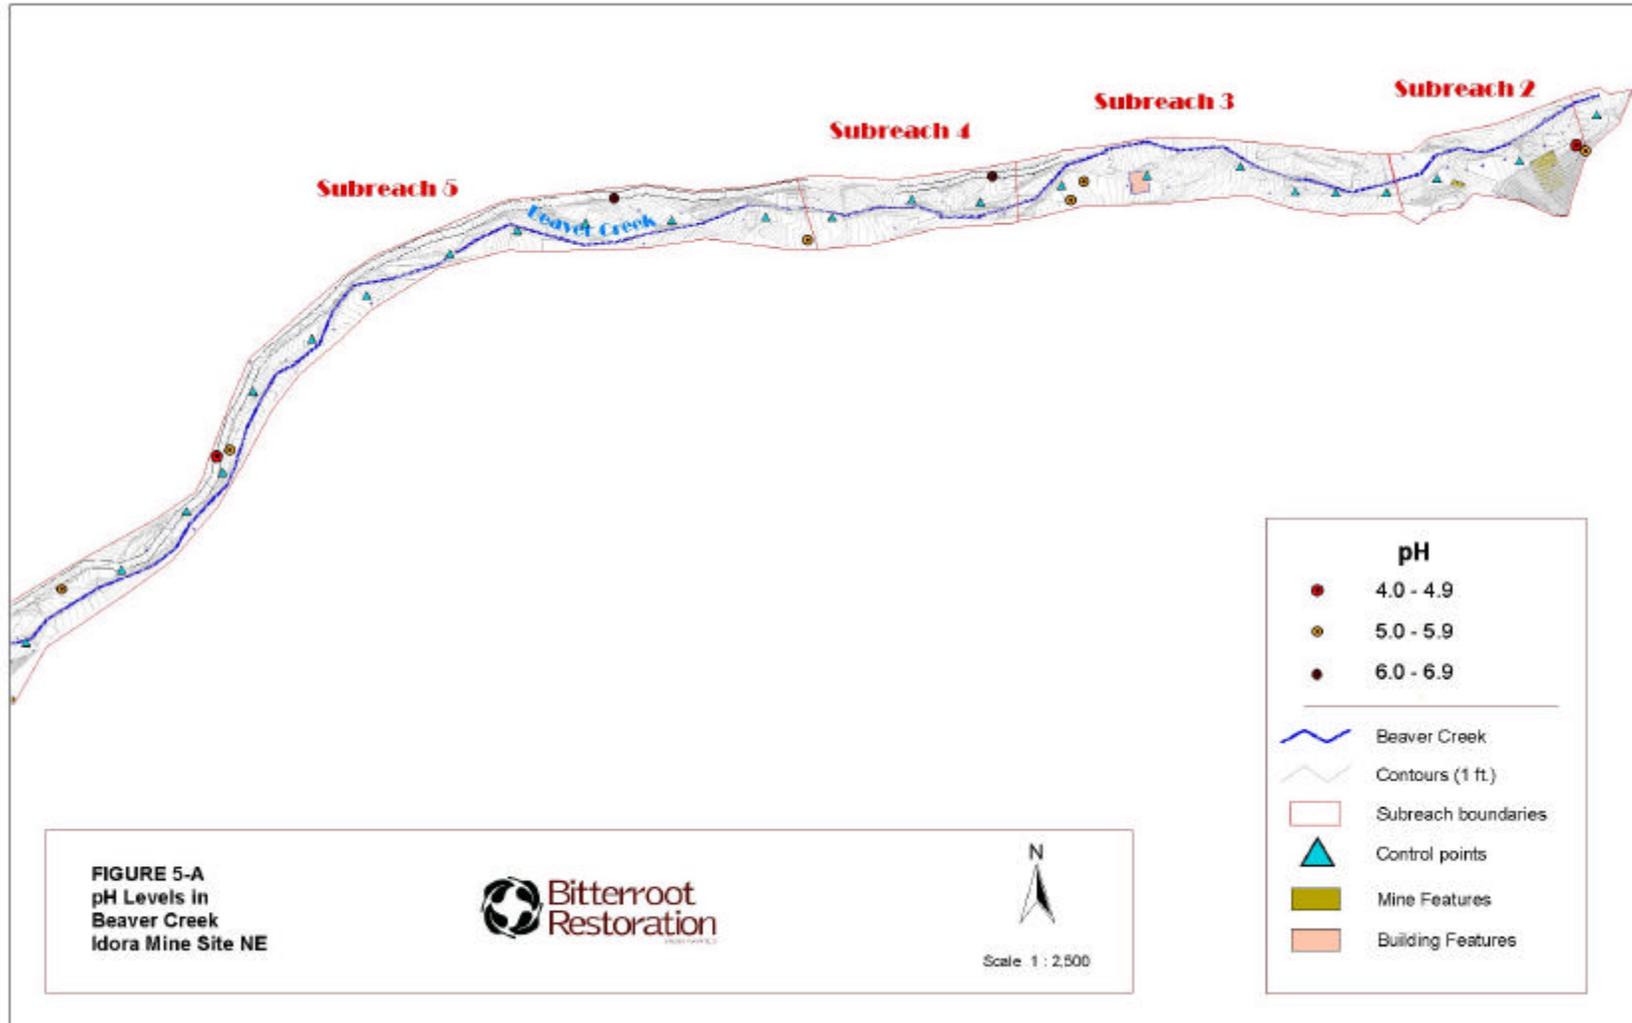
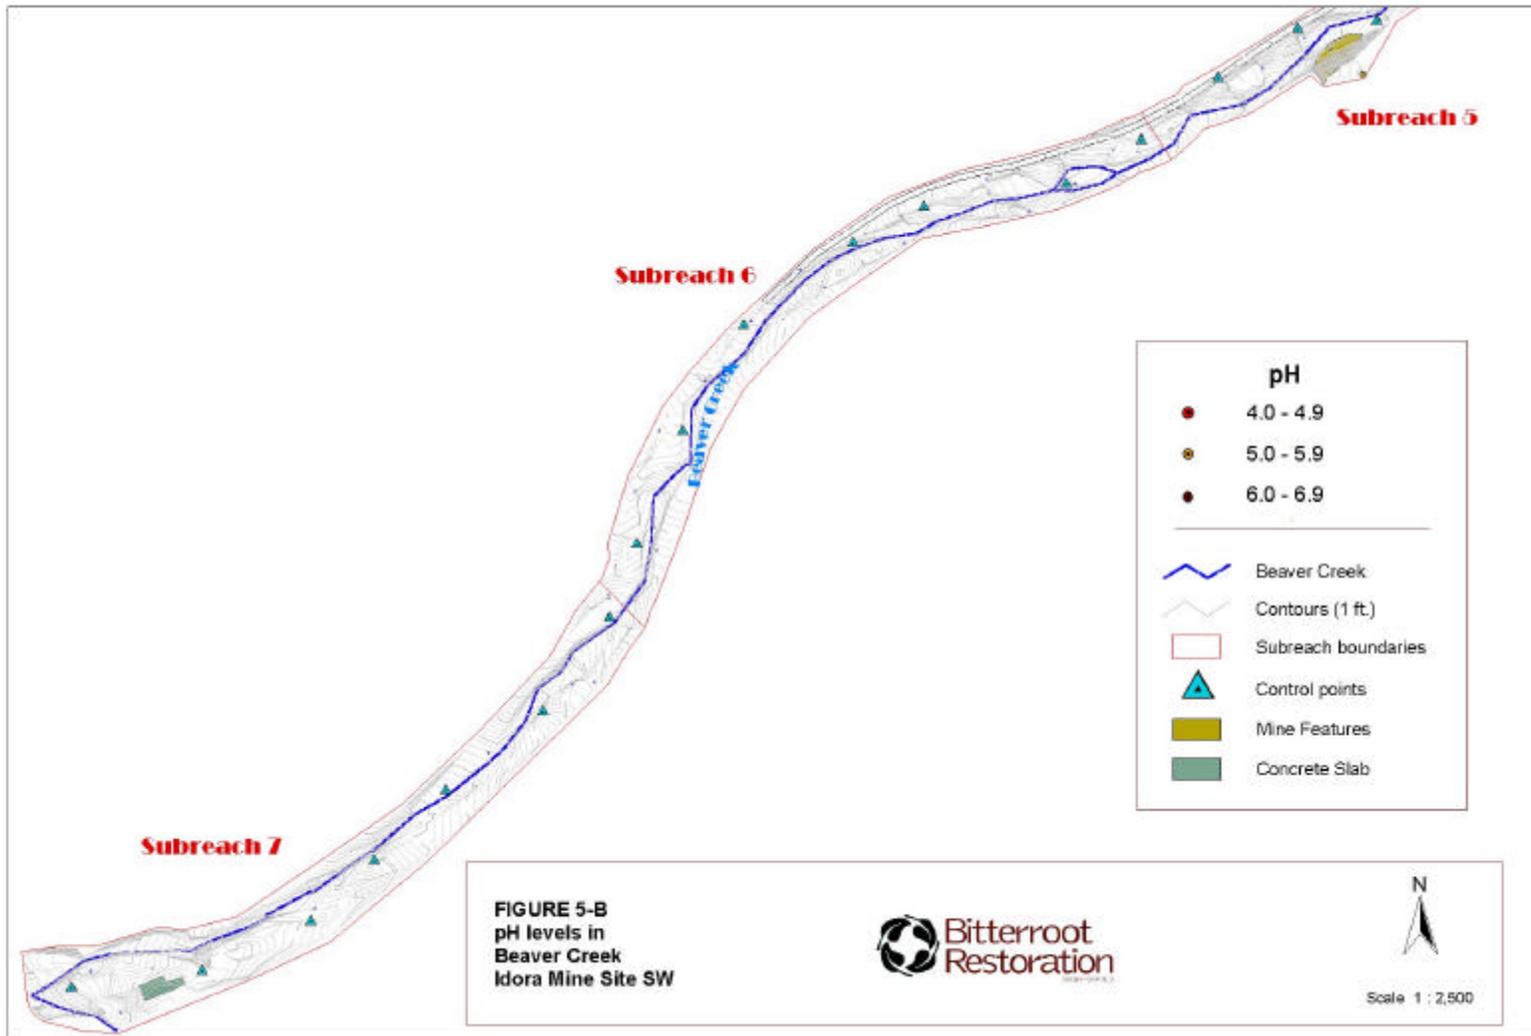
Figure 5-A.

Table 7.5 and Figures 5-A and 5-B present pH and conductivity statistics for the soil/mine waste samples collected from the Idora Mine project site. All samples had acidic values (i.e., less than 7.0 standard units). Fourteen of the 17 samples had pH values less than 5.8 standard units, an indication of significant acidity and low percentage base saturation. Four of the samples had pH values lower than 3.5 and 4.5, a level of high acidity at which exchangeable aluminum can be significantly phytotoxic.
