Regina MDWCA Naranjo Creek Rd Water System Improvements Project September 2025

Appendix C: Geotechnical Engineering Services Report

GEOTECHNICAL ENGINEERING SERVICES REPORT JOB NO. 1-21204

REGINA MDWCA NARANJO CREEK WATERLINE REPLACEMENT SANDOVAL COUNTY, NEW MEXICO

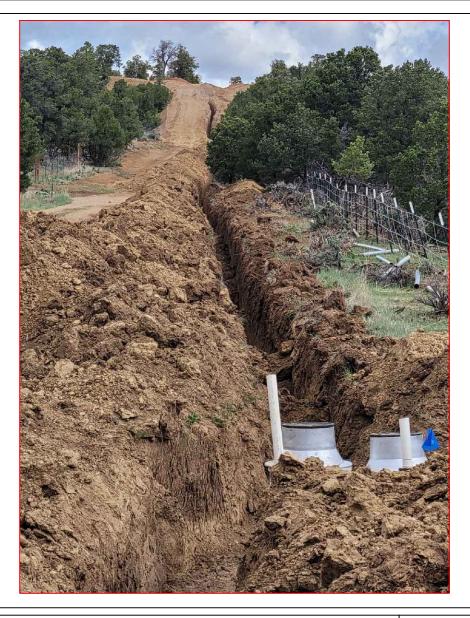
Photo 1: Looking North at a trench between B-6 & B-7

A brief site reconnaissance was performed during our site exploration. The site for the proposed waterline replacement is located on Naranjo Creek Road. The road is unpaved, and we observed markings of an underground communication cable line which runs mainly along the southside and eastside shoulder of the road. We also observed some plastic buried waterline markers which mainly runs along the northside of the road, and it is understood there are a couple areas where the lines crosses the roadway. During our investigation we observed a backhoe trenching for a waterline tie-in. See Photo 1 in a later section of this report.

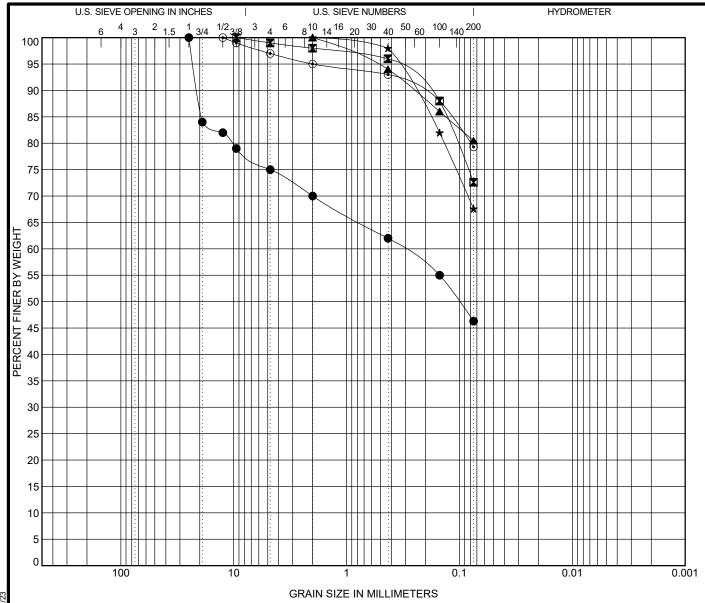
COBBLES	GRA	VEL		SAND)	SILT OR CLAY
COBBLES	coarse	fine	coarse	medium	fine	SILT OR CLAT

COBBLES	CP	GRAIN SIZE IN MILLIMETERS												
CODDLES	GIV	AVEL			S/	AND			ÇI	LT OR				
	coarse	fine	coa	arse	mediun	m	fine		JI	LION	CLAT			
pecimen Identifica	tion			Clas	sification	on			LL	PL	PI	Сс	Cu	
1	5.0	C	LAYEY	SANE) with (GRA	/EL(SC)		37	17	20			
▼ 2 7.5 LEAN CLAY with SAND(CL) ▲ 3 10.0 LEAN CLAY with SAND(CL) ★ 5 15.0 SANDY LEAN CLAY(CL)									24	14	10			
3	10.0		LEAN	CLA	Y with S	SAND	(CL)		32	14	18			
5	15.0		SAN	IDY LI	EAN CL	LAY(CL)		42	10	32			
6	2.5	LEAN			AN CLAY with SAND(CL				35	14	21			
pecimen Identifica	tion [100	D60)	D30 D10 9		%Grav	el %	Sand	 		%Clay		
1	5.0	25 0.318				25.0				28.7		46.3		
2	7.5	9.5							26.4		72.6

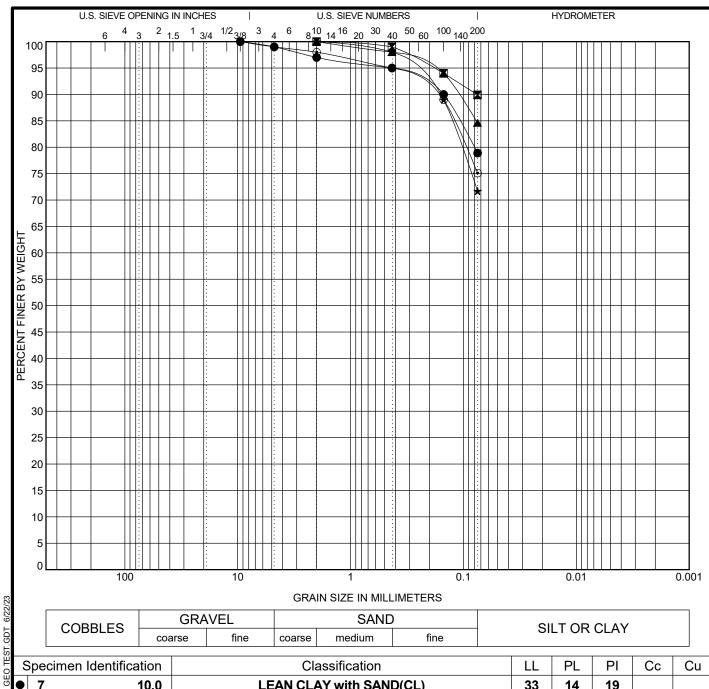
CORRIES	GRA	VEL		SAND)	SILT OR CLAY
COBBLES	coarse	fine	coarse	medium	fine	SILT OR CLAY

S	Specimen Identification		Cla	ssification			LL	PL	PI	Сс	Cu
) GE	•	7 10.0		LEAN CLA	33	14	19					
T.GP.	×	9 7.5		LEA	39	15	24					
MEN	A	10 15.0		LEAN CLA	Y with SAND	O(CL)		33	14	19		
LACE	*	11 7.5		SILTY CLAY	with SAND(CL-ML)		24	17	7		
JARANJO CREEK WATERLINE REPLACEMENT GPJ GEO TE	•	12 1.5		LEAN CLA	Y with SAND	O(CL)		31	14	17		
LINE CLINE	S	Specimen Identification	D100	D60	D30	D10	%Grav	∕el %	Sand	%Sil	t 9	6Clay
ATER	•	7 10.0	9.5				1.0		20.1	78.9		
X X	×	9 7.5	2				0.0		10.1	89.9		
CRE	A	10 15.0	2	2 0.0					15.4	84.6		
ON ON	*	11 7.5	2	2			0.0	0.0 28.3		71.7		
ARA	•	12 1.5	9.5				1.0		23.9		75.1

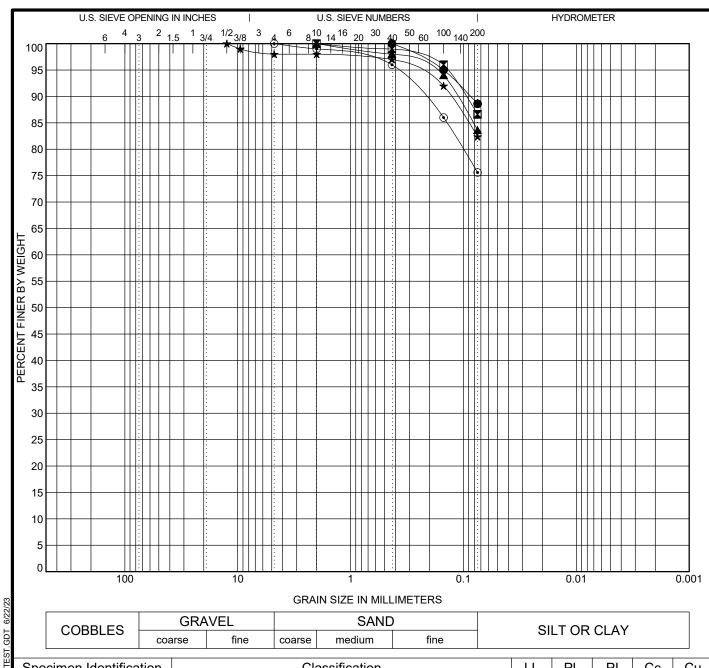
CORRIES	GRA	VEL		SAND		SULT OPICLAY
COBBLES	coarse	fine	coarse	medium	fine	SILT OR CLAT

0	S	Specimen Identification		Cla	ssification			LL	PL	PI	Сс	Cu
J GE		13 7.5		LEAN CLAY(CL)								
ARANJO CREEK WATERLINE REPLACEMENT GPJ GEO TE		14 2.5		LEAN CLAY(CL)						23		
MEN	•	15 7.5		LEAN CLAY with SAND(CL)						13		
LACE	k	16 2.5		LEAN CLA	Y with SAND	O(CL)		37	15	22		
취	•	17 15.0		LEAN CLA	Y with SAND	O(CL)		26	14	12		
	S	Specimen Identification	D100	D60	D30	D10	%Grav	/el %	Sand	%Sil	It 9	6Clay
¥ C		13 7.5	0.43				0.0		11.4		88.6	
-K		14 2.5	2				0.0		13.4		86.6	
SKE V	•	15 7.5	2				0.0		16.4		83.6	
	k	16 2.5	12.5				2.0		15.6		82.4	
AR/	•	17 15.0	4.75				0.0		24.4	75.6

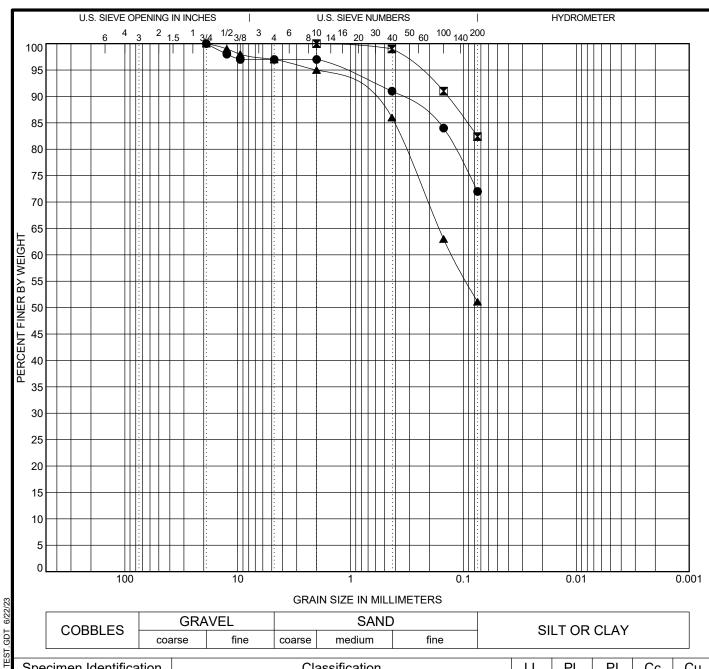
CORRIES	GRA	VEL		SAND)	SILT OR CLAY
COBBLES	coarse	fine	coarse	medium	fine	SILT OR CLAY

0	S	Specimen Identification		Cla	assification		L	.L PL	PI	Сс	Cu
J GE	•	18 10.0		LEAN CLA	AY with SAND	3	8 14	24			
T.GP	X	19 2.5		LEAN CLA	AY with SAND	4	1 15	26			
MEN	A	20 15.0		SANDY	LEAN CLAY	3	5 14	21			
ACE											
REPI											
LINE LINE	S	Specimen Identification	D100	D60	D30	D10	%Gravel	%Sand	%Si	lt (%Clay
AIE A	•	18 10.0	19				3.0	25.0		72.0	
× I	X	19 2.5	2				0.0	17.6		82.4	
SRE	A	20 15.0	19	0.126			3.0	45.9		51.1	
ARANJO CREEK WATERLINE REPLACEMENT.GPJ GEO TE											
ARA
