**US Army Corps
of Engineers®**
Albuquerque District
ACEQUIAS REHABILITATION PROGRAM

Draft
Environmental Assessment
and
Finding of No Significant Impact
for the

Acequia de Llano de San Juan Nepomuceño Rehabilitation Project
Taos County, New Mexico

September 2015

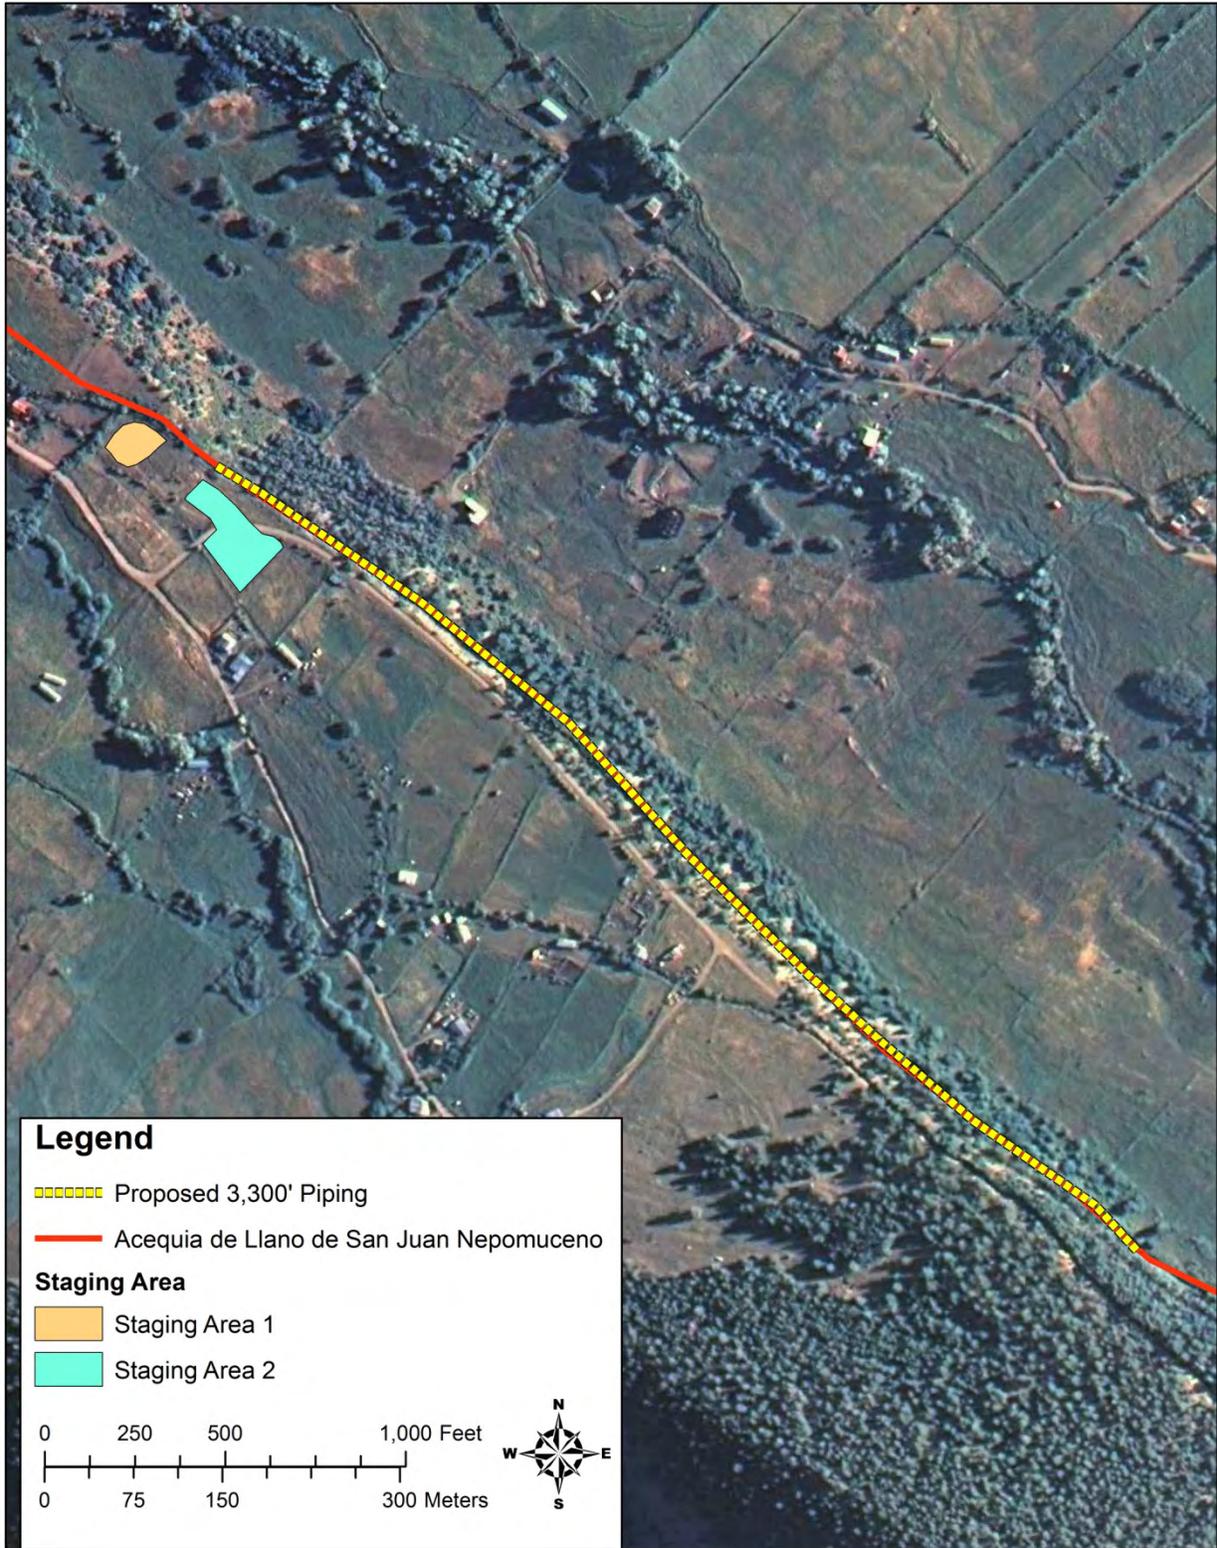
Figure 2. Locations of proposed piping and project staging areas.

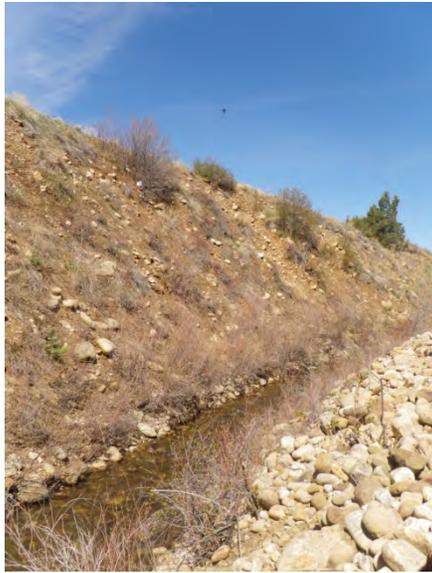
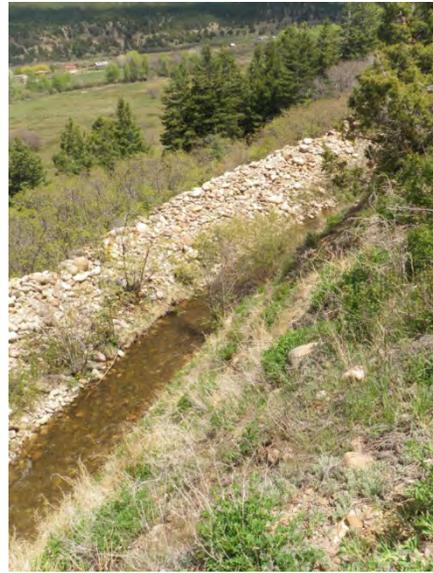
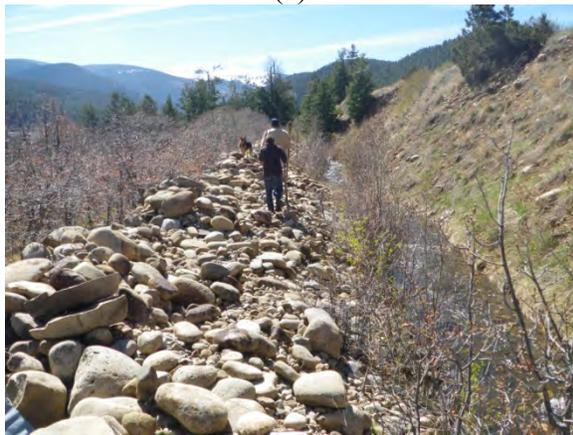
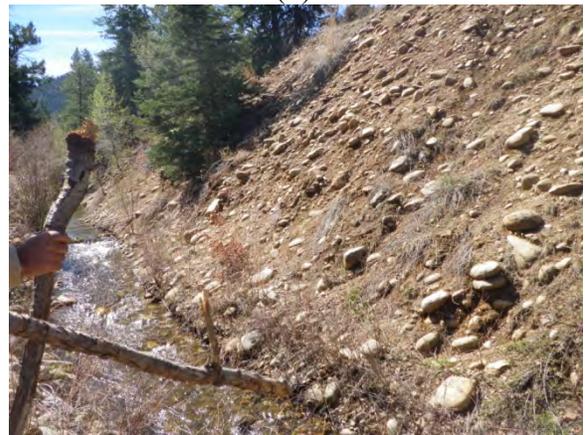
Figure 3. Acequia de Llano de San Juan Nepomuceño existing conditions: (a) view of the Acequia looking downstream (note steep, loose banks); (b) view of the Acequia from the Upper Llano Rd, looking upstream (note the boulders piled to the left of the Acequia); (c) view along Acequia alignment looking upstream (note boulders); (d) steep, eroding hillsides above Acequia.

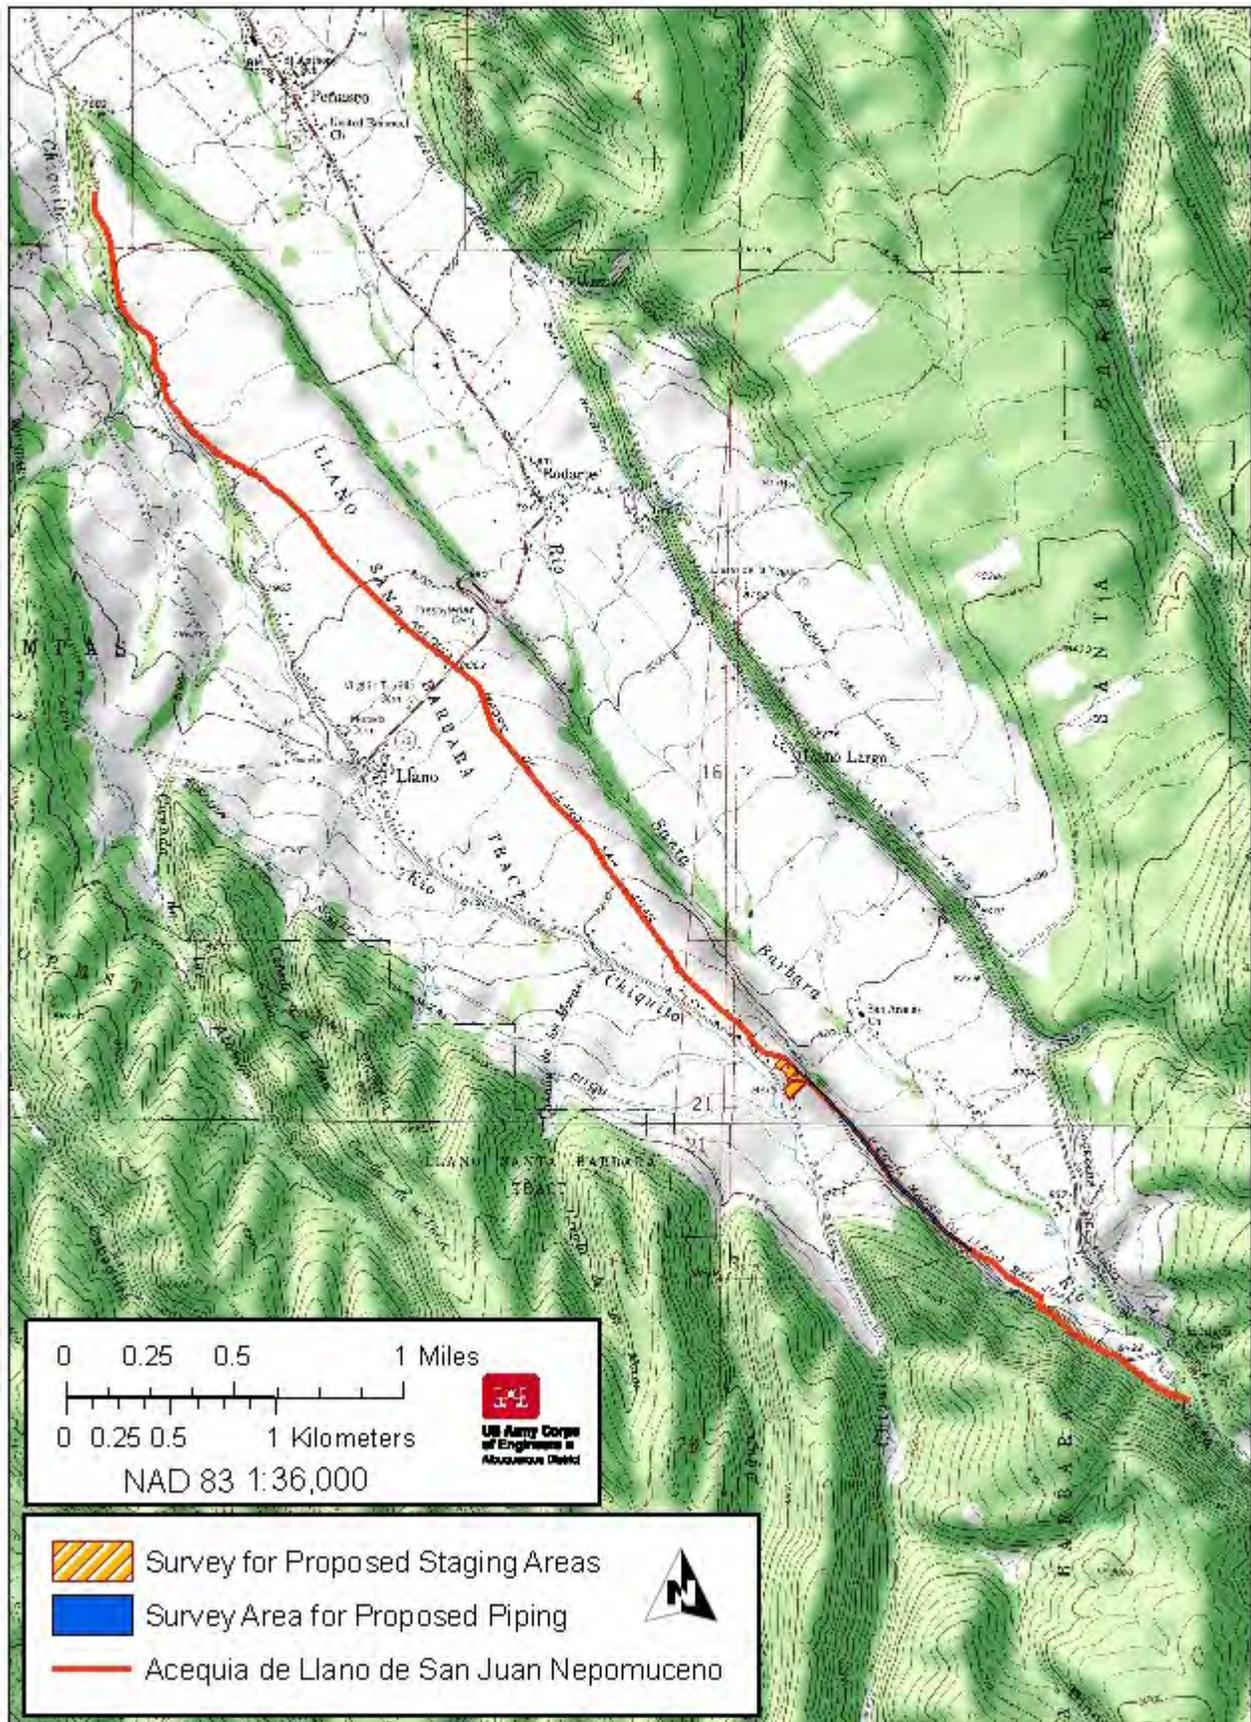
Figure 4.1. Total length of the acequia madre, showing staging areas and construction footprint. USGS 7.5' El Valle (36105-A6) and Peñasco (36105-B6).

Corps archaeologists conducted a cultural resources survey on May 23, 2011. The purpose of the survey was to examine staging areas and the segment of the ditch to be piped, and to document the current negative impacts being experienced by the acequia. Survey areas covered by the current project are shown in Figure 4.1.

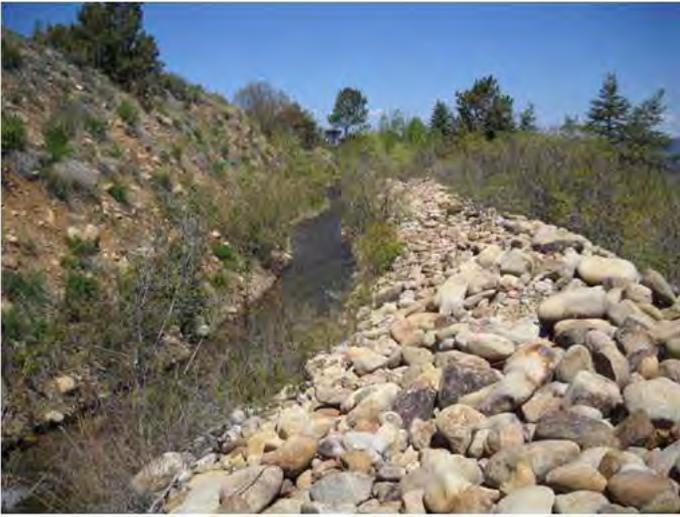
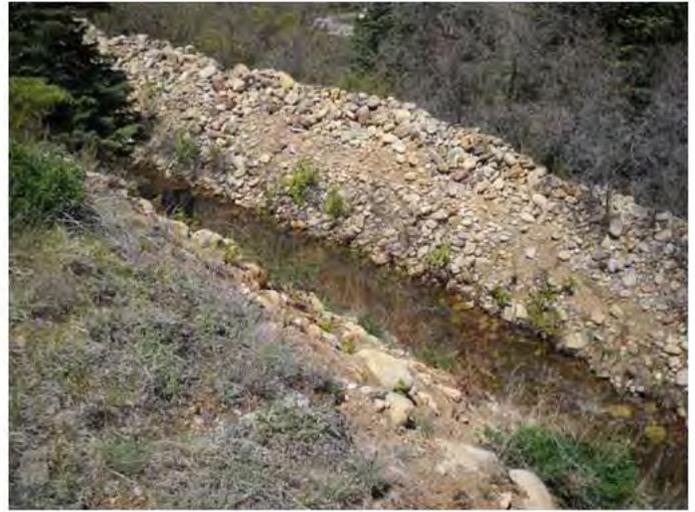
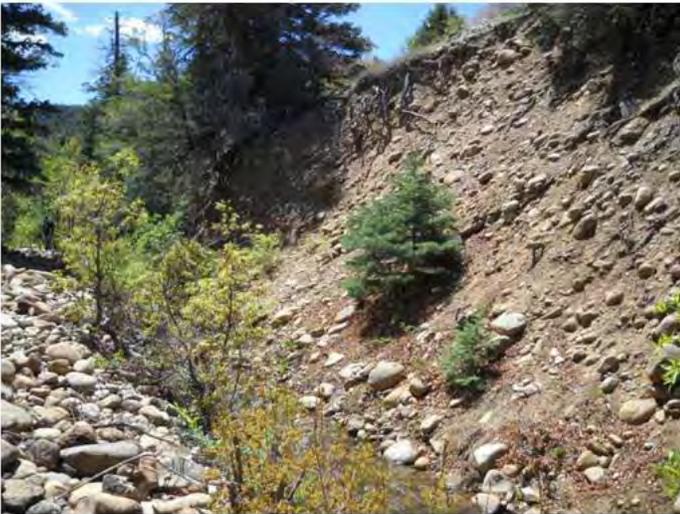
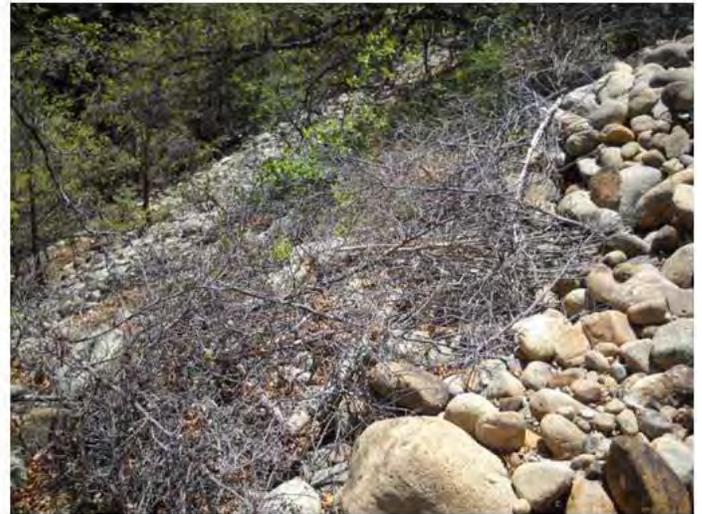
Figure 4.3. Photographs showing the project area. (a) Overview of the ditch facing downstream. (b) View of the ditch from above. Note the volume of rock stacked on the opposite bank. (c) West bank of the ditch looking upstream. Photo shows the volume of rock continuing to erode from the steep slope above the ditch. In other portions of the project area, the steep western bank is more than twice as high as the bank shown. (d) View down the extremely steep slope below the ditch. A number of rocks were thrown down slope in previous years, but recently landowners located down slope have requested that rocks not be thrown onto their land.

The acequia's current function is impacted by heavy erosion along a stretch of ditch that winds along a steep slope. The slope is subject to frequent rockslides which deposit rock and sediment into the ditch, and damage the banks of the channel. Due to the volume of rock and the steepness of the adjacent slopes, the Association requires increasing time, labor, and money to repair and maintain this segment. In addition, the location of the problem area threatens the entire system, as no gates or laterals branch off the acequia madre until water is downstream of the project area. If this area were severely damaged, none of the 230 *parsientes* served by the ditch would receive water.

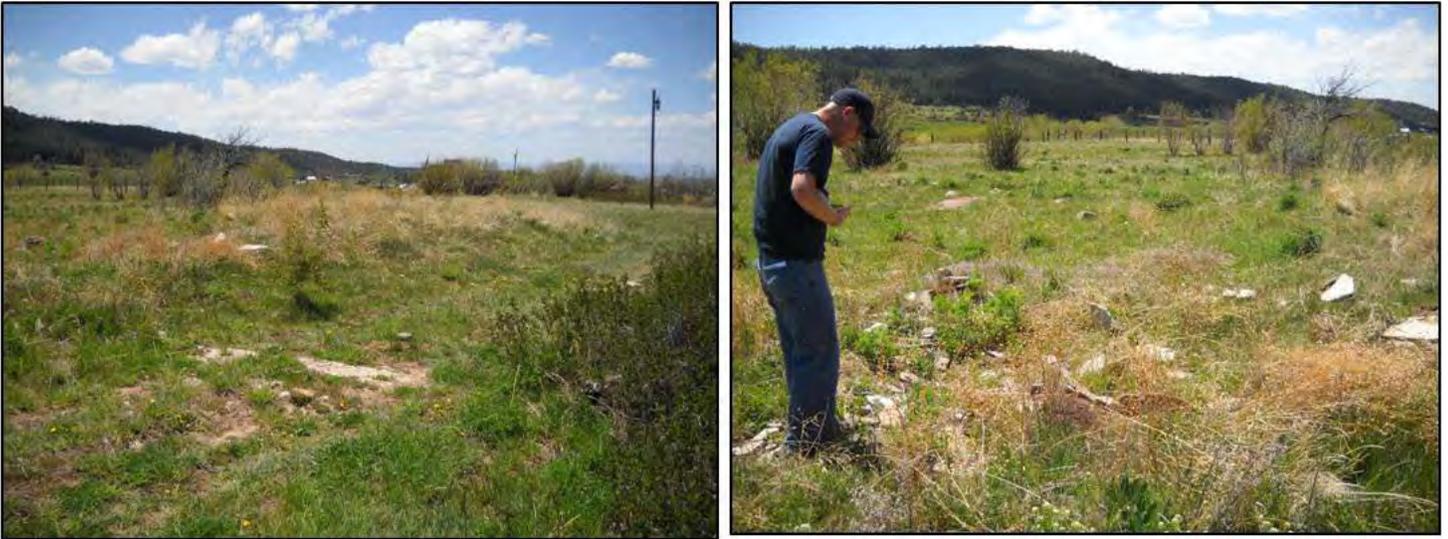
Figure 4.8. Left: mounded remains of the Feature 1 at LA170127, with two track access road in foreground. Staging Area 1 is in the background near the power pole. Right: south end of Feature 1, note the stucco fragments and heavy rodent disturbance.

The site consists of four total features including the main structure (Feature 1), two small, rectangular berms likely representing outbuildings (Features 2 and 3), and a stone alignment (Feature 4). The main structure measures 28x20m at its largest dimensions (Figure 4.8). The structure appears to have been a domestic home, constructed with a concrete pad foundation (Figure 4.9) and a stucco exterior. Wood is scarce on the site, but wooden framing is evident. Nails used in construction are all modern wire nails, and stucco was applied using a typical chicken wire overlay. The chicken wire noted on the site looked almost new, with no indications of rust. Several rooms are evident, but disturbance within the feature makes it difficult to discern interior walls. In general, it appears the structure may have had between 2 and 4 rooms. At the time of fieldwork, the structure was completely collapsed, and vegetation had subsequently grown over much of the remaining mound.

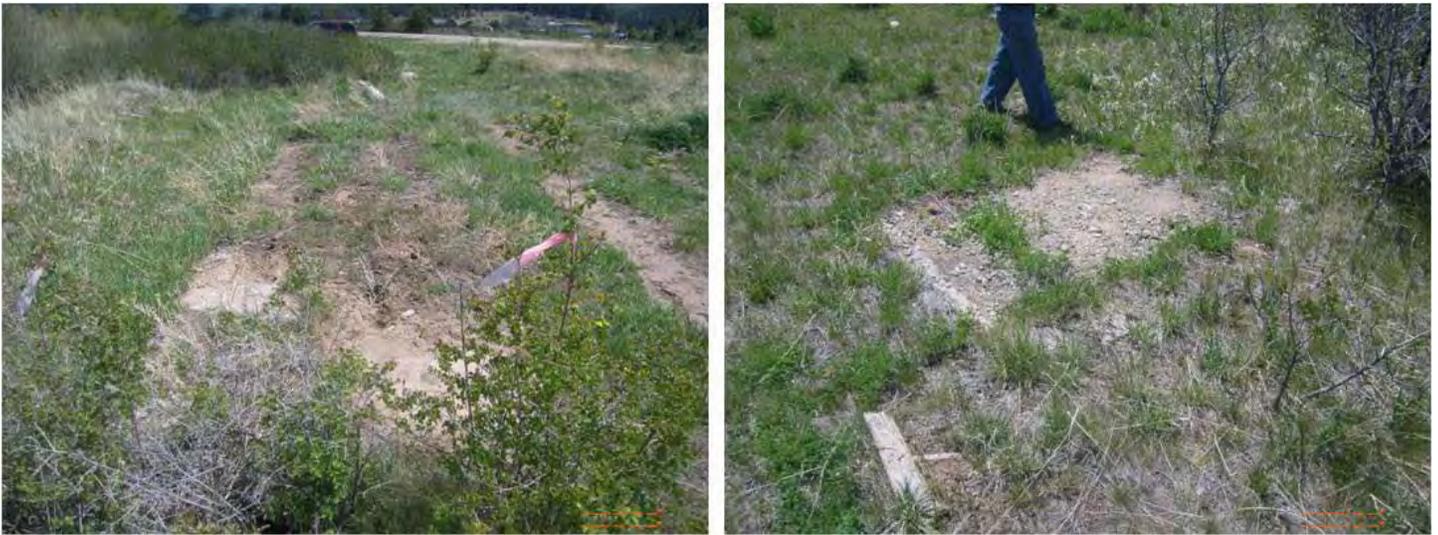
Figure 4.9. Remnants of concrete foundation at Feature 1.
