ENVIRONMENTAL ASSESSMENT
for the
BOSQUE WILDFIRE PROJECT,
BERNALILLO and SANDOVAL COUNTIES, NEW MEXICO

SEPTEMBER 2004

**ENVIRONMENTAL ASSESSMENT FOR THE BOSQUE WILDFIRE PROJECT,
SANDOVAL AND BERNALILLO COUNTIES, NEW MEXICO**

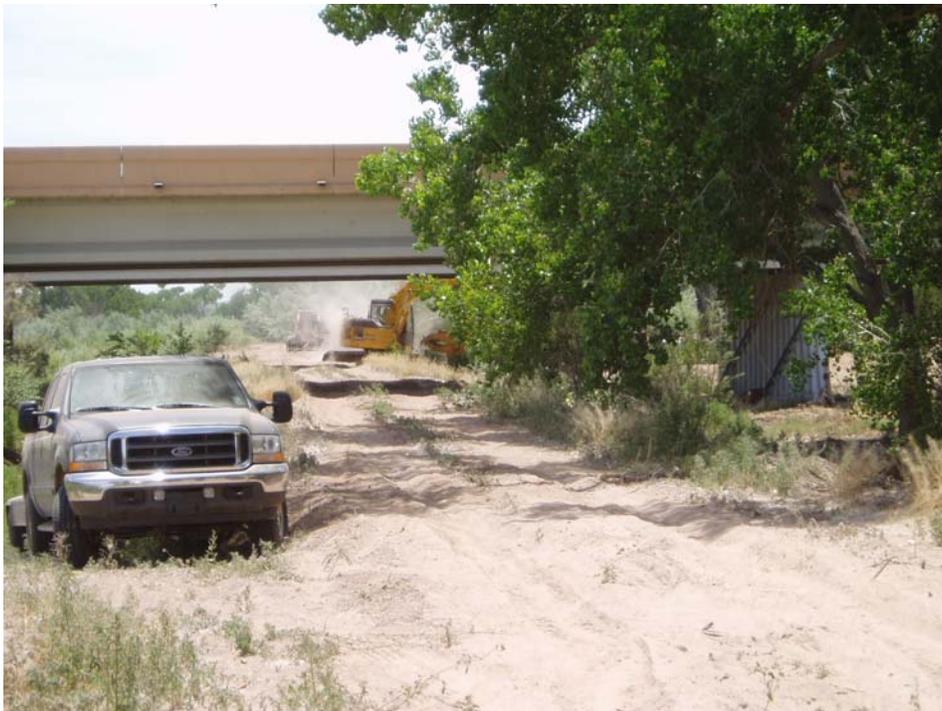
FIGURE 3. EXAMPLE OF LEVEE ROAD IN NEED OF REPAIR.

There are several impediments to emergency vehicle access within the RGVSP, Corrales Bosque Preserve, and Sandia Pueblo bosque. The levees within these areas total approximately 41 miles with a limited number of crossings over the drain to the levee and bosque. Some existing access points have sharp turns that large fire trucks cannot negotiate, thus prohibiting access. Several levee roads need general maintenance to fill in potholes and resurfacing to ensure large fire equipment can safely drive on them (Figure 4). In some locations, the levee is not engineered. Improvements to the levee system in the form of general maintenance would occur along this 41 miles where required.

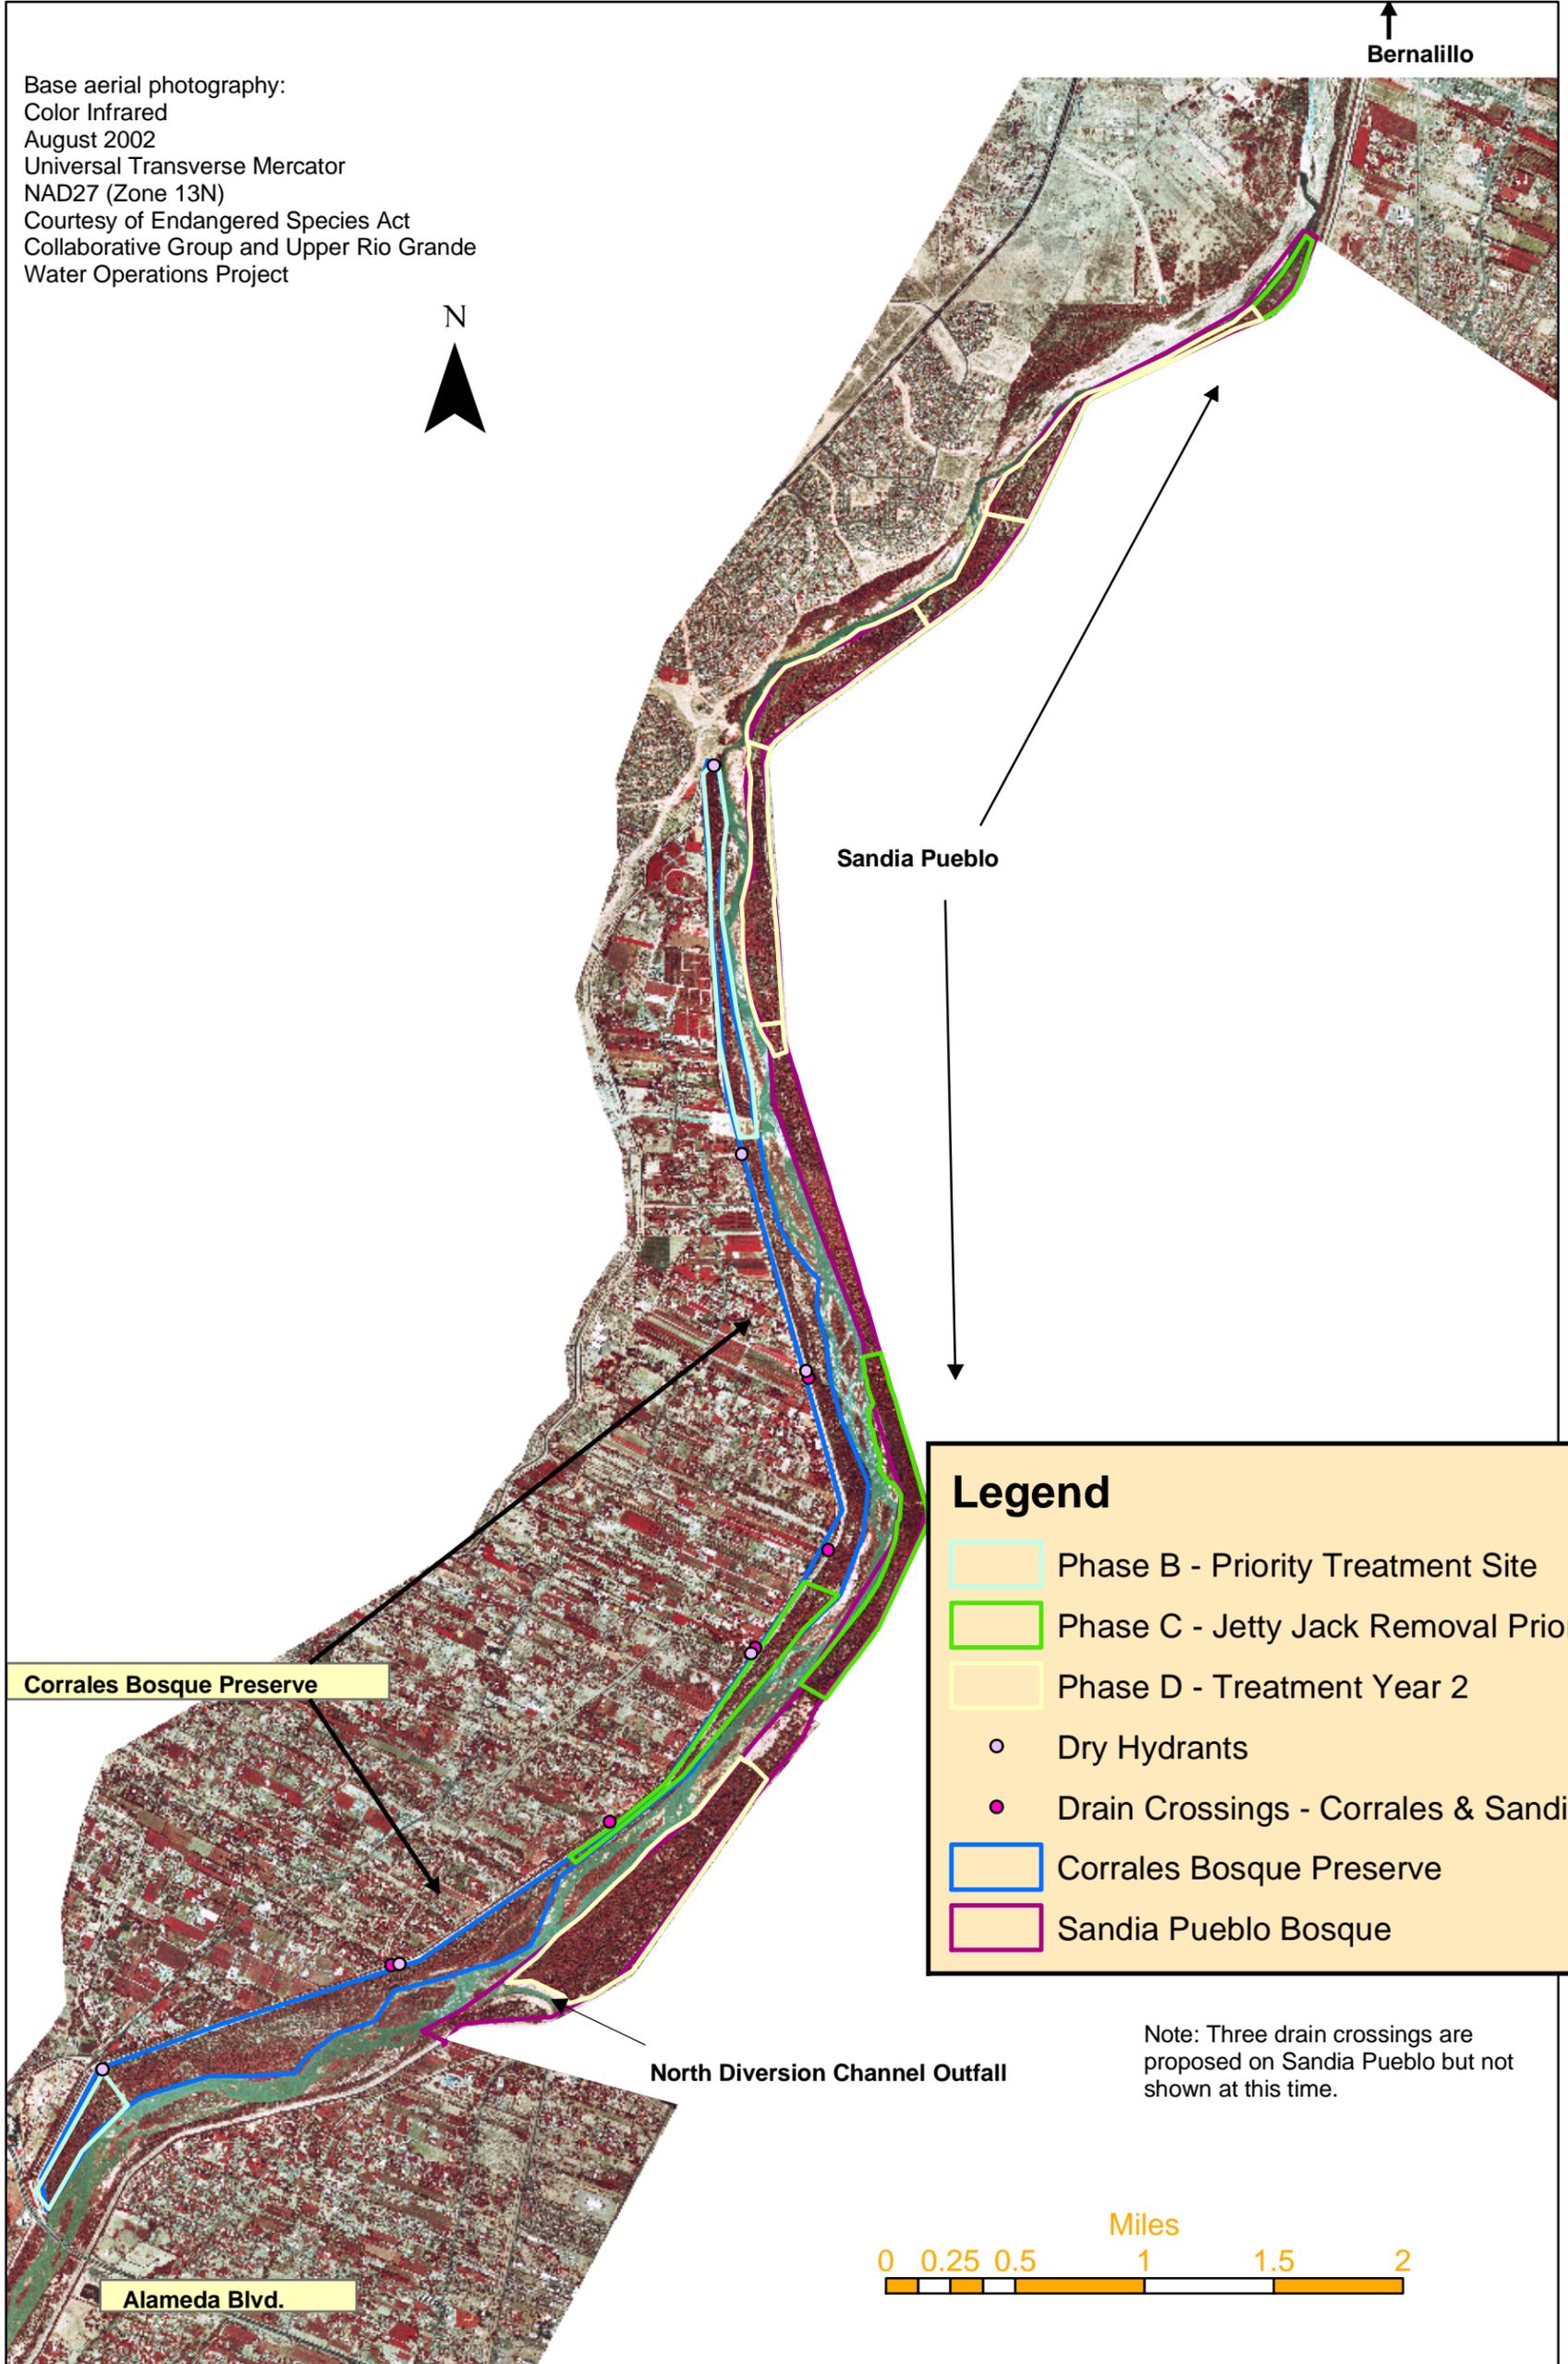
Figure 3A - Bosque Wildfire Corrales Bosque Preserve and Sandia Pueblo

- Phase A - Jetty Jack Removal and Revegetation
- Phase B - Priority Treatment Site
- Phase C - Jetty Jack Removal and Revegetation
- Phase D - Treatment Year 2

The thinning and jetty jack removal activities have been broken down into four phases of work:

- Phase A. High priority areas to be worked in beginning September 2004 include those that have already been mostly cleared or burned and do not have any overstory vegetation. In these areas, existing jetty jacks can be readily removed with little to no disturbance. There are approximately 63 acres of this type in the Albuquerque area. The exact number of jetty jacks within this acreage is unknown at this time. These areas were established as high priority due to the fact that although they have already been thinned, there are remaining adjacent areas that have not been thinned and need access in order to do so and/or fight a fire if one were to occur.
