| | Date: | Rvsd. Date: | Scale: | INDIVIDUAL PERMIT<br>TICO TIME WAVE<br>SAN JUAN COUNTY, NM | |

GRADE CONTROL FEATURE  
DESIGN

INDIVIDUAL PERMIT  
TICO TIME WAVE  
SAN JUAN COUNTY, NM

WAVE FEATURE DESIGN: CROSS  
SECTION

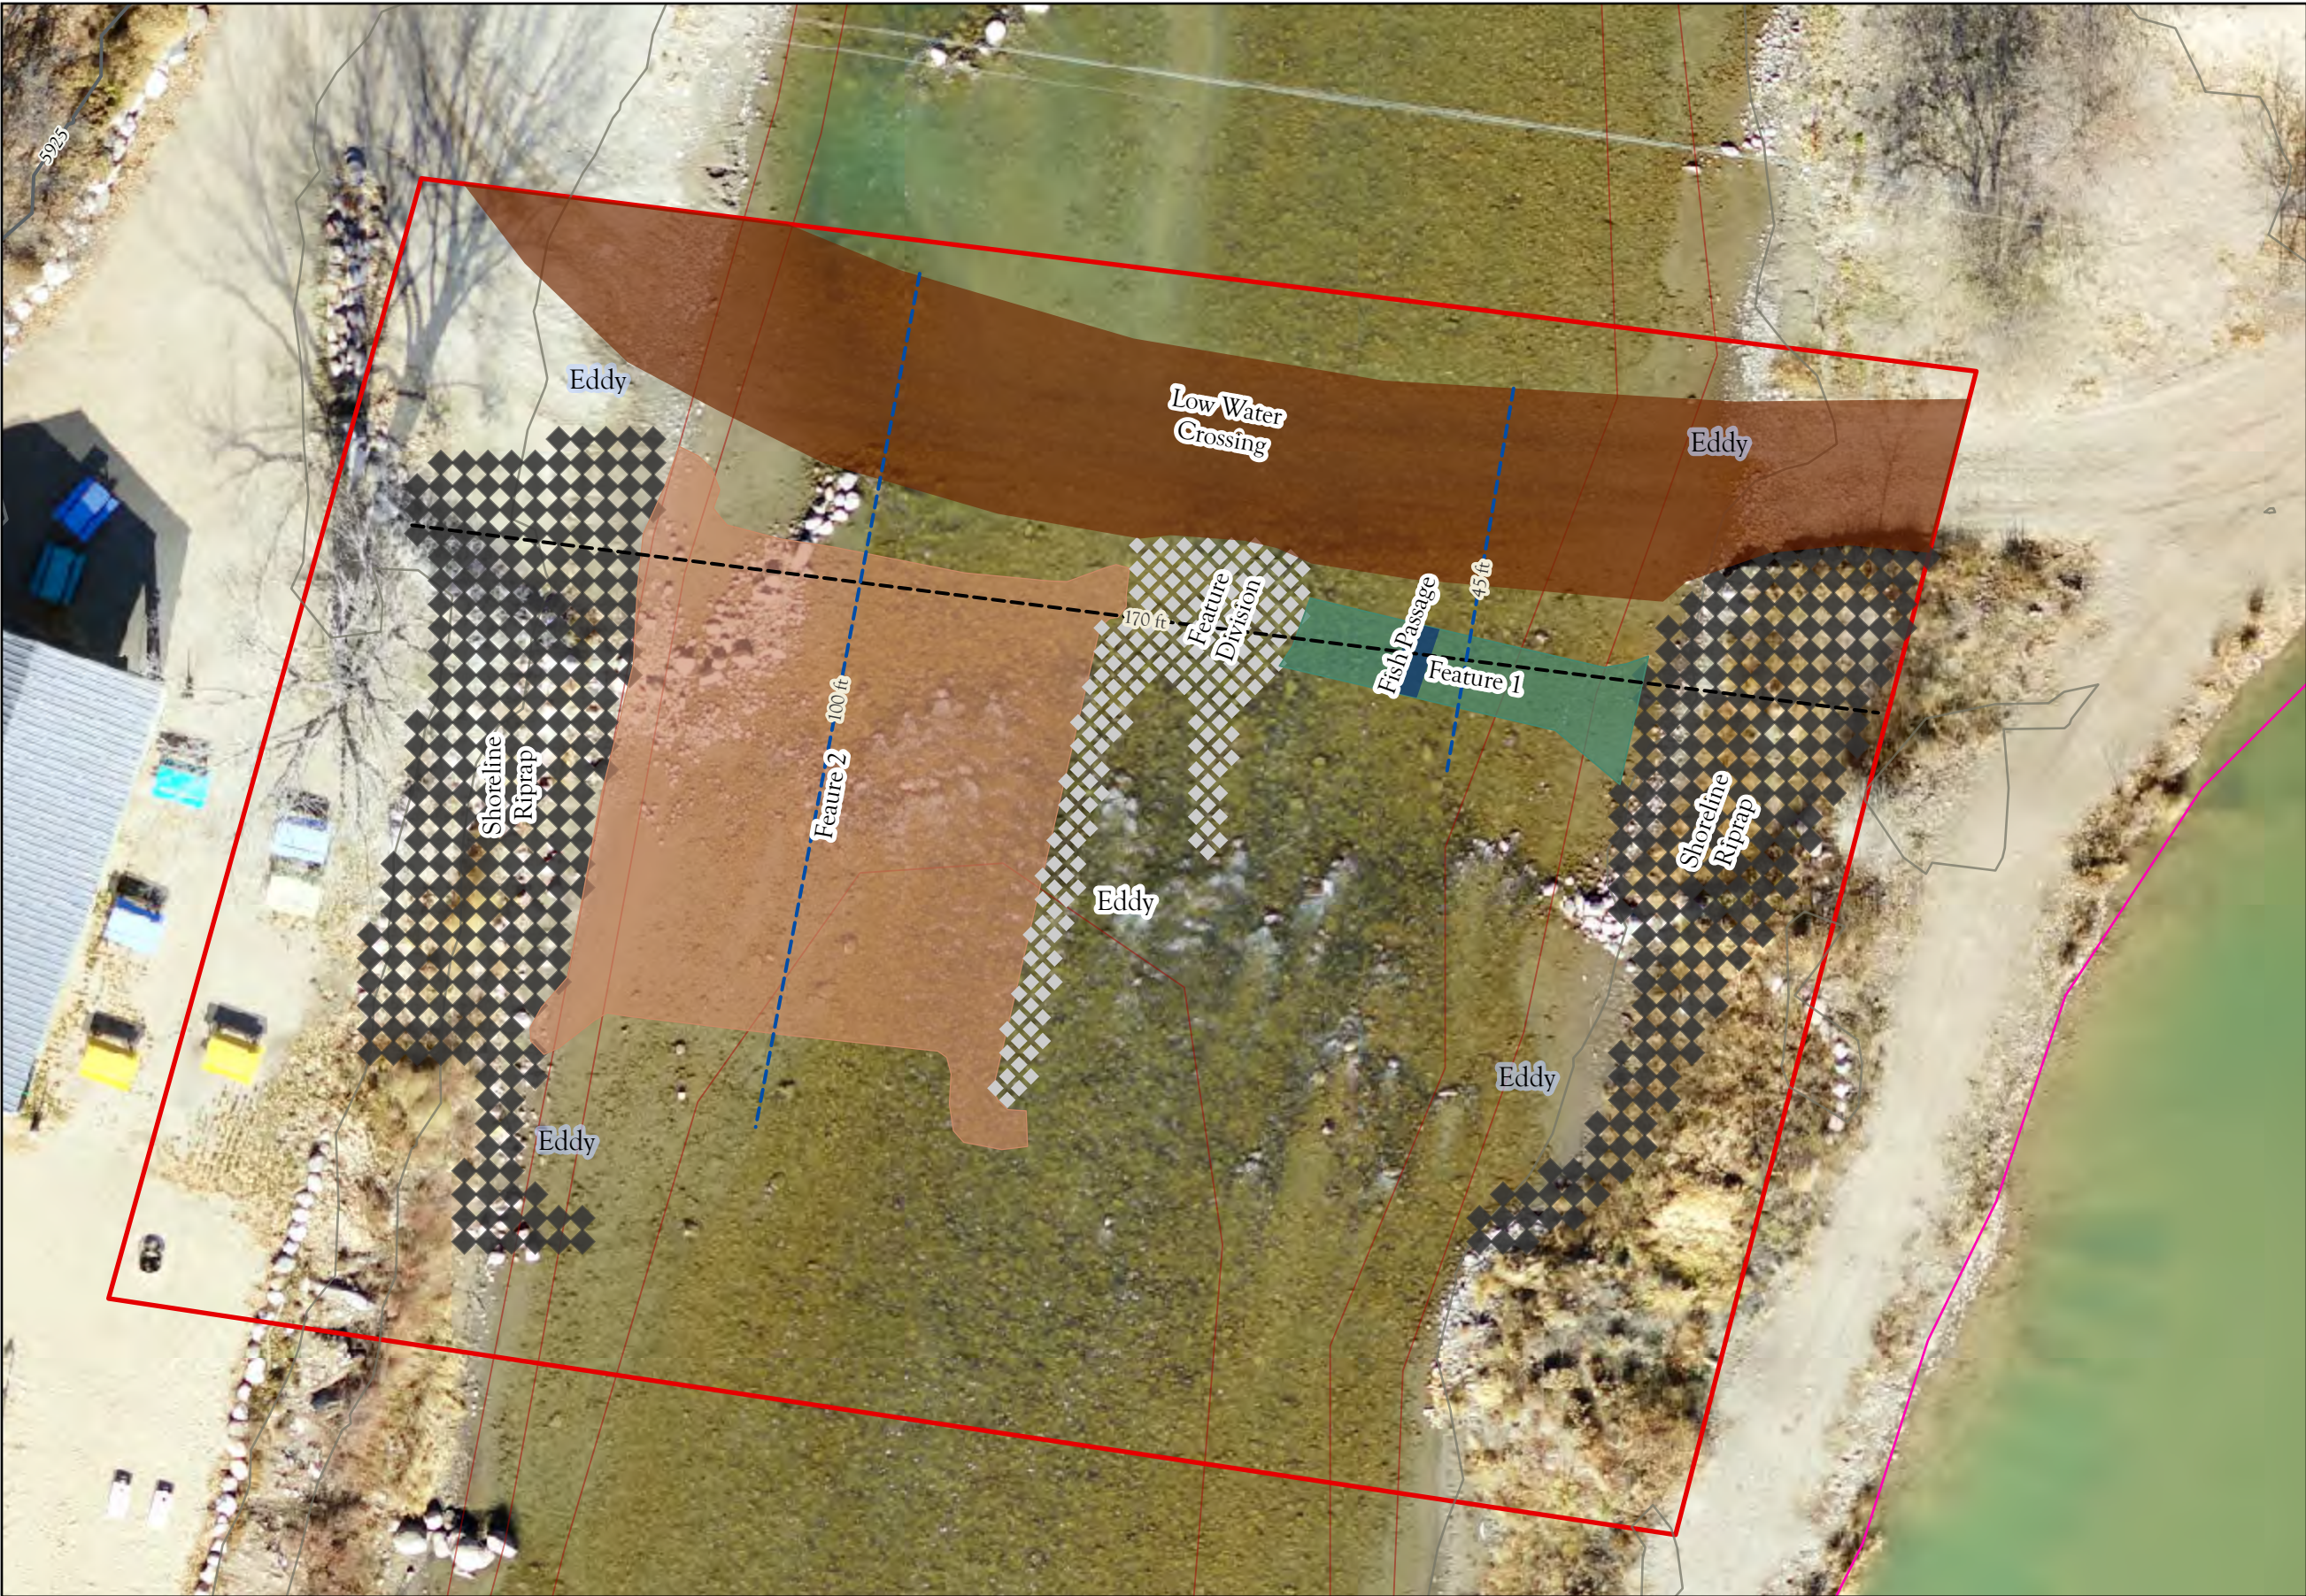
FIGURE  
2

- Survey Area
- Breaklines
- Existing Contour (Major)
- Existing Contour (Minor)
- ESTIMATED 1ft Topo Lines
- Feature 1
- Feature Division
- Feaure 2
- Fish Passage
- Existing Low Water Crossing
- Shoreline Riprap
- Cross Section
- Longitudinal

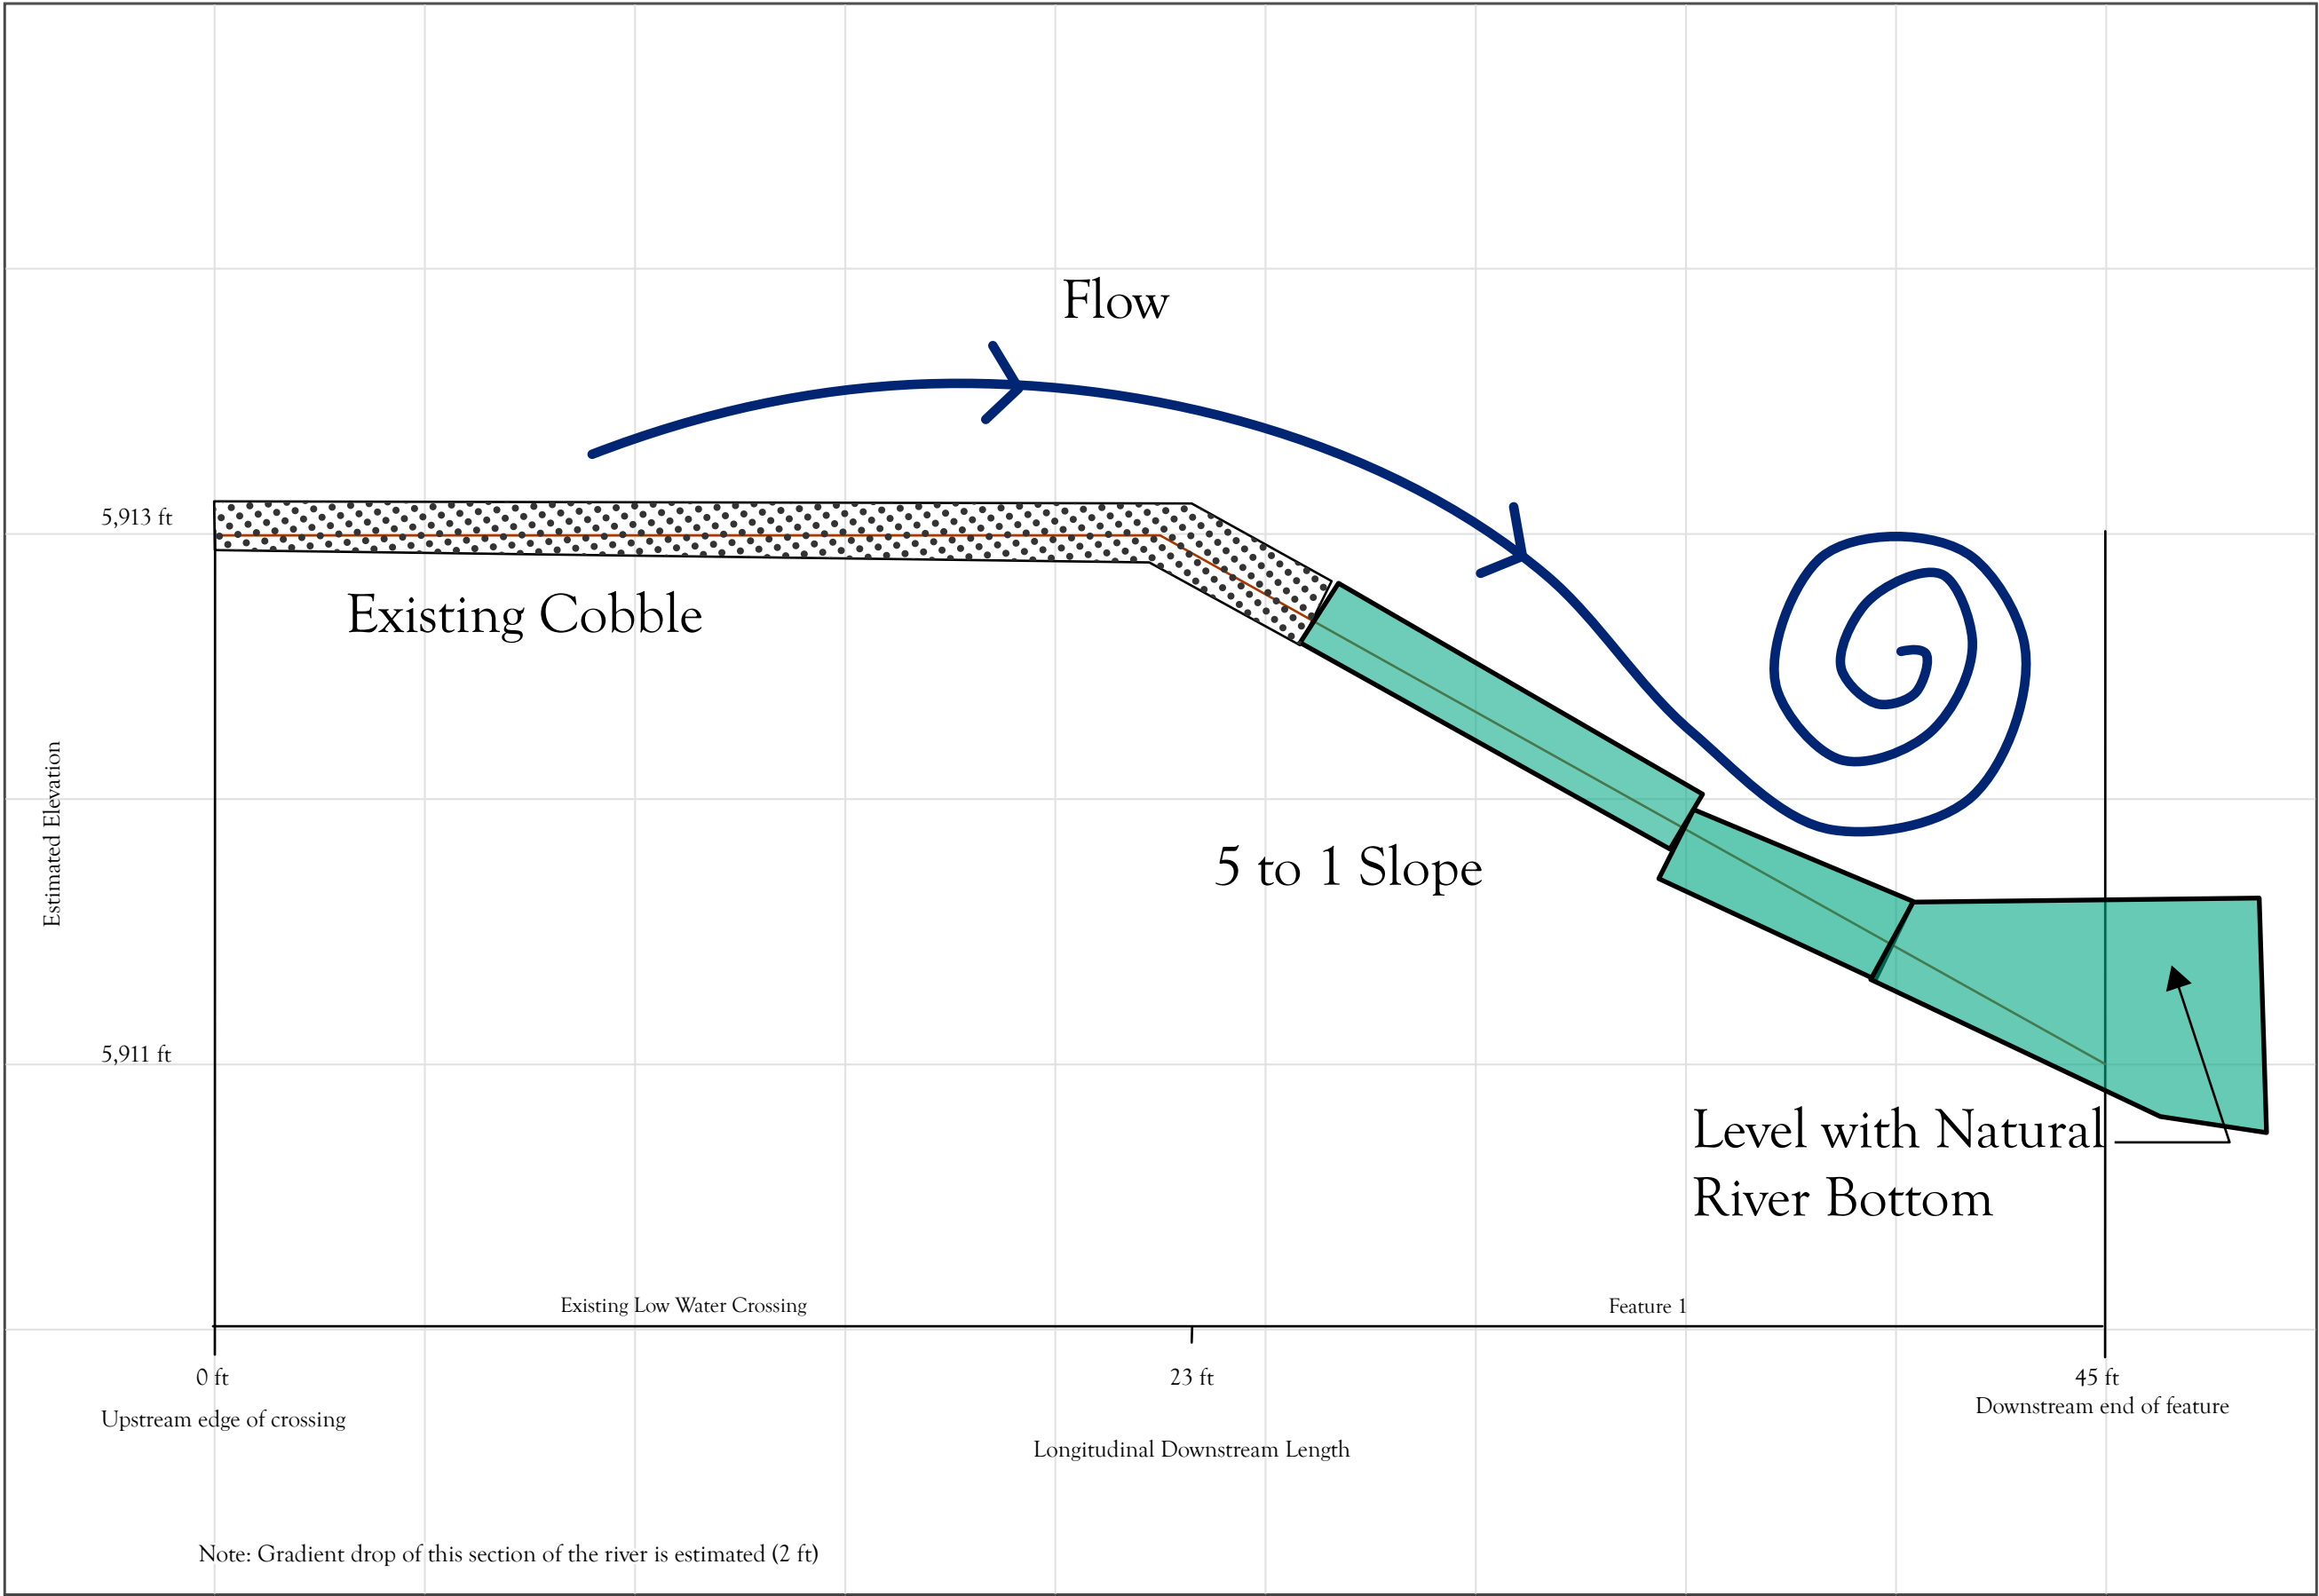
FIGURE  
3.2

FEATURE 1: LONGITUDINAL

Estimated grade drop

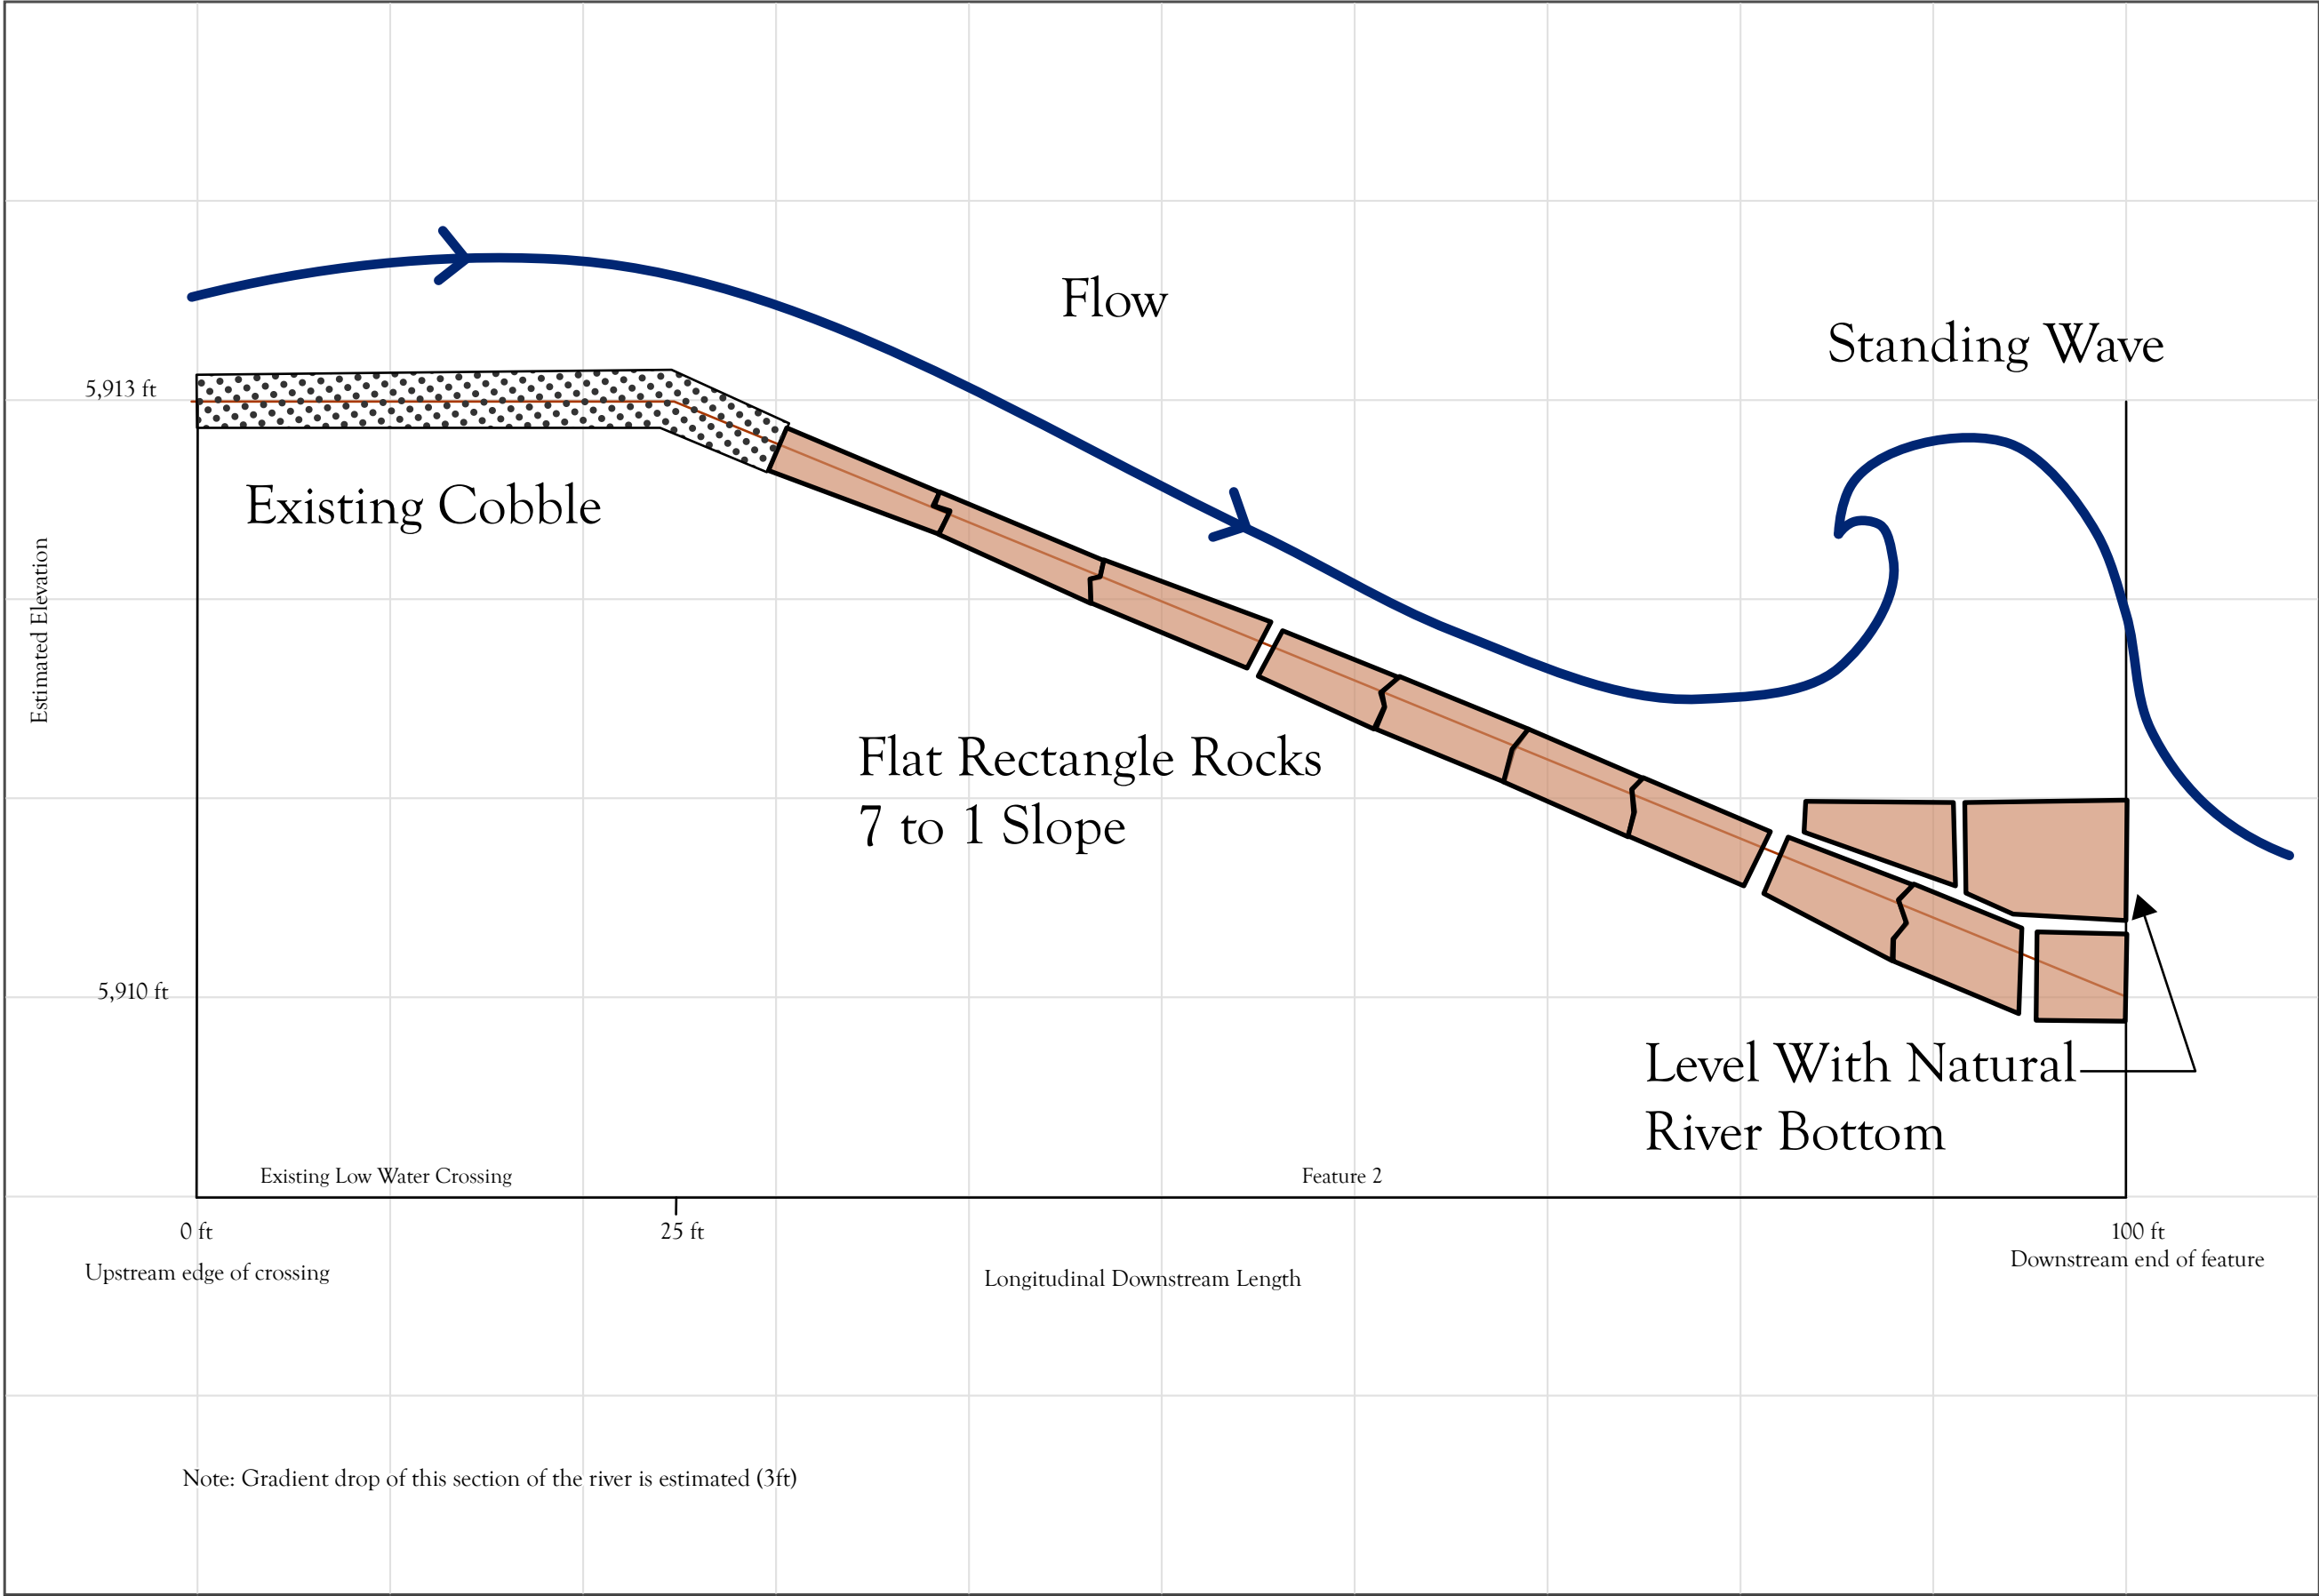
FIGURE  
3.3

FEATURE 2: LONGITUDINAL

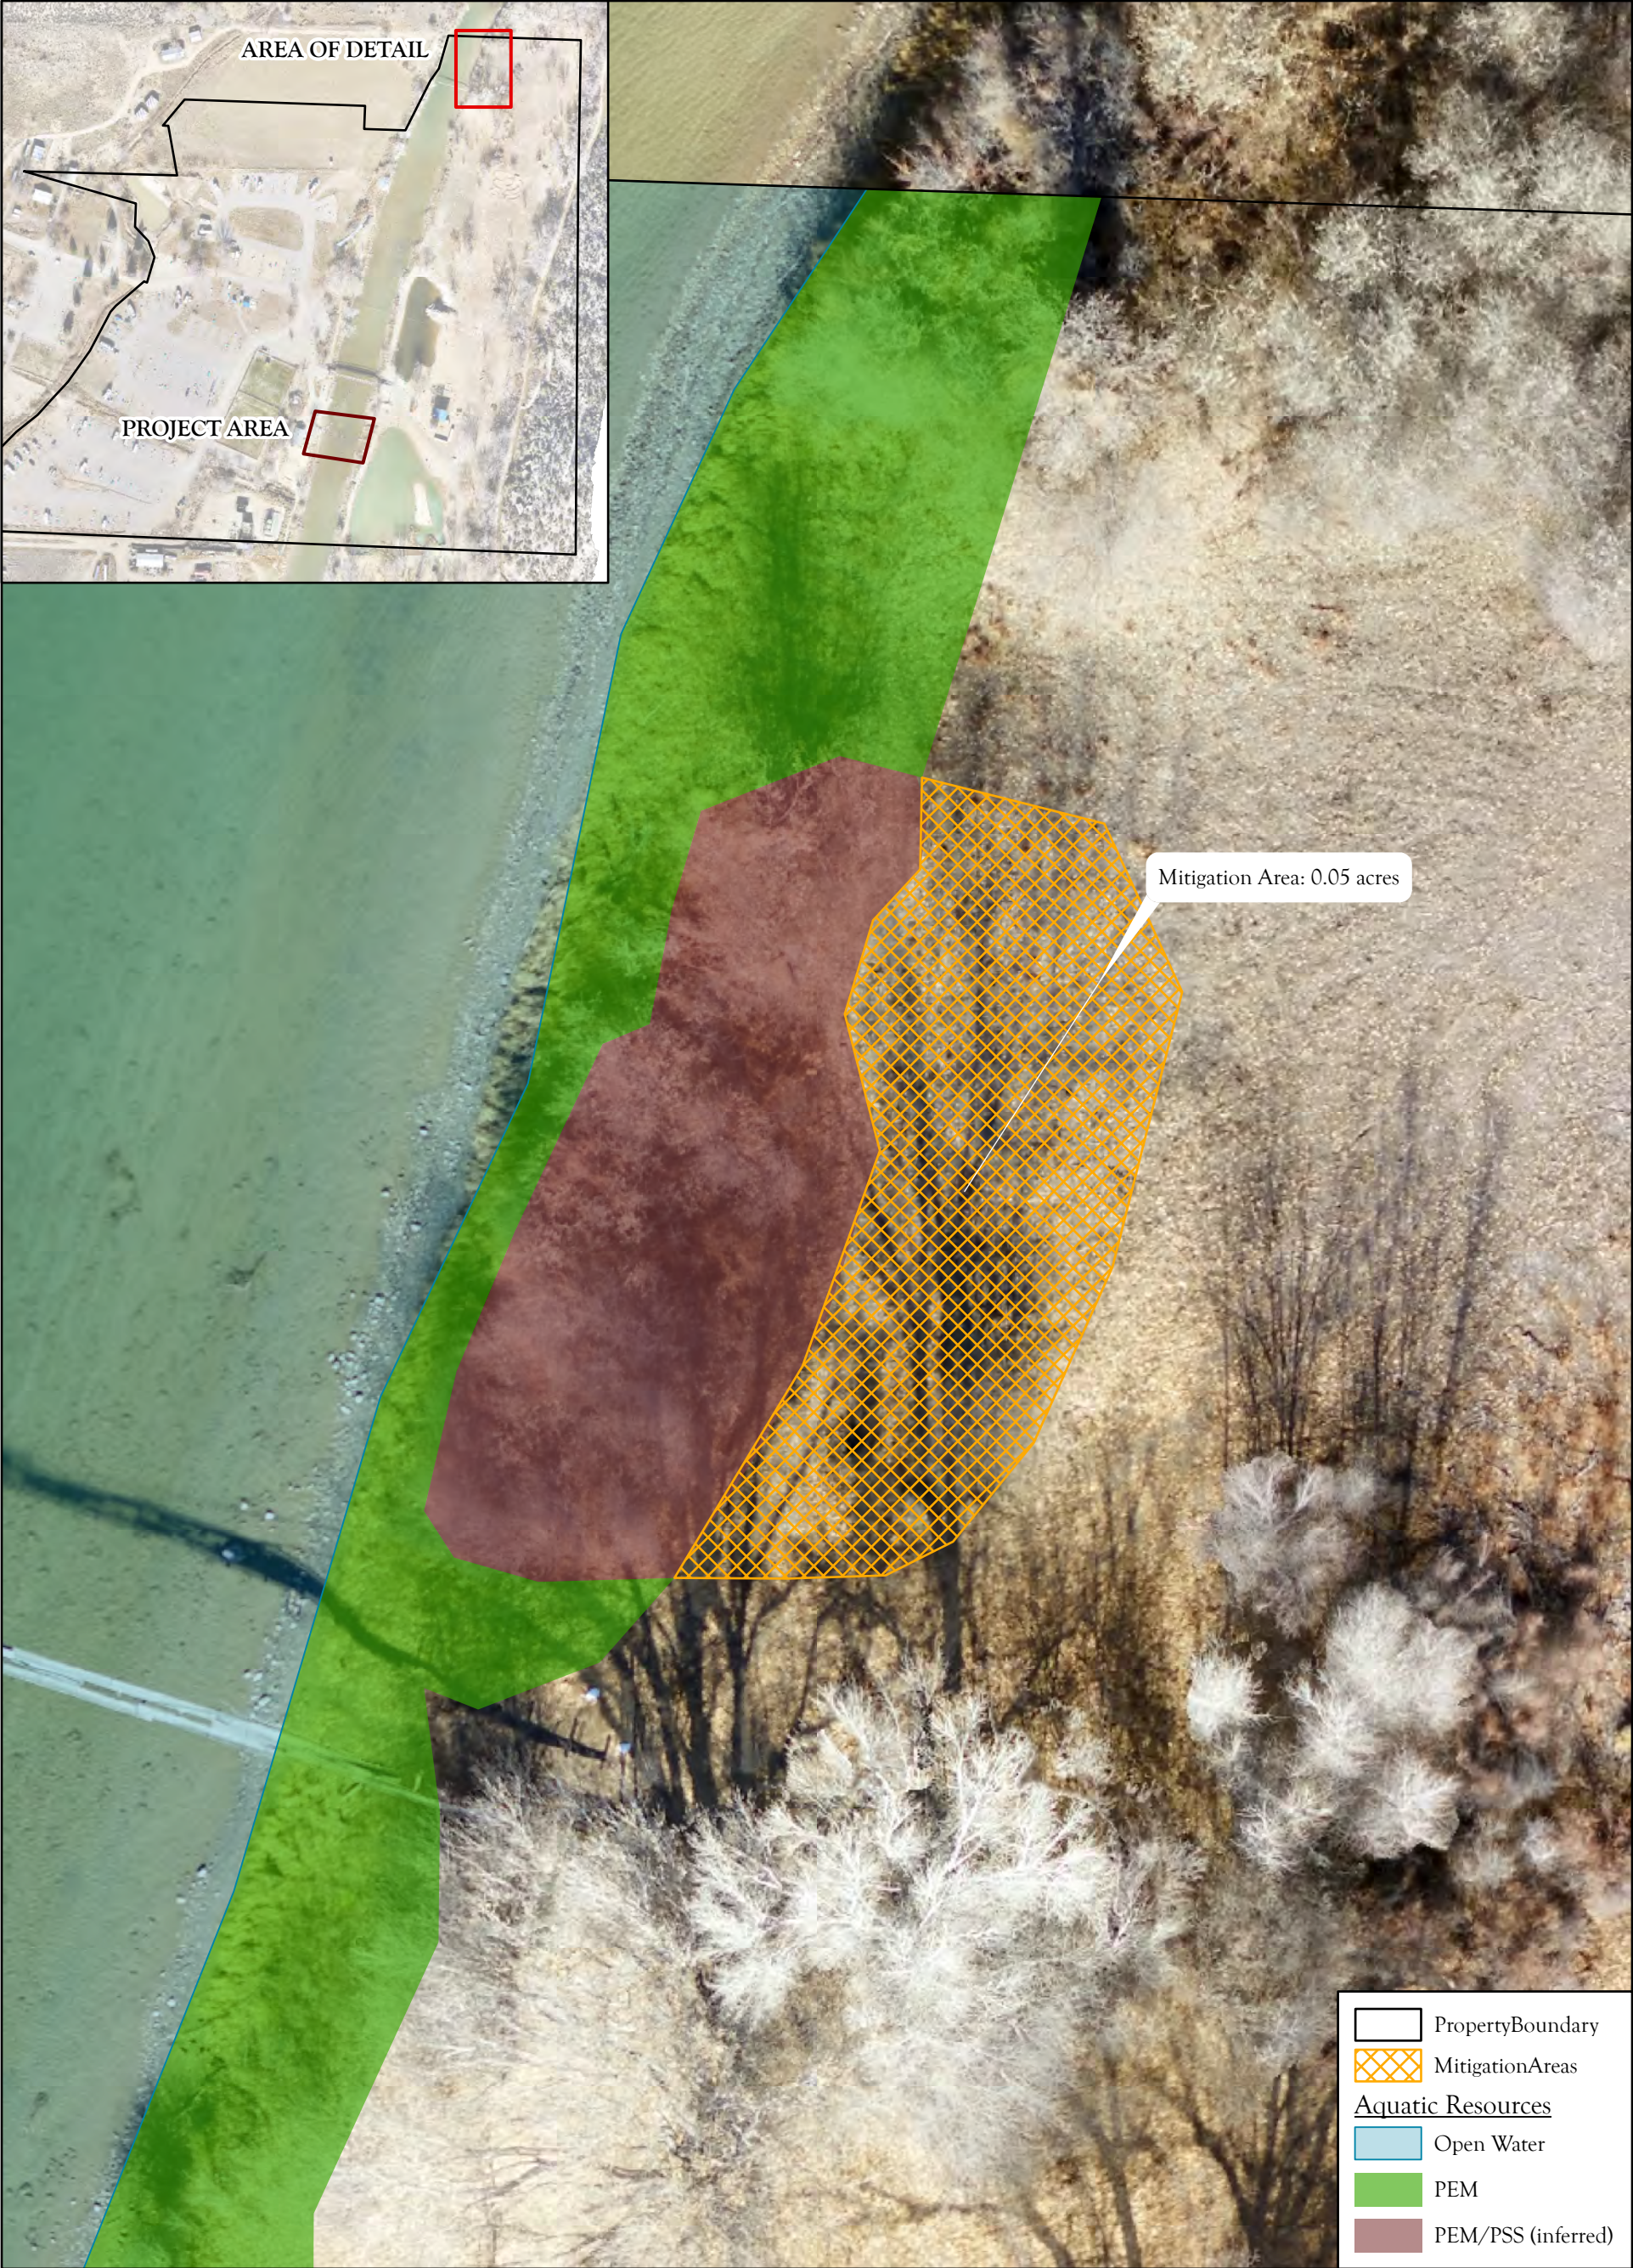
| <br><b>ENVIRONMENTAL CONSULTANTS</b><br>679 East 2nd Ave. Unit E2<br>Durango, Colorado 81301<br>www.sme-env.com<br>(970) 259-9595 | Drawn By: | Rvwd. By: | Proj. No.: | WETLAND MITIGATION MAP | |
