# Conchas Lake

## Vegetation Management Plan

### June 2025

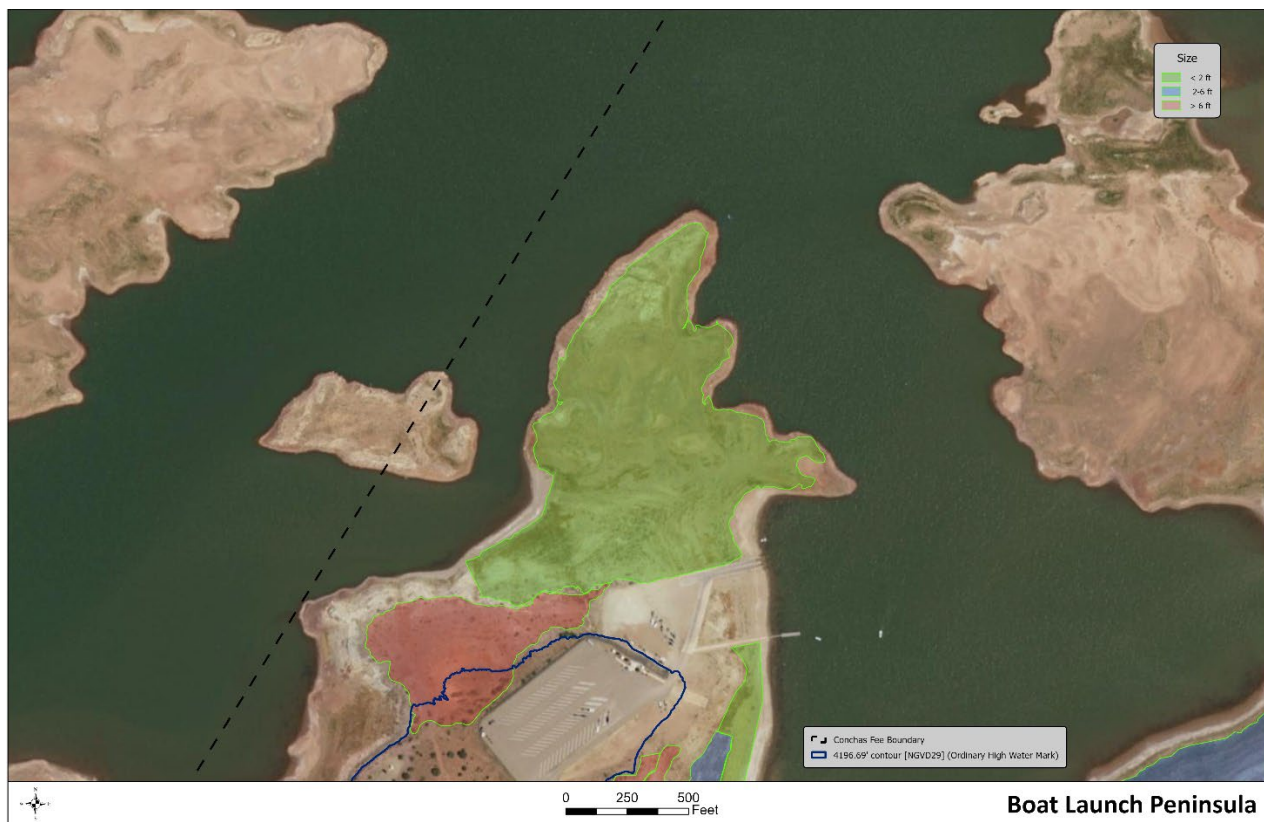
Figure 9: Boat Launch Peninsula

The Boat Launch Peninsula is located just North of Ranger Station Cove and serves as the primary boat ramp for USACE. The area is susceptible to early successional growth of invasive species such as saltcedar and Russian thistle due to fluctuating lake levels frequent ground water inundation. The site can be easily accessed by vehicle, machinery, UTV, or by foot. The area is mostly unvegetated (60% bare ground) with 50% cover of Russian thistle and <10% cover of immature saltcedar. The area is sparsely vegetated with native species such as mixed grasses, *Baccharis*, and mesquite. See Figure 9 below for details.

The recommended treatment types are cut-stump and/or foliar application. Alternatively, mechanical removal is recommended wherever possible. Treatment should be conducted in the fall (September – October) when plants begin storing nutrients prior to winter.

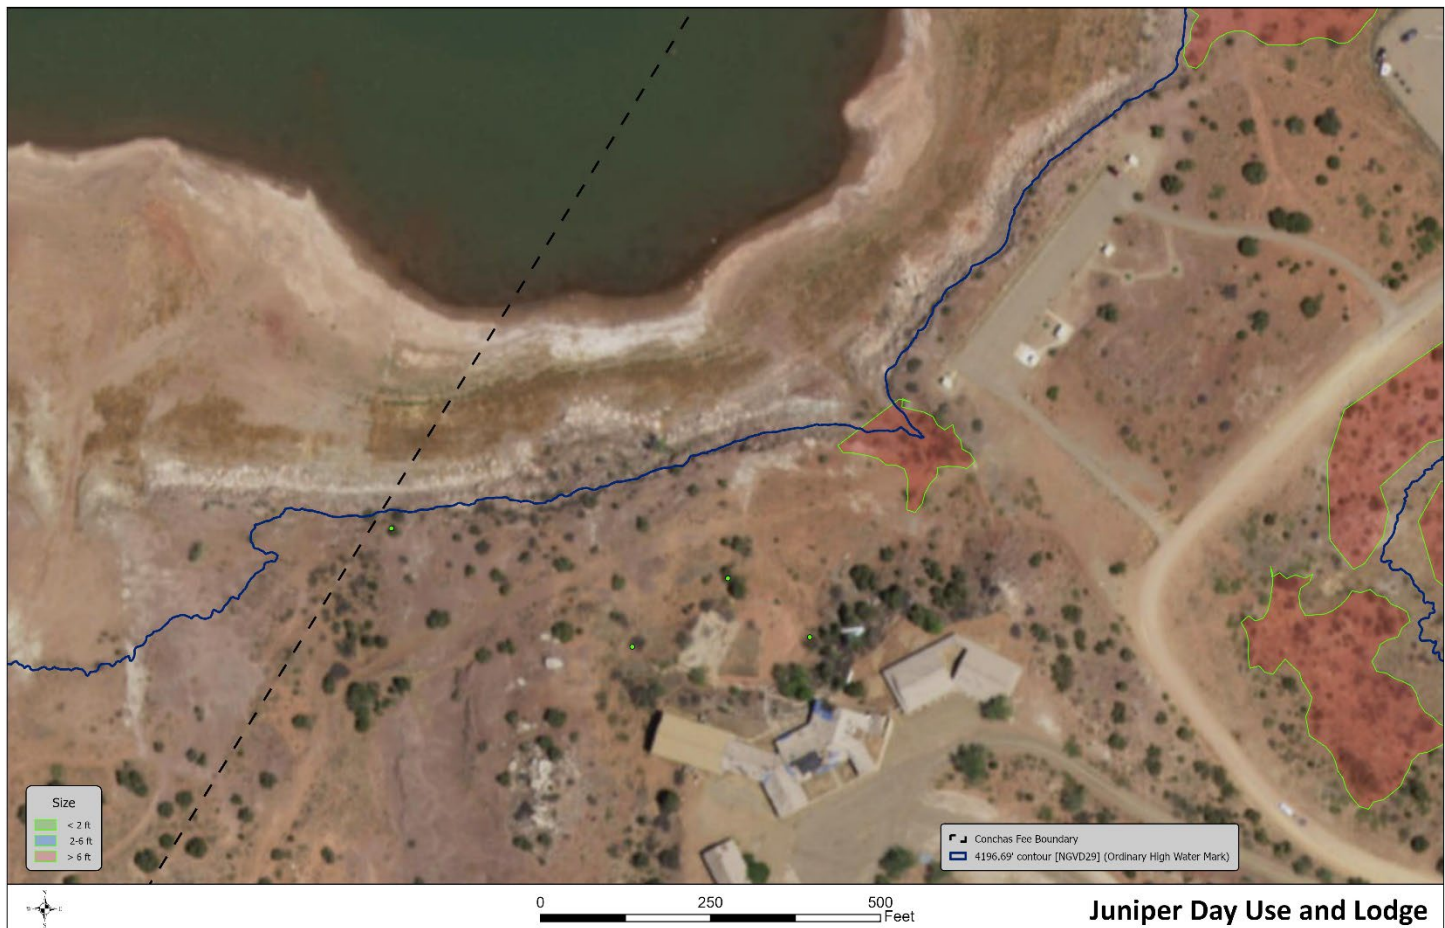
Figure 10: Juniper Day Use Area and Lodge

The Juniper Day Use Area shoreline and Conchas Lodge are located just north and northeast of the historic Conchas Loke. The site can be accessed by vehicle, UTV, and foot. Native vegetation near the shoreline includes several grass species and *Baccharis*, whereas upland areas include more diversity of grass species, *Baccharis*, mesquite, and other mixed shrubs and forbs. Invasive species were mapped according to height and canopy cover in Figure 10 below.

The recommended treatment types are cut-stump and/or foliar application. Alternatively, mechanical removal is recommended wherever possible. Treatment should be conducted in the fall (September – October) when plants begin storing nutrients prior to winter.
