Española Valley, Rio Grande and Tributaries, New Mexico

Appendix D

Cultural Resources

May 2017

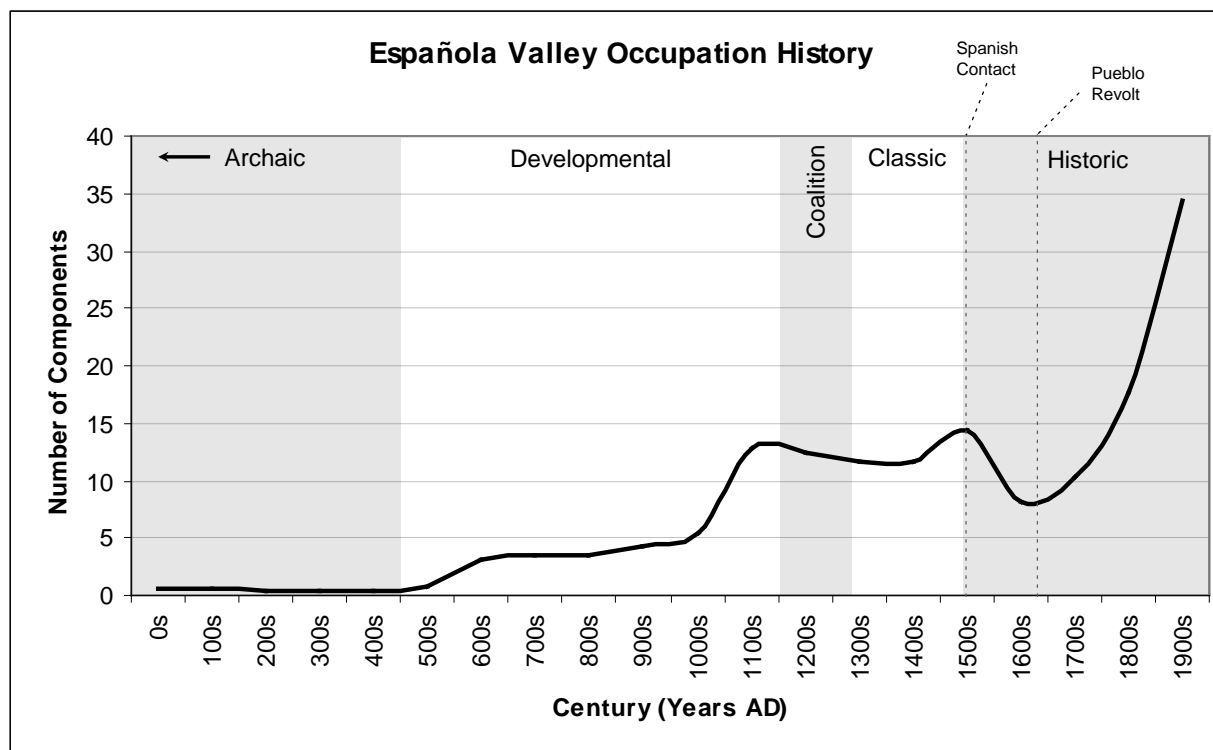
Figure 1. Occupational history of the Española Valley study area, expressed as the number of identified archaeological components over the last 2,000 years, based on available ARMS records.

There is no documented Paleo-Indian presence in the overall study area (Figure 1), and only meager definitive evidence of Archaic-period occupations (three out of 221 components). However, there are a substantial number of components containing chipped-stone artifacts that have not been assigned to a time period, and it is likely many of these artifacts date to the Archaic period. The trend demonstrates a substantial increase in archaeological components beginning approximately 1,500 years ago, which is consistent with overall trends for the Rio Grande Valley as described in the culture history in Appendix D. Cultural use of the Española Valley begins to increase during approximately the AD 600s, or the beginning of the Developmental period. The rate of increase accelerates during the AD 1100s, right at the end of the Developmental and the beginning of the Coalition periods. This is consistent with trends throughout the northern Rio Grande, as populations from the north and west (including the Chaco Canyon and Mesa Verde areas) likely migrated to the Rio Grande during this period. Overall cultural use of the area peaks slightly at the end of the Developmental period, dips slightly, and then peaks again at the end of the Classic period.

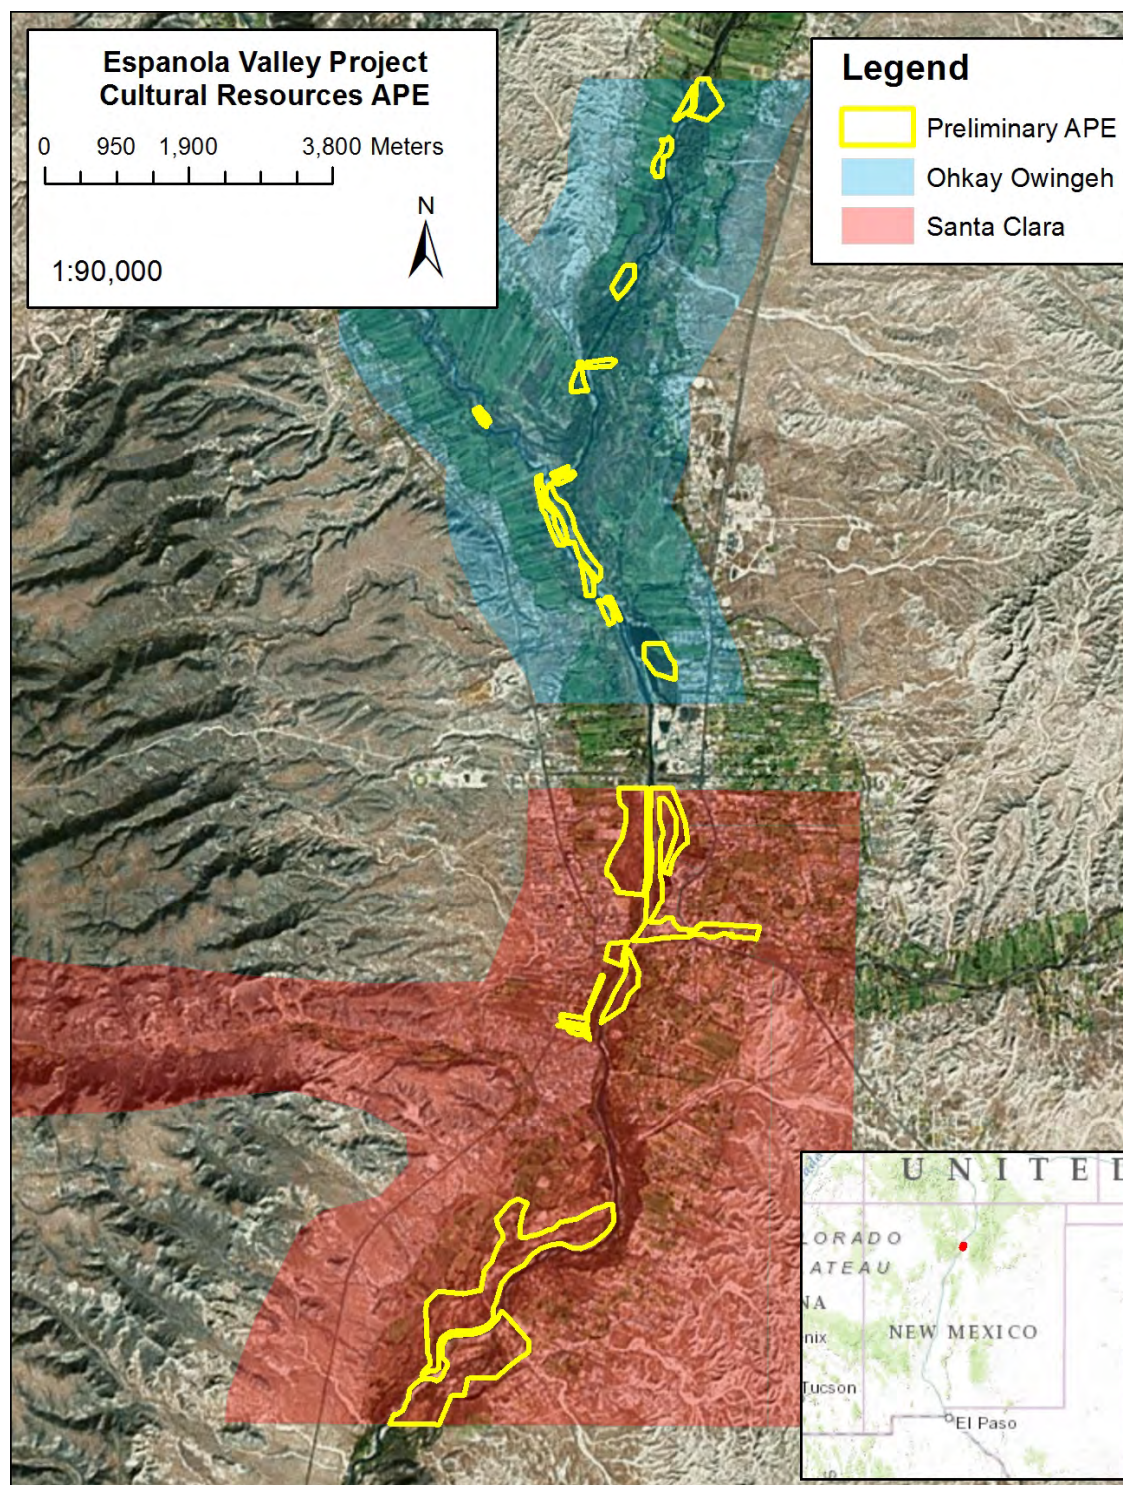
Figure 2. Preliminary Area of Potential Effect for cultural resources for proposed project.

- For Section 106 purposes, the expected APE for the proposed project, as currently understood, totals approximately 1,419 acres (925 acres within Santa Clara Pueblo, and 494 acres within Ohkay Owingeh).
- The entirety of the expected APE for this project falls within what would be categorized as “floodplain” or “lowland” areas in the above analysis

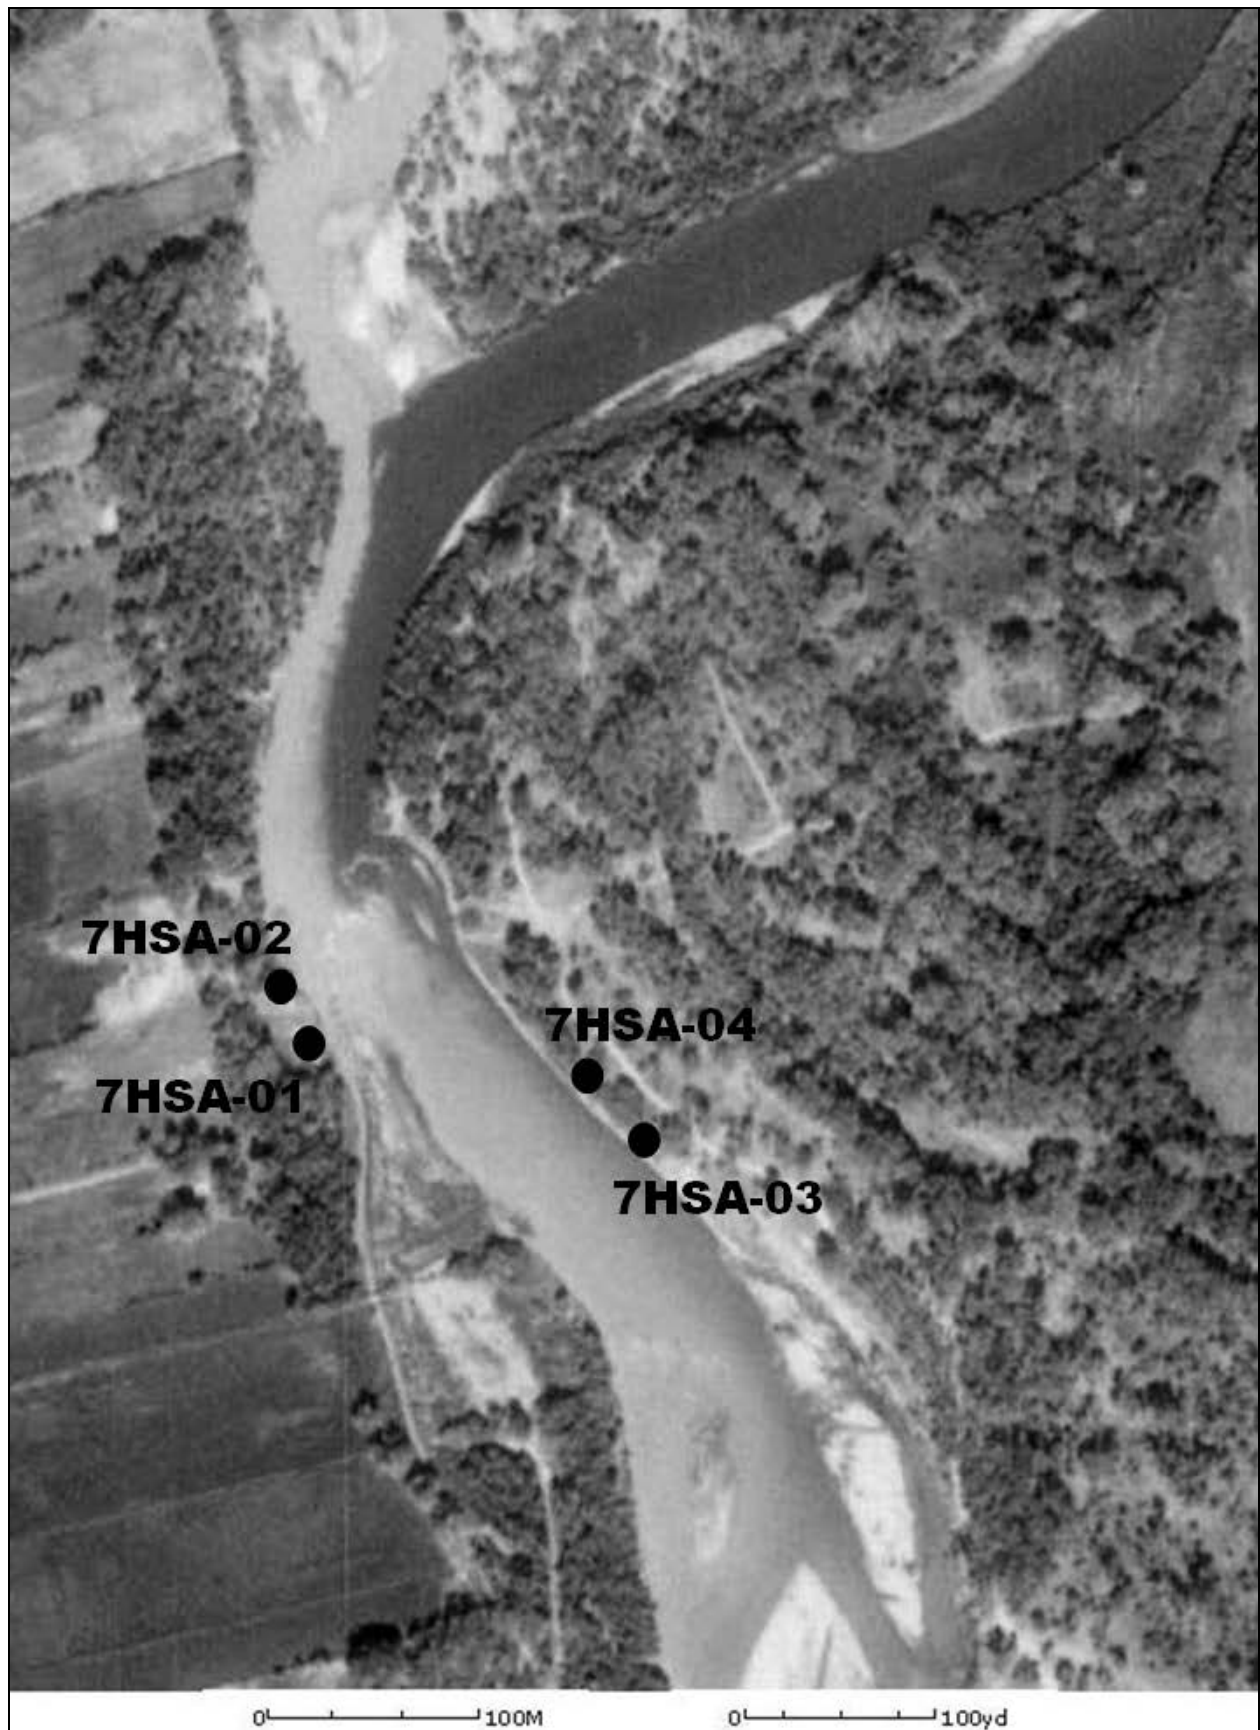
Borehole ID	sample depth (ft.)	USCS Classification	liquid limit	plasticity index	Blow count Per 6"	gravimetric moisture content	% finer than US #4 sieve (by weight)	% finer than US #40 sieve (by weight)	% finer than US #200 sieve (by weight)
7HSA-01	0	SM	NV	NP	10,8,5	10.5	98	86	37
7HSA-01	-2.5	SC	26	10	1,12,22	25.9	97	84	43
7HSA-01	-5	SP	NV	NP	4,13,21	11.7	75	42	4
7HSA-01	-7.5	GP	NV	NP	8,16,17	7.6	45	20	2.3
7HSA-01	-10	GP	NV	NP	10,27,44	5.3	47	21	3
7HSA-01	-12.5	GW	NV	NP	6,18,11	14.8	38	14	2.9
7HSA-01	-15	SP	NV	NP	9,19,50	8.3	58	16	2.6
7HSA-01	-17.5	SM	NV	NP	2,15,35	14	98	73	16
7HSA-01	-20	SC	25	8	4,15,39	11.7	98	80	20
7HSA-01	-22.5	SP-SM	NV	NP	13,20,25	15.1	100	74	12
7HSA-01	-25	SP-SM	NV	NP	7,14,37	14.5	100	62	10
7HSA-01	-27.5	SM	NV	NP	10,14,20	16.8	--	91	17
7HSA-01	-30	SM	NV	NP	6,19,22	15.9	--	80	14
7HSA-02	0	SM	NV	NP	6,3,5	4.8	97	88	19
7HSA-02	-2.5	CL	31	9	1,4,8	28.3	--	99	95
7HSA-02	-5	SM	22	3	2,4,11	25	90	82	49

7HSA-02	-7.5	SP-SM	NV	NP	4,3,6	17.1	78	67	5.9
7HSA-02	-10	GP	NV	NP	28,32,19	7.1	43	18	3.9
7HSA-02	-12.5	SP-SM	NV	NP	25,45,50	11.6	72	31	9.4
7HSA-02	-15	SP-SM	NV	NP	11,19,30	14.6	83	61	8.2
7HSA-02	-17.5	SP-SM	NV	NP	10,18,18	17.6	100	87	11
7HSA-02	-20	SM	NV	NP	15,30,50	14.7	--	78	13
7HSA-02	-22.5	--	--	--	--	--	--	--	--
7HSA-02	-25	SP-SM	NV	NP	12,19,22	15.9	100	68	6.9
7HSA-02	-27.5	SP-SM	NV	NP	11,14,38	16.5	--	70	9.5
7HSA-02	-30	SP-SM	NV	NP	6,24,38	17.2	--	55	7.8
7HSA-03	0	SM	NV	NP	2,37,32	3.3	64	60	17
7HSA-03	-2.5	GP	NV	NP	13,11,9	2.7	45	22	3.3
7HSA-03	-5	SP-SM	NV	NP	9,46,47	1.8	51	23	4.6
7HSA-03	-7.5	GP-GM	NV	NP	27,19,30	6.6	48	20	5.1
7HSA-03	-10	GP	NV	NP	13,30,42	7.2	44	20	3.6
7HSA-03	-12.5	GP	NV	NP	28,15,10	6.5	50	15	1.8
7HSA-03	-15	SP	NV	NP	9,9,4	8.7	77	17	2.5
7HSA-03	-17.5	GP	NV	NP	16,23,18	8.1	46	24	3

Subsurface information specific to proposed construction sites is currently not available. Depth to bedrock is unknown but not expected to be within the proposed limits of foundations. A subsurface investigation was not conducted. As the project alternatives are developed in greater detail, a subsurface investigation will be planned to investigate the subsurface conditions at those specific locations. Subsurface information from the proposed Los Vigiles Grade Reduction Facility (GRF), Española, New Mexico; is provided in a summary table below. This information was obtained in the general vicinity of this project and in 2007.

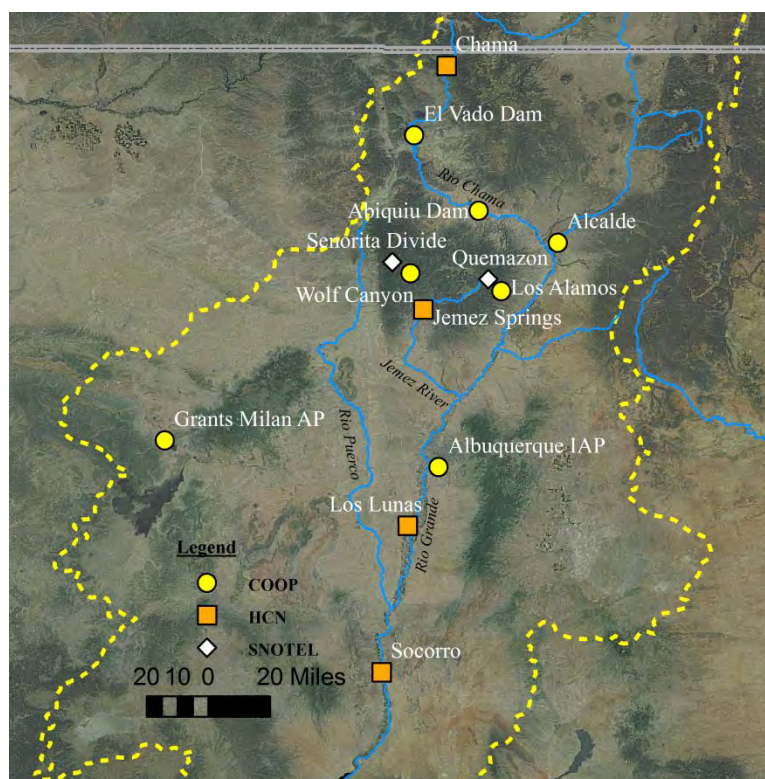
Figure 1: Map showing sites used in the analysis (site names keyed to Table 3).

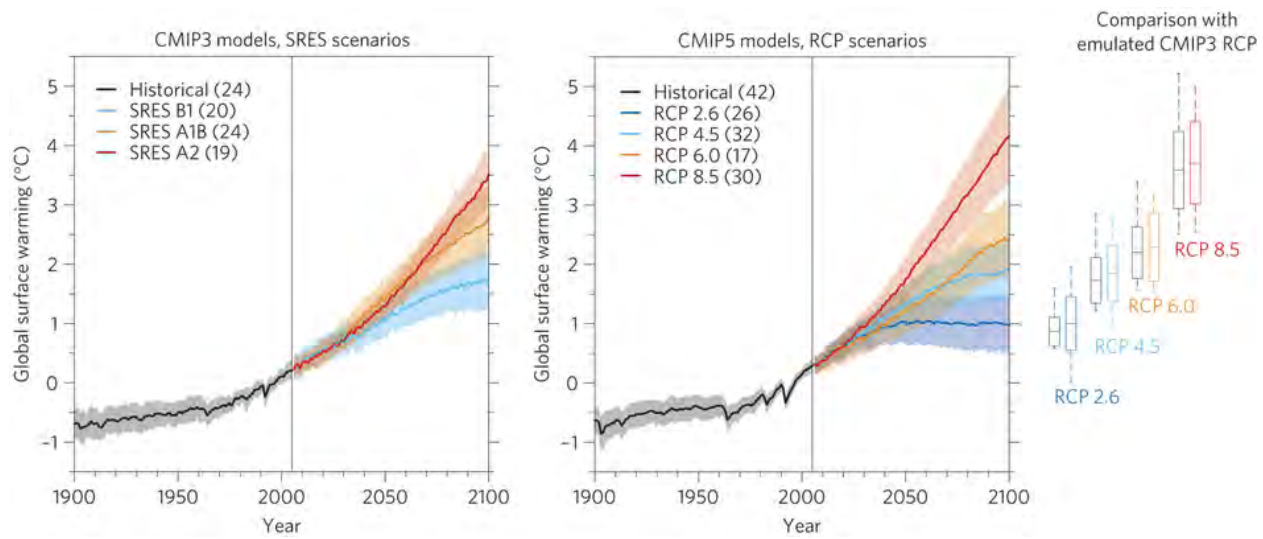
Figure 2 Comparison of projected global mean annual temperatures under various SRES and RCP scenarios (Knutti and Sedlacek, 2013:Fig. 1).

The SRES and RCP approaches have converged on projected future greenhouse gas concentrations in the atmosphere. RCP 8.5 produces mean future warming comparable to the SRES A1FI scenario, which is slightly greater than the more commonly used for modeling SRES A2 (high emissions) scenario; RCP 4.5 produces warming comparable to the SRES B1 (low emissions) scenario (Knutti and Sedlacek 2013).

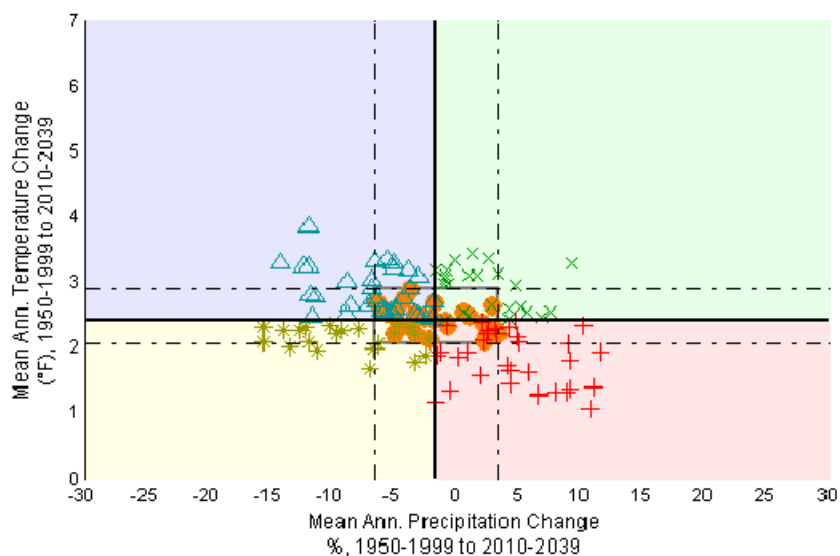
Figure 3: Modeled changes in temperature and precipitation in the period 2010-2039.

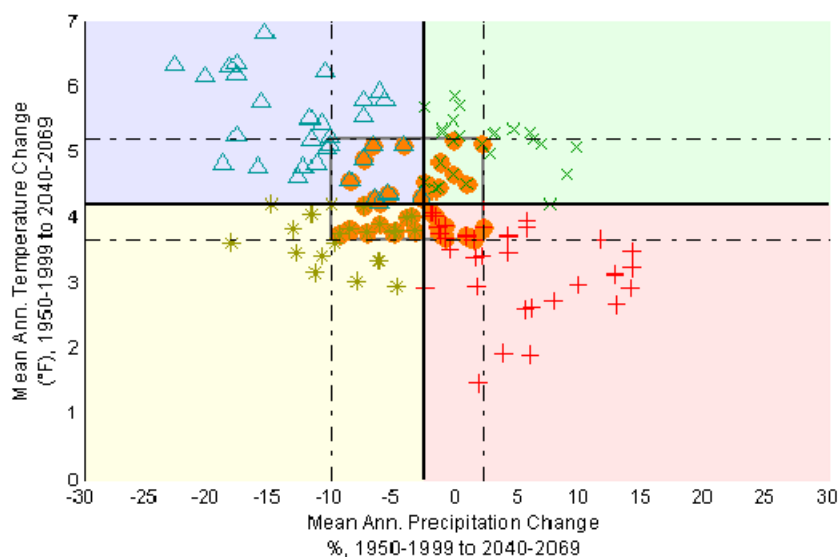
Figure 4: Modeled changes in temperature and precipitation in the period 2040-2069.

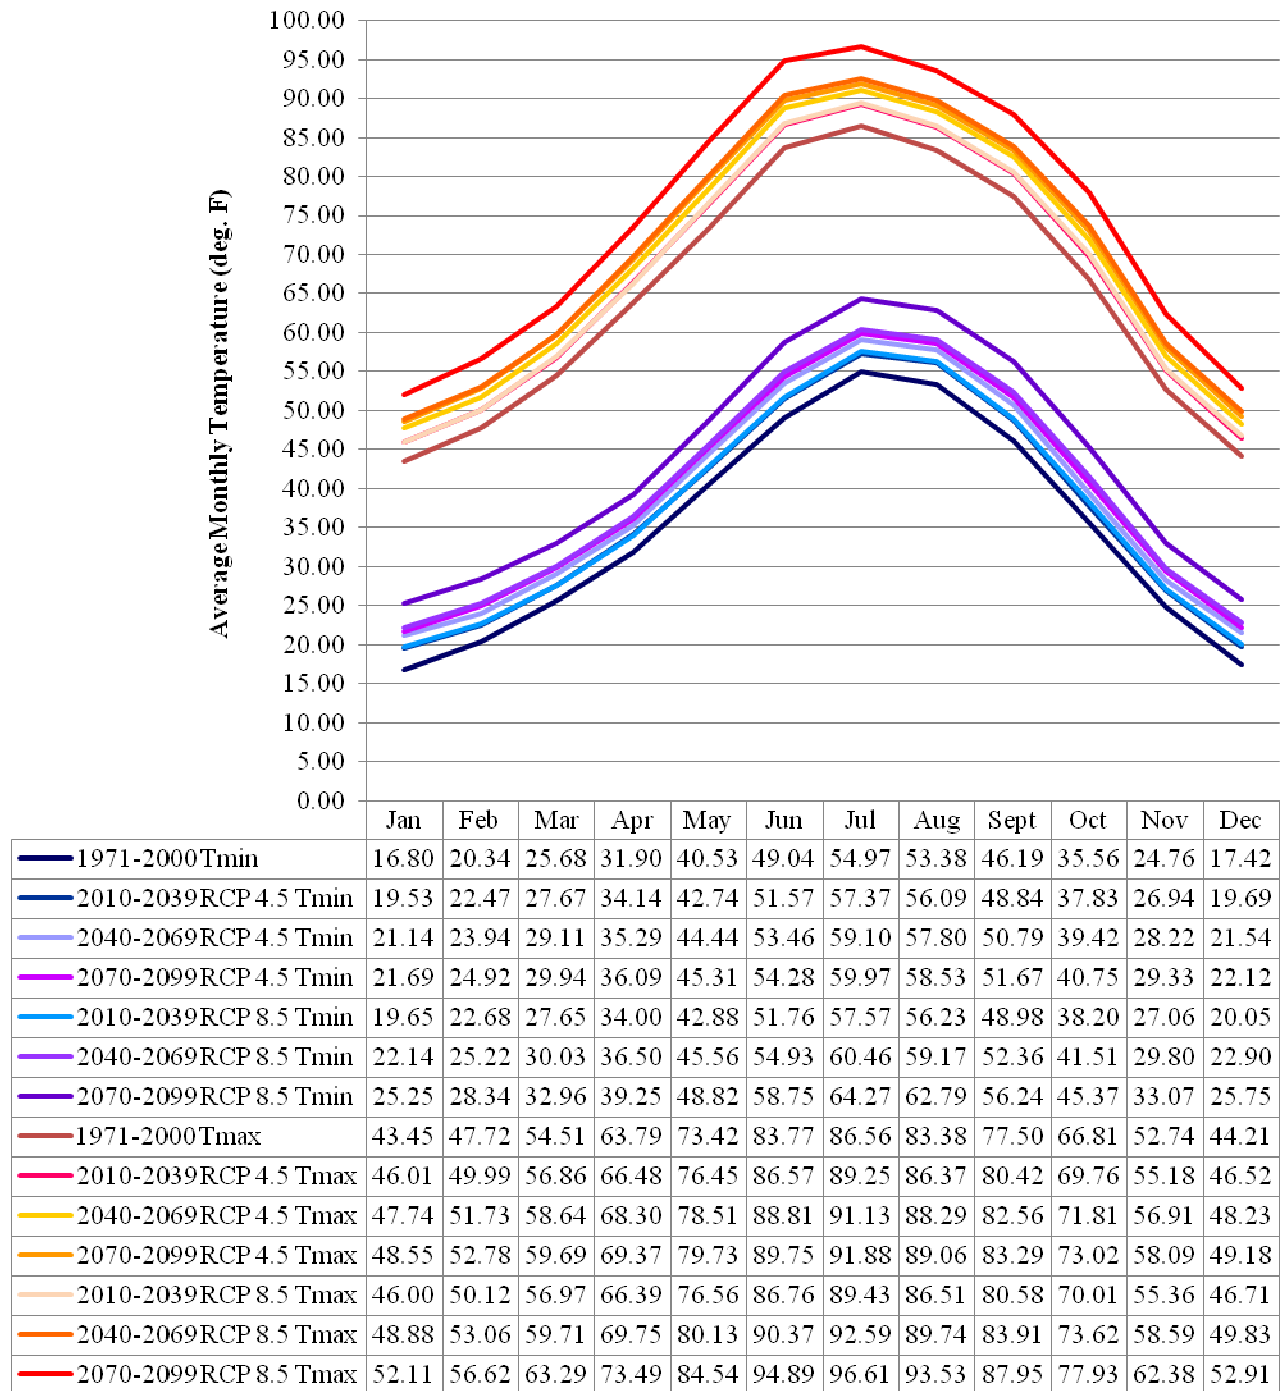
Figure 5 Projected temperature change in Sandoval County, NM, based on the NASA NEX-DCP30 dataset.

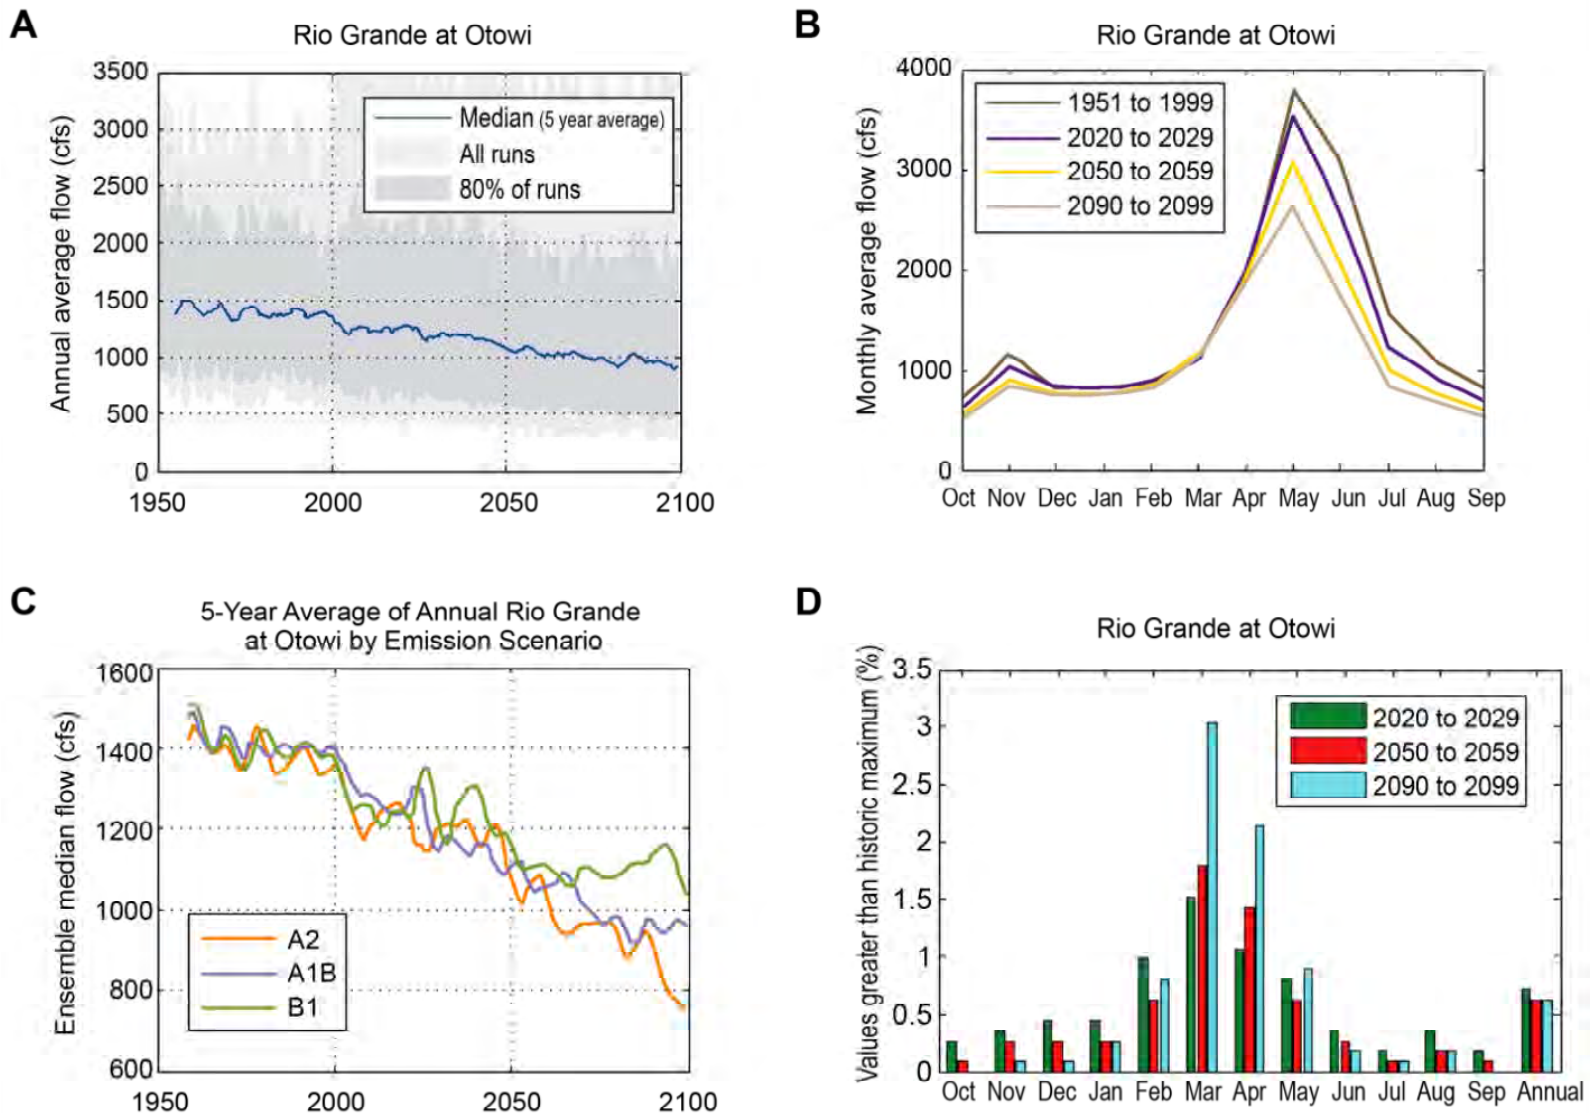
Figure 6 Projected Rio Grande flows at Otowi Gage (Reclamation et al. 2013: Fig. 31).

At the Central Avenue gage in Albuquerque, flows are anticipated to decrease 36%, from an annual average of approximately 1,100 cfs during the historic period (1950-1999) to less than 700 cfs by the 2090s (Reclamation et al. 2013). May through August flows are likely to be reduced significantly, but there is likely to be little advance in spring runoff timing (Reclamation et al. 2013).

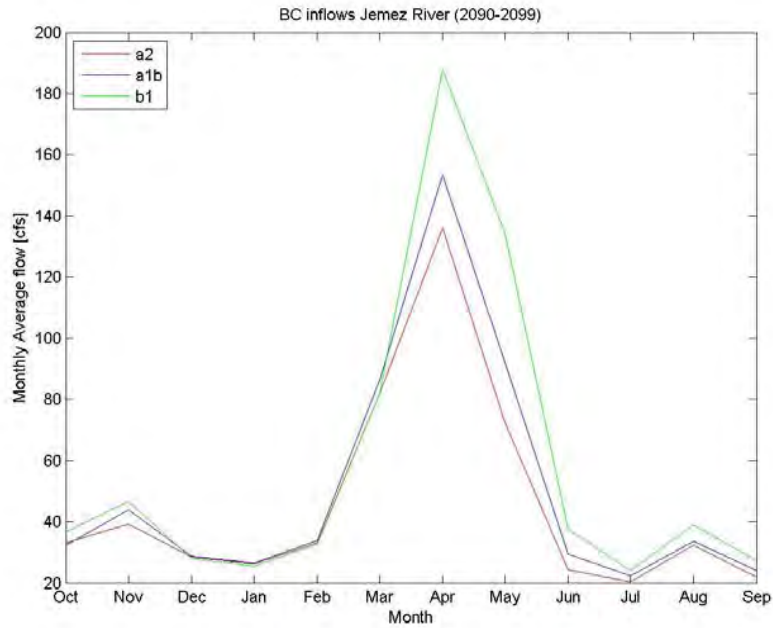
Figure 7 Jemez River monthly average flows in 2090-2099 under different projected emissions scenarios (unpublished data, Reclamation).

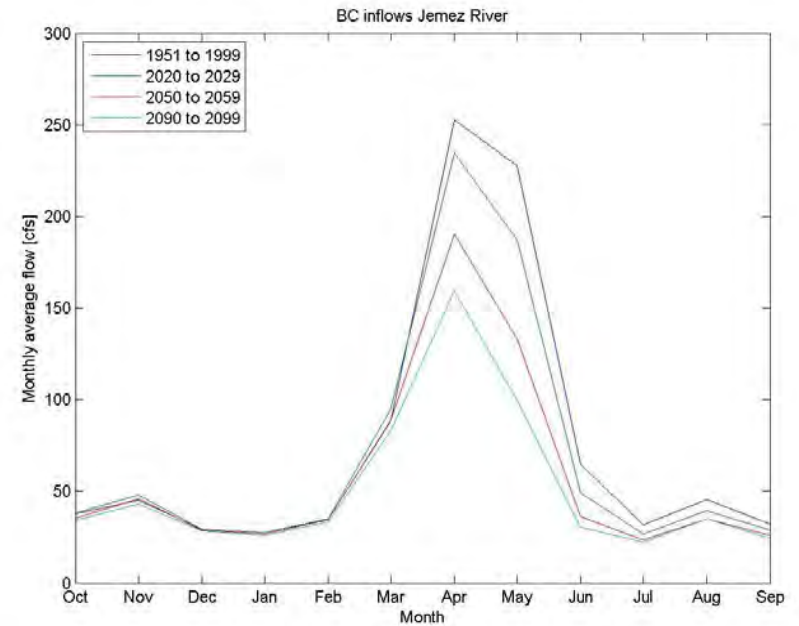
Figure 8 Jemez River monthly average flows, model averages (unpublished data, Reclamation).

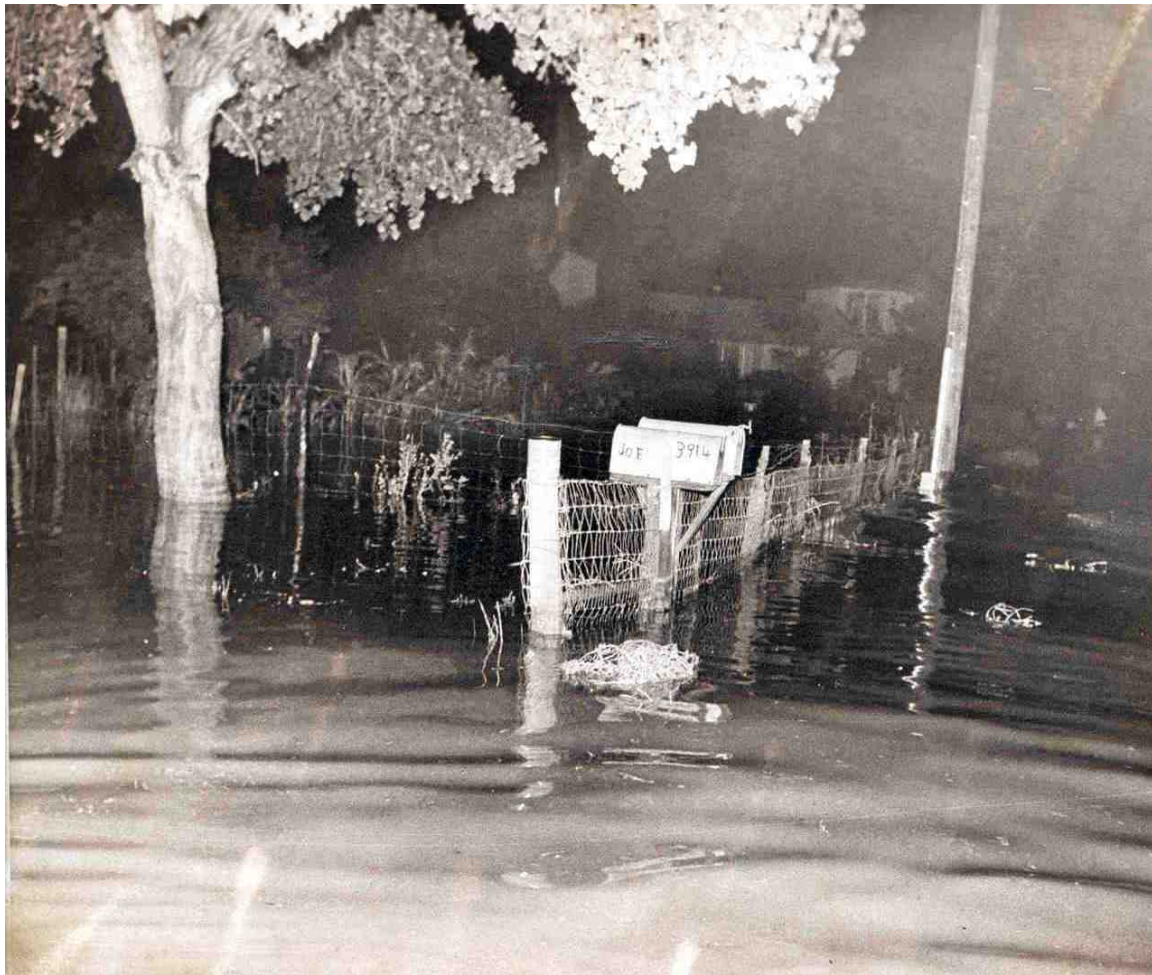
Figure 6 Española Valley floods of 1941.

Scurlock (1998) documented floods of greater than 10,000 cubic feet / second (cfs) within the Española Valley, to include the Pueblos of Ohkay Owingeh, Santa Clara and San Ildefonso, for the years 1835, 1874, 1880, 1884, 1901, 1903, 1912 (29,000 cfs), 1920 (24,400 cfs), 1921 (100,000 cfs), 1941, 1942, and 1951. SPA also has documentation for the floods of 1969 and 1977. The National Oceanic and Atmospheric Administration (NOAA) and the U.S. Geological Survey (USGS) have records of historic flood crests. USGS has determined that the flood stage at the Otowi gage begins at 9 feet. Their website has recorded flood stages for following years: 1904 (14.50 feet), 1920 (14.10 feet), 1941 (13.54 feet), 1911 (13.10 feet), 1905 (12.05 feet), 1916 (10.93 feet), 1942 (10.22 feet), 1919 (10.10 feet), 1924 (10.06 feet), and 1985 (9.96 feet).

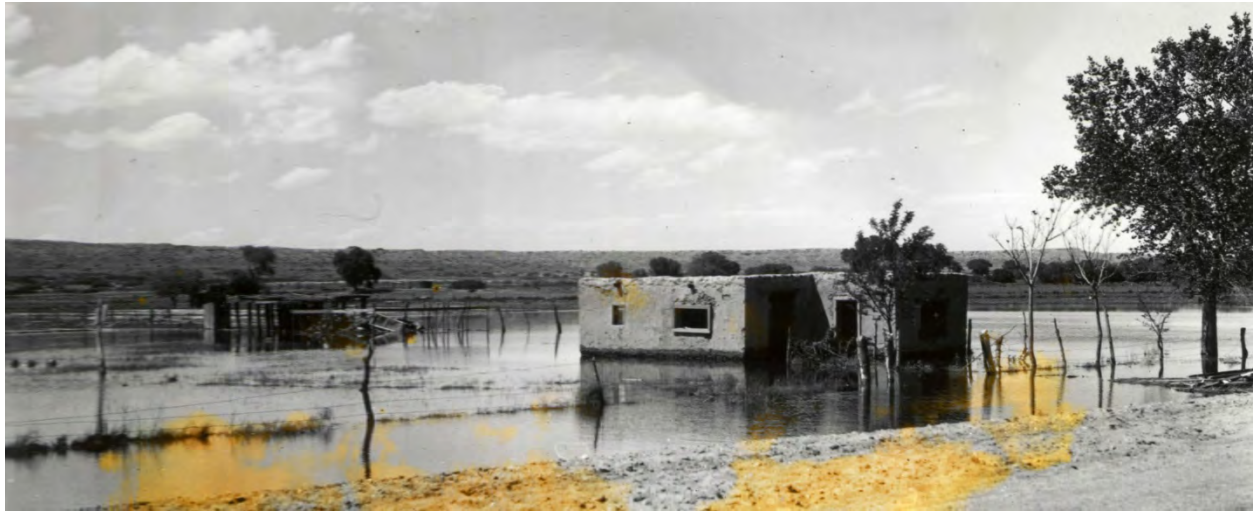
Figure 7 Española Valley floods of 1942 showing ponding and saturation of this structure's adobe walls.

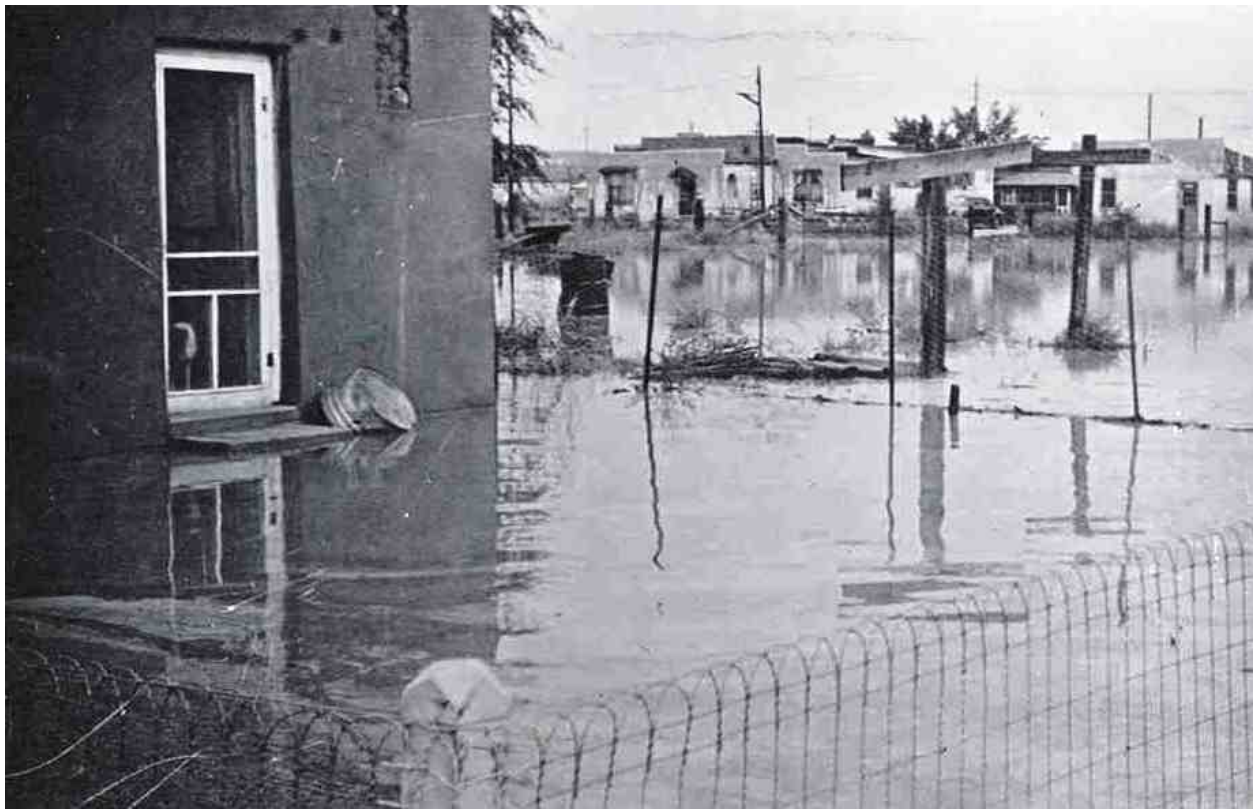
Figure 8 Española Valley floods of 1951 showing ponding days after Rio Grande floodwaters receded.

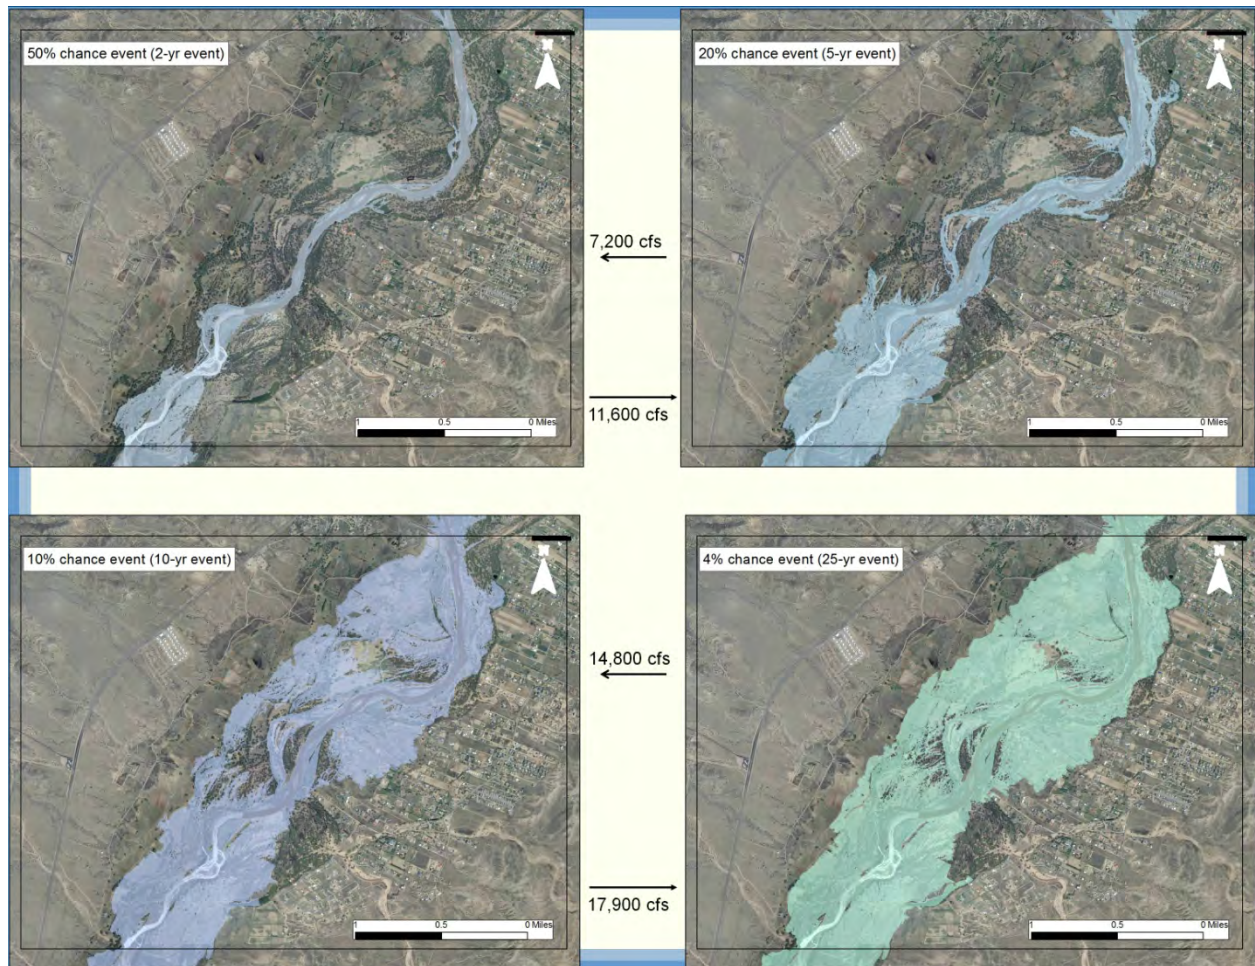
Figure 9 Existing conditions flood plain mapping for the 50%, 20%, 10% and the 4% chance exceedance precipitation events.

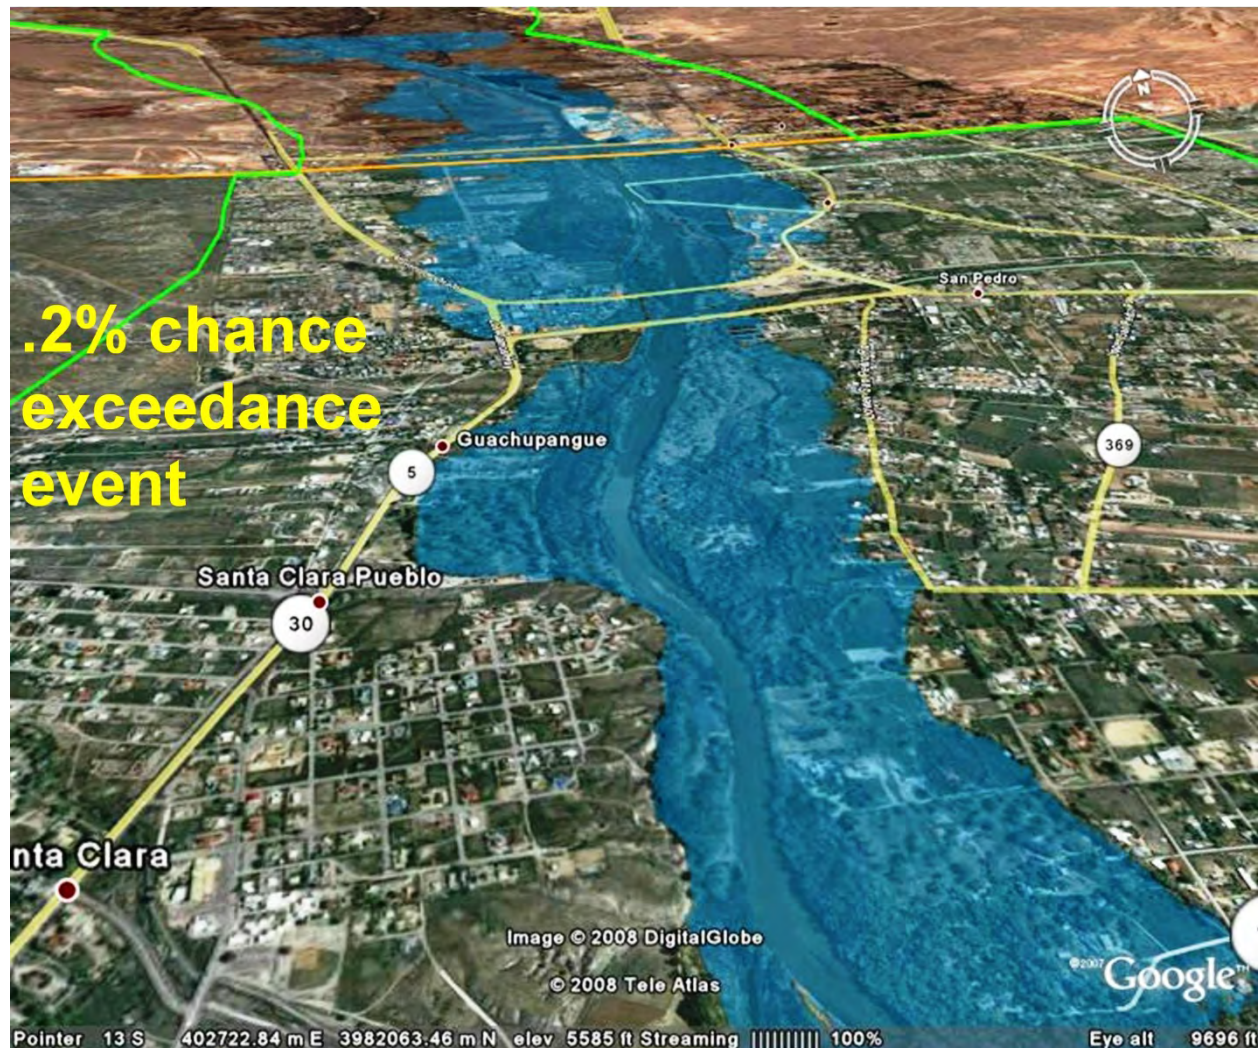
Figure 10 Existing conditions flood plain mapping for the 0.2% chance exceedance precipitation event.

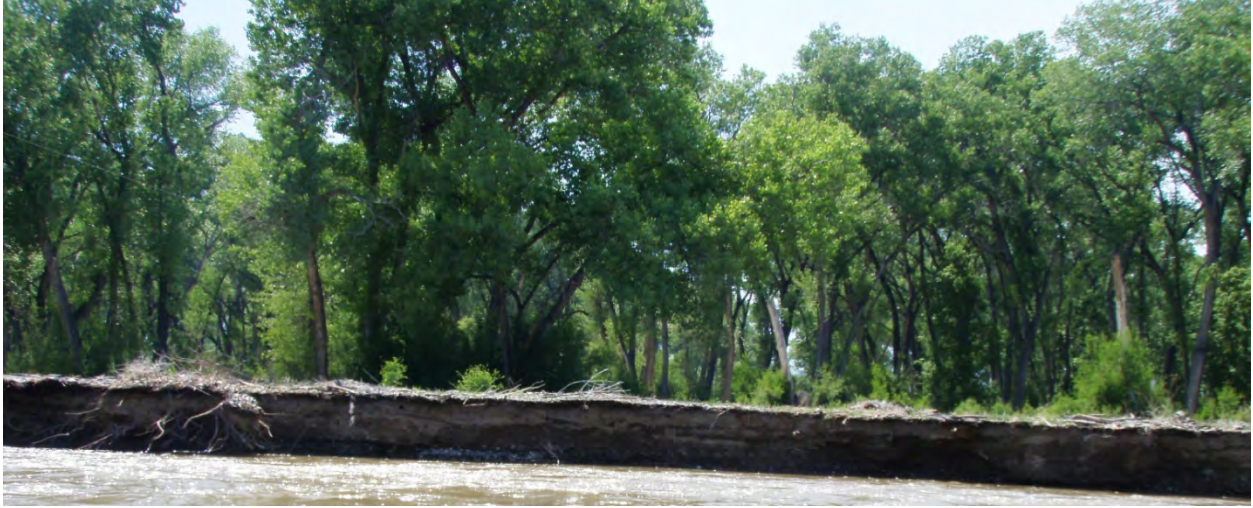
Figure 11 High terrace on preventing Rio Grande overbanking on Ohkay Owingeh Pueblo during spring runoff in 2009.

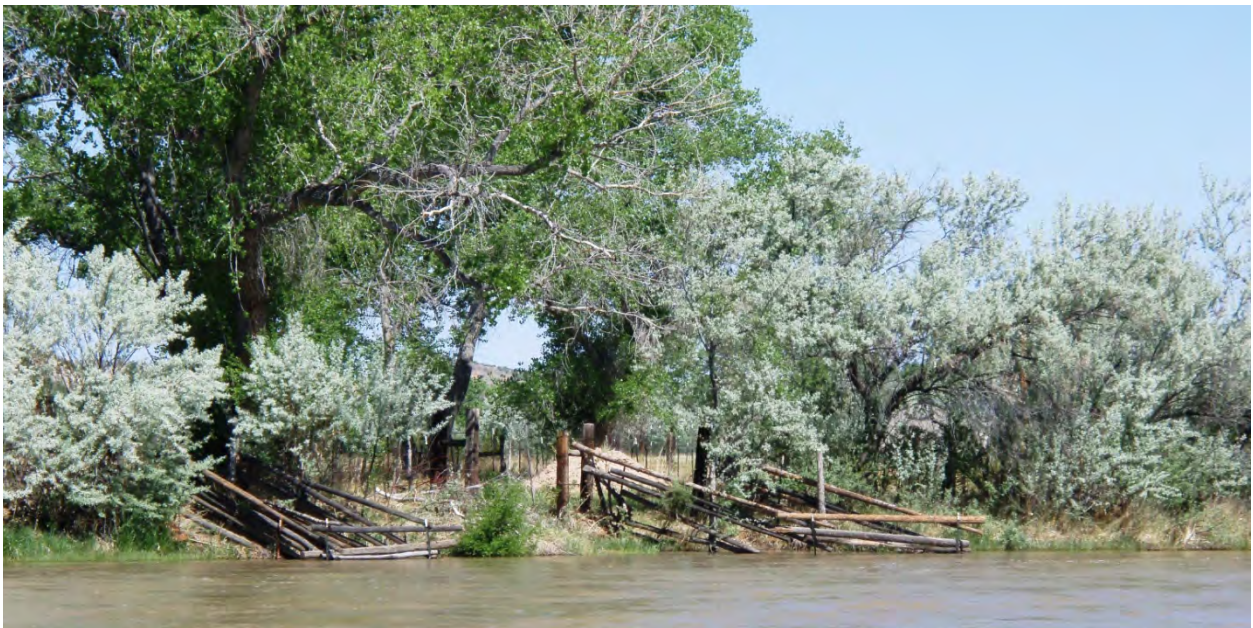
Figure 12 Exotic species (Russian olive) lining the Rio Grande's bank on Ohkay Owingeh Pueblo during spring runoff in 2009.

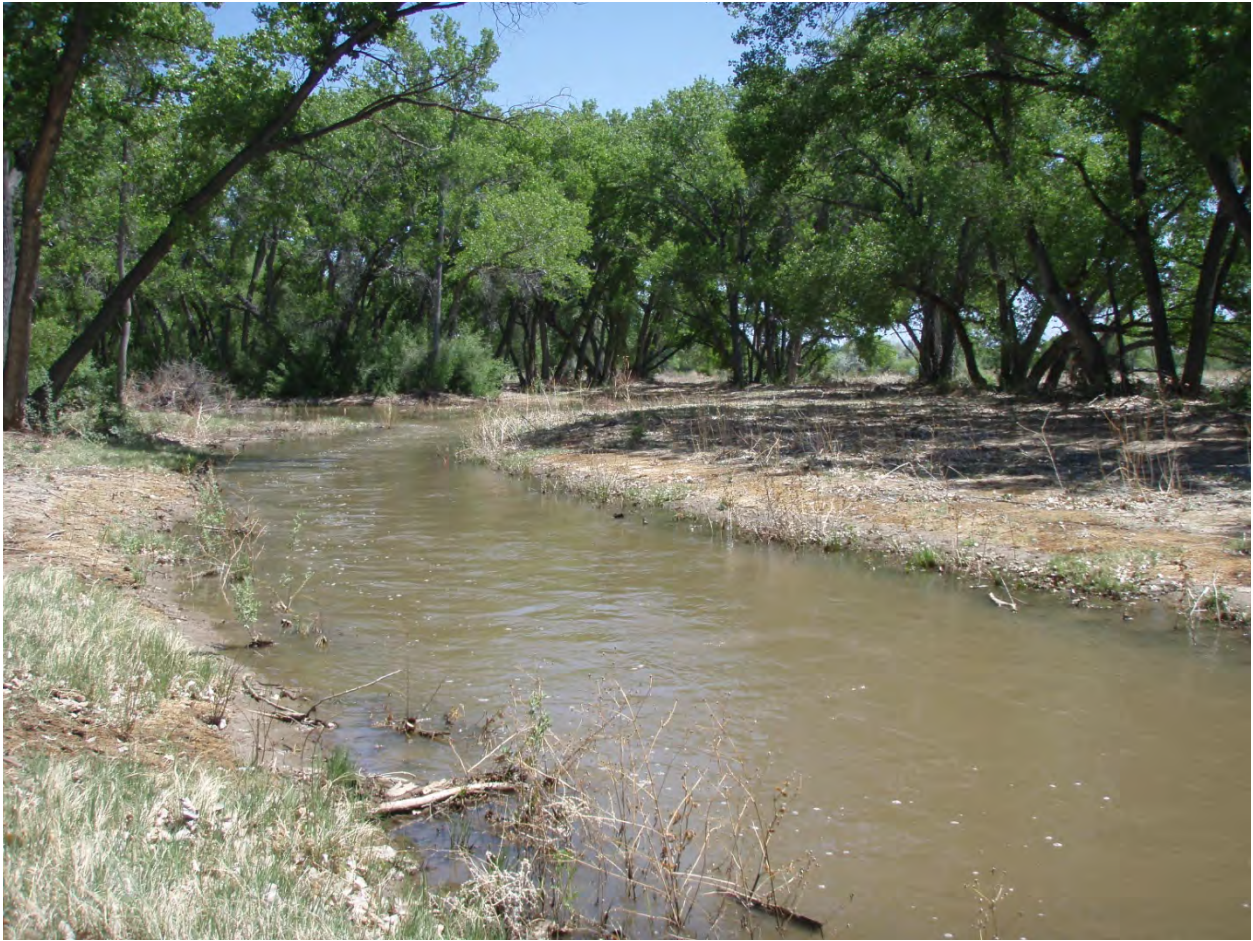
Figure 13 Functioning high flow channel at Ohkay Owingeh Pueblo during spring runoff in 2009.

Even during spring runoff or larger monsoon events, most of the historic high flow channels throughout the study area do not receive flows from the Rio Grande or its tributaries.

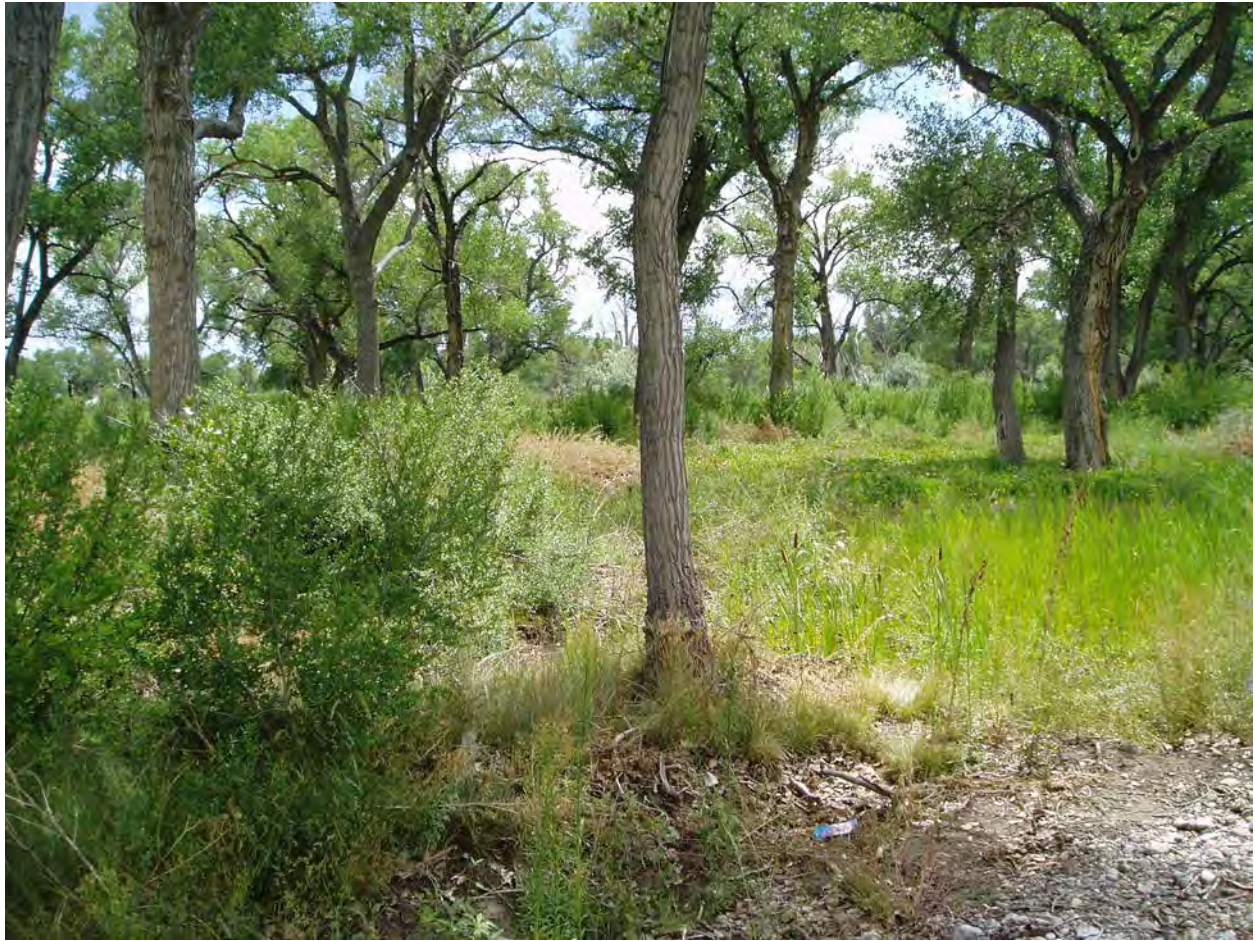
Figure 14 Cottonwood galleries on the floodplain at Ohkay Owingeh Pueblo during spring runoff in 2009.

Most of the cottonwoods are the same age; in some areas, the cottonwoods are reaching senescence. This photo demonstrates little undergrowth and part of what undergrowth there is exotic Russian olive.
