Española Valley, Rio Grande and Tributaries, New Mexico

Appendix D

Cultural Resources

May 2017

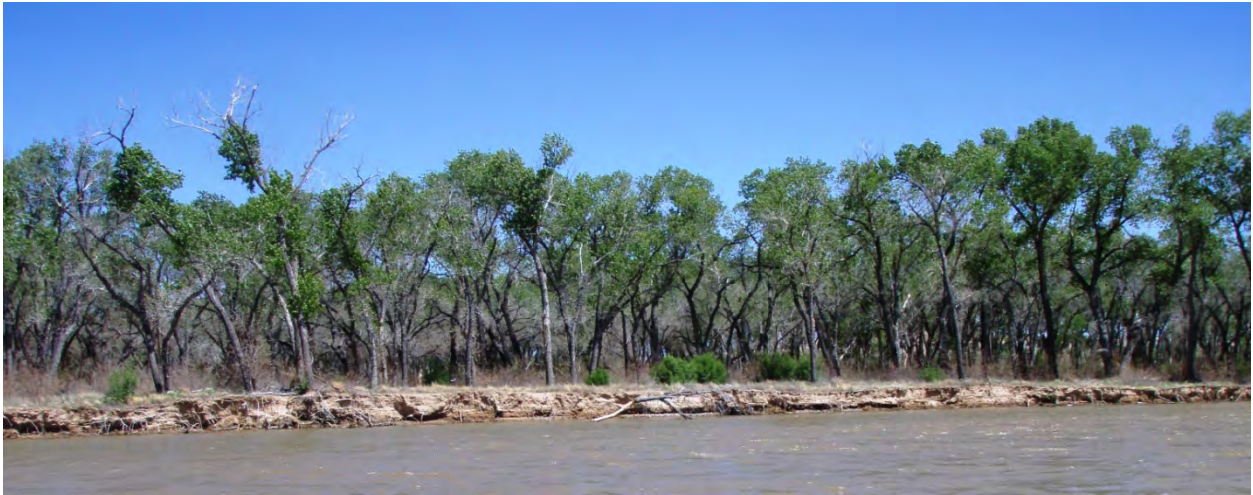
Figure 15 Cottonwood gallery forest on a Rio Grande terrace at Santa Clara Pueblo during spring runoff in 2009.

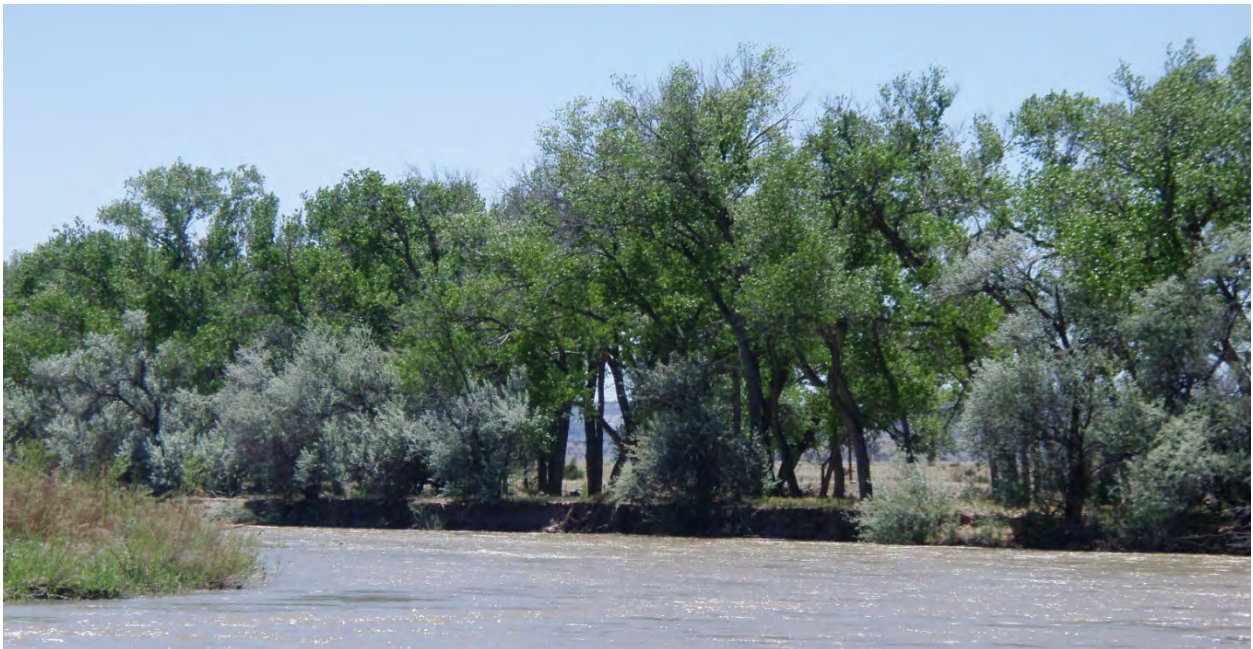
Figure 16 Mature cottonwood gallery with Russian olive on a Rio Grande terrace at Santa Clara Pueblo during spring runoff in 2009.

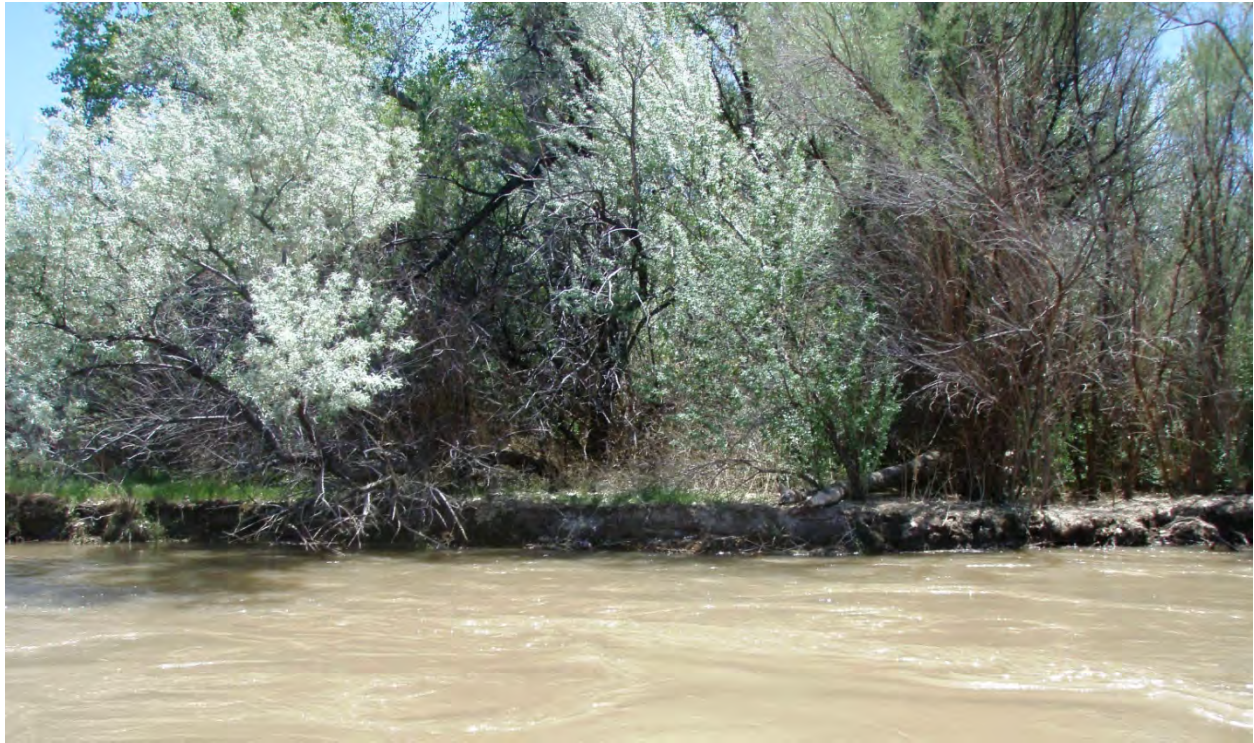
Figure 17 Exotic species (Salt cedar and Russian olive) on a Rio Grande terrace at Santa Clara Pueblo during spring runoff in 2009.

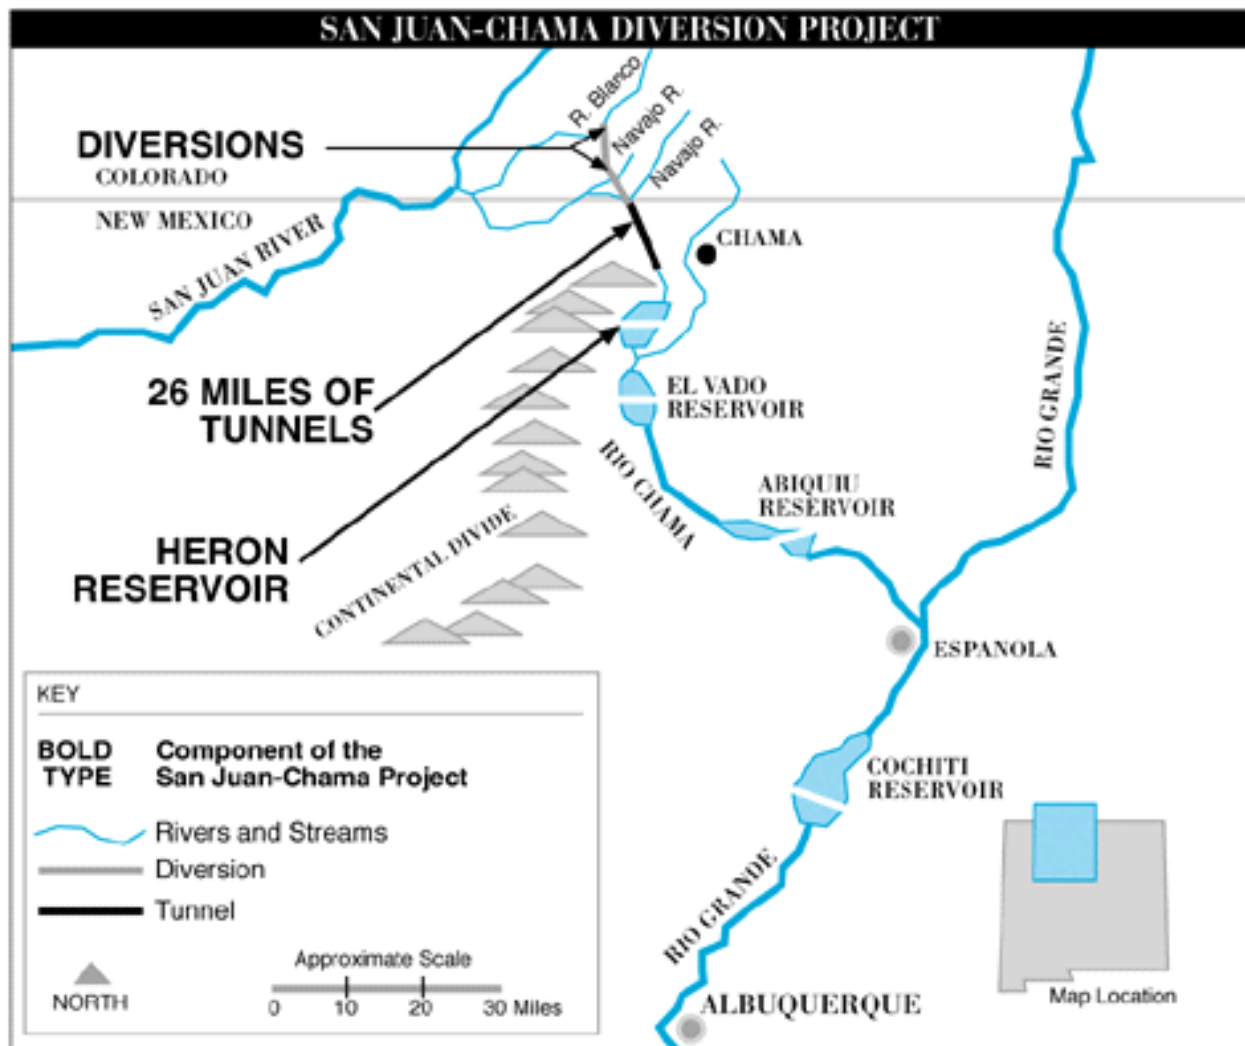
Figure 18 Map of San Juan – Chama Diversion Project.

The SJC was authorized by Congress in 1962 through PL 87-483), which amended the Colorado River Storage Act of 1956 (PL 84-485) to allow diversion of Colorado River basin water into the Rio Grande Basin of New Mexico. The original planning projections were for an ultimate diversion of 235,000 acre-feet per year, with an initial phase development for an average annual diversion of up to 110,000 acre-feet. Only the initial phase was authorized and subsequently constructed by the BOR.

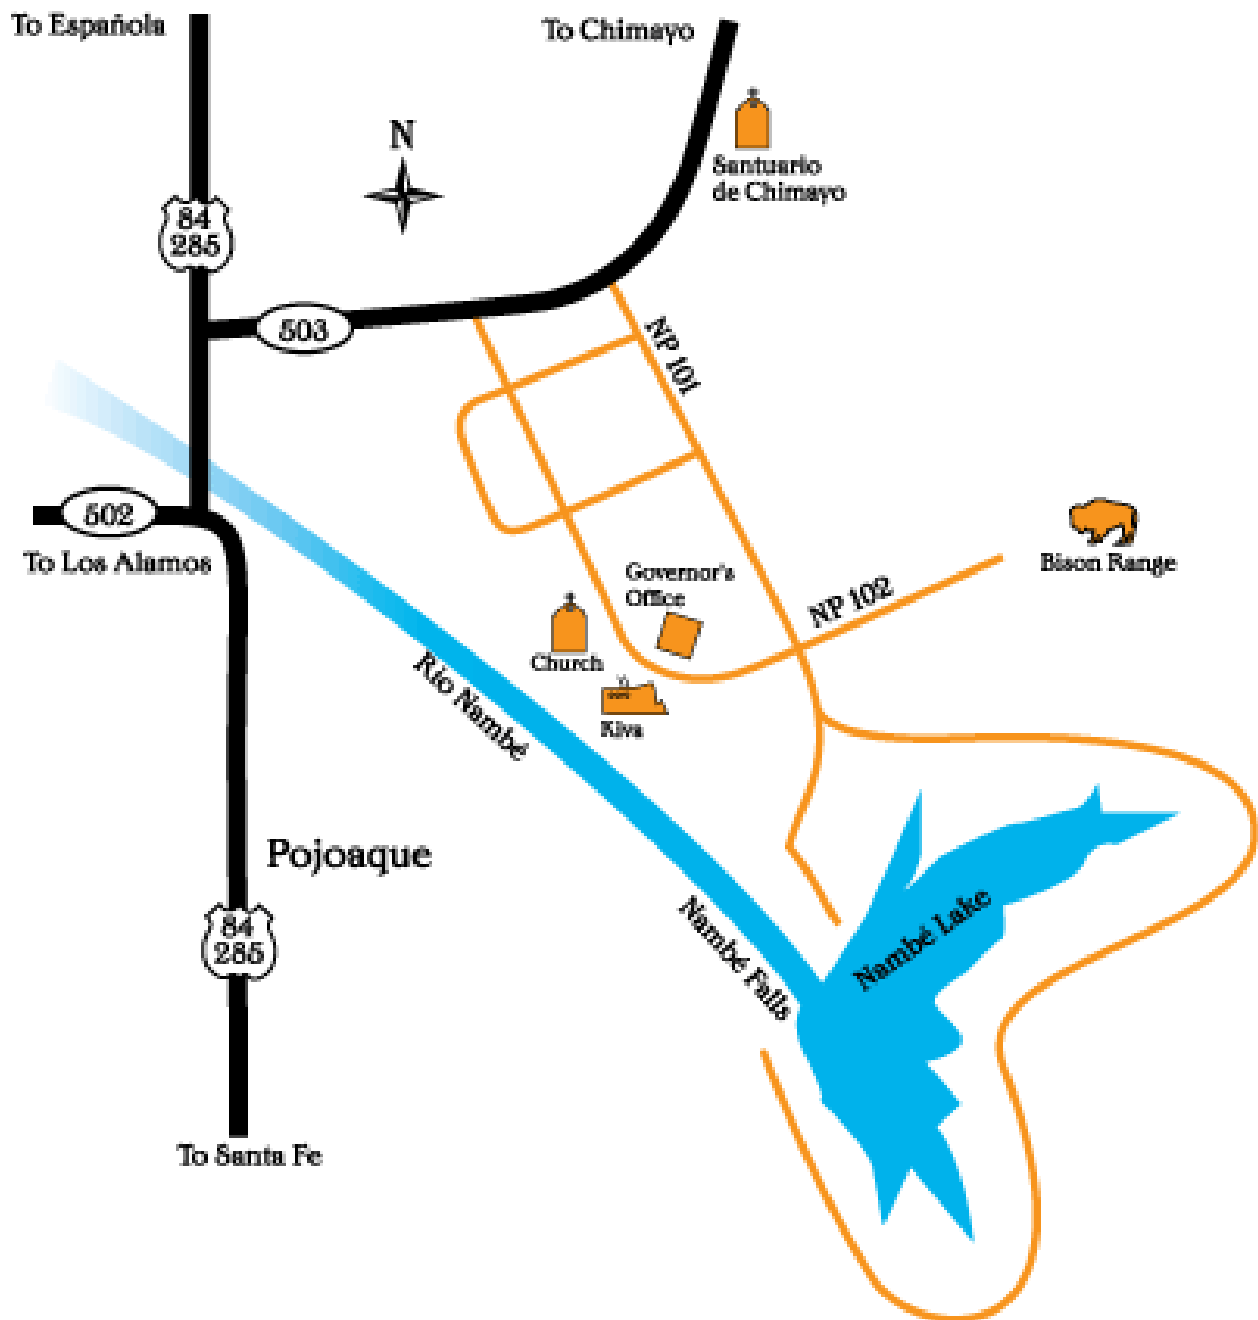
Figure 19 Map to Nambe Falls Lake and Dam from the study area.

The dam is a concrete and earthen embankment structure 150 feet high, which forms a reservoir with a capacity of 2,023 acre-feet.

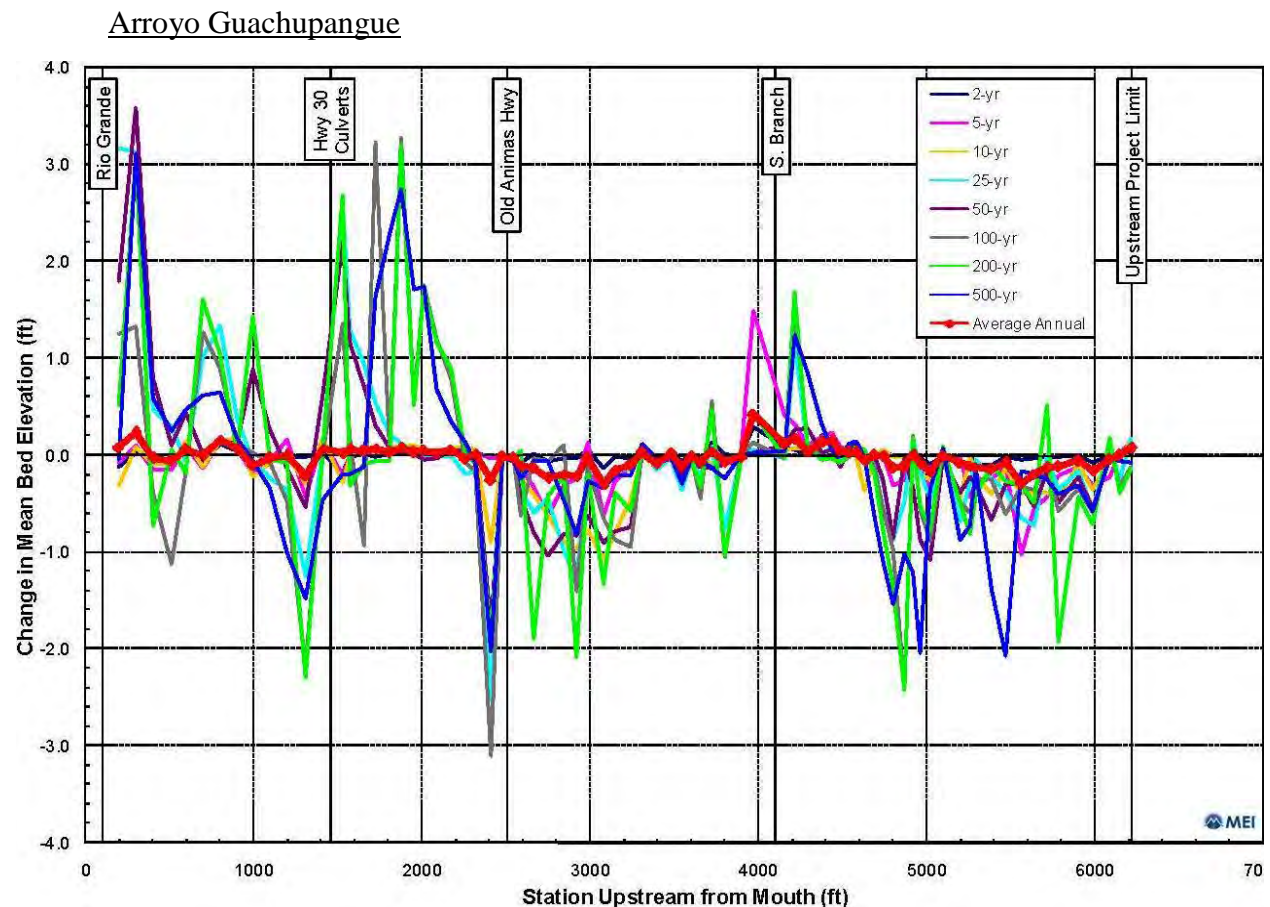
Figure 20 Modeled change in bed elevation in Arroyo Guachupangue.

Existing and future without project analysis was done only for the Arroyo Guachupangue and the Rio Pojoaque. The model geometry and basic structure were taken from the hydraulic model that was developed for the floodplain delineation mapping of the arroyo. In-channel bed-material information was developed from bed-material samples collected during the October 2007 field surveys.

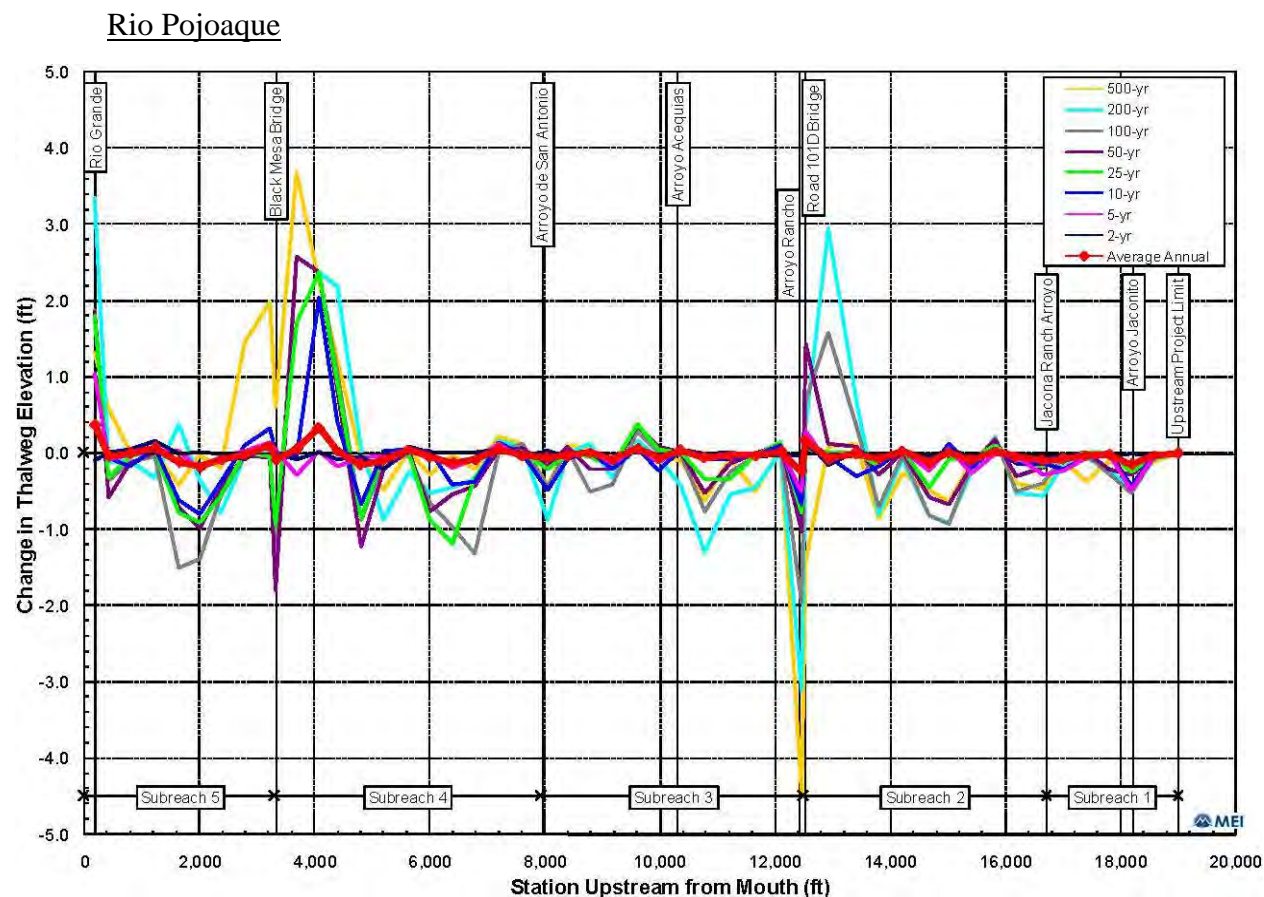
Figure 21 Modeled change in bed elevation in the Rio Pojoaque.

General sediment transport trends found that generally little to no change in channel bed elevation was expected except in the immediate vicinity of bridge/culvert crossings and tributary confluences. However, two locations along the Rio Grande had notable trends: the Rio Grande upstream from the Ohkay Owingeh Pueblo's southern boundary and upstream and downstream from the Rio Pojoaque confluence.

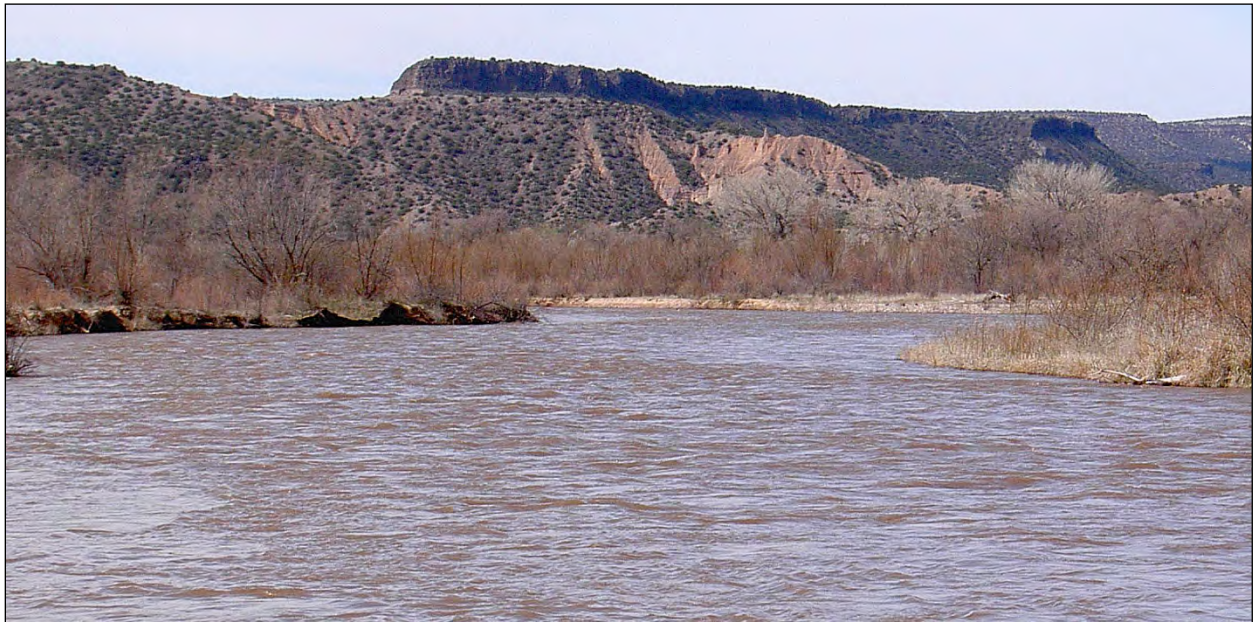
Figure 22 Rio Grande downstream from Rio Pojoaque, April 2005.

In the southern end of Ohkay Owingeh Pueblo, the future sediment trends indicate two important results: 1) the old mining scar will continue to fill over the next 26 years, and 2) significant degradation will occur upstream from the mining scar, as the ‘head-cut’ migrates upstream slowly. The affects on the floodplain delineation is a slight improvement of river-floodplain connection in the old mining area, but a slight decrease in connection in the upstream area where degradation is predicted.

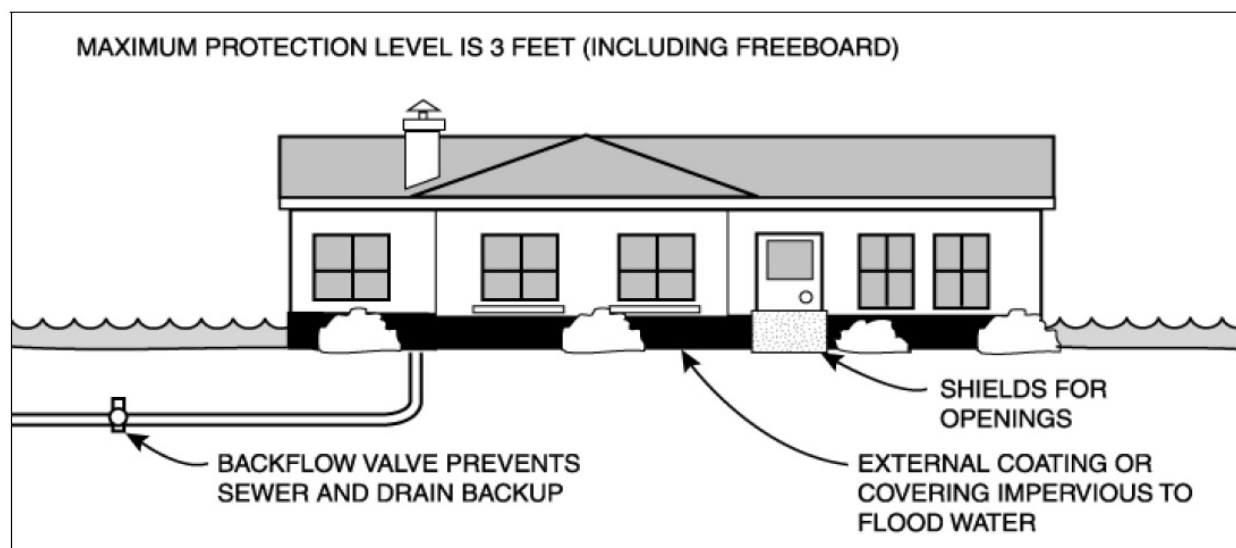
Figure 26 Typical dry floodproofed structure.

Per FEMA's *Selecting Appropriate Mitigation Measures for Floodprone Structures*, a dry floodproofed structure is made watertight below the level that needs flood protection to prevent floodwaters from entering. Making the structure watertight requires sealing the walls with waterproof coatings, impermeable membranes, or a supplemental layer of masonry or concrete.

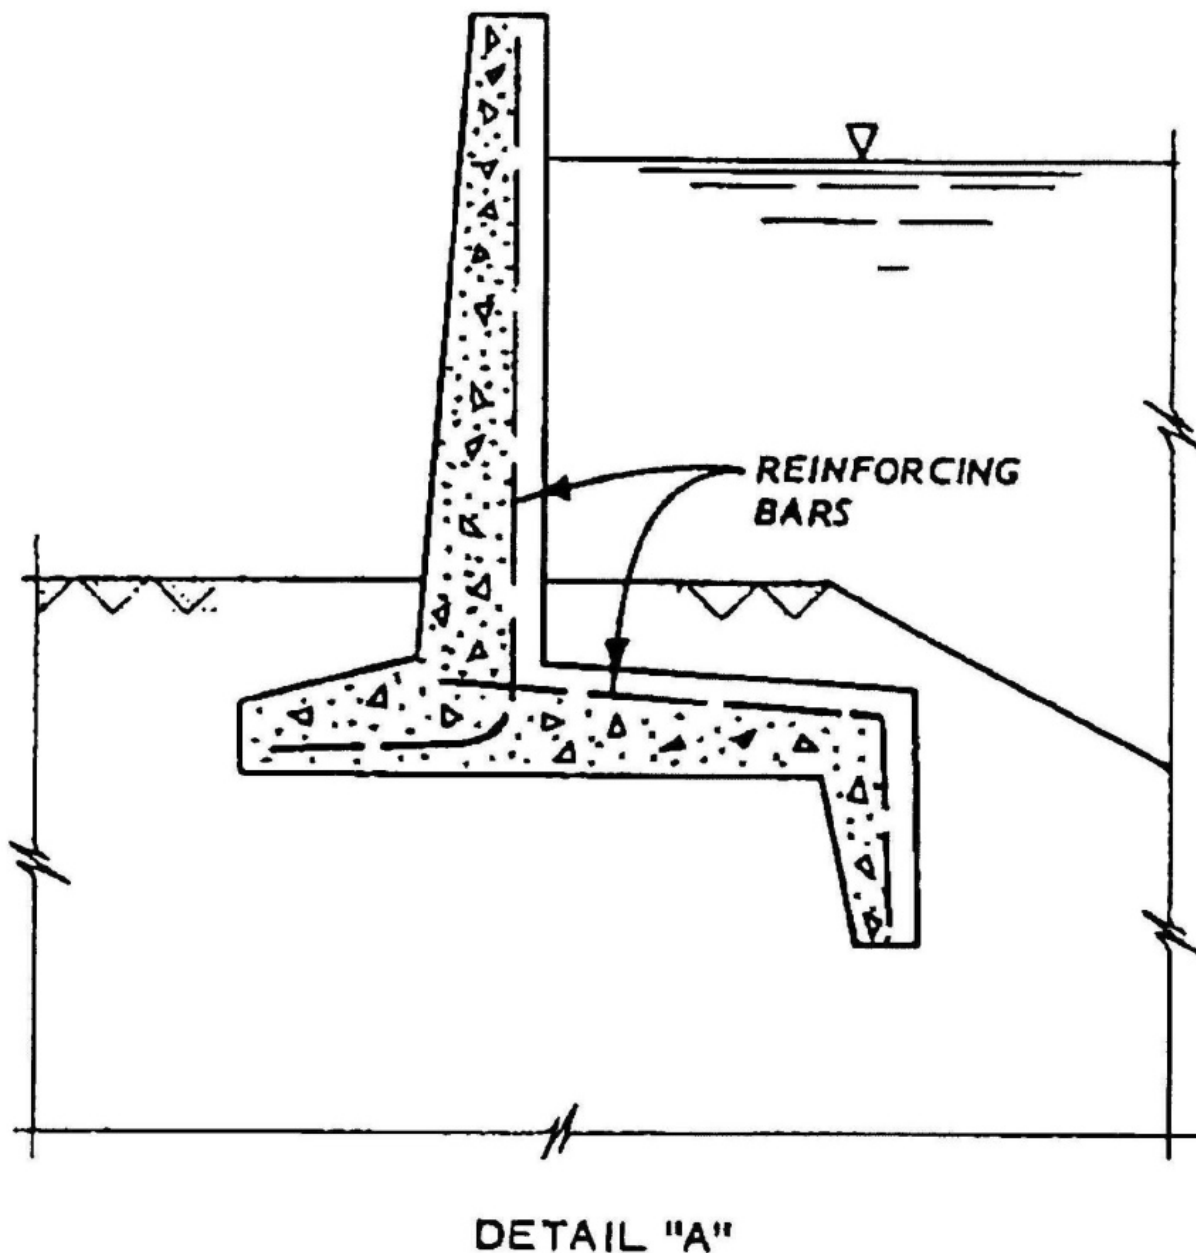
Figure 28 Inverted T-type floodwall

In such a system where only limited right-of-way is available, ramps built between sections of floodwalls to allow entrance and egress to and from the protected structures may be viable. In essence, a road may be built that goes over an earthen section between floodwall sections. This alternative removes the necessity of human intervention in flooding situations.

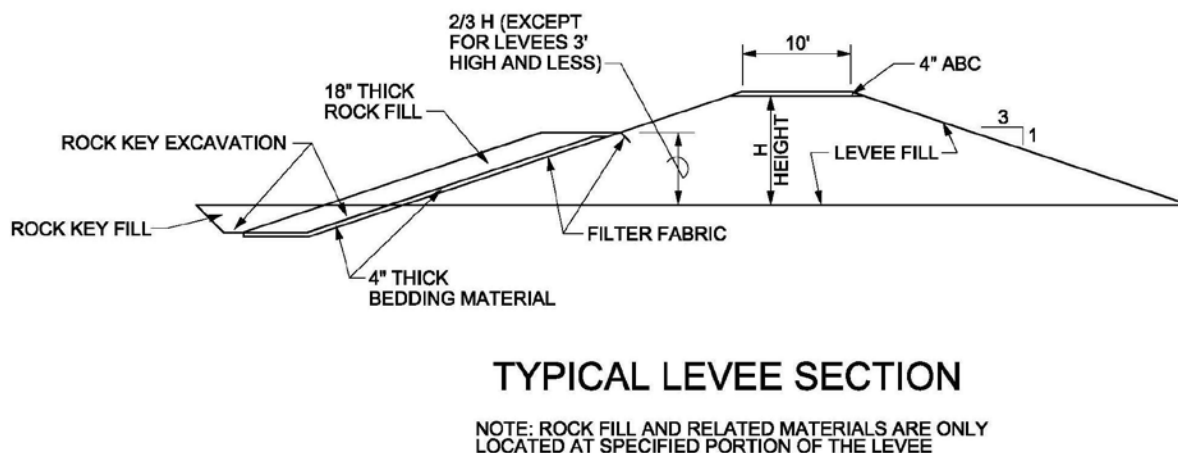
Figure 29 Typical levee cross section.

For this study, the typical levee section consists of an earth embankment with a 10 foot wide crest and 1 vertical to 3 horizontal side slopes for levees greater than 3 feet in height and 2:3 for levees less than 3 feet in height. Aggregate base course (4 inches thick) is placed on the dam crest. Erosion protection (18 inch thick rock with 4 inch thick bedding material and filter fabric) is placed on the river-side embankment at levee location that may be susceptible to erosion (from adjacent rivers/arroyos). Erosion protection typically extends from the levee toe to two-thirds total levee height; and is keyed into existing grade. Varying top of levee elevations were considered at each study location.

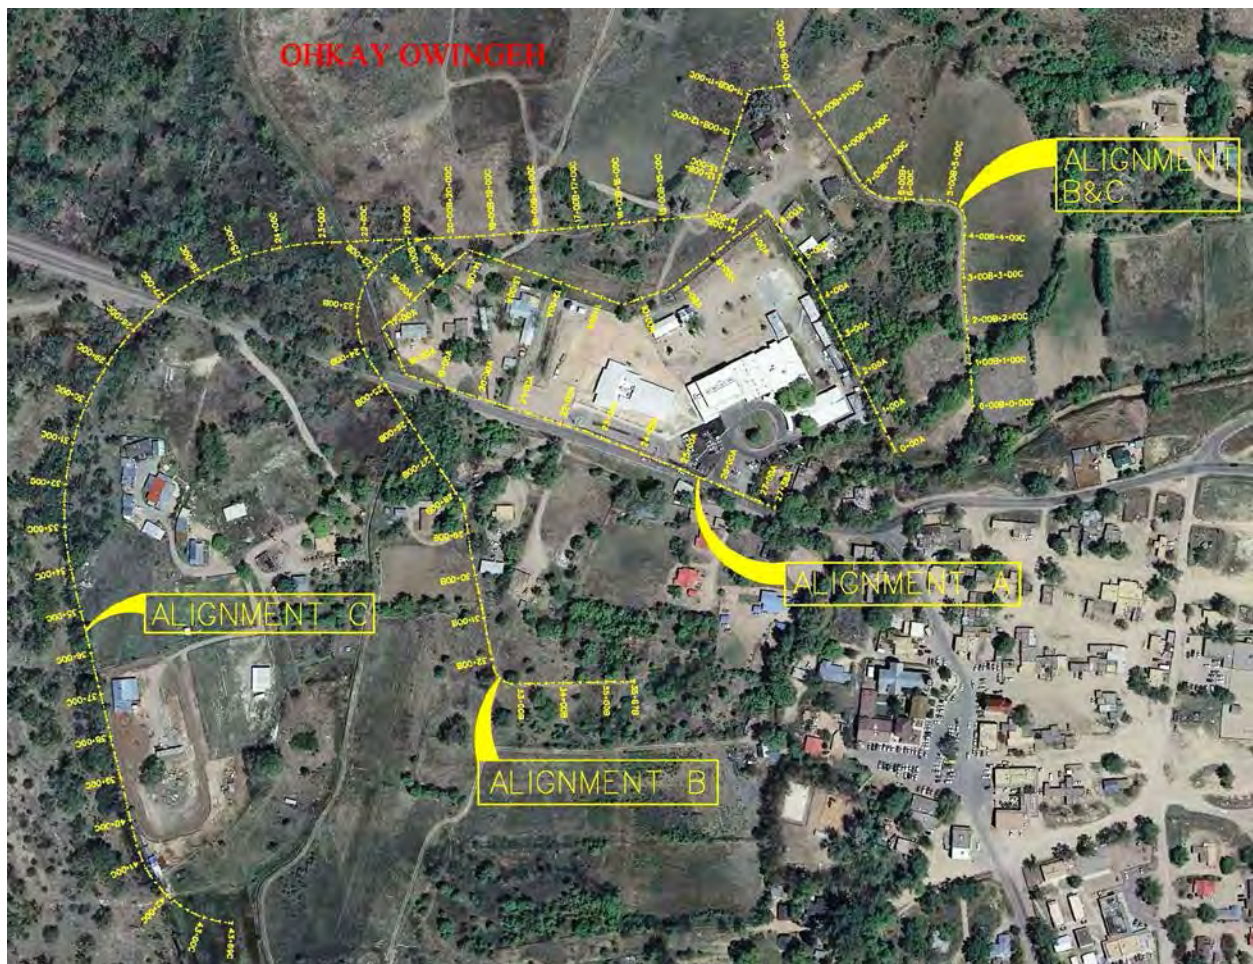
Figure 30 Floodwall and ring levee alignments around the San Juan Elementary School.

Alignment B (ring levee) begins to the west of the San Juan Elementary School compound and runs generally counter clock-wise for approximately 3,567 feet. Because the PDT believed that neither a floodwall nor ring levee would be economically justified based only upon the school's structures, this alignment also included three private homes and three outbuildings just to the west of the school and two more homes to the south west.

Alignment C (ring levee) begins to the west of the San Juan Elementary School compound and runs generally counter clock-wise for approximately 4,369 feet. Because the PDT believed that neither a floodwall nor ring levee would be economically justified based only upon the school's structures, this alignment also included three private homes and three outbuildings just to the west of the school and two more homes to the south west. This alignment would also protect

approximately an additional six homes and 12 out buildings.

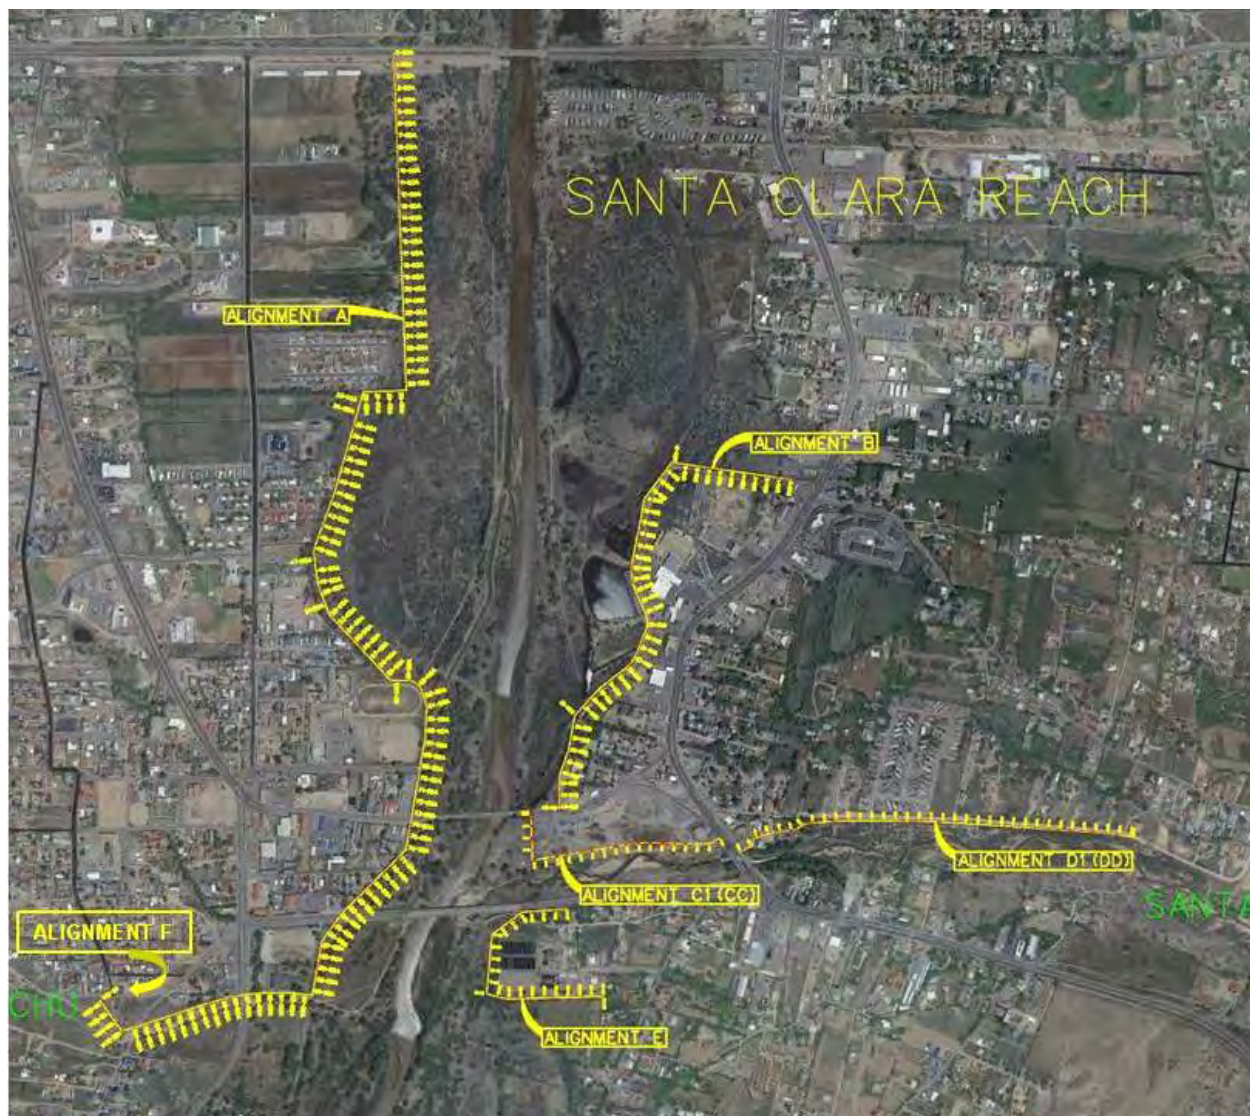
Figure 31 Santa Clara levee alignments along the Rio Grande, Santa Cruz River and Arroyo Guachupangue.

Levee Alignment D begins at its tie-in to high ground on the southern edge of Corlett Road approximately 1,620 feet southwest of its junction with NM Highway 76. This levee measures approximately 3,403 feet west along the north bank of the Santa Cruz River towards its junction with the Rio Grande where it ties-in to high ground at South Riverside Drive (US Highway 285).

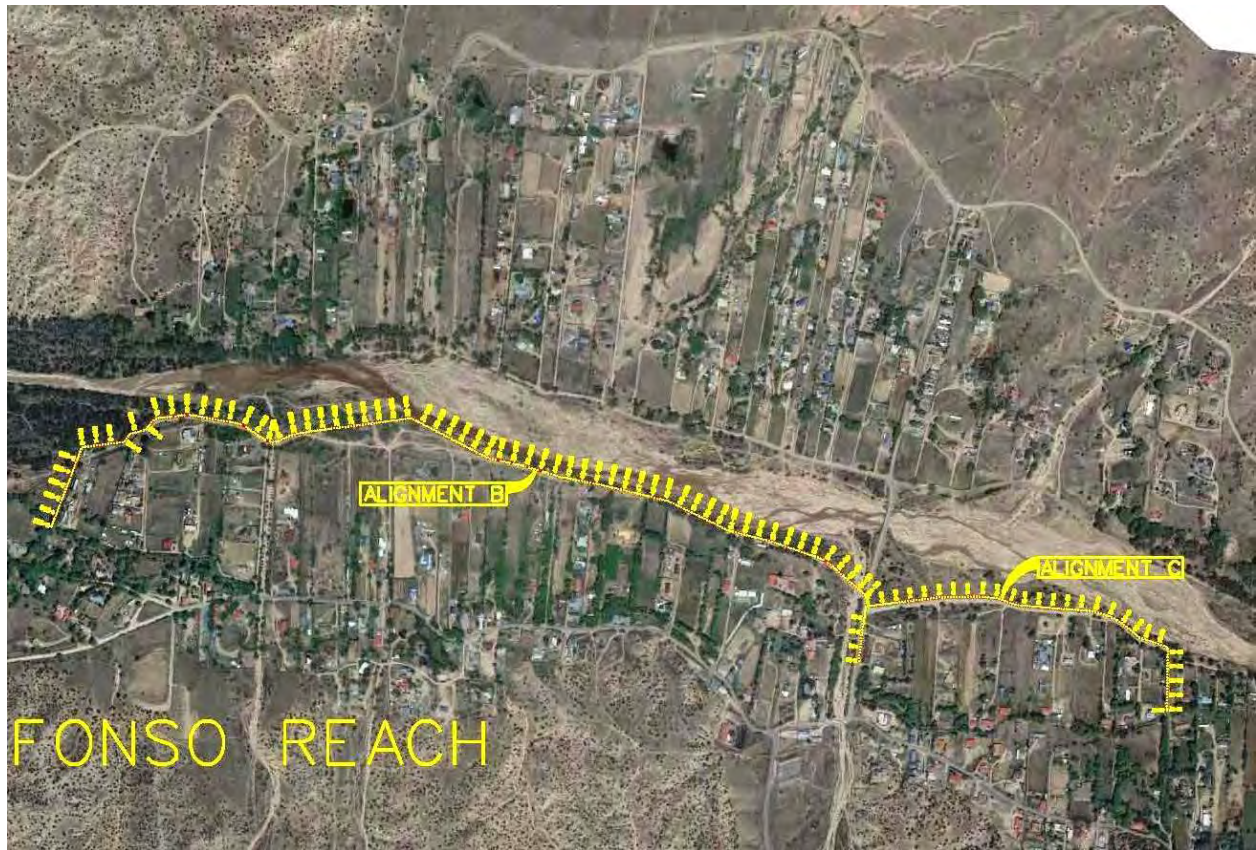
Figure 32 San Ildefonso levee alignments B and C along the Rio Pojoaque.

Levee Alignment C is along the south bank of the Rio Pojoaque and begins at its tie-in to high ground at approximately 35.8906 by -106.0759 (DD) on an unnamed dirt road. The levee runs from that point, north to Tribal Road CR-84A, west towards the Rio Grande along north side of Tribal Road CR-84A to Evergreen Lane and then approximately 400 feet south along the east of Evergreen Lane to high ground. The levee measures approximately 3,800 feet in length.

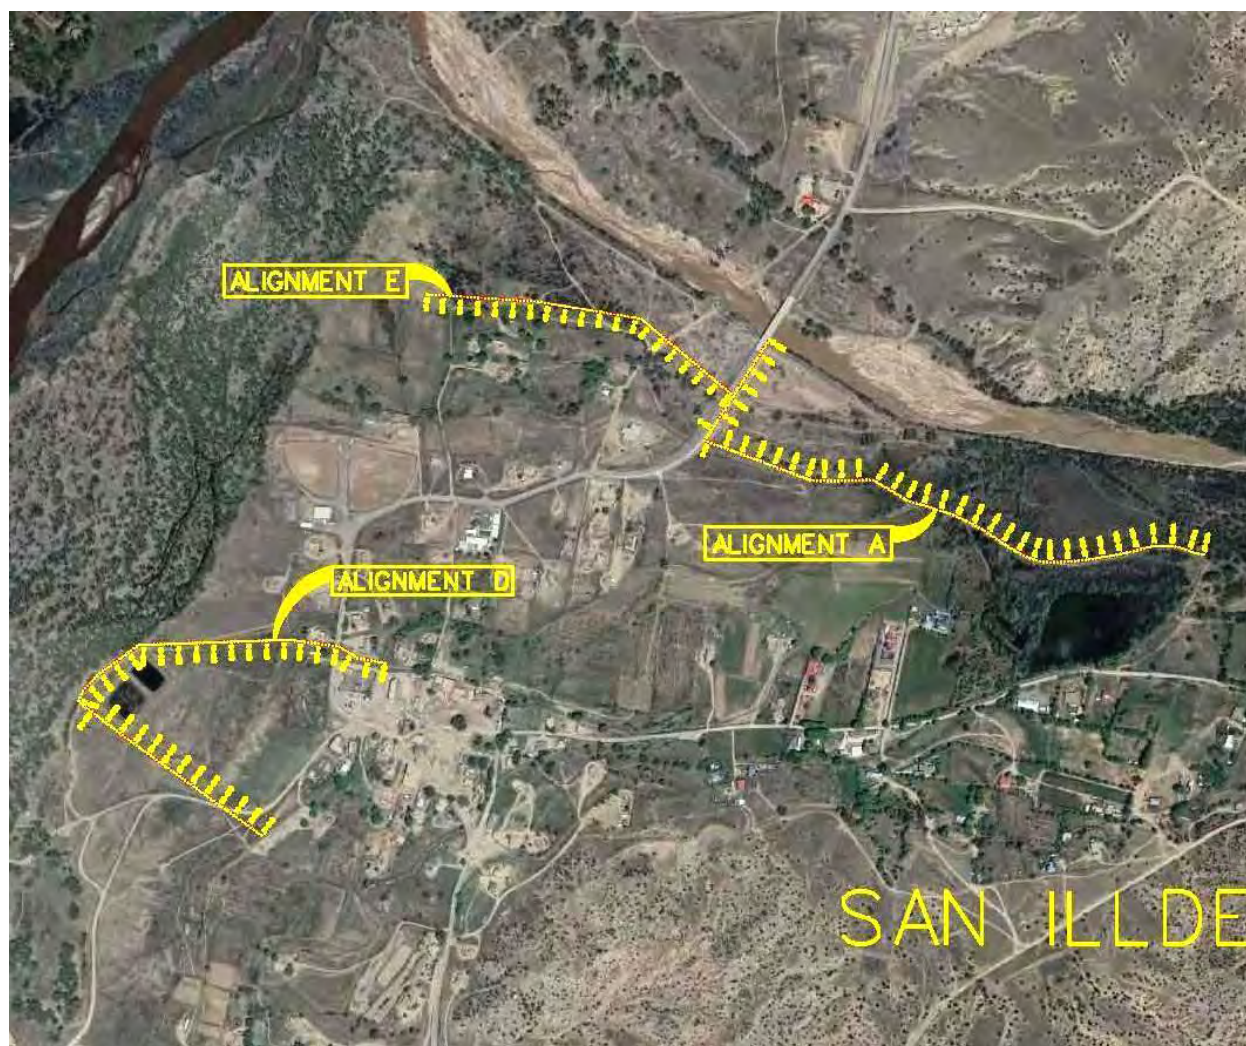
Figure 33 San Ildefonso levee alignments A, E and D along the Rio Pojoaque.

Levee Alignment E begins at the Tunyo Po Bridge over the Rio Pojoaque and runs west towards the Rio Grande, crossing San I Senior road, following the north verge of Poh-see-Buu Road and tying in to high ground. The levee measures approximately 1,838 feet in length.
