# **Rio Grande Environmental Management Program, CO, NM, TX**

## **Sandia Pueblo to Isleta Pueblo, New Mexico Ecosystem Restoration Feasibility Study and Environmental Assessment**

**FINAL**

**May 2019**

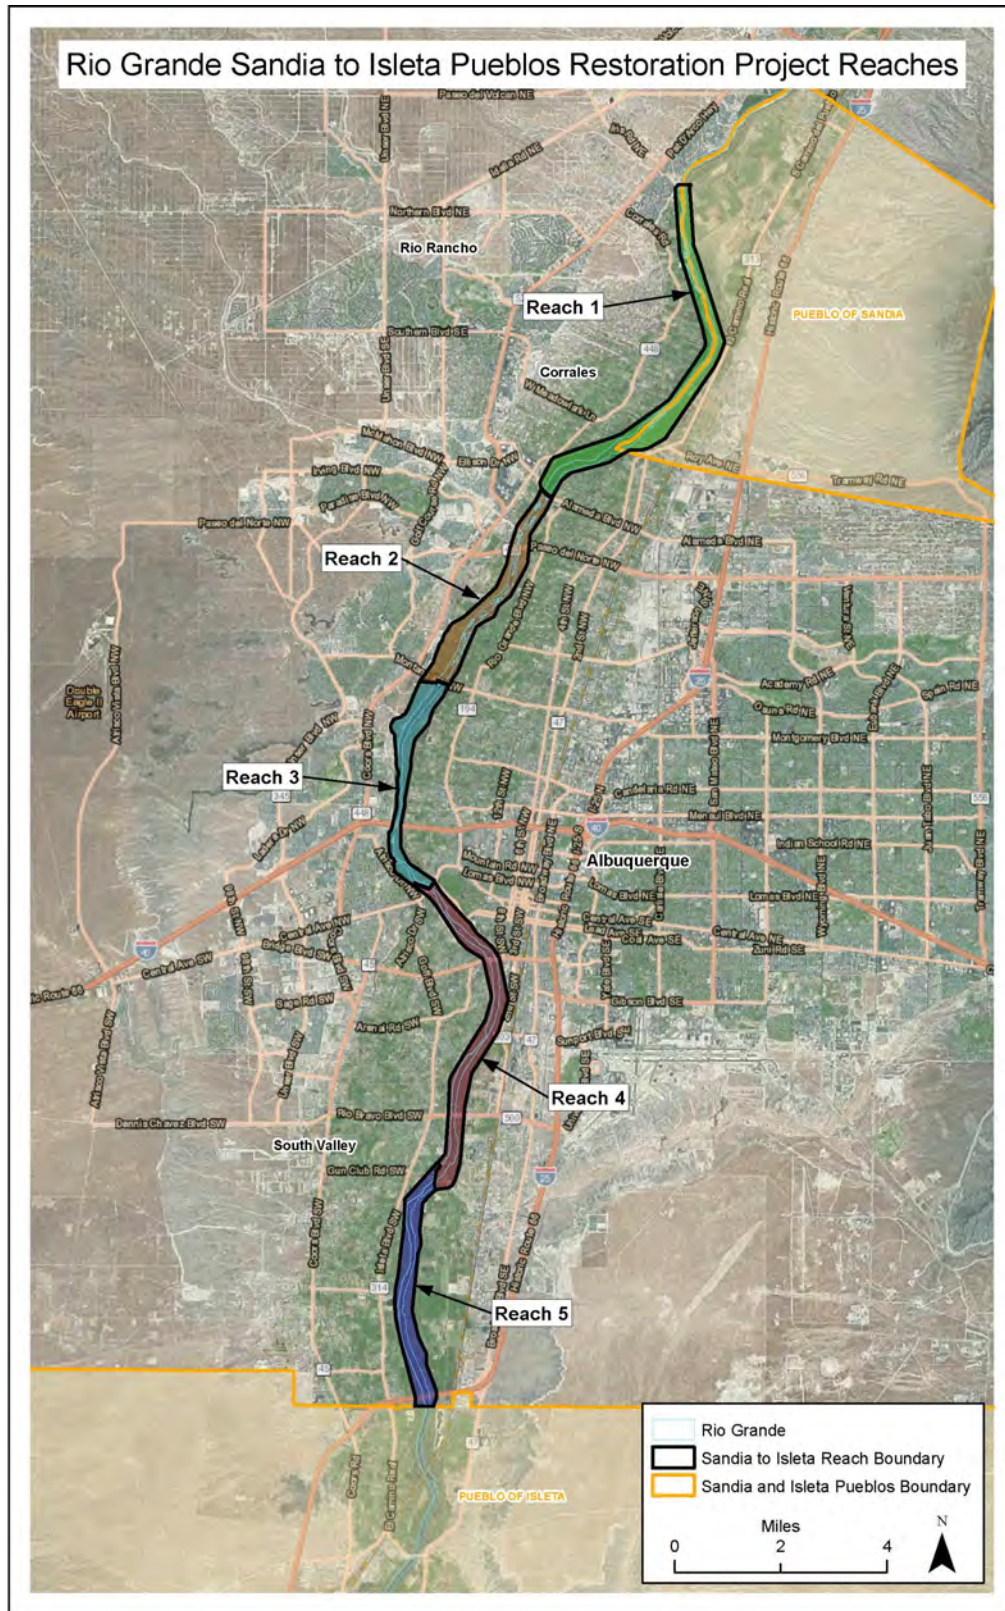
Figure 2. Study Area Reaches

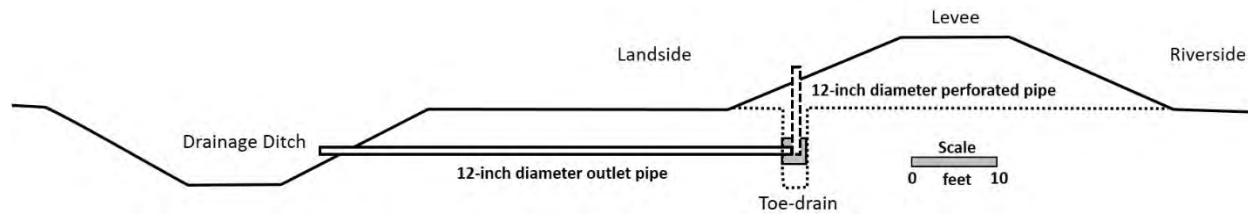
**Figure 3. Typical Levee Cross-Section.**

Within the study area, existing levees on both sides of the river provide flood risk management to the neighboring residential, commercial, and agricultural community. The proposed project will include geomorphic, or land-shaping, excavations to create high flow channels, swales, river connections, and riverbank terracing, and these activities may encroach on the riverside of the existing levees. The proposed geomorphic excavations are not expected to pose a significant risk to the existing levees because of the levee configuration, shown in Figure 3.

Excavation on the riverside of the levees could potentially shorten the flowpath for seepage flowing through or beneath the levee from riverside to landside, resulting in a higher pore pressures and greater potential risk of levee failure. However, most levees in the proposed excavation areas have a toe-drain that directs seepage flow to an existing drainage ditch on the landside (Figure 3), and this drain system prevents excessive pore pressures. During PED individual levee segments will be evaluated for potential risk caused by riverside scour and proposed projects once plans for geomorphic excavations have been developed, additionally discharge capacity of toe drain will be evaluated as described in EM 1110-2-1901.

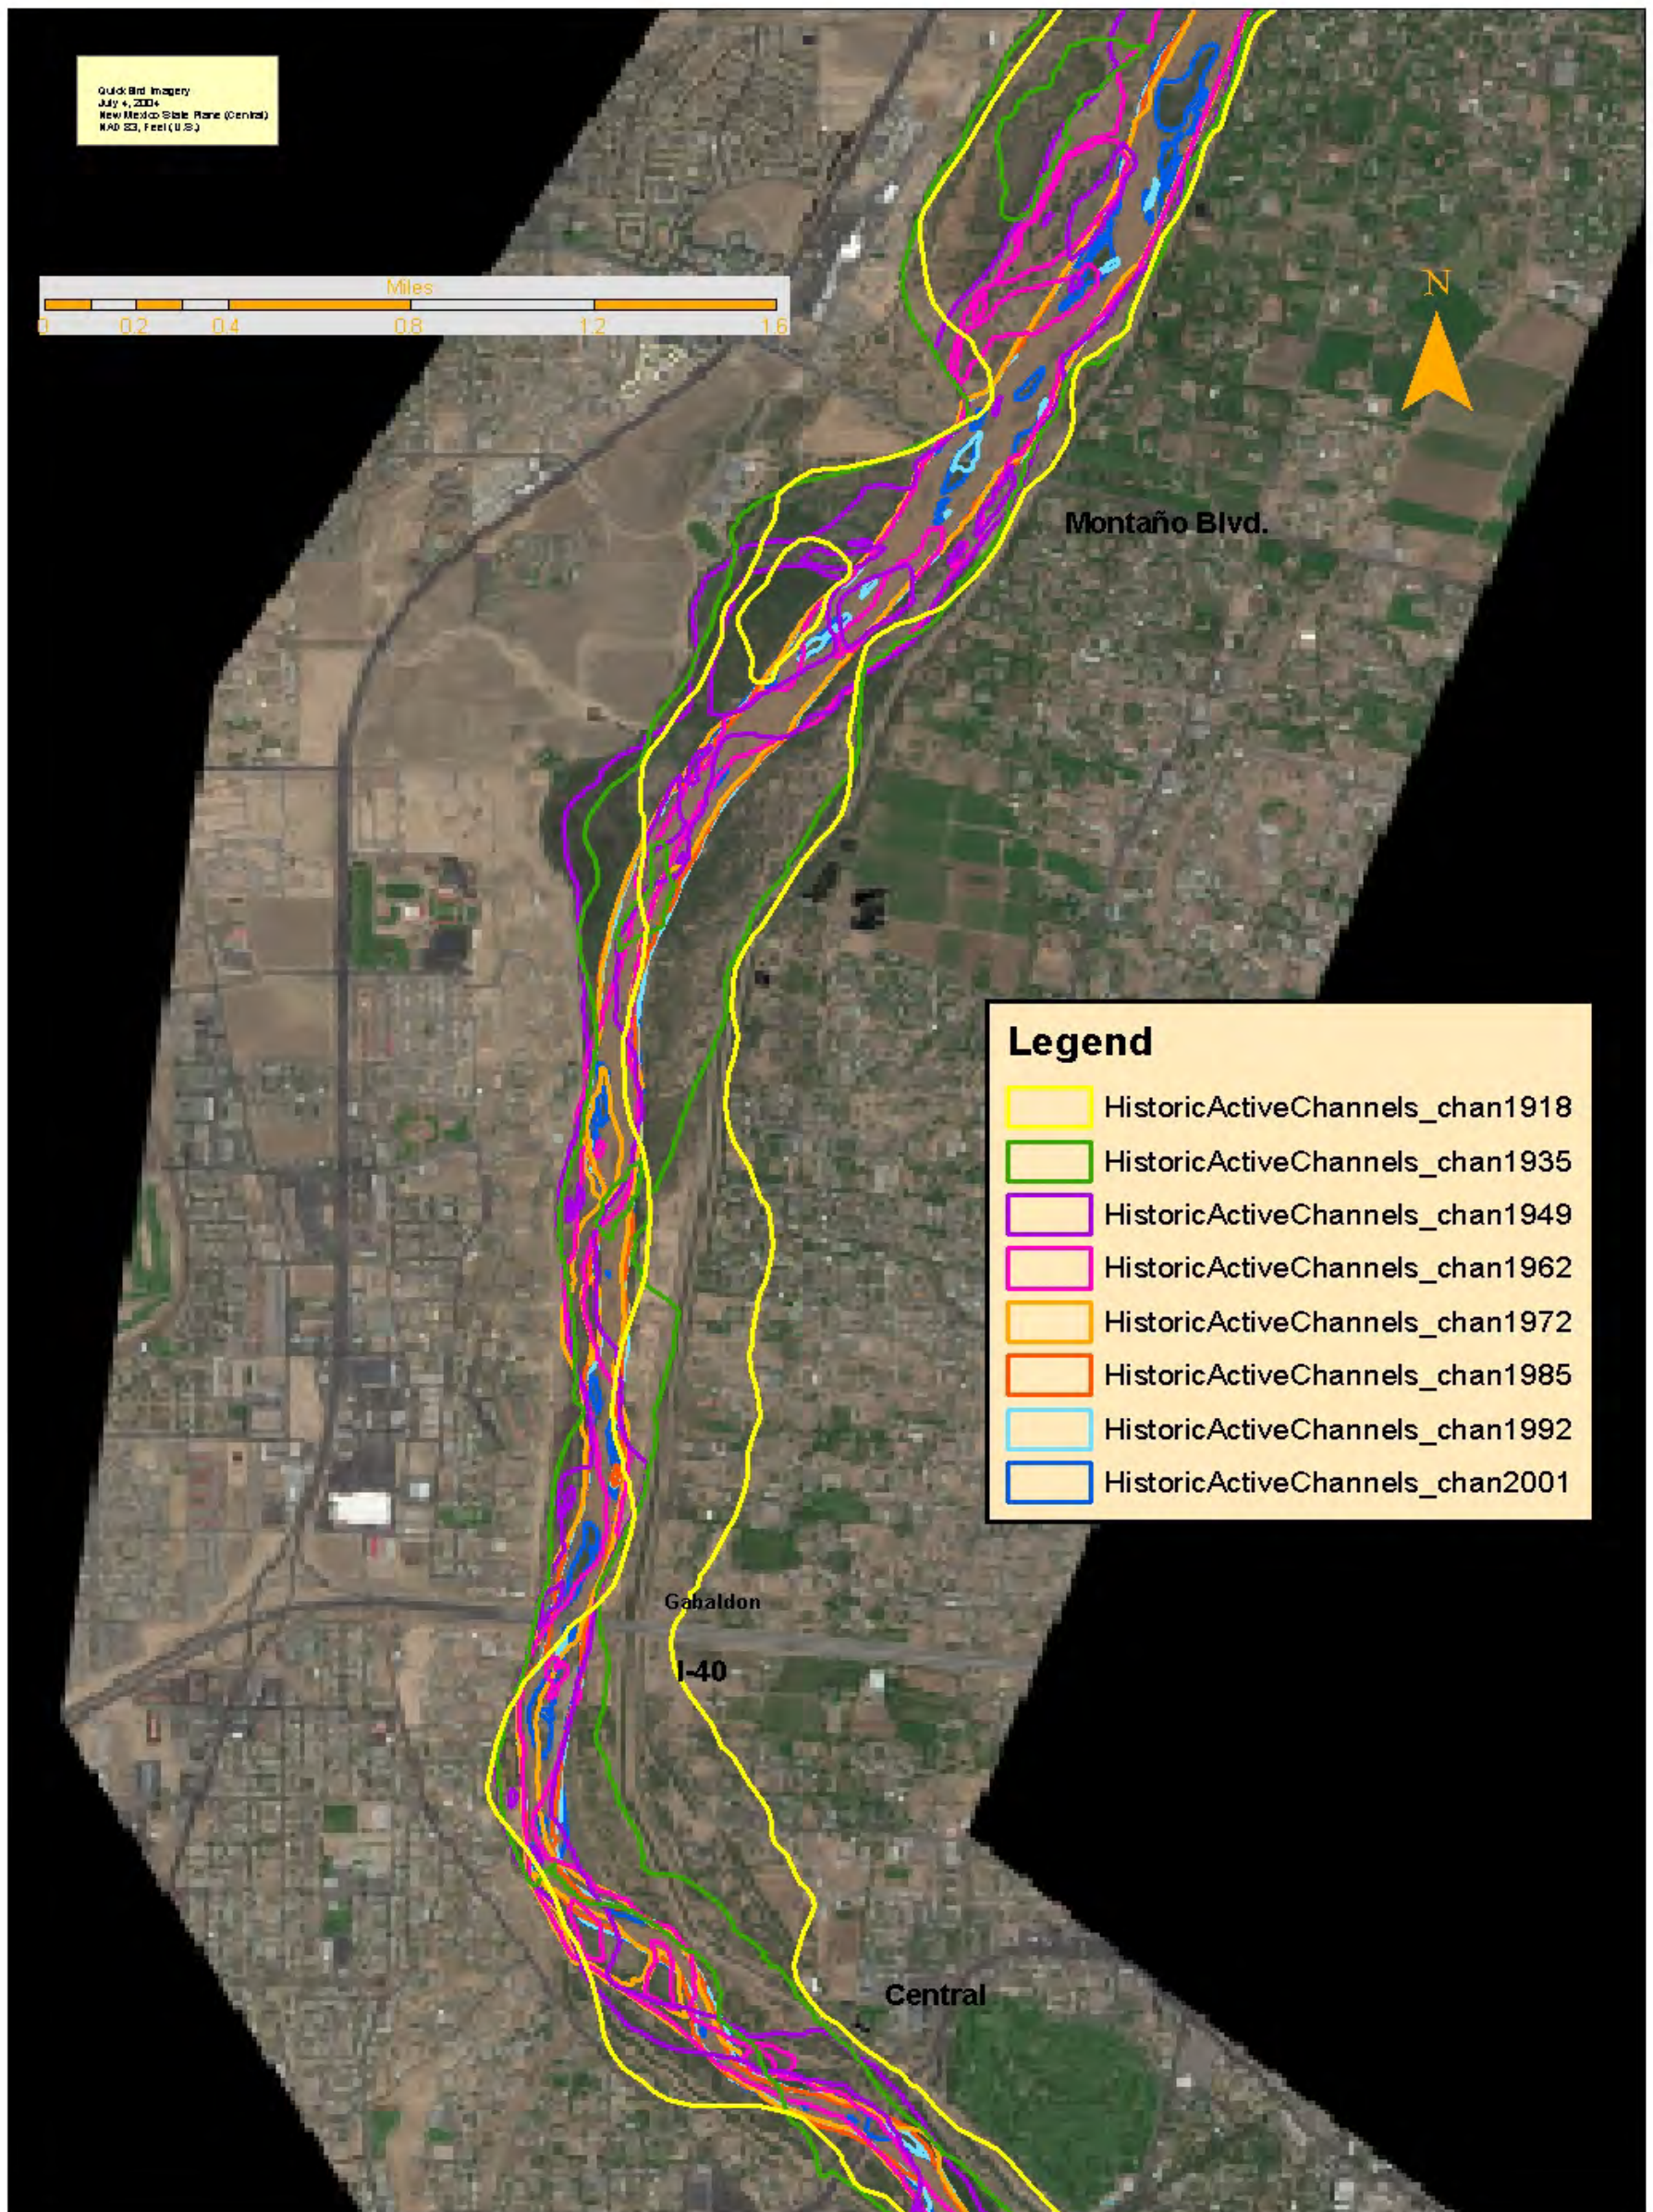
Figure 4. Historical channel change on the Rio Grande active channel in the Albuquerque area. Active channel locations, digitized from historical aerial photography are shown with 2004 aerial photography as the background.

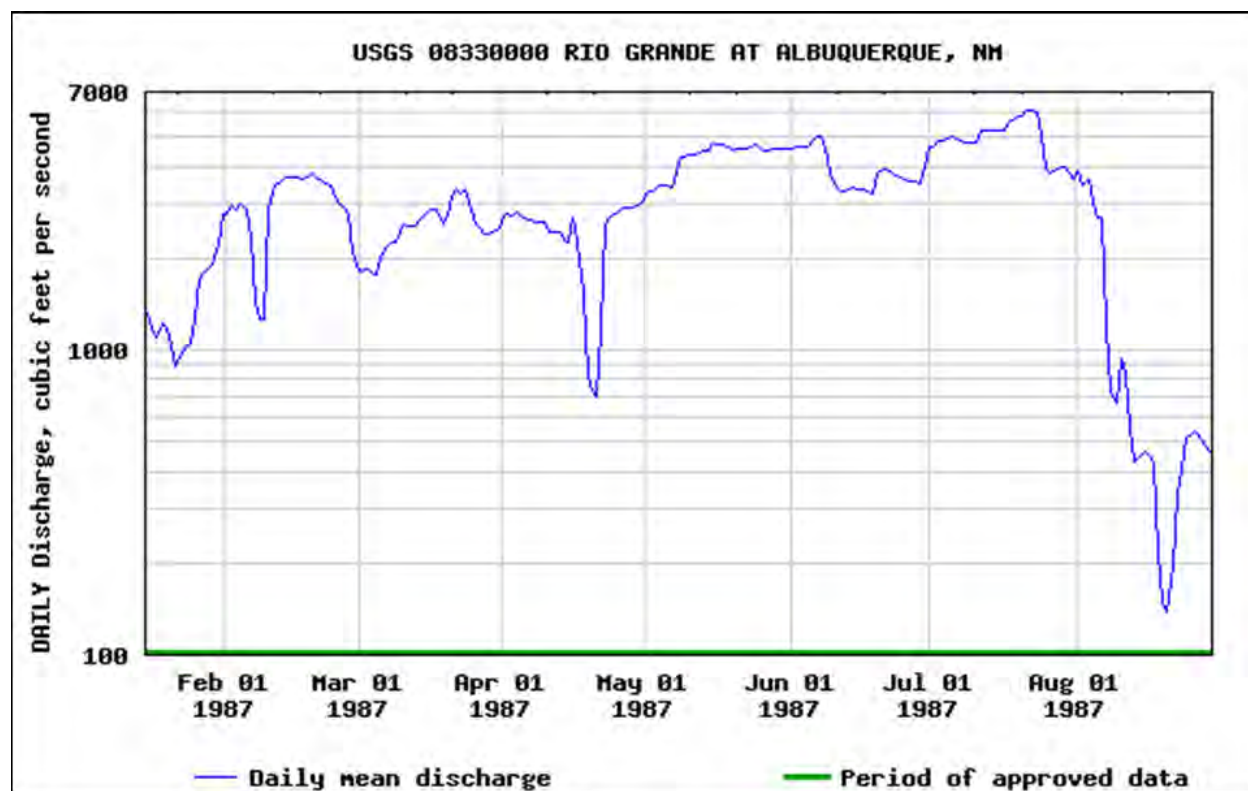
For comparative purposes, Figure 5, below shows the 1987 hydrograph taken from the gage record. This hydrograph was selected because were it not for the effects of regulated flow from Cochiti Dam, this hydrograph would have reached a peak flow of 10,881 cfs resulting in widespread overbank flows at Albuquerque.

Figure 5. 1987 Hydrograph for USGS Gage at Albuquerque.

According to Figure 5, the unregulated flow for 1987 would have been 10,881 cfs. This would perhaps be comparable to the 1949 hydrograph with a peak daily flow of 10,556 cfs. This flow rate would cause widespread overbank flows through the Rio Grande bosque under existing conditions based on the results from the FLO-2D analysis. The 1949 hydrograph is shown in Figure 7.

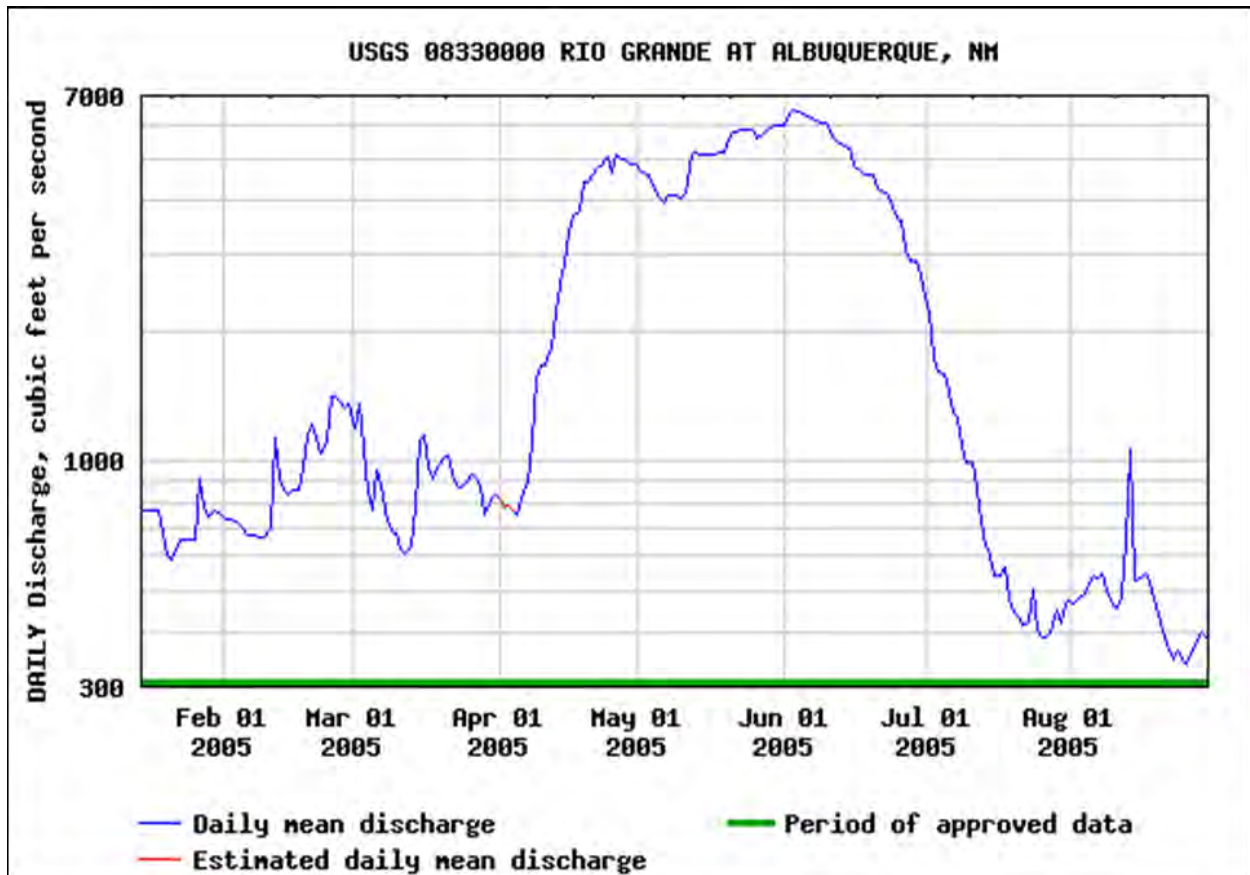
was similar in peak flow and resulted in relatively limited overbank flows prior to MRG Bosque Restoration Projects. The 2005 hydrograph is shown below in Figure 6.

Figure 6. 2005 Hydrograph for USGS Gage at Albuquerque.

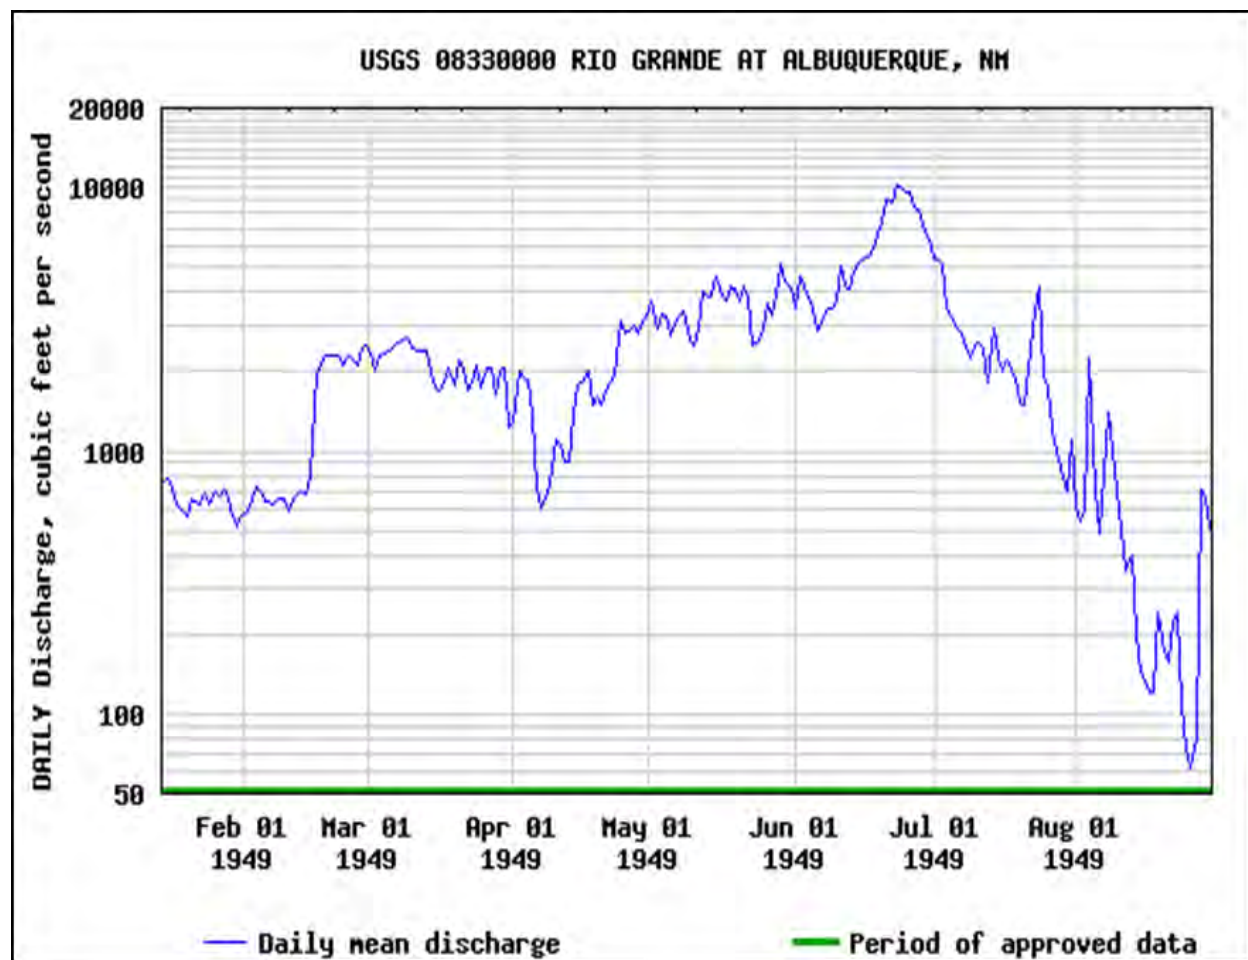
Figure 7. 1949 Hydrograph for USGS Gage at Albuquerque.

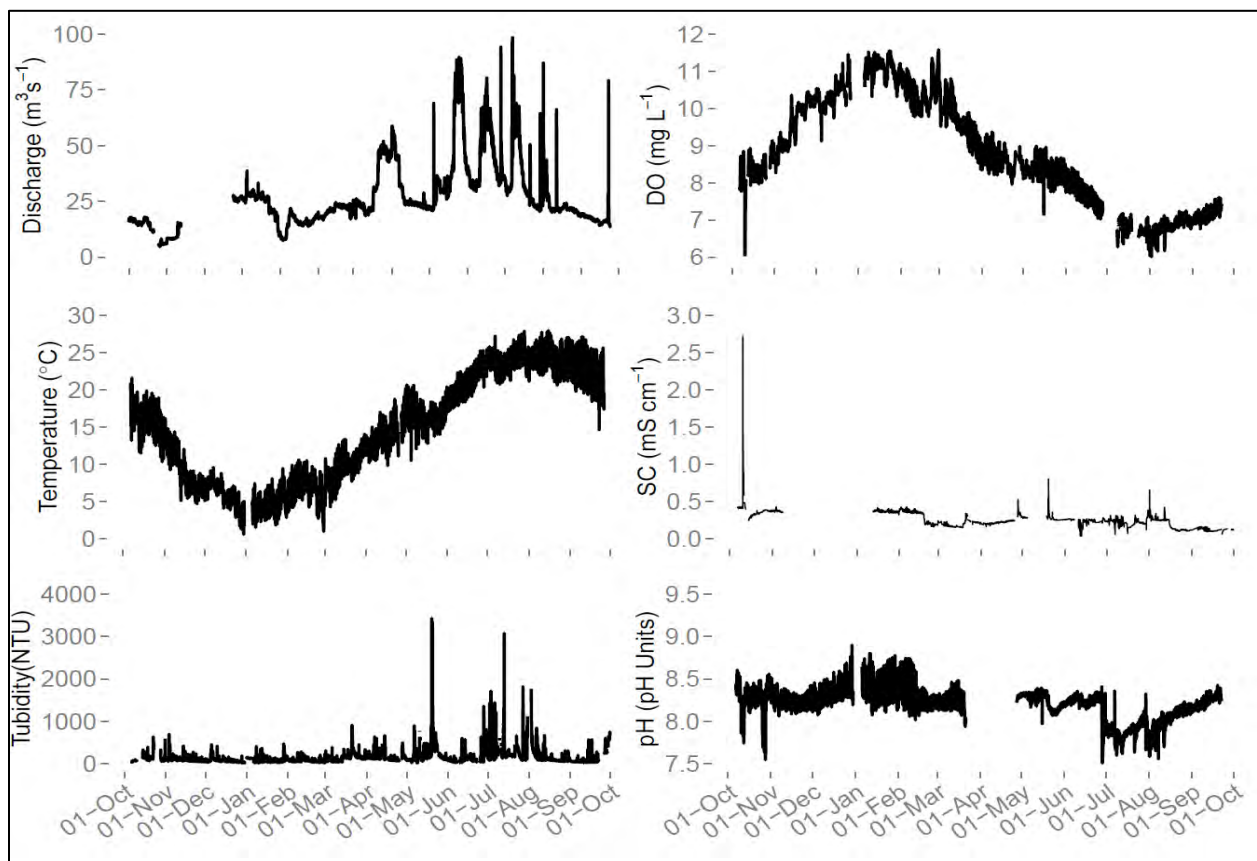
Long-term and continuous monitoring of water temperature, pH, dissolved oxygen (DO), turbidity, and specific conductance are measured at three stations (i.e., Alameda Bridge, Rio Bravo Bridge, and I-25 Bridge) within the project area since 2006 (Dahm et al. 2013, Van Horn et al. 2016). Figure 8 provides a representative example of the daily and seasonal temporal variability in water quality parameters on the Rio Grande (i.e., Alameda Bridge) within the project area during a recent water year (i.e., 2015). Low DO has been documented from the AMAFCA North Diversion Channel (NDC) (DBSA 2009, Van Horn Unpublished). Recent modifications to improve the NDC outfall to reduce the volume of anoxic water that accumulates there in warm months have been implemented (SWCA 2015, USFWS 2015). To date, the effectiveness of these modifications have not been evaluated. The Las Conchas fire (2011) also impacted water quality within the study area through 2013 (Dahm et al. 2015, Reale et al. 2015). Impairments included multiple DO sags to less than 2 mg L<sup>-1</sup>.

**Figure 8. Water quality and discharge data for the Rio Grande at Alameda during Water Year 2015. Discharge data is from the USGS gage at Alameda (Van Horn et al. 2016).**

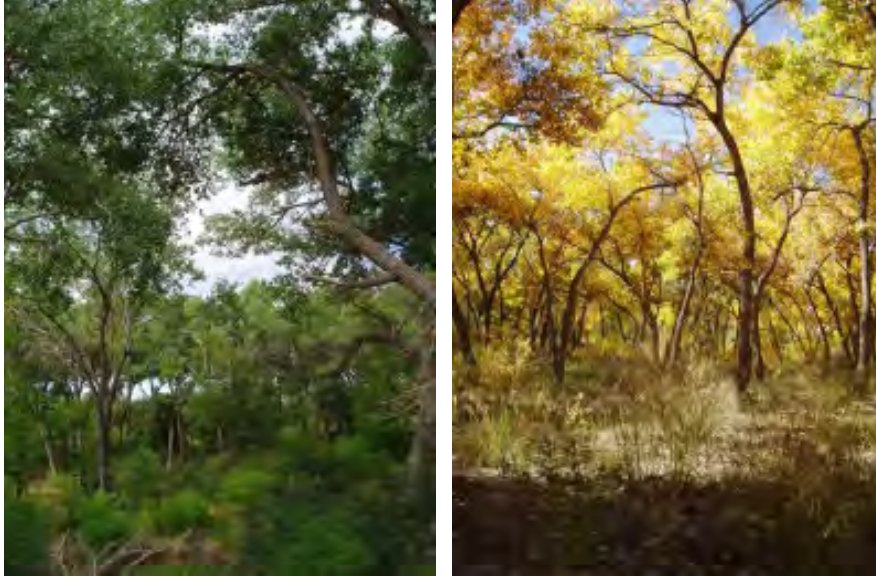
**Type 1:** Mature Riparian Forests with tall trees ranging from 50 to 60 feet in height, closed canopies, and well established (relatively dense) understories composed of saplings and shrubs.

**Figure 9. Classic examples of Type 1 vegetation in the Proposed Project Area.**

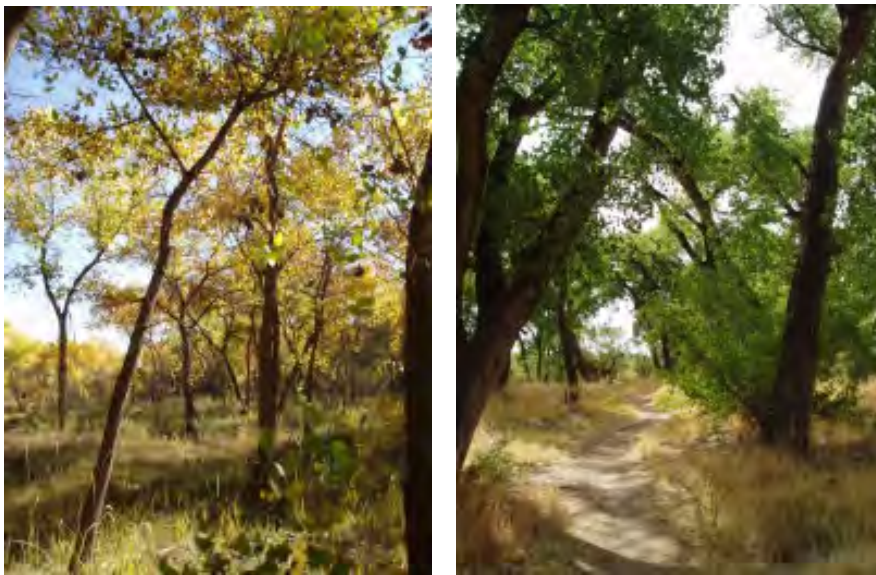
**Type II:** Mature Riparian Forests with tall trees exceeding 40 feet in height and nearly closed canopies, but limited saplings and shrub understories.

**Figure 10. Classic examples of Type II vegetation in the Proposed Project Area.**

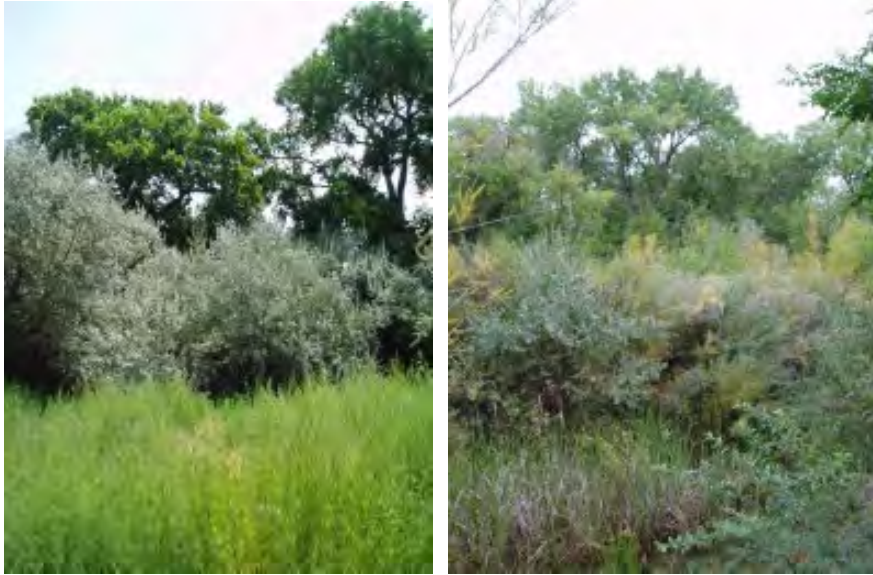
**Type III:** Intermediate-aged Riparian Woodlands characterized by mid-sized trees less than 30 feet in height, but with closed canopies and dense understories.

**Figure 11. Classic examples of Type III vegetation in the Proposed Project Area.**

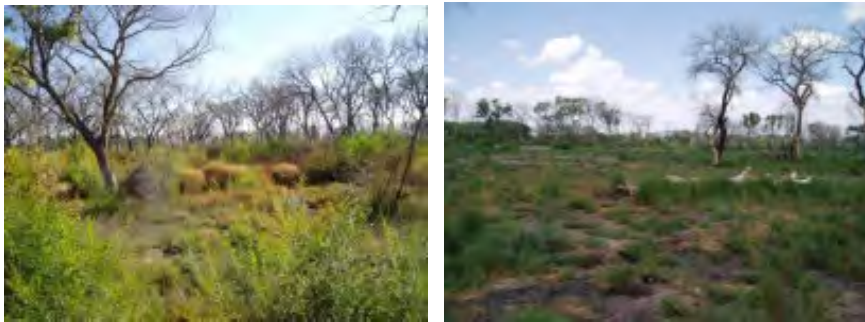
**Type IV:** Intermediate-aged Riparian Woodland/Savannahs characterized by open stands of mid-sized trees with widely scattered shrubs and sparse herbaceous growth underneath.

**Figure 12. Classic examples of Type IV vegetation in the Proposed Project Area.**

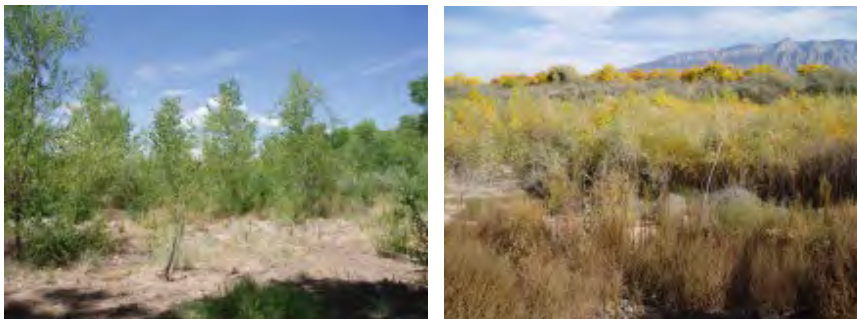
**Type V:** Riparian shrubs characterized by dense vegetation (shrubs and saplings) up to 15 feet in height, but lacking tall trees species, and often having dense herbaceous growth underneath.

**Figure 13. Classic examples of Type V vegetation in the Proposed Project Area.**

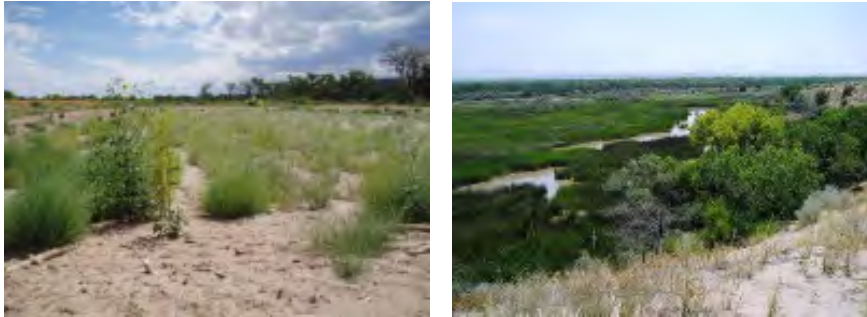
**Type VI:** Dry grass meadows and wet marshes characterized by scattered plant growth composed of short shrubs (less than 5 feet in height), seedlings, and grasses. This category includes both dry meadows and the rare marshes found in the oxbow of the Rio Grande that are vegetated with cattail, bulrush, sedges, watercress and algae.

**Figure 14. Classic examples of Type VI vegetation within the Proposed Project Area.**

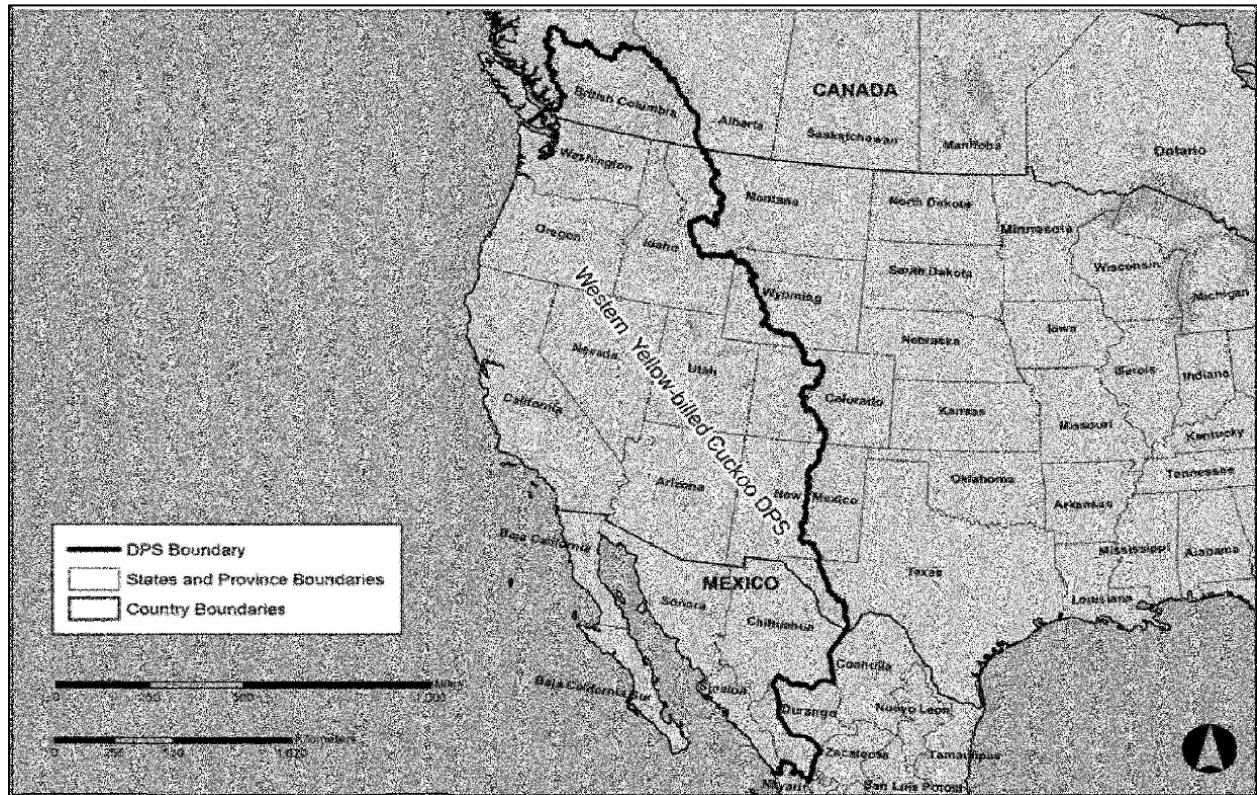
**Figure 15. Range of the Western Distinct Population Segment of the Yellow-billed Cuckoo.**

The USFWS identified cuckoos west of the Continental Divide as a Distinct Population Segment (DPS) based on physical, biological, ecological and behavioral factors; but in central and southern New Mexico, the boundary of the western DPS is along the crest of the southern Rocky

Mountains (see Figure 14) (USFWS 2014). Cuckoos currently breed in California, Arizona, New Mexico, Utah, Wyoming, Colorado, Idaho, and Texas (USFWS 2014). The State of New Mexico currently does not include the cuckoo in any formal protection category.

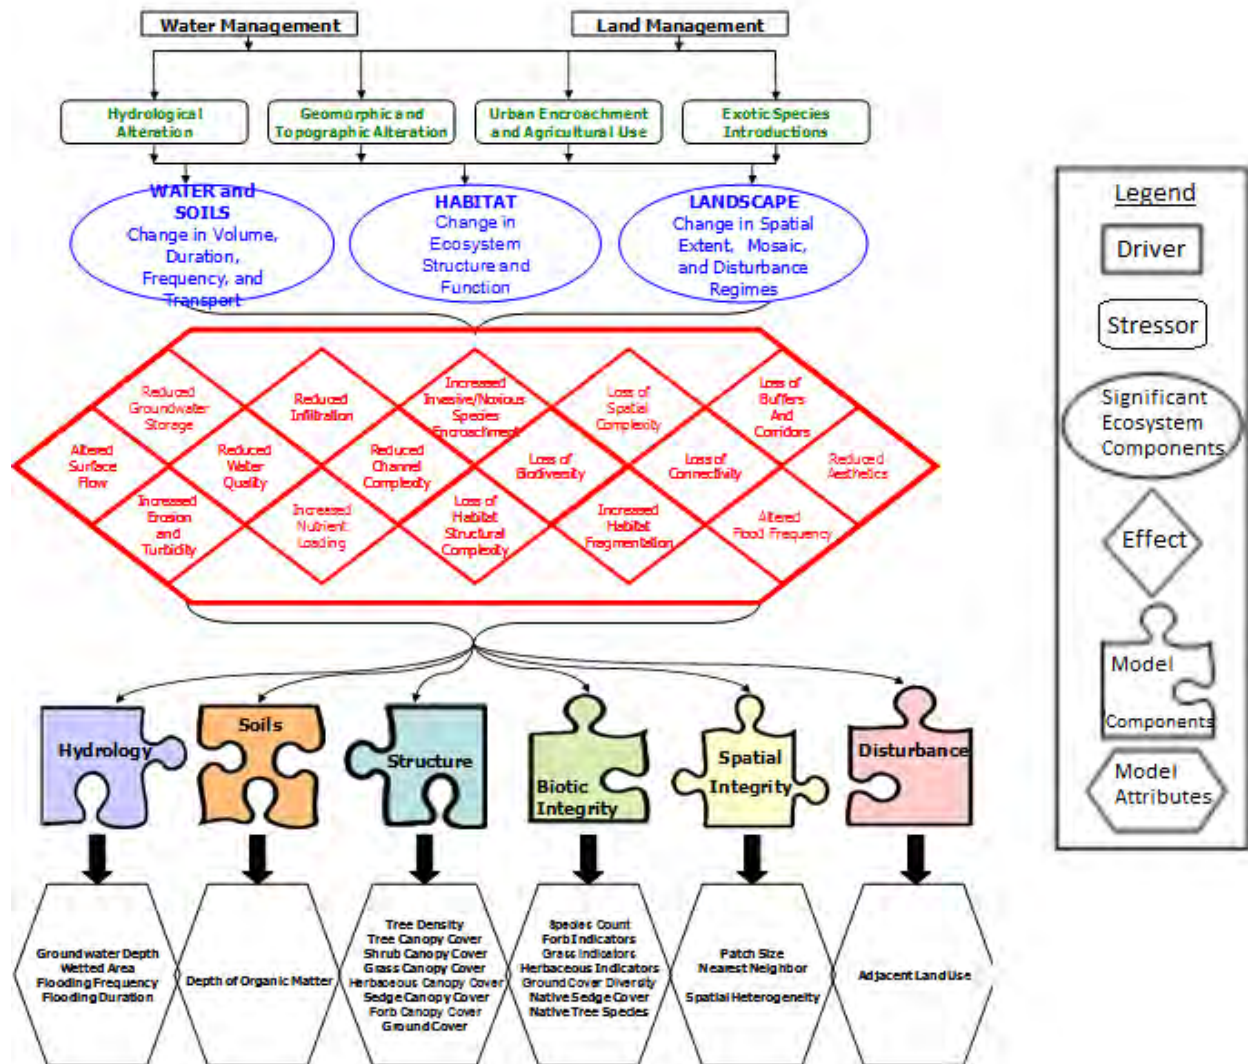
Figure 16 Conceptual Model for the Middle Rio Grande Bosque Ecosystem.

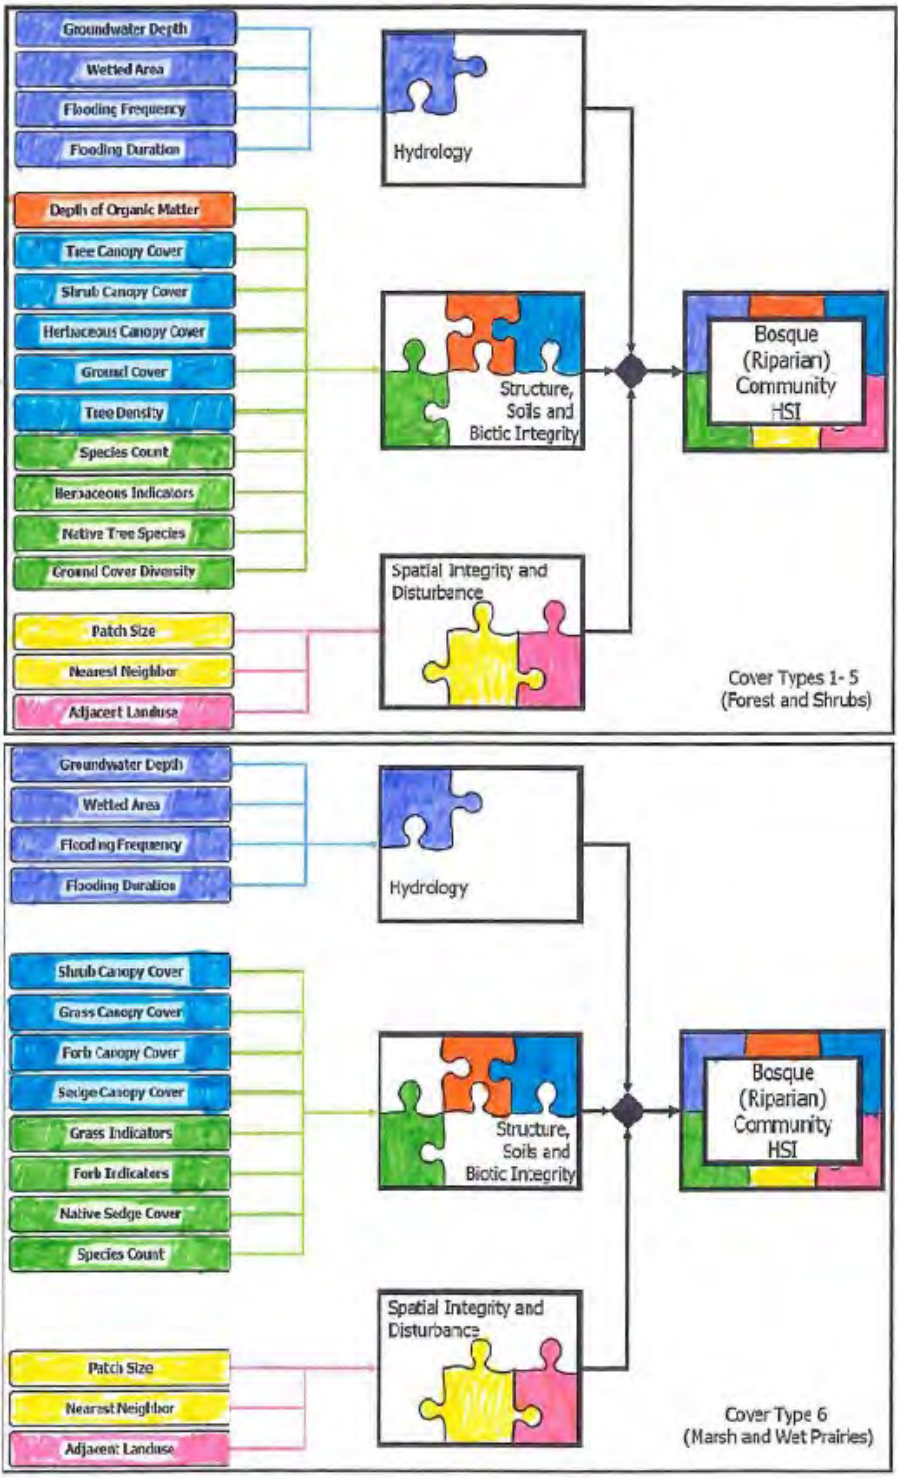
Figure 17 Flow diagram depicting combinations of model components and variables to from the Bosque community index model.

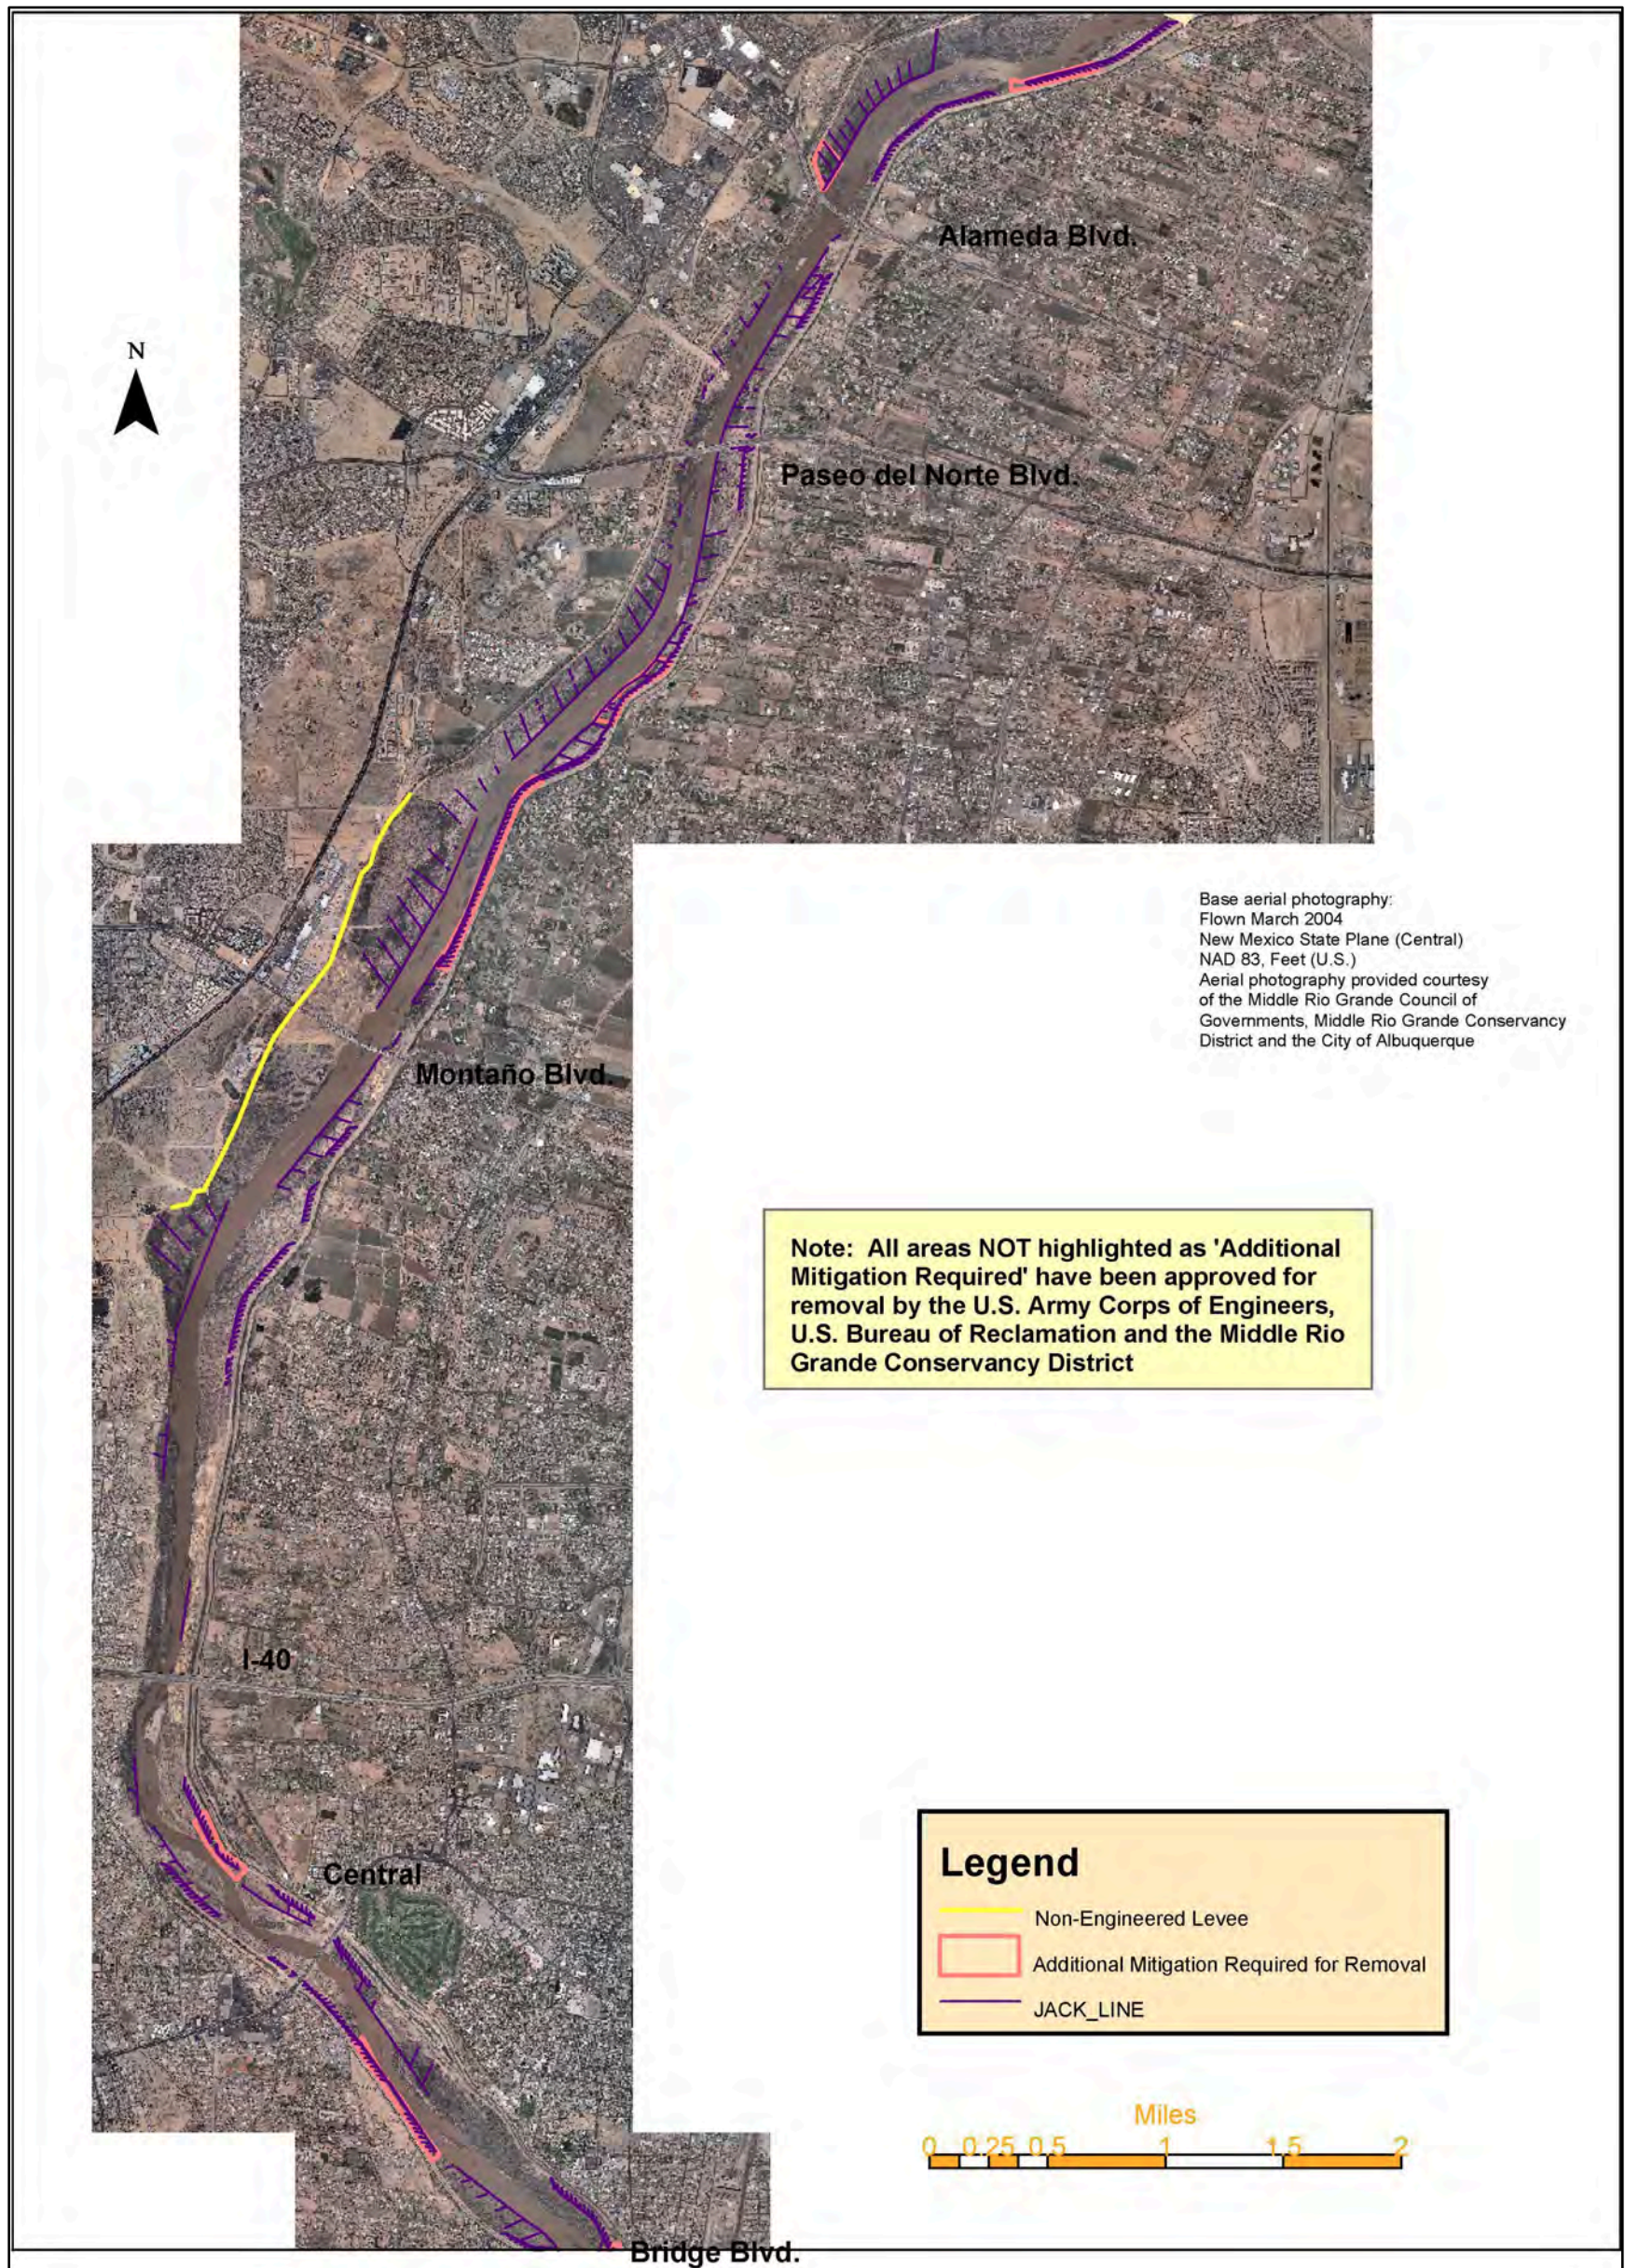
Within the study area, all jetty jacks were assessed by USACE, Reclamation, and the MRGCD. Both non-essential jetty jacks and jetty jacks that continue to provide necessary stabilization functions were identified and mapped. The three agencies agreed to the strategy of identifying non-essential jetty jacks (Figures 34 and 35), and the agencies agreed that jetty jacks within these areas can be removed by any of these agencies and/or other local stakeholders as part of restoration projects after receiving approval from USACE, MRGCD, and Reclamation. Any proposed alternatives that include areas where jetty jacks cannot be removed without additional protection would be evaluated to determine what type of protection would be needed in order to remove the jetty jacks as part of the study.

Figure 18. North Jetty Jack Locations and Segments Approved for Removal.
