# **Rio Grande Environmental Management Program, CO, NM, TX**

## **Sandia Pueblo to Isleta Pueblo, New Mexico Ecosystem Restoration Feasibility Study and Environmental Assessment**

**FINAL**

**May 2019**

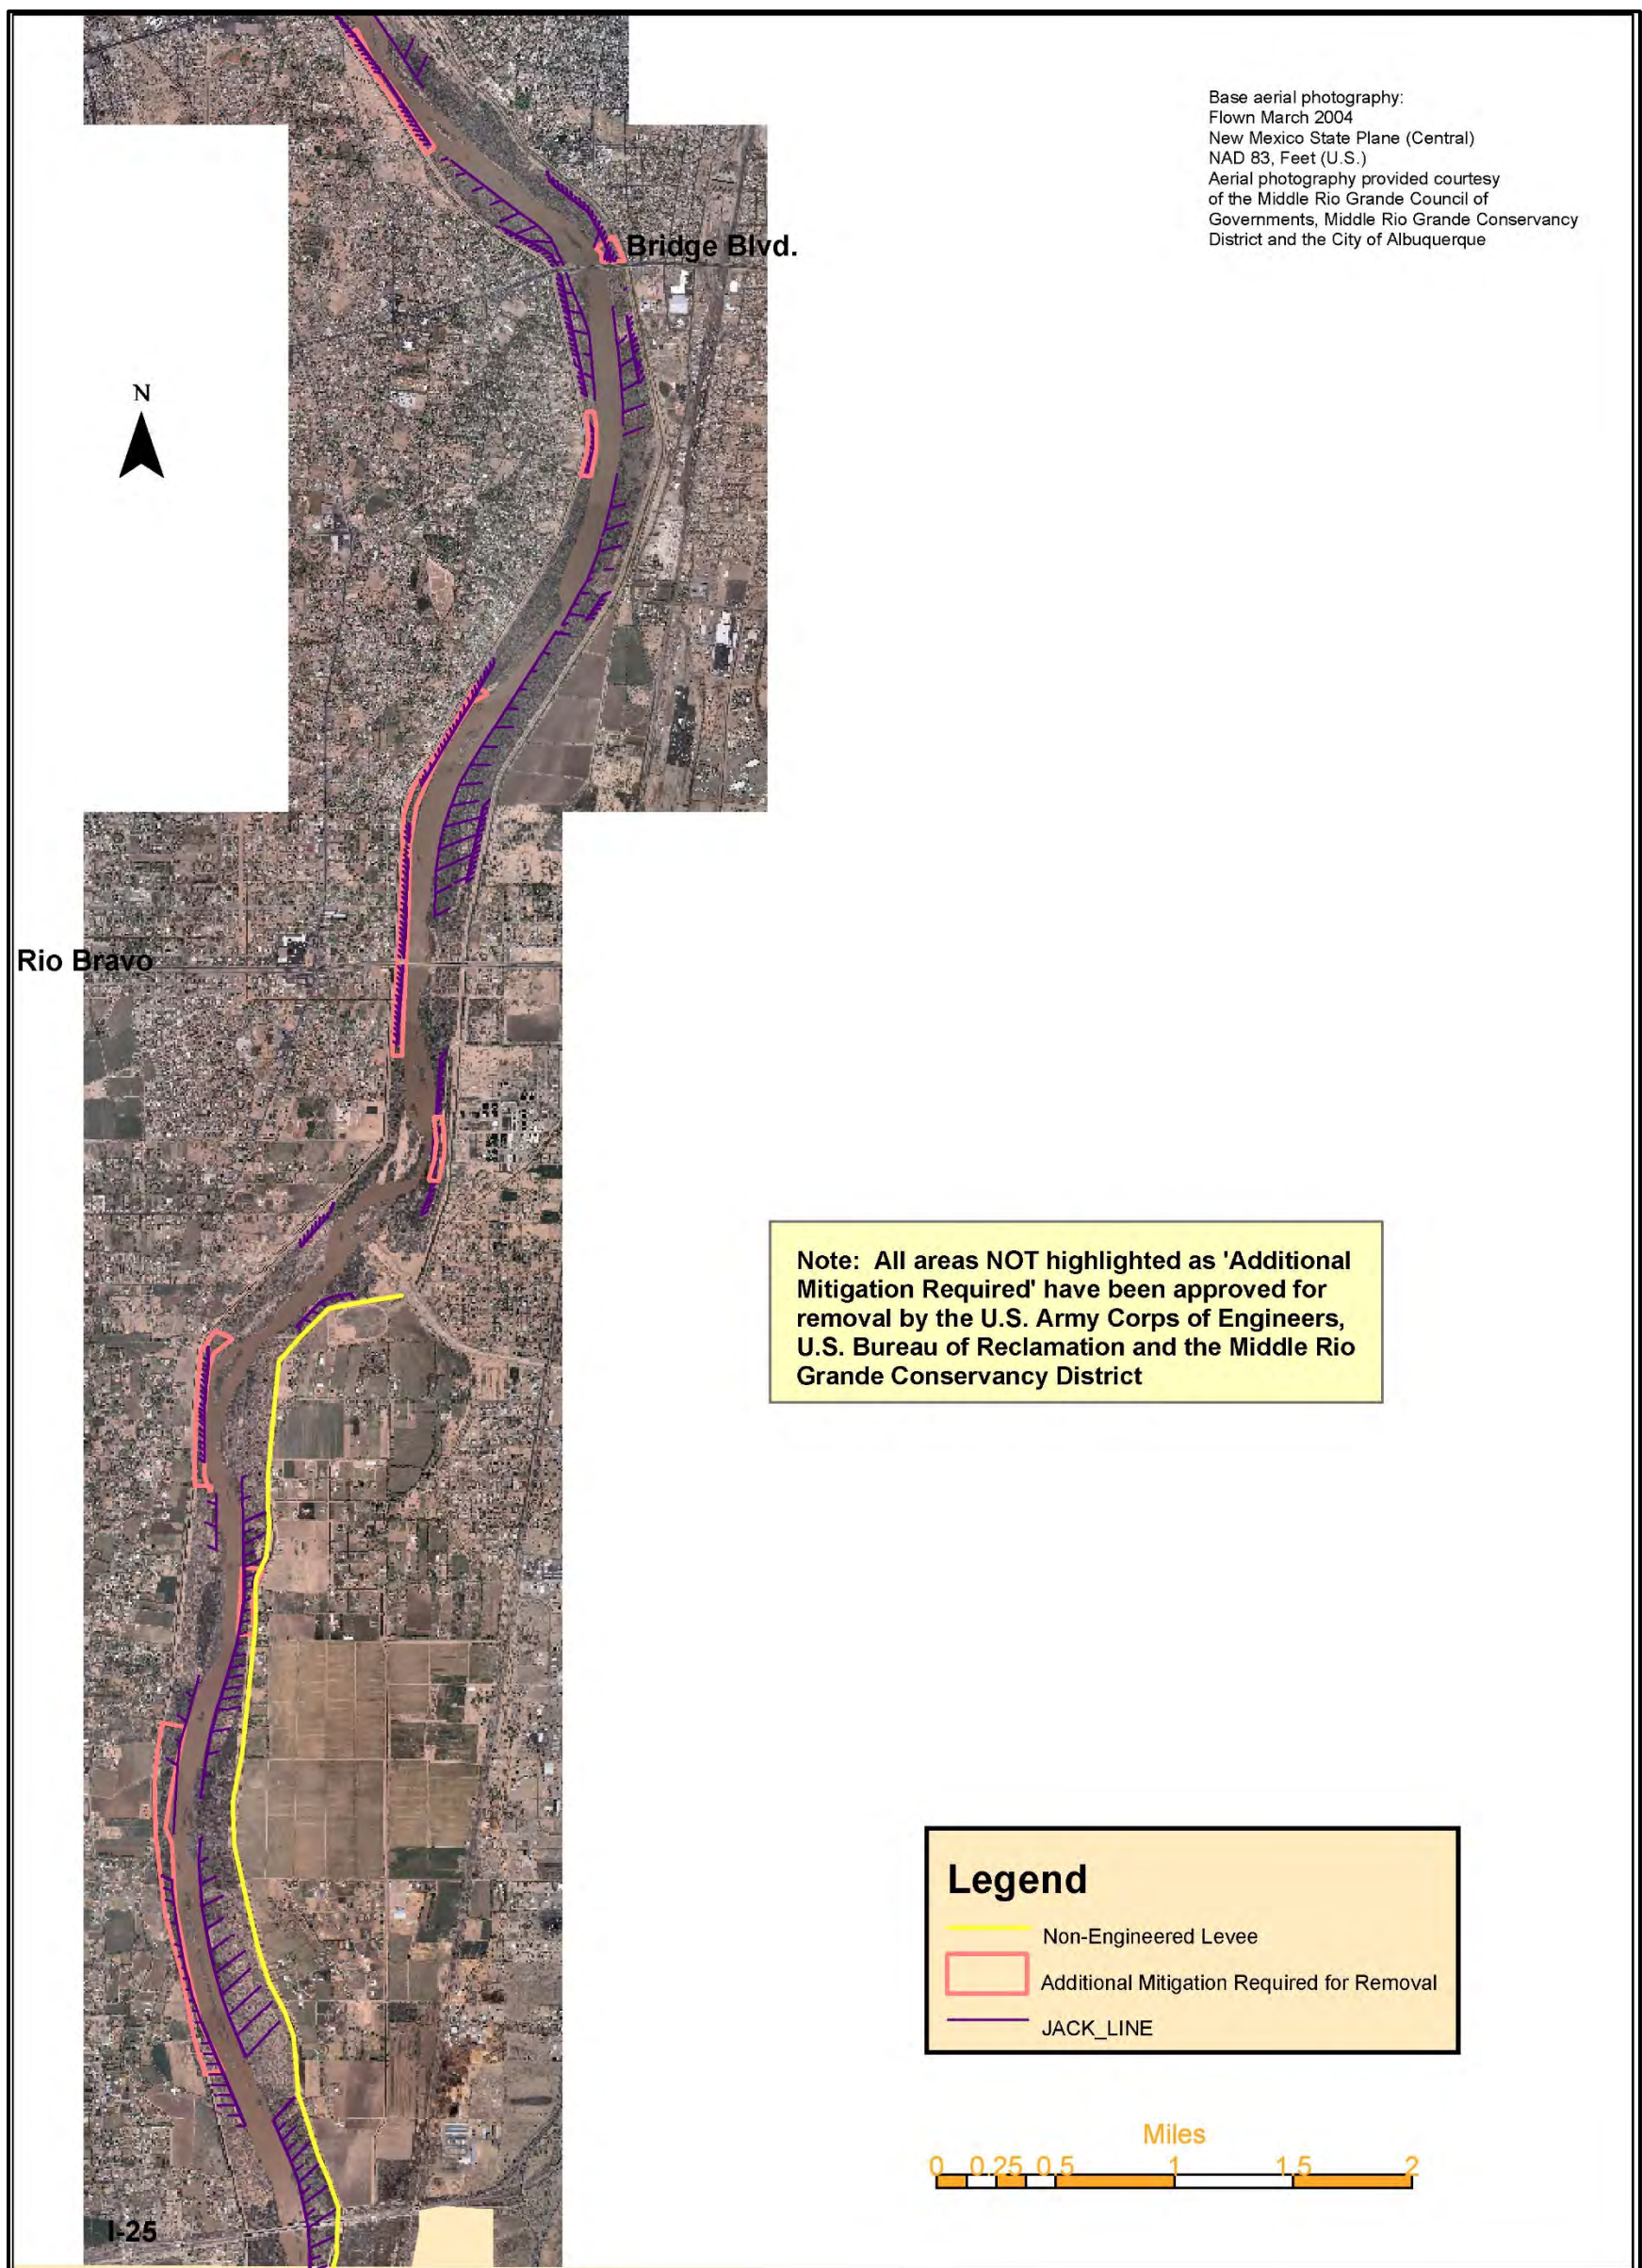
Figure 19. South Jetty Jack Locations and Segments Approved for Removal.

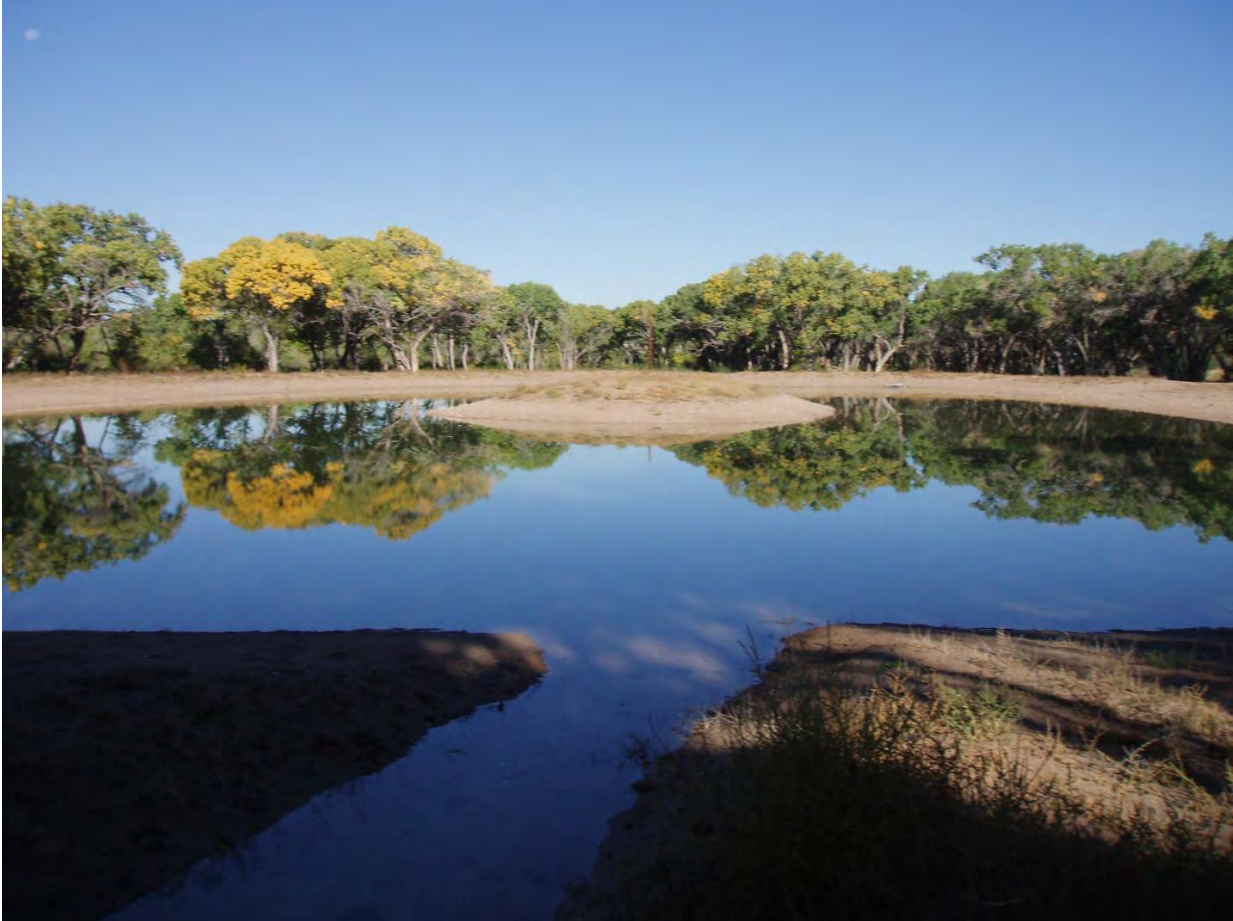
An open water wetland could be something similar to that constructed at the Albuquerque Biological Park Wetland (Figure 20). Wetlands of this type provide open water habitat for migrating and local waterfowl and aquatic habitat for numerous species.

**Figure 20. Albuquerque Biological Park Wetlands prior to wetland plant establishment.**

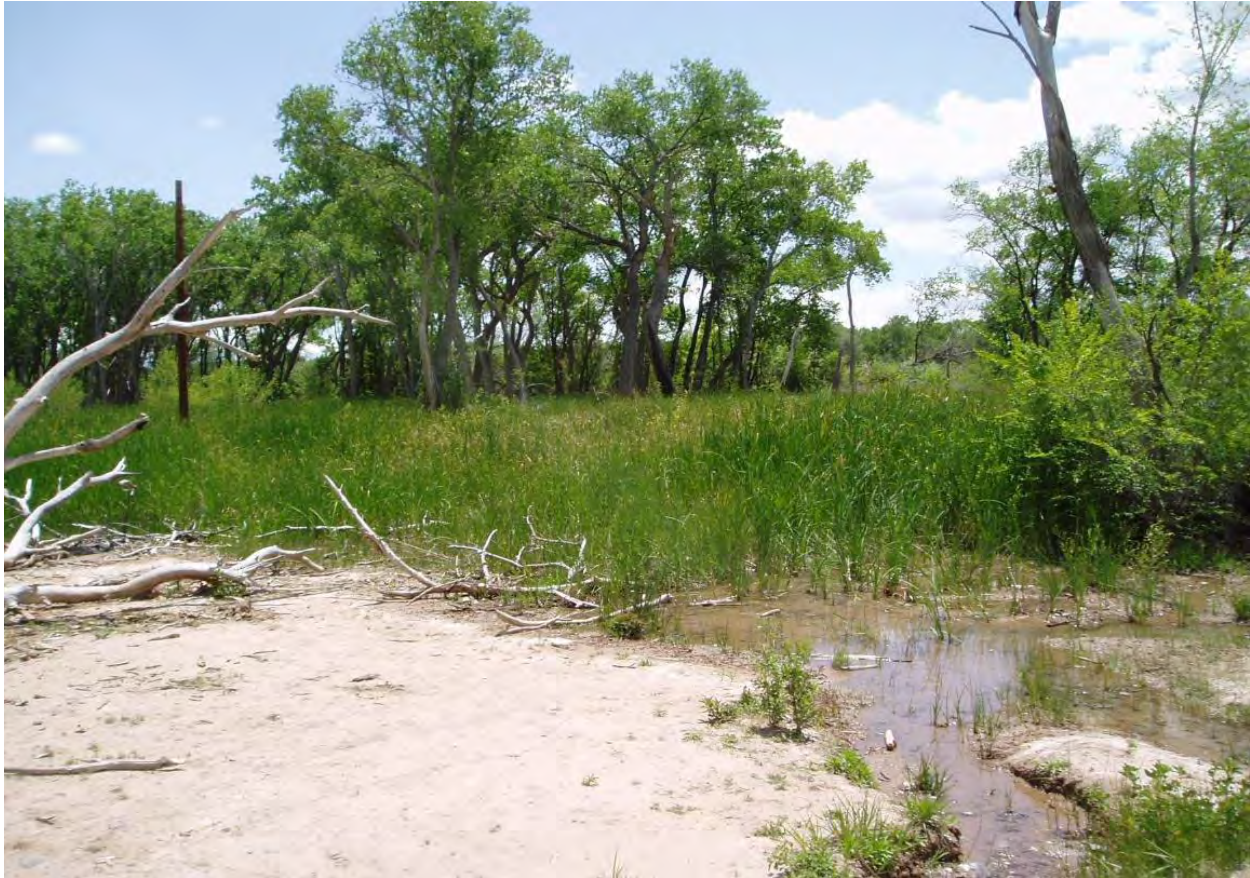
A marsh wetland (or wet meadow) would have fluctuating water levels and various vegetative species. These areas can be created by lowering the ground level and/or letting surface water from a wetland area flow into a riparian area. Marshy or moist soil habitat is created, similar to that of the wet meadow at the Albuquerque Biological Park Wetland (Figure 21).

**Figure 21. Albuquerque Biological Park Wetlands Wet Meadow, May 2007.**

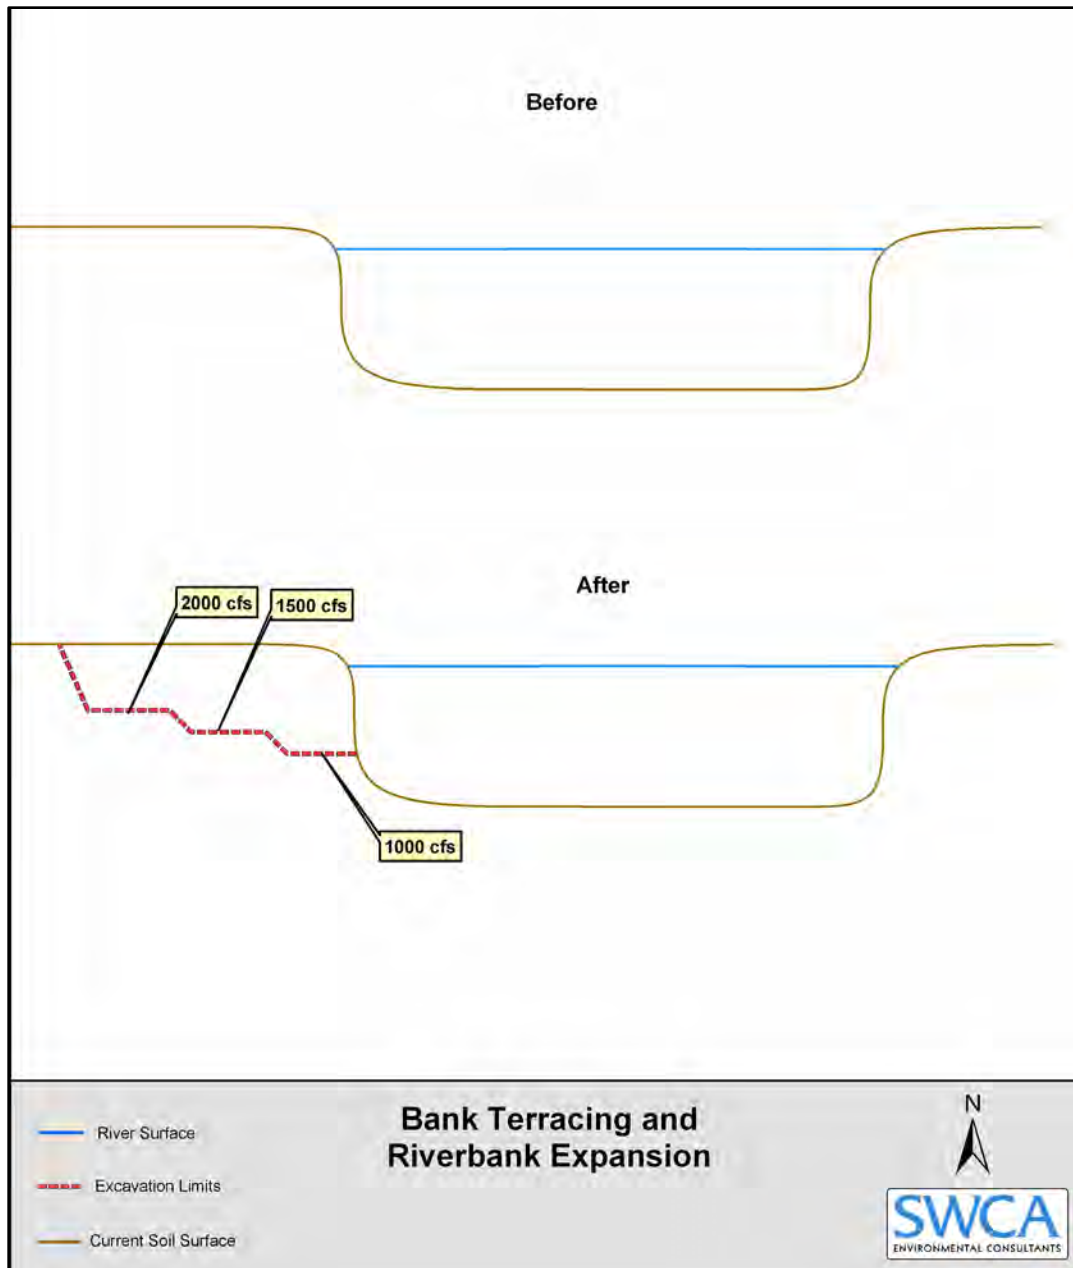
Bank lowering involves the removal of vegetation and excavation of soils adjacent to the main channel to enhance the potential for overbank flooding (Tetra Tech 2004). This technique, demonstrated in Figure 22, has been used in various locations of the Middle Rio Grande, primarily for creation of potential habitat for the Rio Grande silvery minnow by the MRGESCP. The E-team analyzed various locations for bank lowering potential.

Figure 22. Schematic of bank (lowering) (SWCA, 2006).

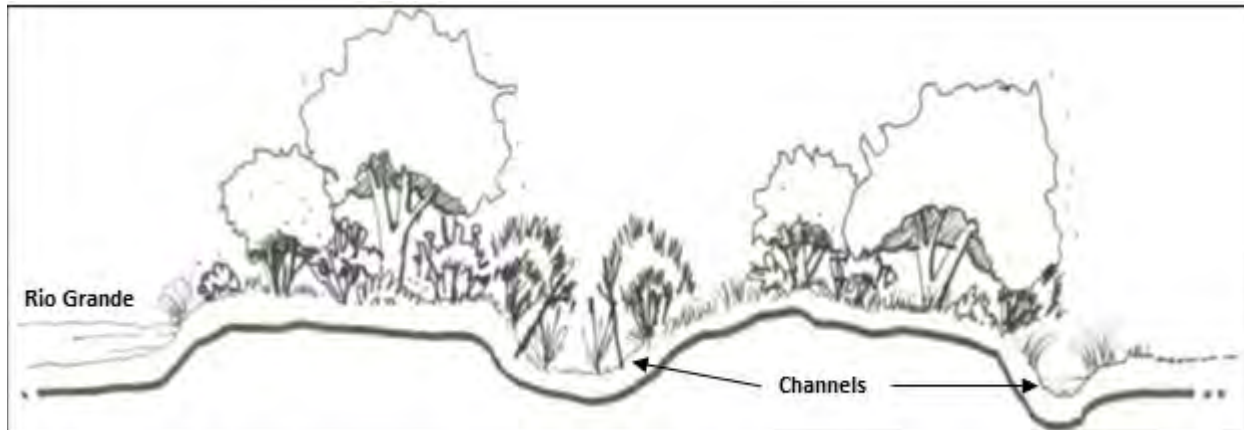
with native plants to increase the habitat quality within the bosque. High-flow channels would deliver much-needed water to bosque vegetation and increase potential water-based habitats for animals.

**Figure 23. High flow channel schematic.**

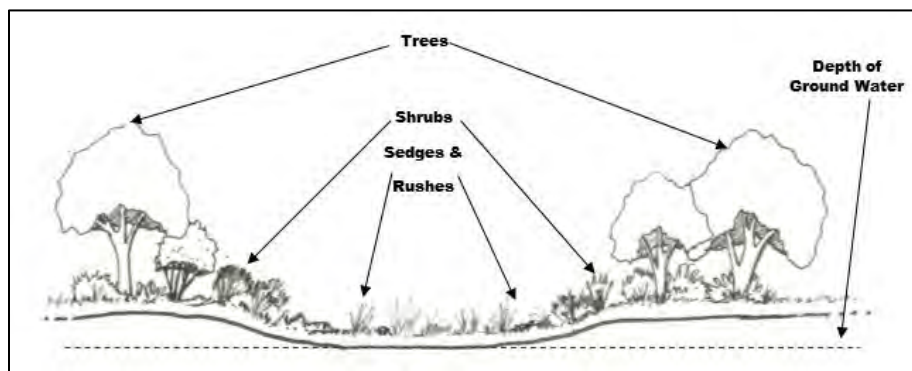
The willow swale measure entails optimizing the depressions created by removal of non-native vegetation, dumped debris, and jetty jacks to provide micro-environments to contain native plants that can thrive due to the decreased distance to the water table and moist soils. In certain areas of the bosque, the depth-to-water table is minimal, and even slight excavations expose water (Figure 24). Willow swales also help create vegetative habitat where establishment of native plants or seed would be challenging due to soil type. Sample plots have illustrated that standing water can occur when the non-native phreatophytes are removed. These excavated areas could be planted with riparian shrub, wetland, or mesophytic plants. Depending upon the location, there could be a series of willow swales that become progressively drier with increasing distance from the river or water table. Once established, native plants could thrive in these depressions. This measure would create wet meadow and shrub habitat. A series of depressions, approximately one half acre in size, would be created within a five- to 10-acre area. The number of depressions within each swale would be determined by site-specific conditions.

**Figure 24. Schematic concept for Swale.**

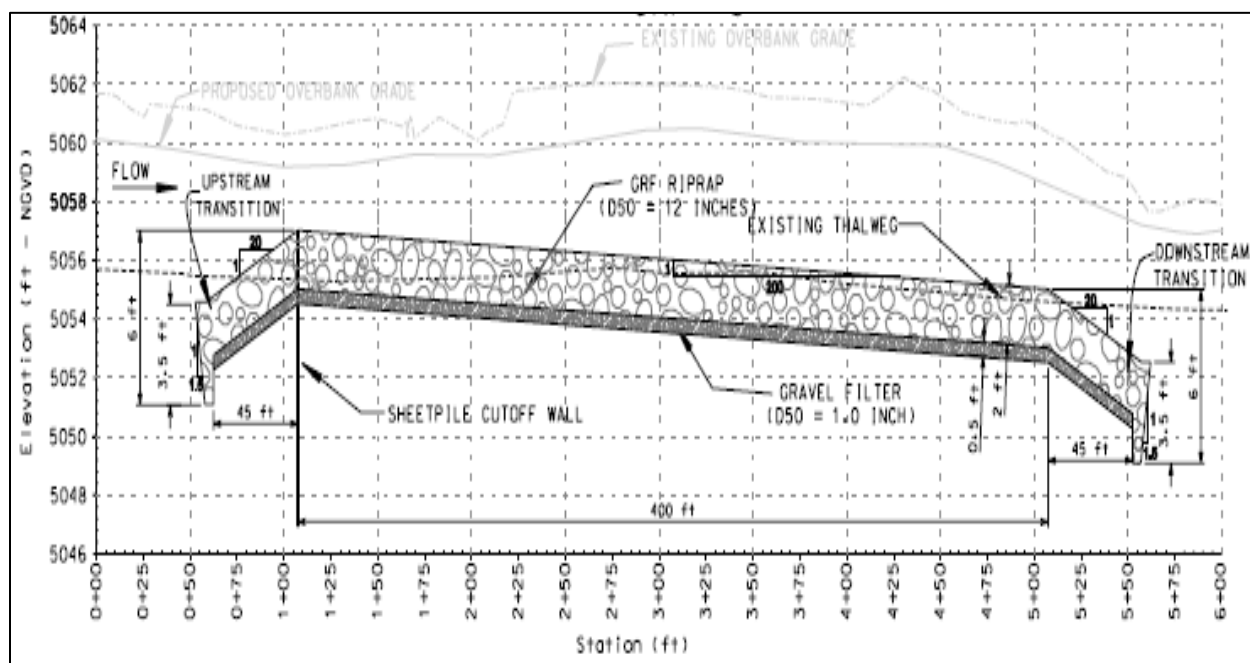
Considering the objectives of habitat restoration, channel bed stabilization is useful in light of the future degradational tendency of the Rio Grande expected for this reach. A gradient restoration facility (GRF) would be considered for grade control to stabilize the current river bed also while providing fish passage opportunities. A GRF is a sloping rock structure that can provide vertical channel stabilization while maintaining fish passage (Figure 25). GRF's include several structural components: sheet pile/cutoff wall, main channel apron, overbank armor, upstream and downstream channel transitions, upstream and downstream overbank cap, and bankline revetment keys. The GRF acts as an artificial riffle and provides a gradual increase in channel and water surface elevations rather than a vertical drop structure.

**Figure 25. Grade Reduction Facility Conceptual Design.**

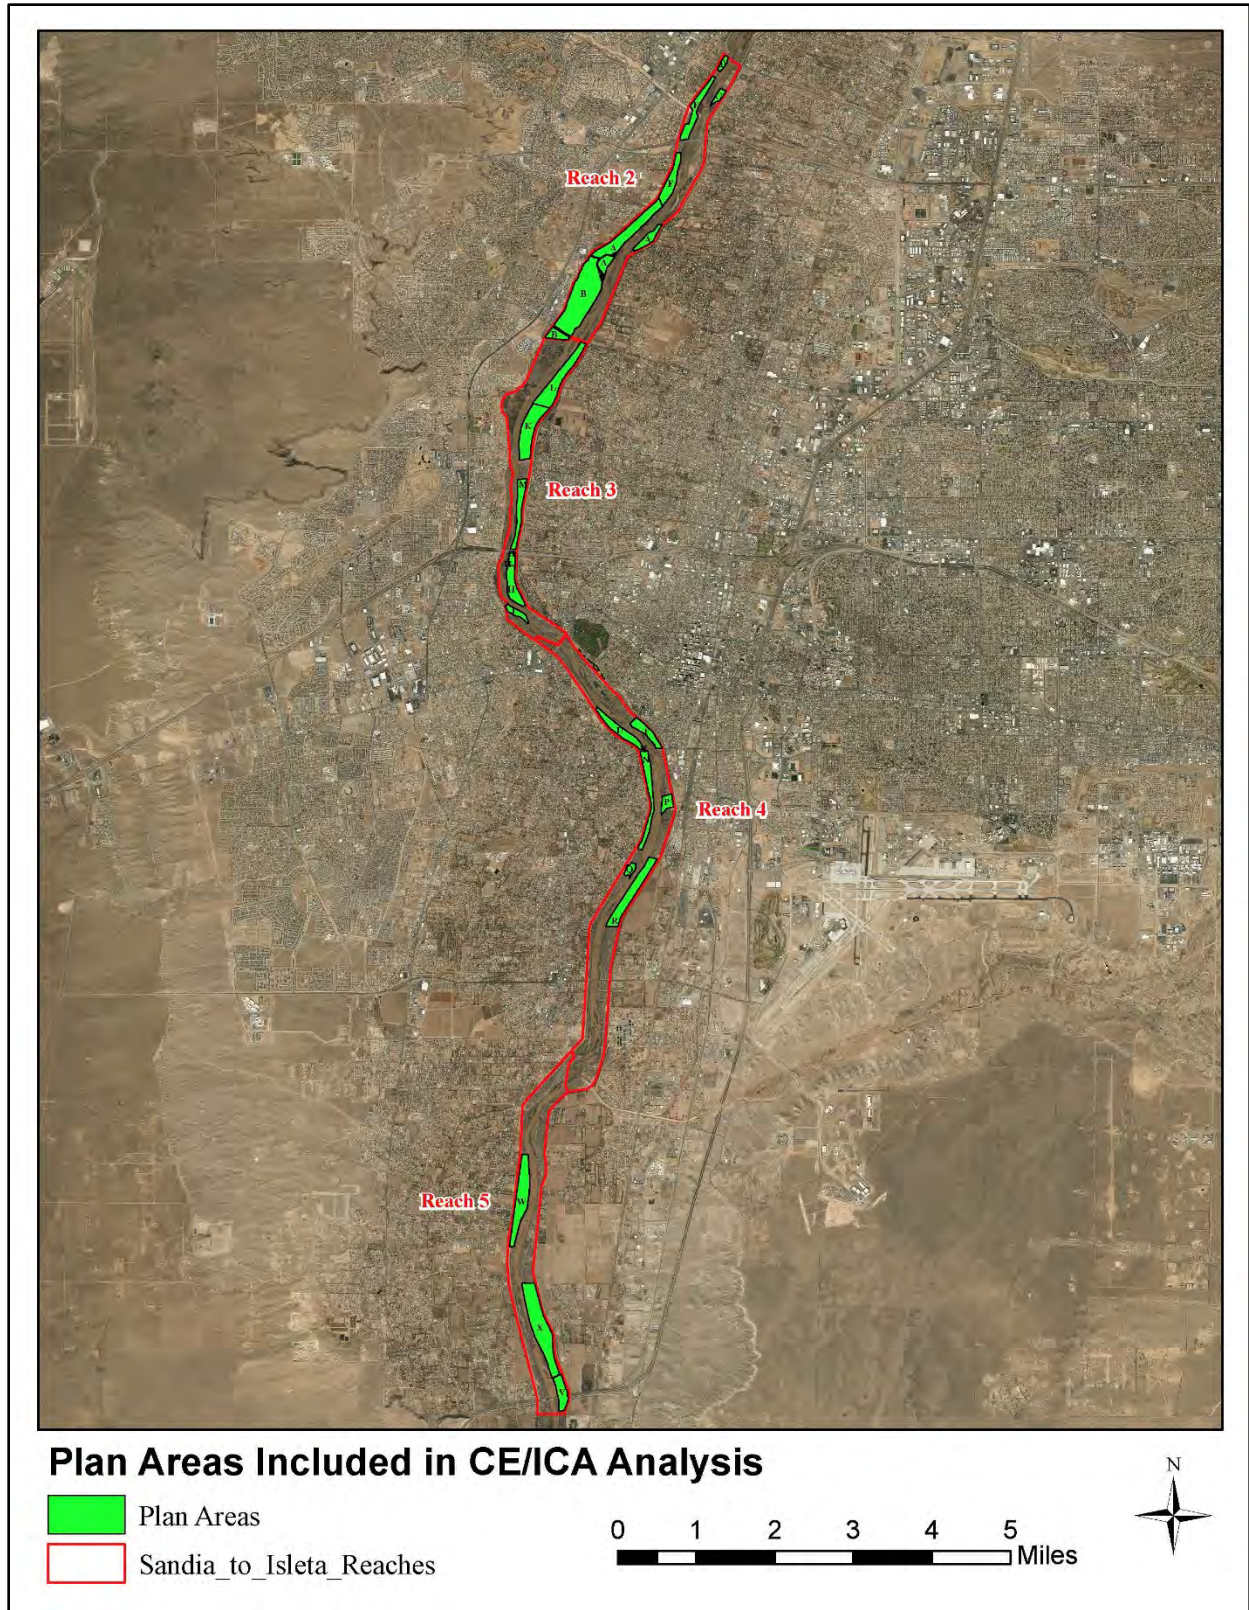
Figure 26. Plan Areas Included in CE/ICA Analysis.

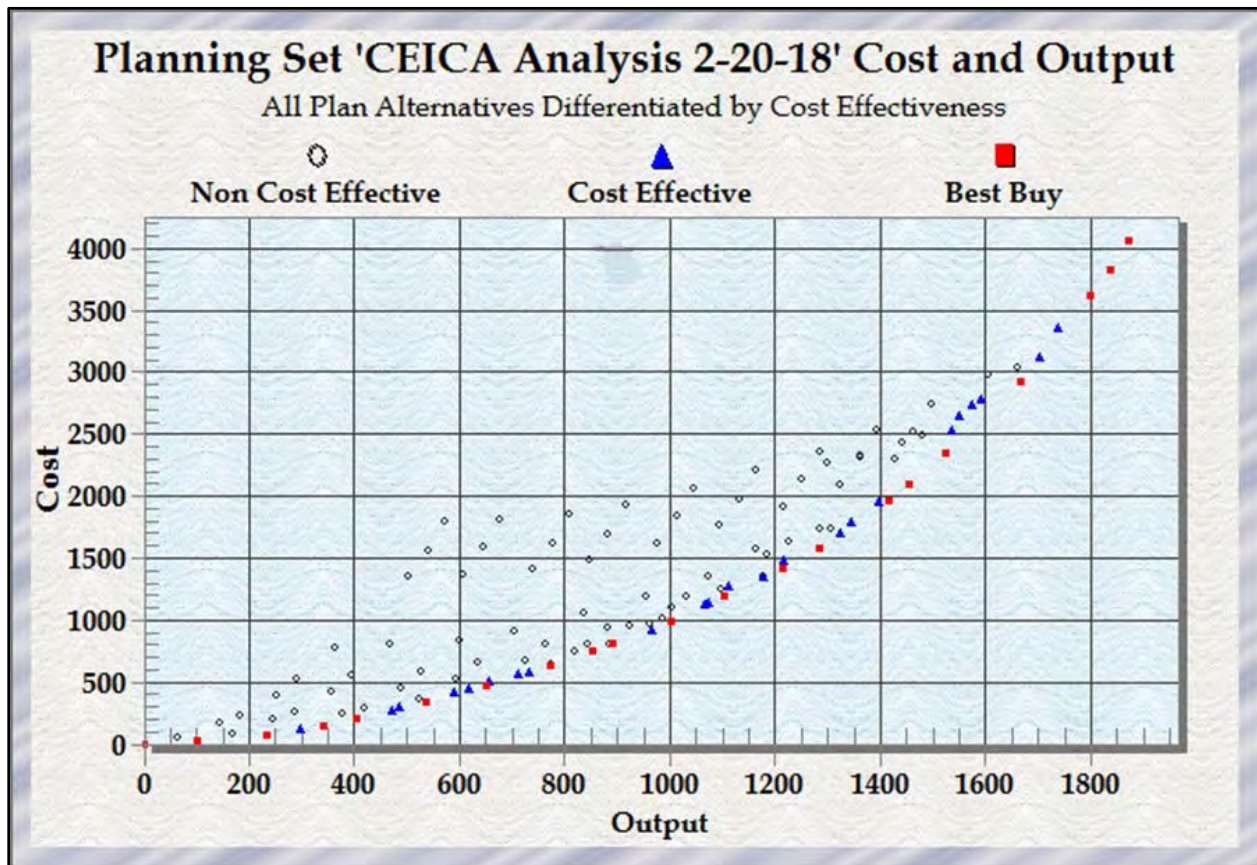
Once the cost and output of each of the 20 plan areas were assigned, the CE/ICA determined which combinations of plan areas or alternative plans produced the most output for the unit cost. The CE/ICA was used to screen out all alternative plans that were not cost effective. The results of the analysis resulted in a set of 119 alternatives, of which 44 were cost effective and 20 were best buys (Figure 27). The cost of the best buy plans ranges from \$597,000 to \$101,000,000. Output is measured by the HEAT/BCIM as increase in average annual habitat units (AAHUs), ranges from 104 AAHU to 1872 AAHU (See Section 2.9.1). Figure 28 shows the distribution of the best buy plans plotted as cost versus output.

Figure 27. CE/ICA Scatter Plot Graph.

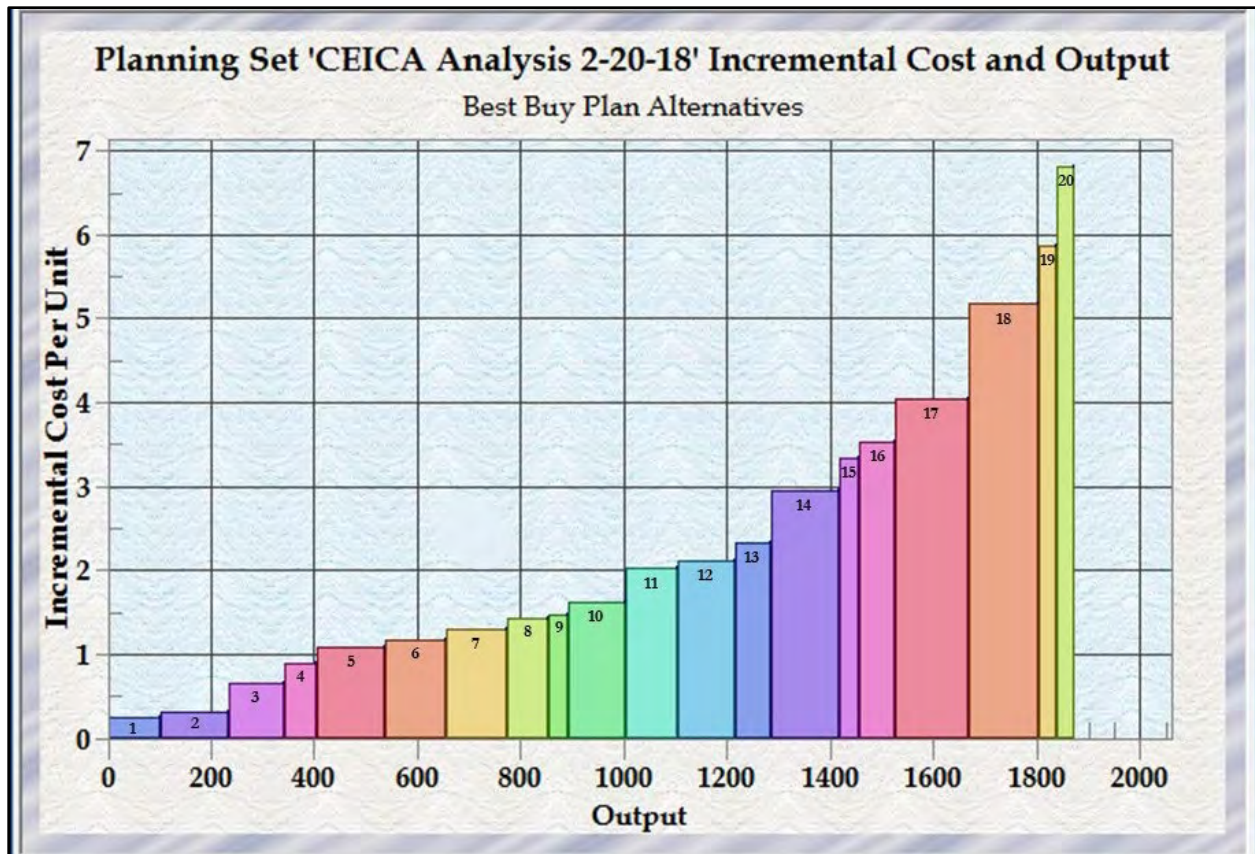
Figure 28. CE/ICA Bar Graph.

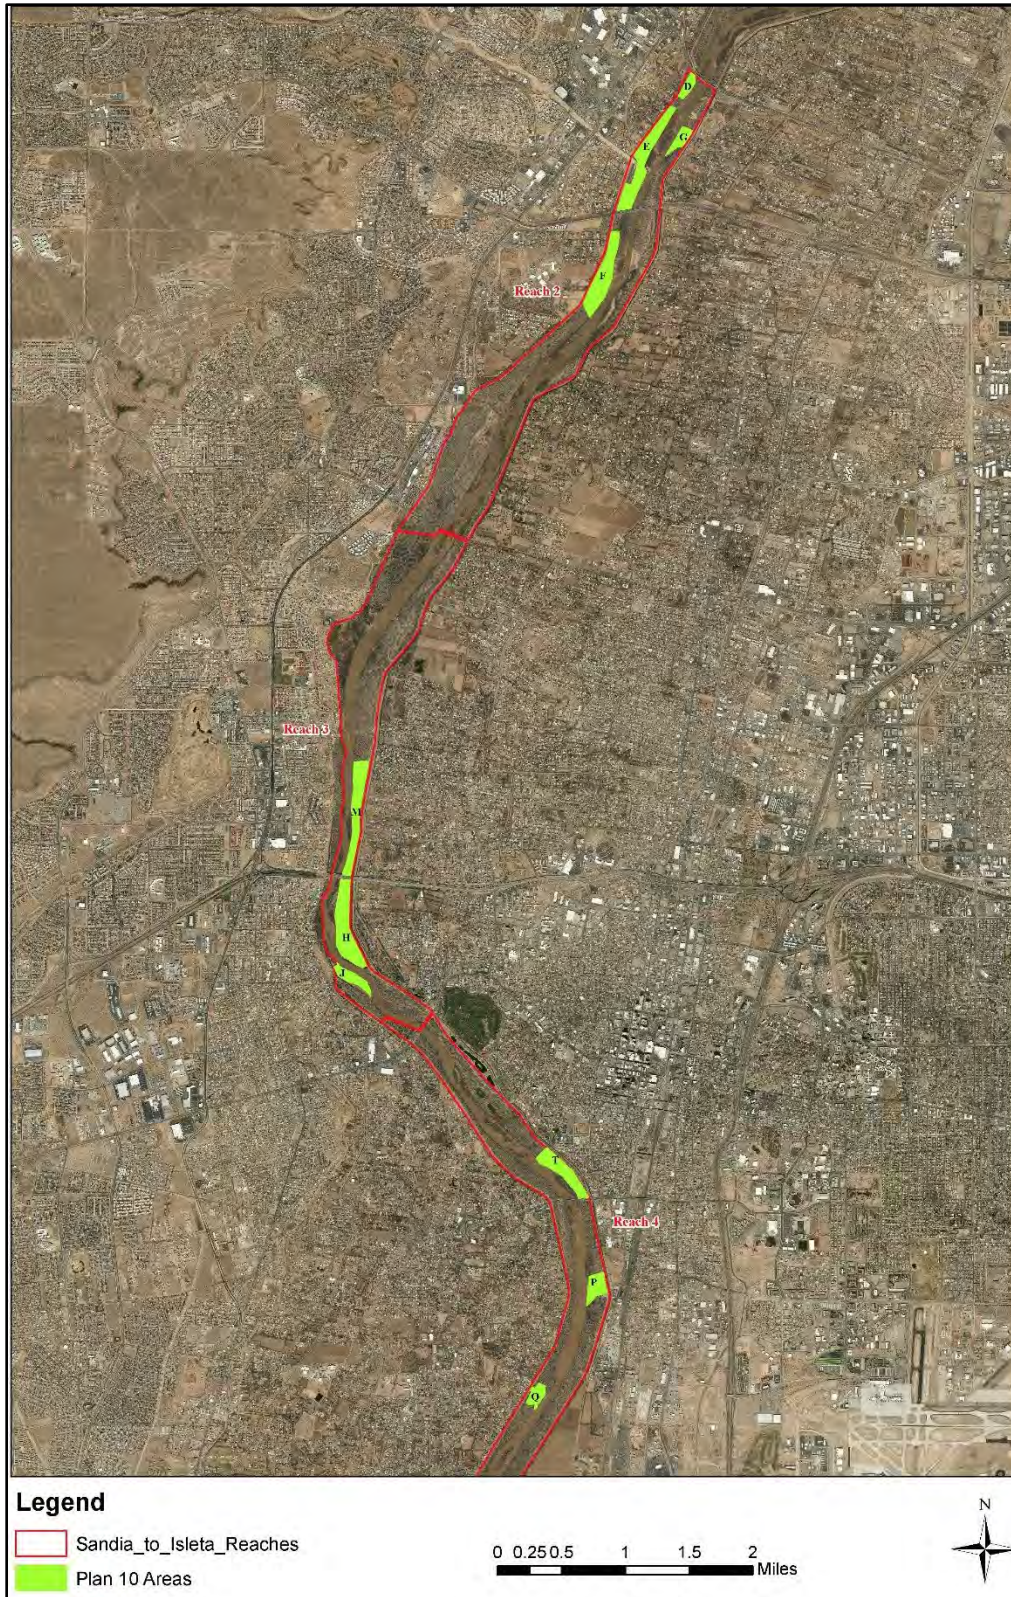
Based on the analysis presented above, the TSP, or National Ecosystem Restoration Plan, is Best Buy Plan #10. As discussed, the TSP incorporates plan areas D, E, F, G, H, J, M, Q, P, and T. The areas provide the following measures: 42 Willow swales, 15 Treat-Retreat-Reveg, 5 Hi-flow Channels, 3 Wetlands, 2 Connections to River, 1 Enhance ditch for wet habitat, 1 Wet Meadow, 1 Divert outfall flows, 1 Bankline terrace, 3 Remove berms. The TSP has an approximate cost of \$22,587,023 implementing measures over approximately 261 acres and provides for an increase of 1,003 AAHUs. Figure 29 shows the TSP plan areas within the study area. Best Buy #10 is the first plan (see Table 13) to include bankline terracing which is an important water feature that meets study objectives for the lowest cost.

Figure 29. Plan Areas for the Tentatively Selected Plan.
